## **Planning Conditions - CM7**

**Address:** 36 & 38 Rose Street

**Application Ref:** 250221 and 242929

### **CM7 – Further Details Required**

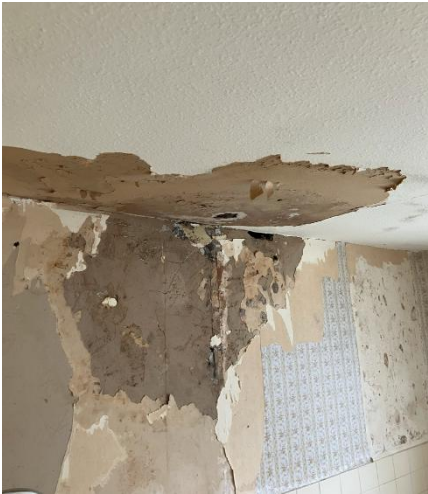
| Photo No | Description | Location | |
|---|---|---|---|
| Photo 1 | Damp wall | No 36. First floor | |

**Walls:** The existing plasterboard will be carefully removed by hand to expose the underlying studwork. Where the existing boarding is a modern, non-original addition, it will be replaced with a more breathable and sympathetic alternative — such as wood fibreboard or traditional lath — depending on the existing build-up.

The new boarding will be finished with a lime-based plaster system to ensure breathability and compatibility with the building's historic construction. Works will be undertaken in a manner that preserves adjacent historic fabric, with minimal intervention.

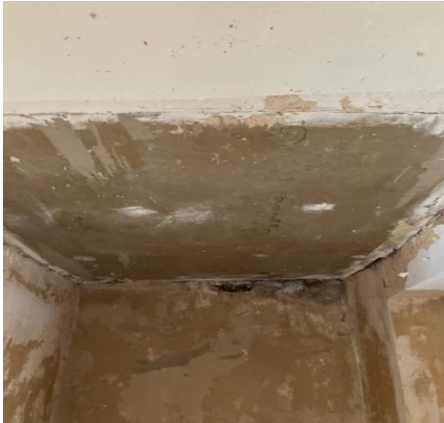
| Photo No | Description | Location | |
|---|---|---|---|
| Photo 2 | Damp Wall | No 36. First floor | |

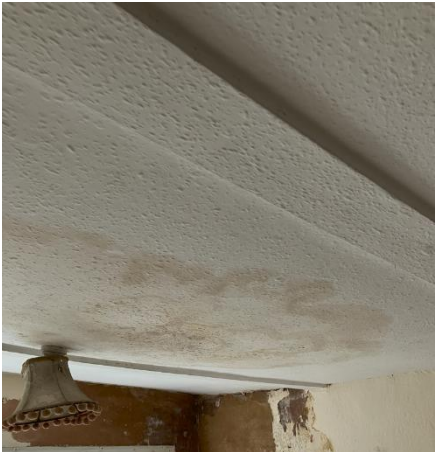
| Photo No | Description | Location | |
|---|---|---|---|
| Photo 3 | Damp Ceiling | No 36. First floor | |

**Ceilings:** The damaged ceiling area will be opened up with care to assess the condition of any concealed structural timbers and lath. Where original lath-and-plaster construction remains, it will be repaired using compatible lime-based materials, and new hardwood laths will be introduced only where existing are too deteriorated to retain.

Where modern plasterboard has previously been installed, this will be removed and replaced with a more suitable breathable system, such as lath and lime plaster or wood fibre board with lime finish, to support moisture movement and protect the building's fabric. All repairs will be made using traditional methods, with minimal loss of original material.

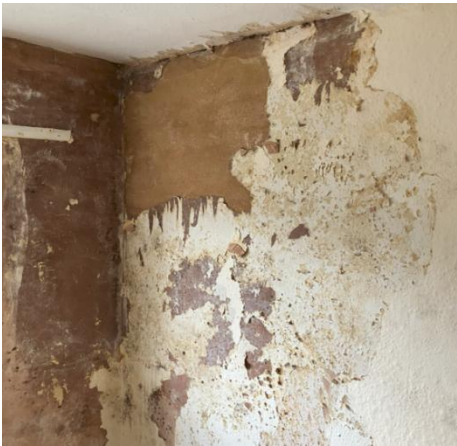
| Photo 4 | Damp Wall | No 36. First floor | |

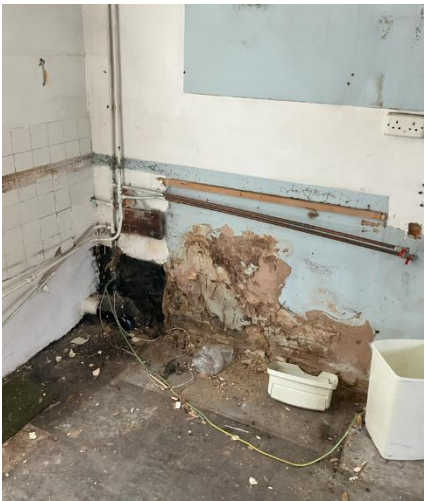
| Photo 5 | Damp Wall | No 36. Ground floor | |

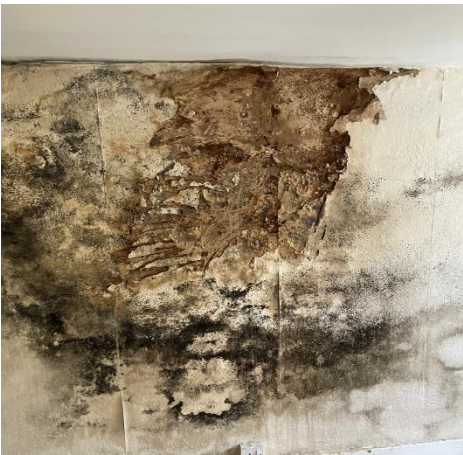
| Photo 6 | Damp Wall | No 38. First floor | |

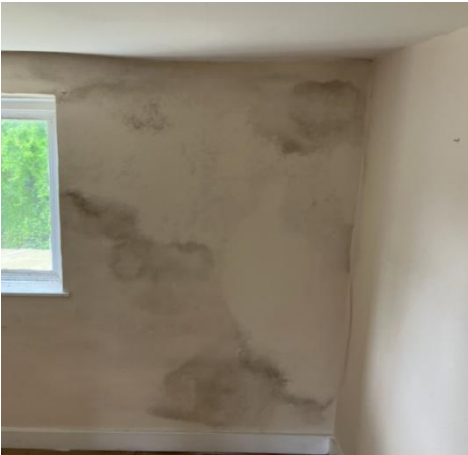
| Photo 7 | Damp Wall | No 38. First floor | A close-up photograph of a wall in a room. The wall is off-white and shows significant water damage, including large, dark, irregular stains and areas where the paint has peeled or bubbled. A small window is visible on the left side of the frame. |

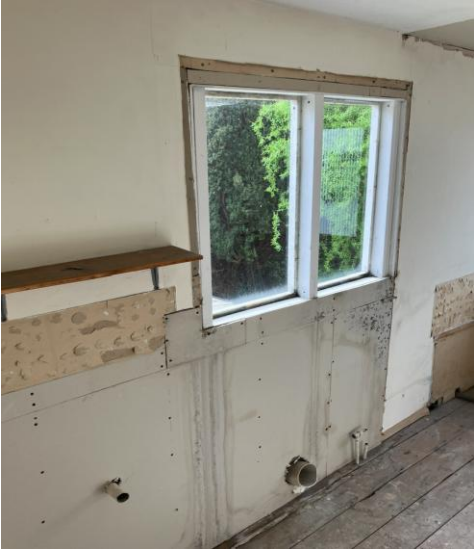
| Photo 8 | Damp Wall | No 38. First floor | A photograph of a room with a window. The wall below the window is covered in a light-colored, textured material, possibly plaster or a repair compound, which appears damaged and peeling. The floor is made of dark wooden planks. A small wooden shelf is mounted on the wall to the left of the window. |

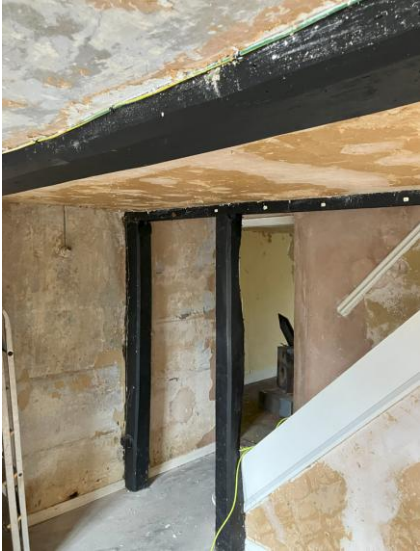
| Photo No | Description | Location | |
|---|---|---|---|
| Photo 1 | Painted black timber beam | No 36. Ground floor | |

- The beams will be cleaned using non-abrasive, dry methods such as soft-bristled brushing and low-suction vacuuming to gently remove surface dust and debris without damaging the timber surface.
- No chemical stripping, abrasive sanding, or mechanical tools will be used in order to preserve the integrity and historic character of the timber.
- Any flaking or loose surface coatings will be carefully removed using hand tools (e.g., scalpels or scrapers), under the supervision of a suitably experienced conservation professional.
- Where redecoration is appropriate, a breathable, conservation-grade finish—such as linseed oil paint or limewash—will be applied. The chosen finish will be agreed in advance with the Conservation Officer to ensure suitability with the historic context and material.

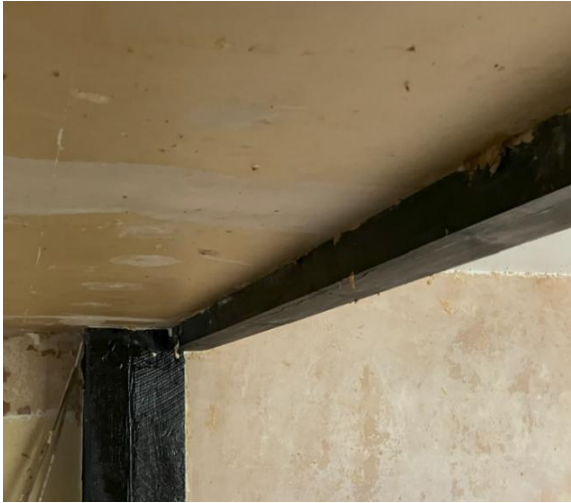
| Photo No | Description | Location | |
|---|---|---|---|
| Photo 2 | Painted black timber beam | No 36. Ground floor | |

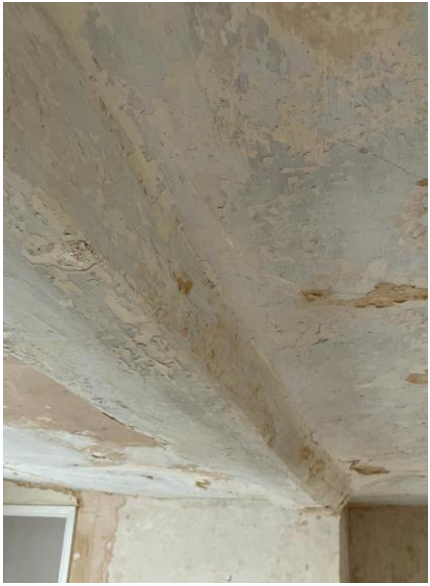
| Photo 3 | Plastered timber beam | No 36. First floor | |

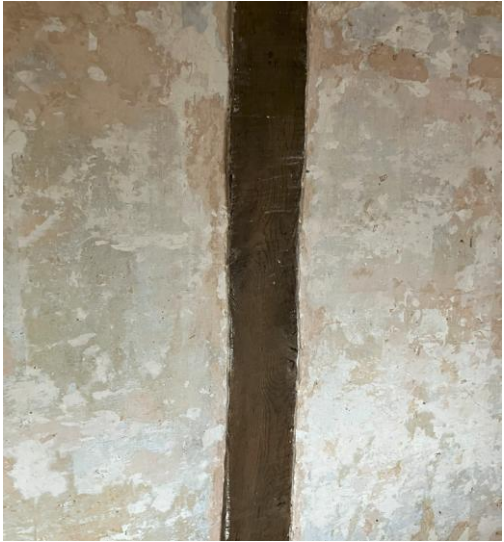
| Photo 4 | Timber beam | No 36. First floor | |

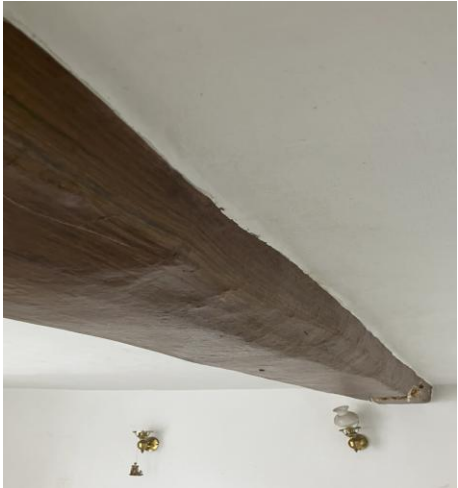
| Photo 5 | Timber beam with laminate cover | No 38. Ground floor | |

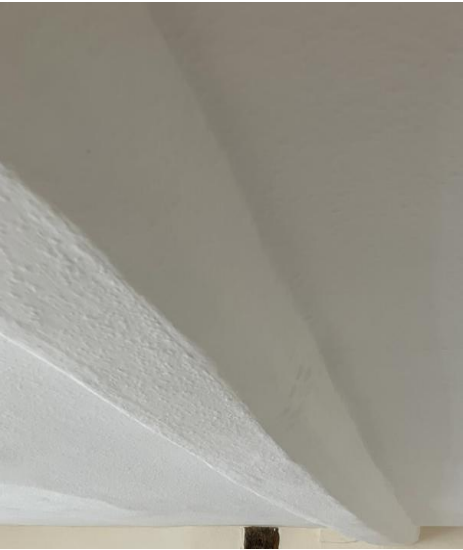
| Photo 6 | Plastered and painted timber beam | No 38. First floor | |

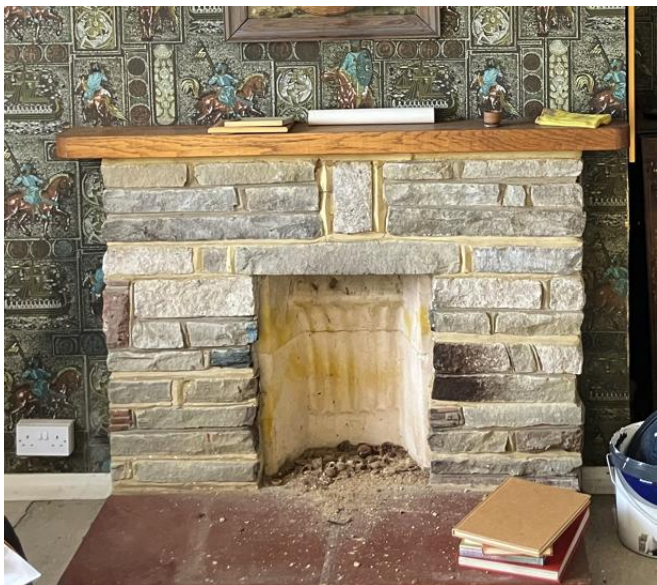
- The existing fireplace in the ground-floor front room is a modern installation with no architectural or historic significance. It is proposed to be carefully removed to allow for the installation of a more appropriate feature.

| Photo No | Description | Location | |
|---|---|---|---|
| Photo 1 | Existing fireplace | No 36. Ground floor | |

- A reclaimed fireplace surround of similar age and style to the building (likely Georgian or early Victorian) will be sourced from a reputable antiques or architectural salvage supplier. The selected piece will be of comparable scale and material to what may have existed originally (e.g., timber or cast iron).

- The replacement will be installed as a decorative feature only, with no functional chimney or flue alterations proposed.
- Installation will involve minimal disturbance to the surrounding wall and hearth area. Where making good is required, lime-based plaster and breathable finishes will be used.
