## **LEVEL 3 TREE INSPECTION AT TWYCROSS ROAD**

**Prepared on instructions from:  
Wokingham Borough Council  
Shute End  
Wokingham  
RG40 1BN**

**18 August 2026**

**Ref: SPH/VTa-26/11.08**

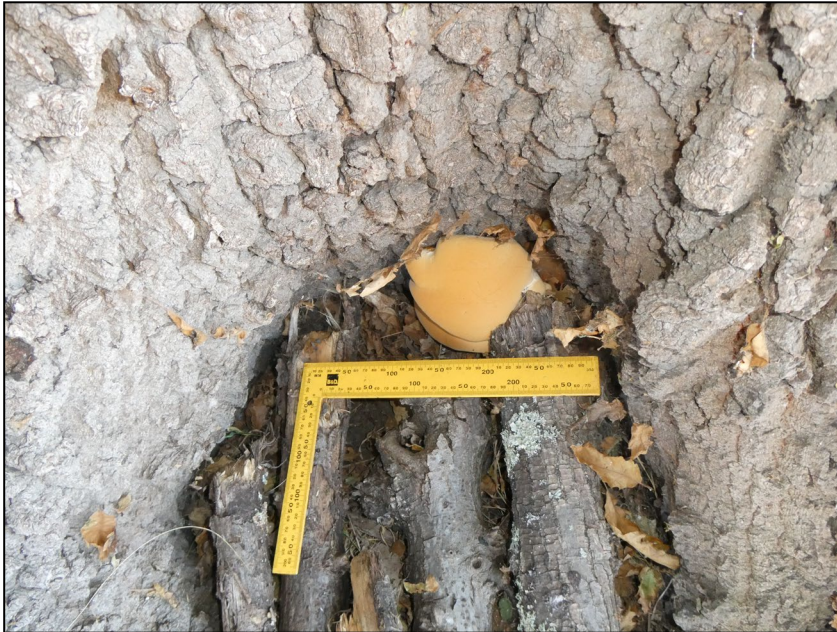
Figure 1, north side

- 3.2.1 There was no visible sign of movement around the base of the tree, no mounding or soil heave was observed, and the root plate appears stable within its surroundings at the time of inspection. There are dead branches piled on the north side of the stem however this did not constrain the inspection. Juvenile fungal fruiting bodies (FFB) were observed at ground level on the north side, and mature fruiting bodies on the west side from ground level to 1.0 metre above ground level (AGL), see Figure 1 and 2 below. The remains of a desiccated FFB were observed on the east side between the buttressing, see Figure 3 on page 6.

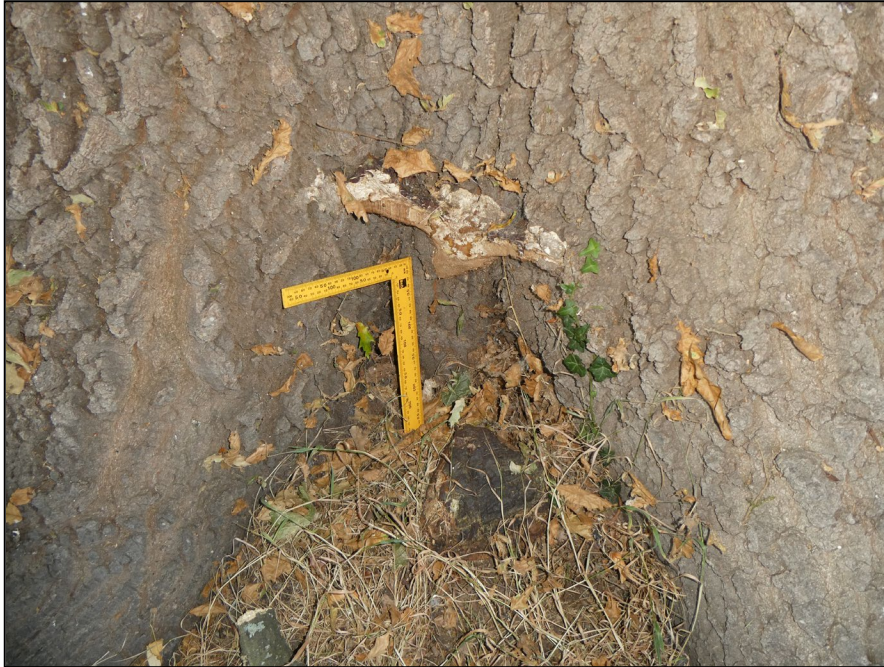
Figure 3, east side

- 4.1.1 The fungal fruiting bodies observed on the tree are a mixture of old and new and are most likely to be that of *Ganoderma resinaceum*. *G. resinaceum* occurs on oak colonising the heartwood whilst radiating towards the sapwood, resulting in adaptive growth, (swelling), this can be seen in the trees buttressing. Based on our last report and council records the fungal brackets were observed in 2016 however, no correlation can be made between the age of the brackets, size or quantity of brackets and the progress of decay.
- 4.1.2 *G. resinaceum* frequently fall from the host leaving a tell-tale scar similar to those seen on the subject tree and is infrequently associated with tree failure.

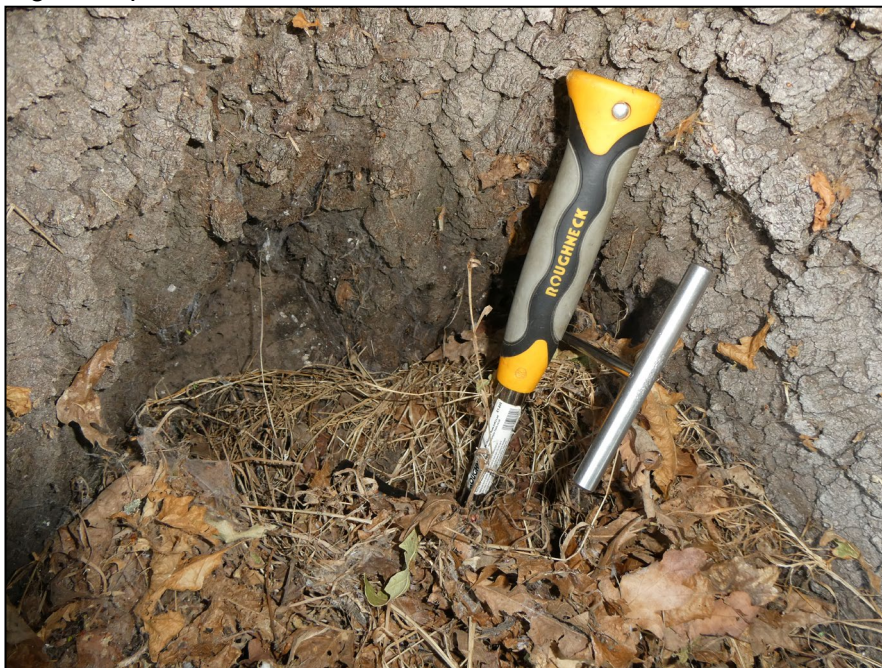
Figure 4, probe into base of stem

- 3.2.2 The basal area of the tree has significant buttressing (adaptive growth) and when inspected with a stainless-steel probe decay and hollowing was detected between the buttresses on the north, west and south sides, see example of probe in Figure 4 below.

- 4.1.3 The readings from the ground level micro drillings indicate that the fungal fruiting bodies detected at the base of the tree have significantly altered the structure of the wood, in particular on the north and west sides where hollowing was detected and this correlates with tests undertaken in 2021 that also identified hollowing.

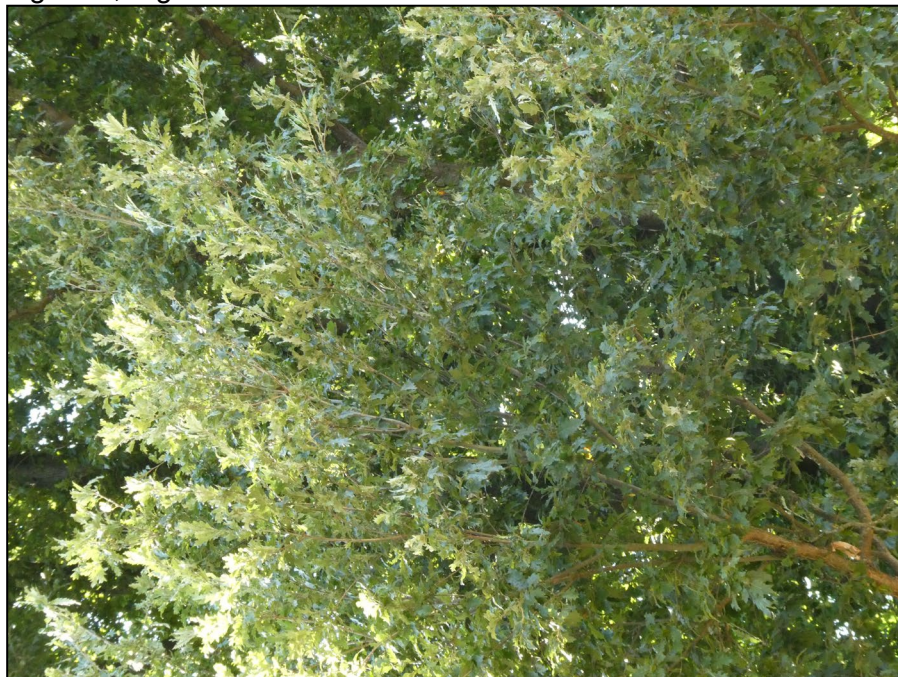
Figure 5, regrowth

- 3.2.4 The canopy has been reduced and has vigorous regrowth, see Figure 5 below. The physiological indicators of leaf colour size and density are normal for the species.

- 4.1.6 The dense regrowth observed in the canopy has occurred as a result of the crown reduction.
- 4.1.7 The decline of trees can take many years before the tree becomes a hazard and they require remedial measures however; the decay associated with the fungal fruiting bodies has resulted in hollowing of the stem and advancing decay up the main stem. The tree is a vigorous species, and the trees vitality is normal. It is capable of significant future growth.

- 5.1.1 The tree height must be reduced by 3 metres +/- 0.25 metres to reduce the biomechanical load upon the main stem leaving a final height of approximately 21 metres. The lateral growth should be reduced to provide a suitable framework for redevelopment and be balanced to meet the natural characteristics of the tree following the reduction in height. This work to be undertaken within 12 months.
- 5.1.2 The tree must be visually reinspected in two years and a further advanced inspection in 5 years.

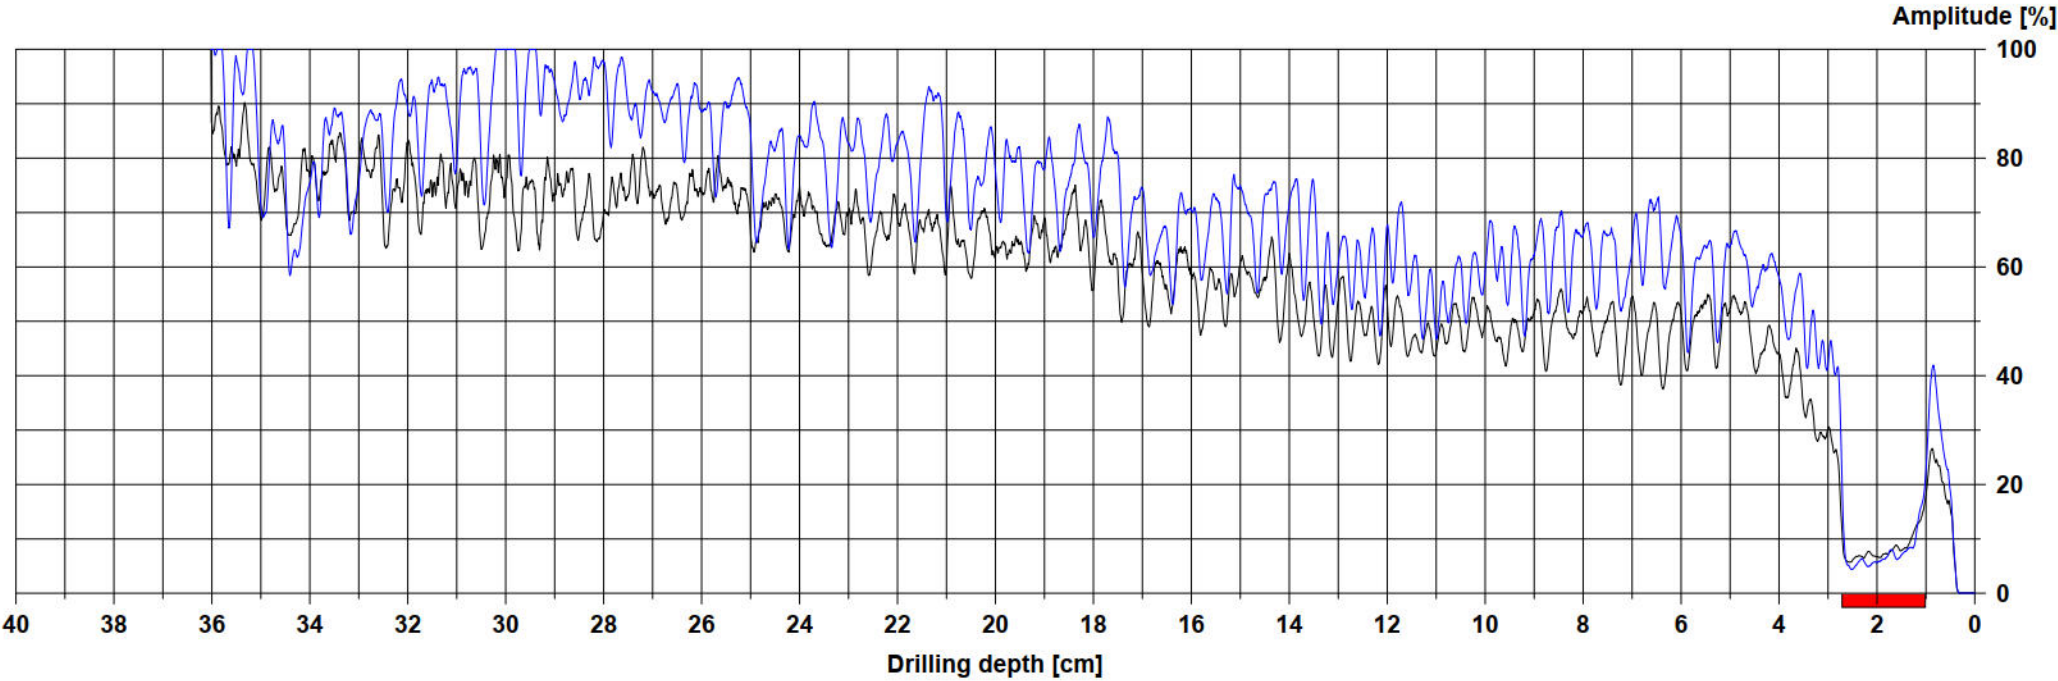
■ From 1,01 cm to 2,71 cm : Decay

Control at 1.5m AGL east side, decay behind bark, no significant decay beyond this point.

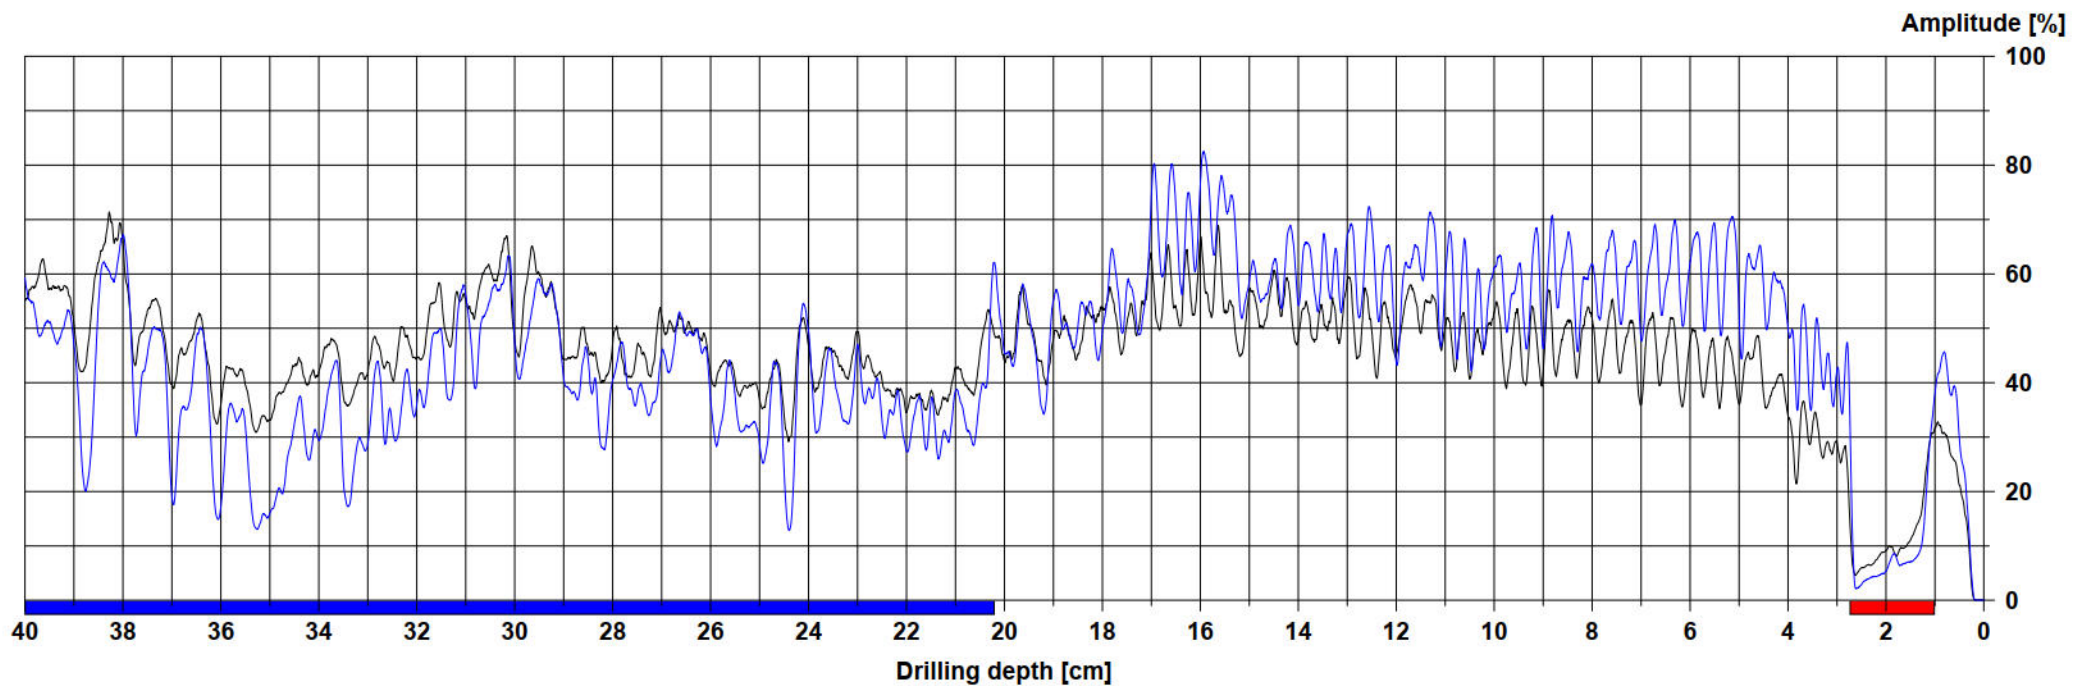
**From 1,01 cm to 2,73 cm : Decay**  
**From 20,21 cm to 40,00 cm : Incipient decay**

Control at 1.5m AGL North side. Decay behind bark with irregular amplitude indicating incipient decay.

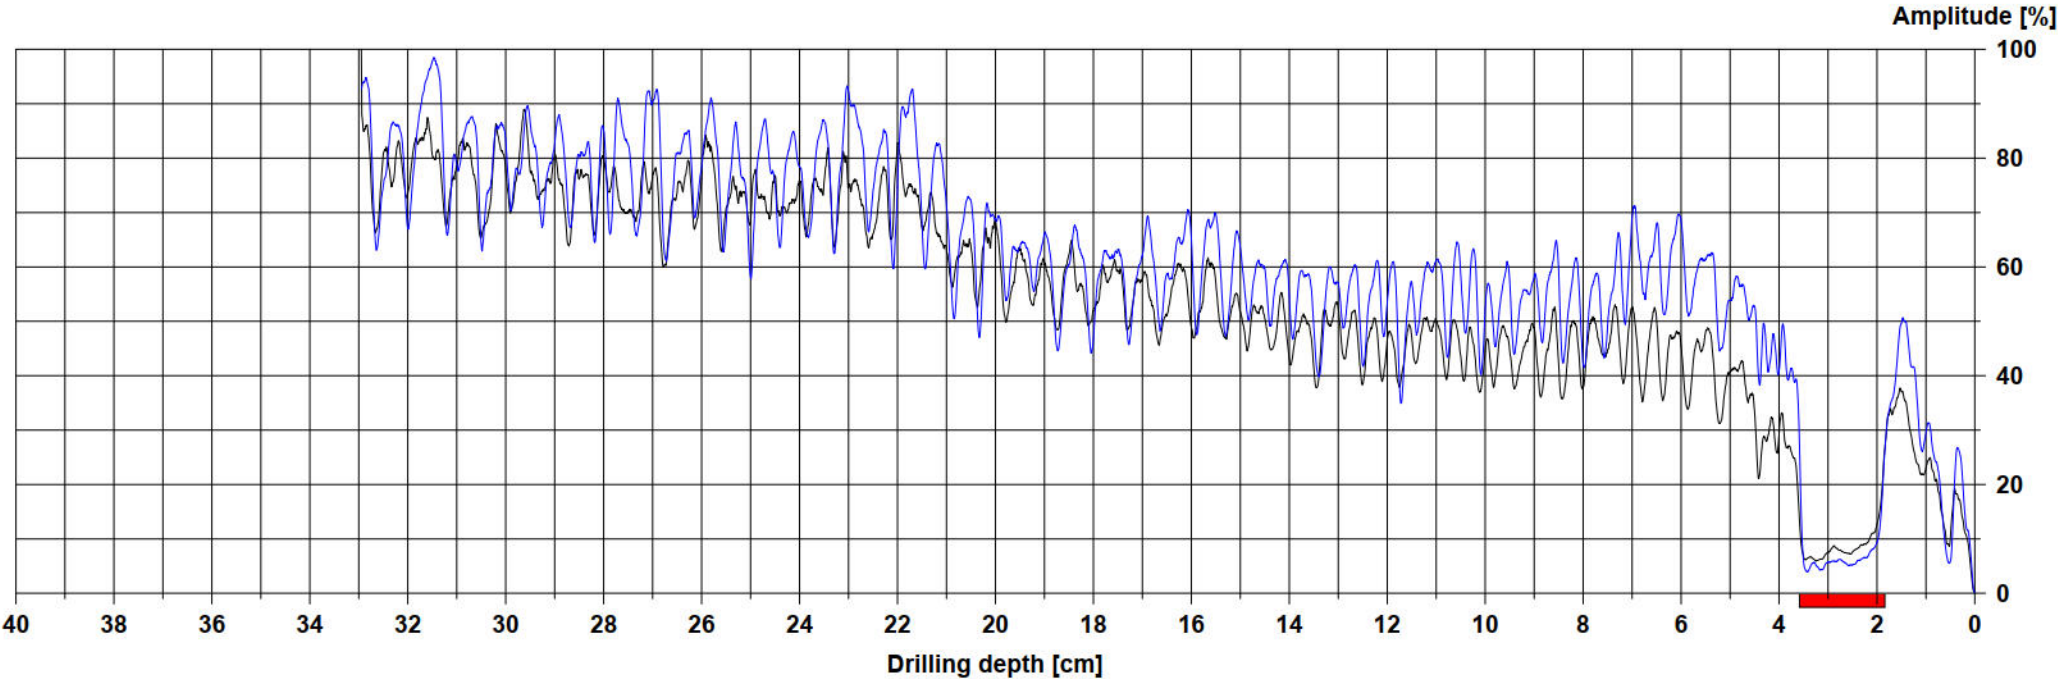
■ From 1,84 cm to 3,58 cm : Decay

Control at 1.5 south side. Decay behind bark, no significant decay beyond this point.

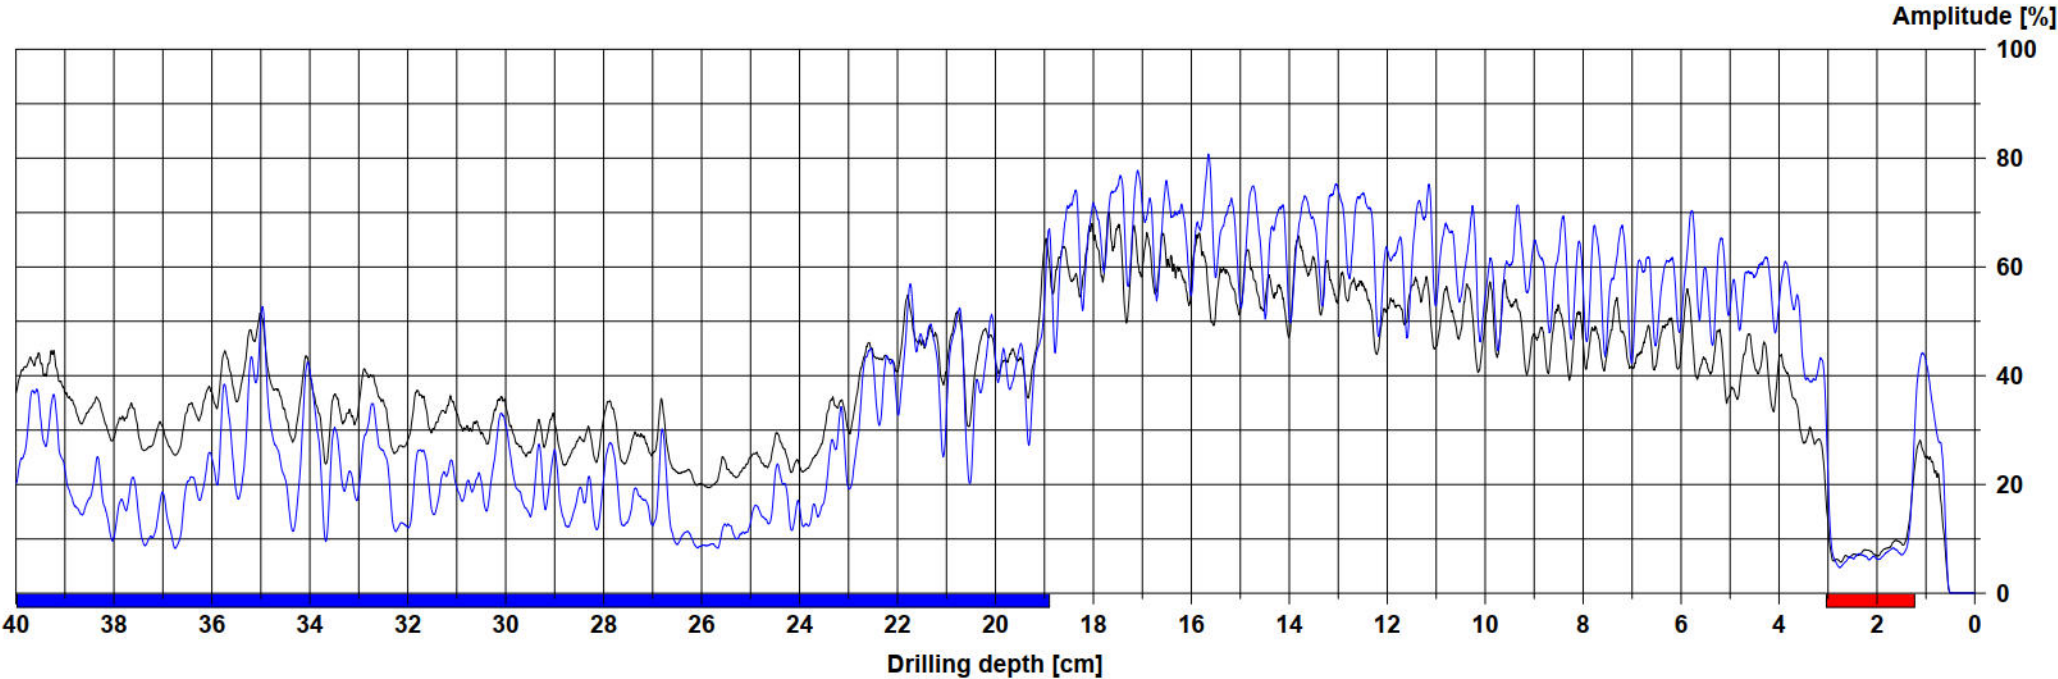
- From 1,23 cm to 3,03 cm : Decay
- From 18,90 cm to 39,98 cm : Incipient decay

Control at 1.5m west side. Decay behind bark, with incipient decay from 19cm.

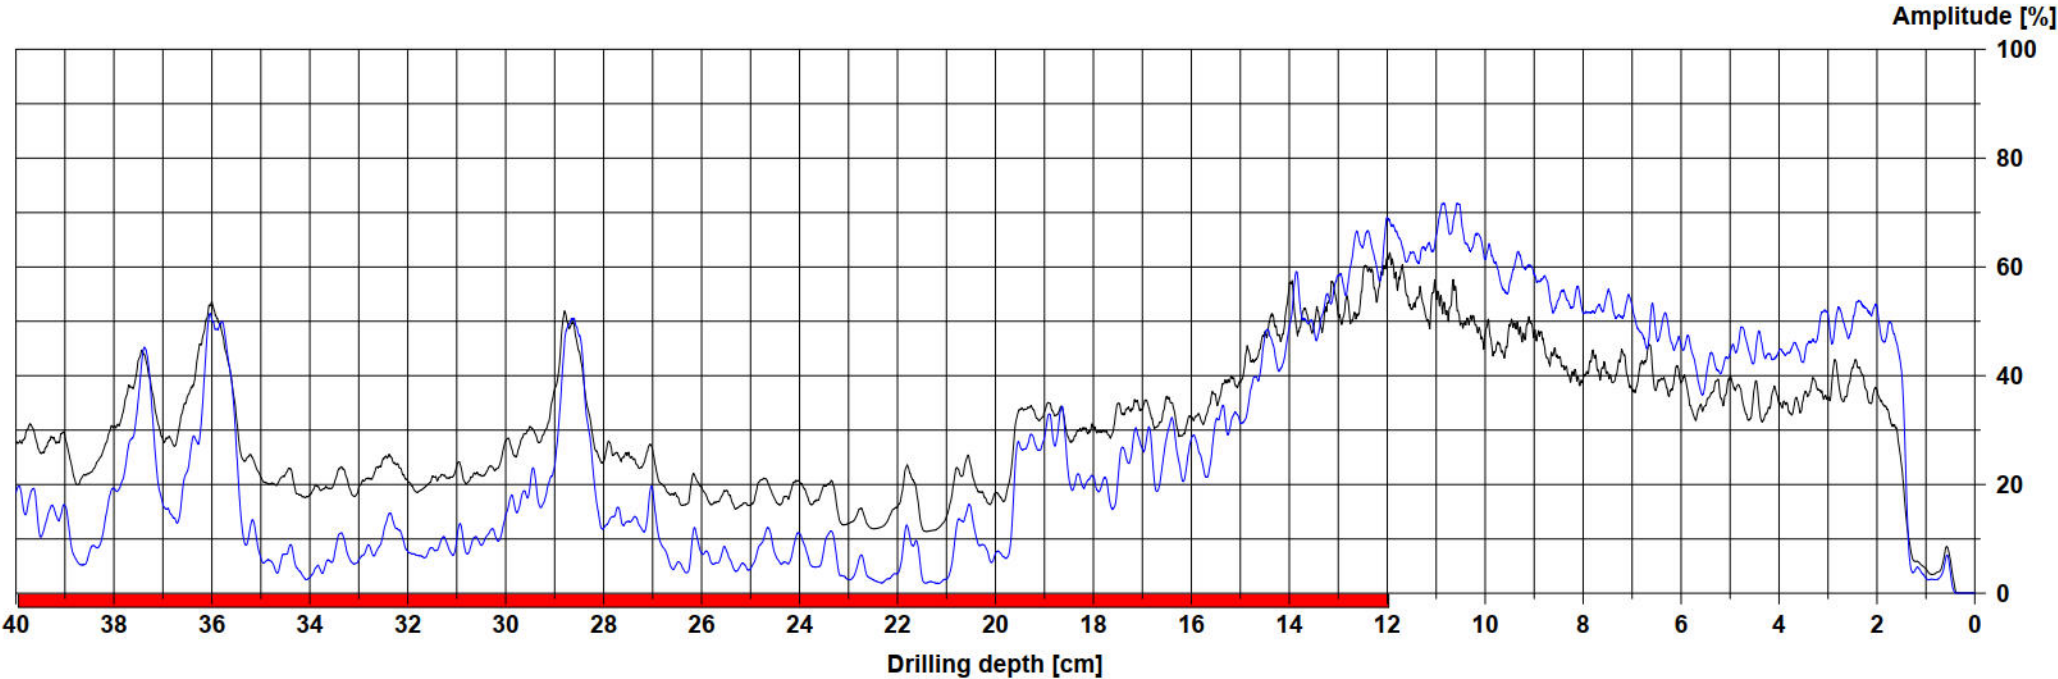
From 11,97 cm to 39,95 cm : Decay

East side, amplitude falls from 12cm and fluctuates indicating decay.

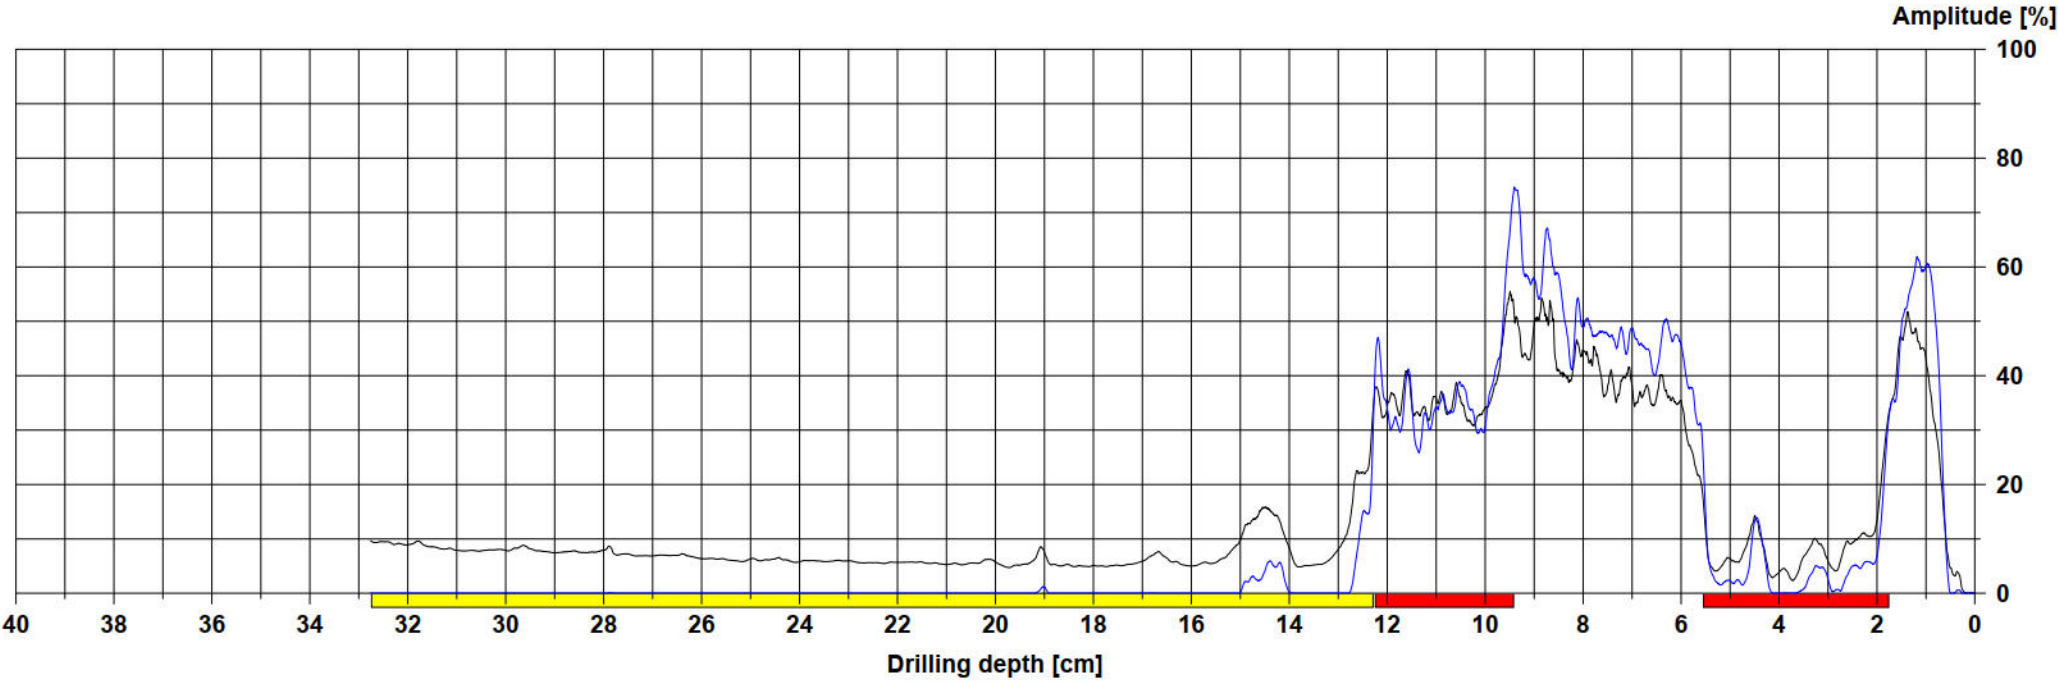
| From 1,76 cm to 5,54 cm | : Decay |
| From 9,42 cm to 12,24 cm | : Decay |
| From 12,29 cm to 32,74 cm | : Cavity |

North side, cavity from 12cm.

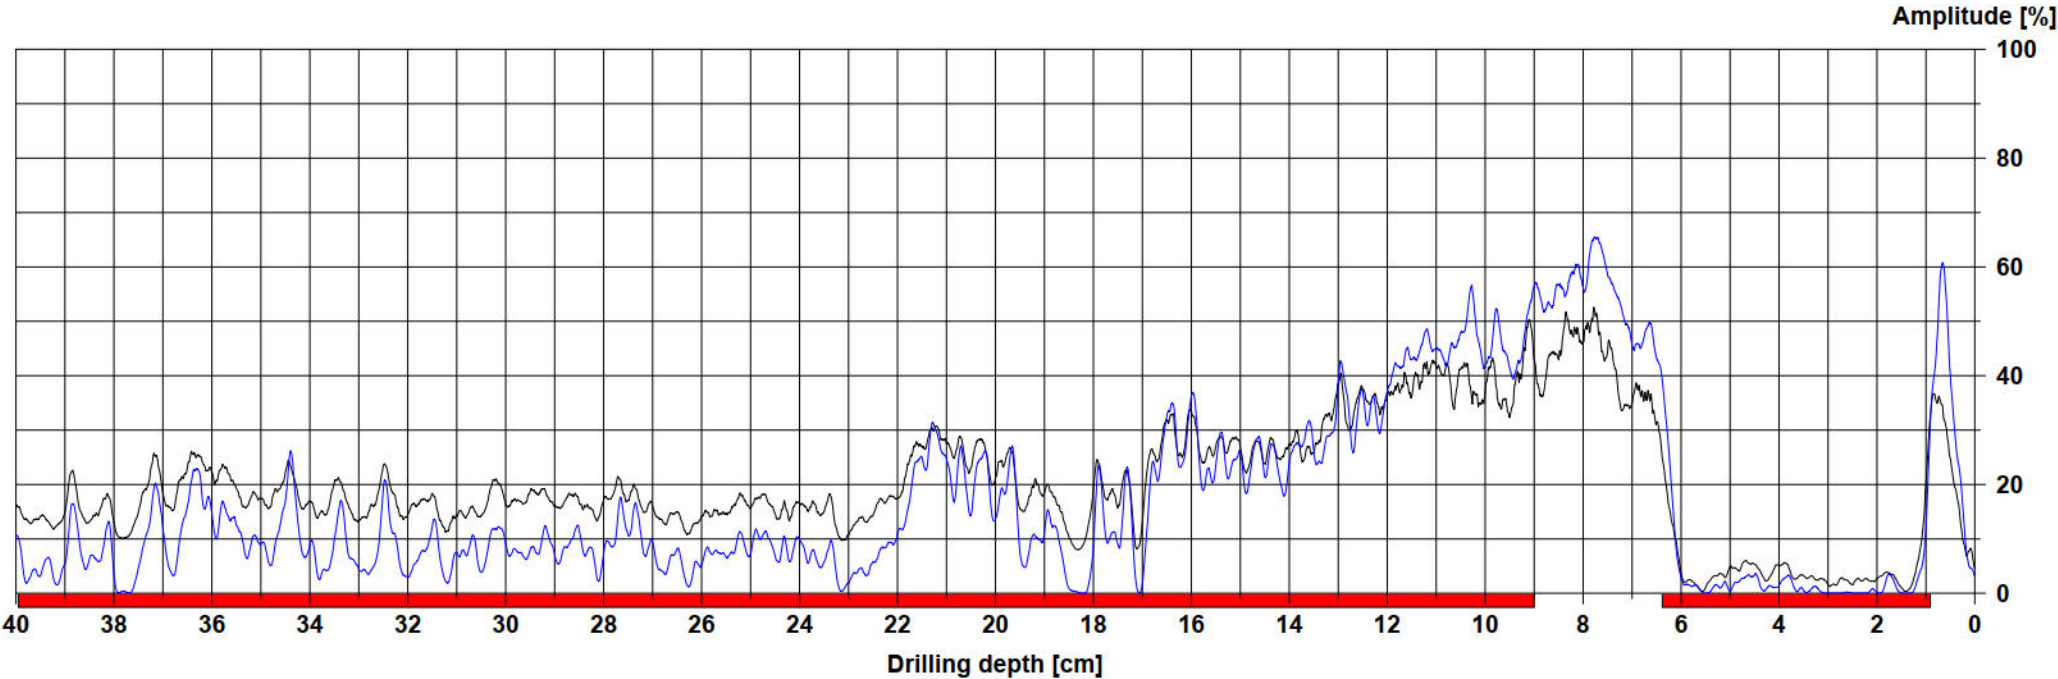
- From 0,91 cm to 6,38 cm : Decay
- From 9,00 cm to 39,95 cm : Decay

South side. Advanced decay behind bark, further decay from 9cm.

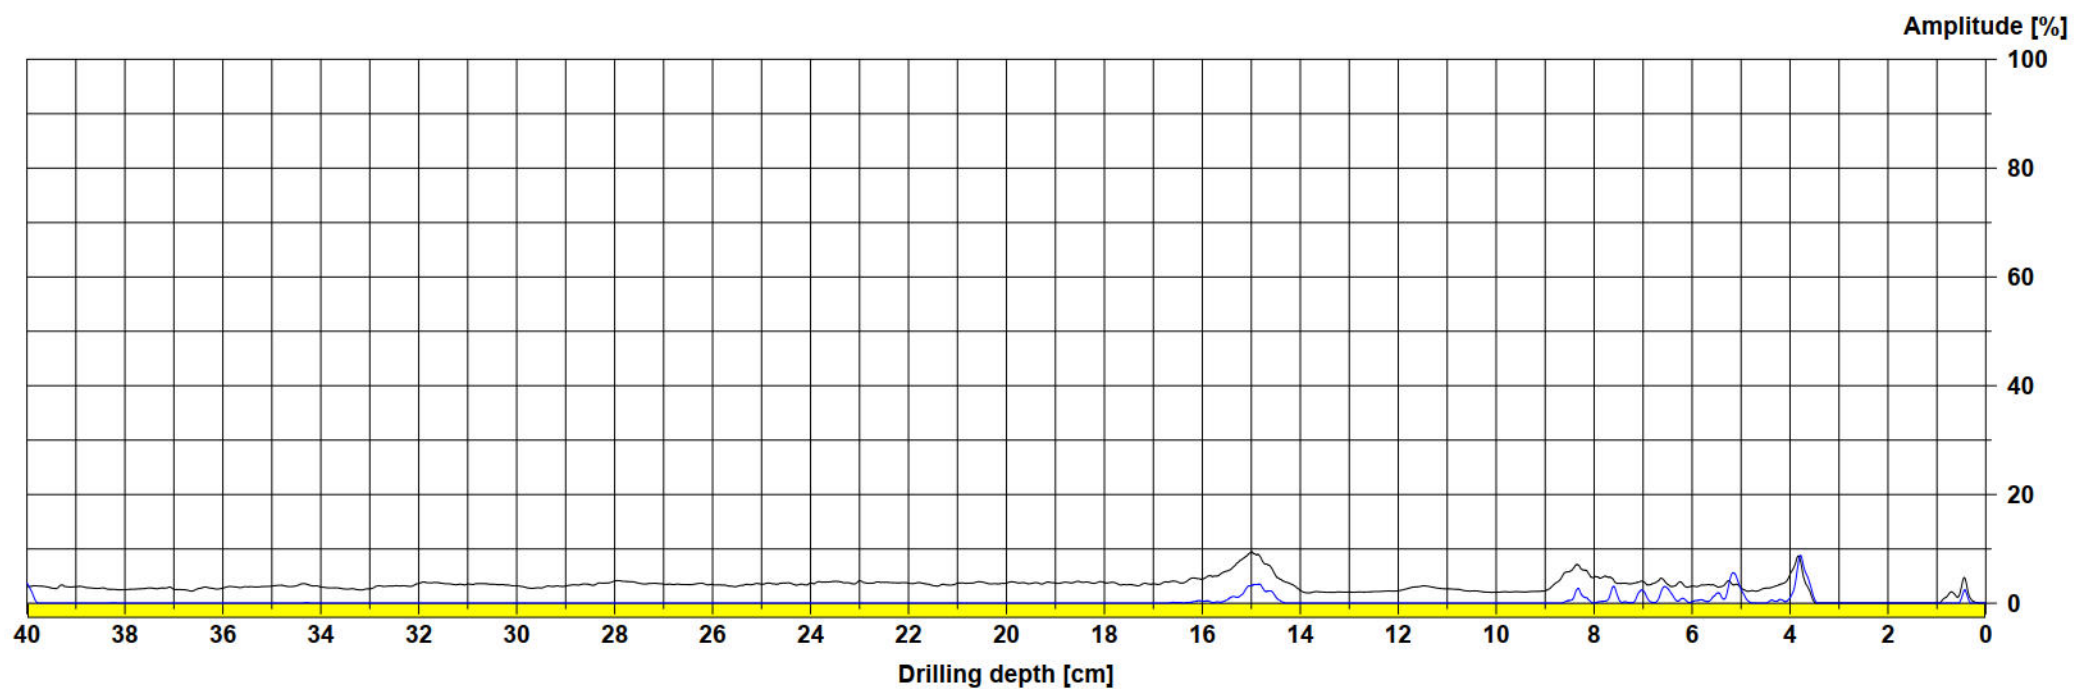
From 0,02 cm to 39,98 cm : Cavity

West side, cavity from bark. No sound wood.
