## TREE INSPECTION REPORT

40 KIBBLEWHITE CRESCENT  
TWYFORD  
READING  
BERKSHIRE  
RG10 9AX

JULY 2020

Ref: SCD 05410/2020

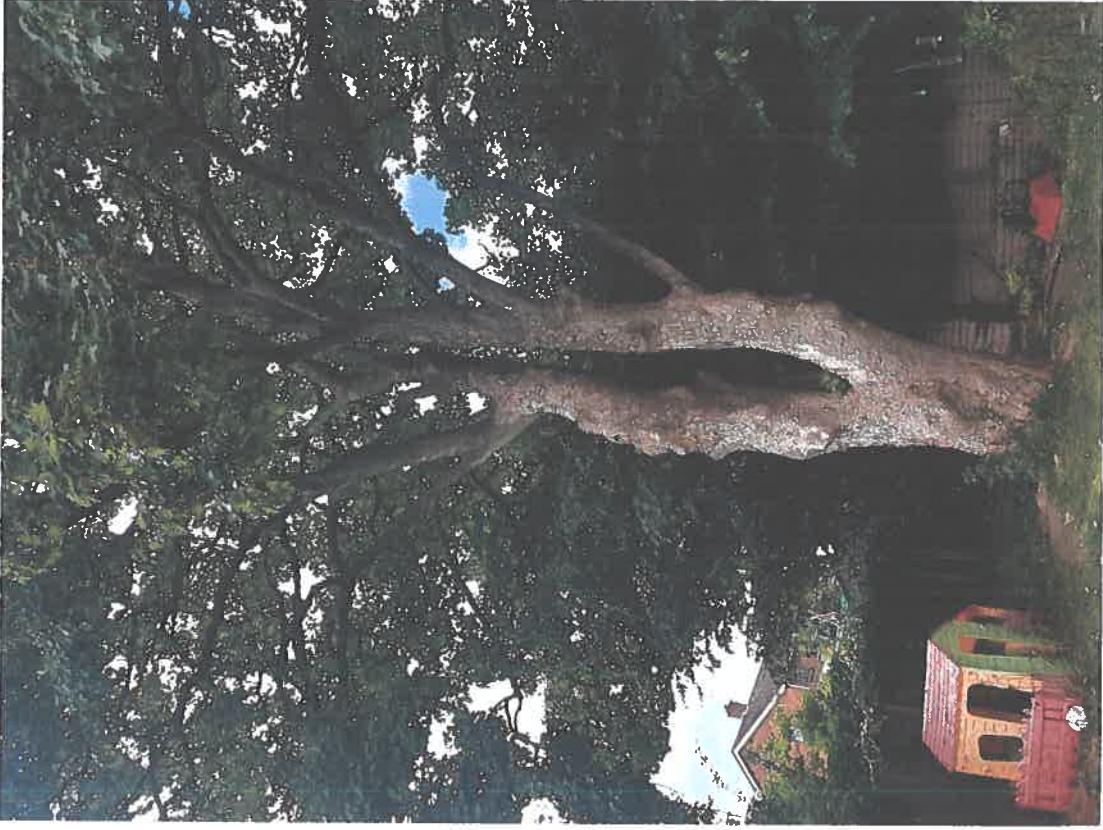
Figure 1 -South side of T1 (Sycamore)

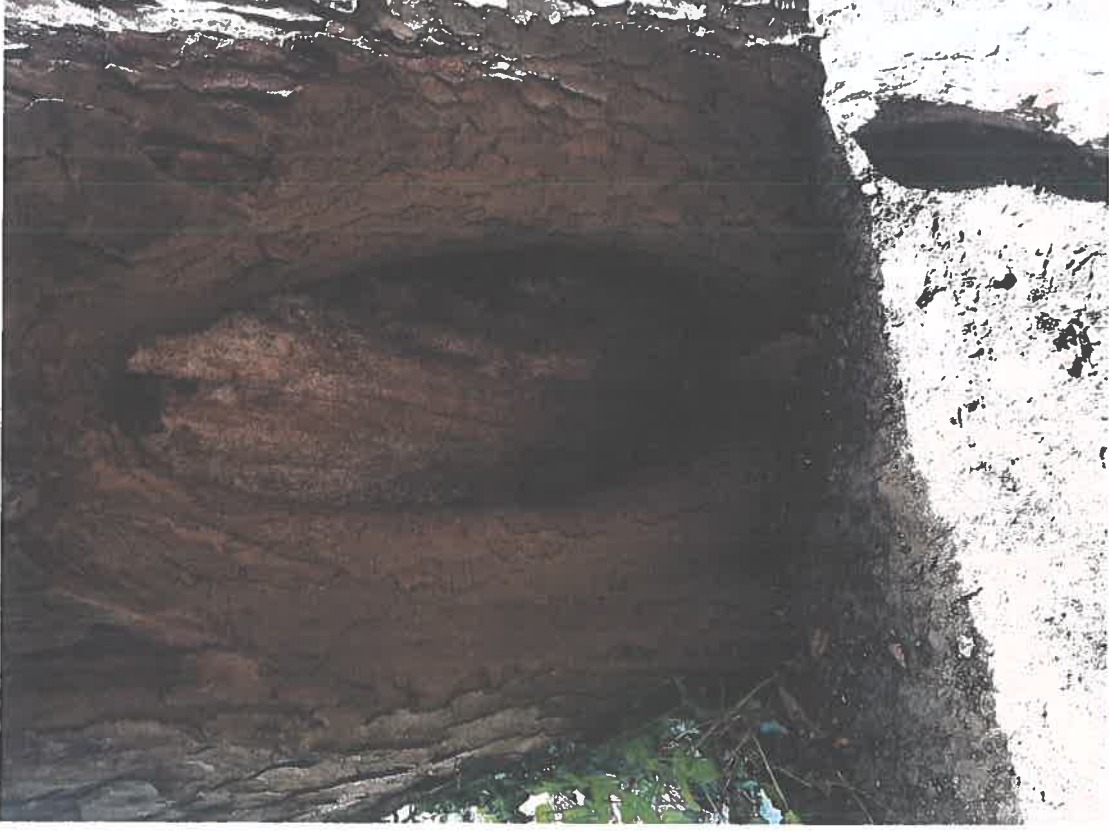
| <b>Roots &amp; Surrounding Ground</b> | | <p><b>Cracking, heave, compaction</b></p> <p>BASE: Full access was available around the base and trunk of the tree. Compacted soil around base, exposed surface roots. There is a wound on the northern side of the lower trunk, 640mm high and 240mm wide commensurate with historic fire damage. No associated cavity, audible decay / fungal fruiting bodies frass or other indicators of decay. Good ribs of wound wood around the wound. Elsewhere, base clear, bark intact.</p> | | | | | |

Figure 2 – Historic wound on north side of lower trunk

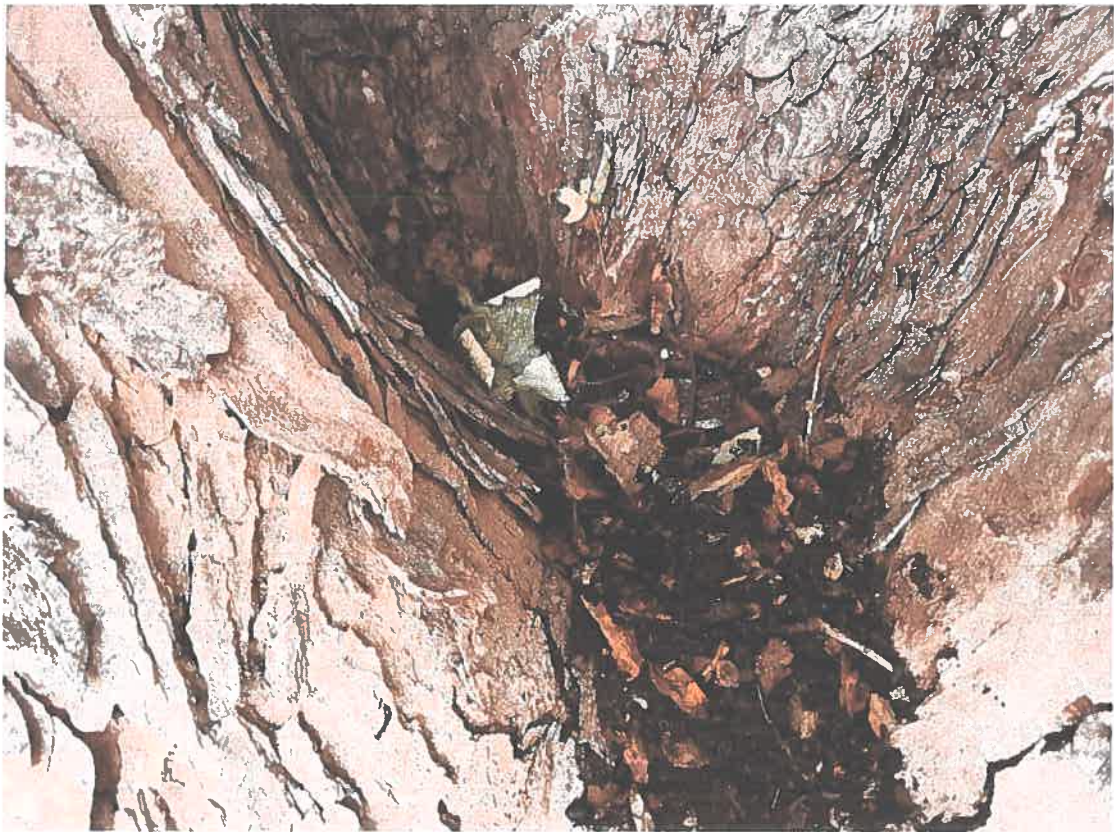
| <b>Buttresses</b> | | <p><b>Decay, ffb, physical damage, structural integrity</b></p> <p>STEM: Single stem to 2.3m above which the stem forks. Union filled with some composted organic matter in which small sycamores had rooted (these were removed during my inspection). Slight bark inclusion but good 'cup' union forming. Metal probe does not extend into cavity further than 100mm.</p> | | | | | |

Figure 5 - Upper view of stem fork.

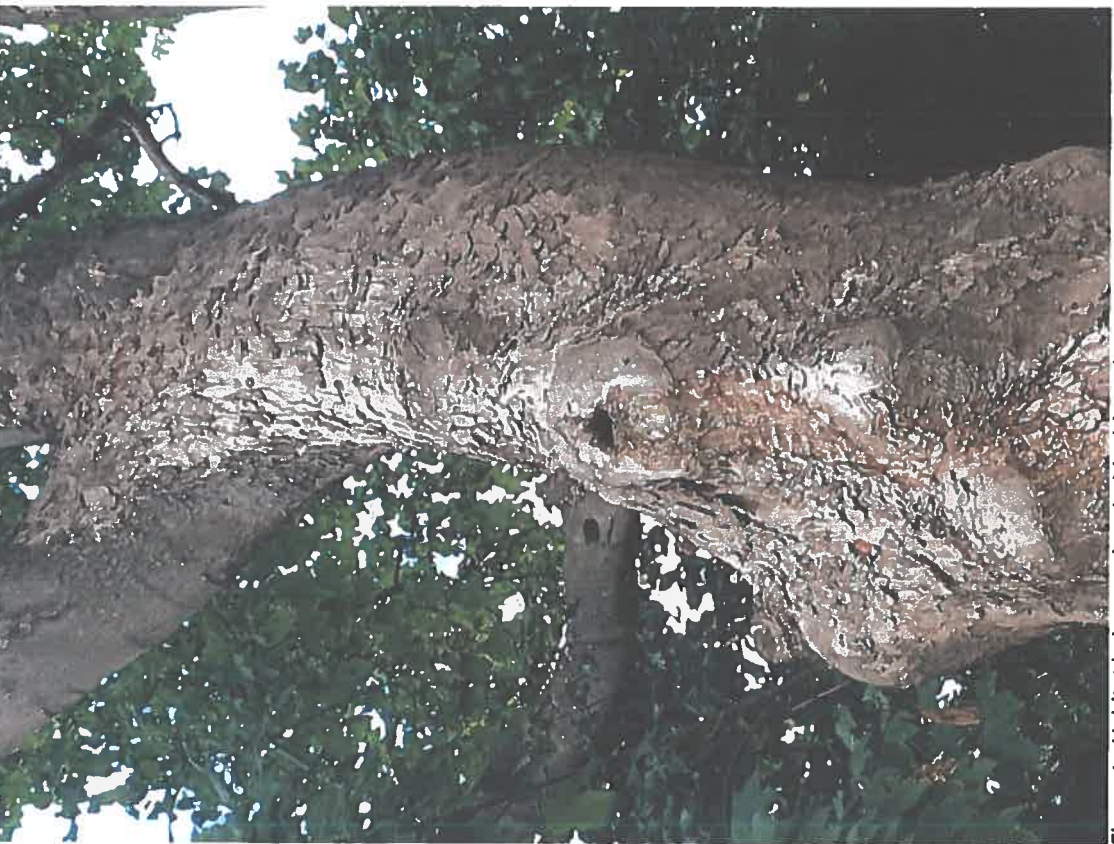
| <b>Main Union</b> | | <p><b>Canopy:</b> Habitat hole on westernmost stem, 4.5m above ground level. Rood surrounding ribs of wound wood.</p> | | | | | |

Figure 4 - Habitat hole associated with old pruning cut

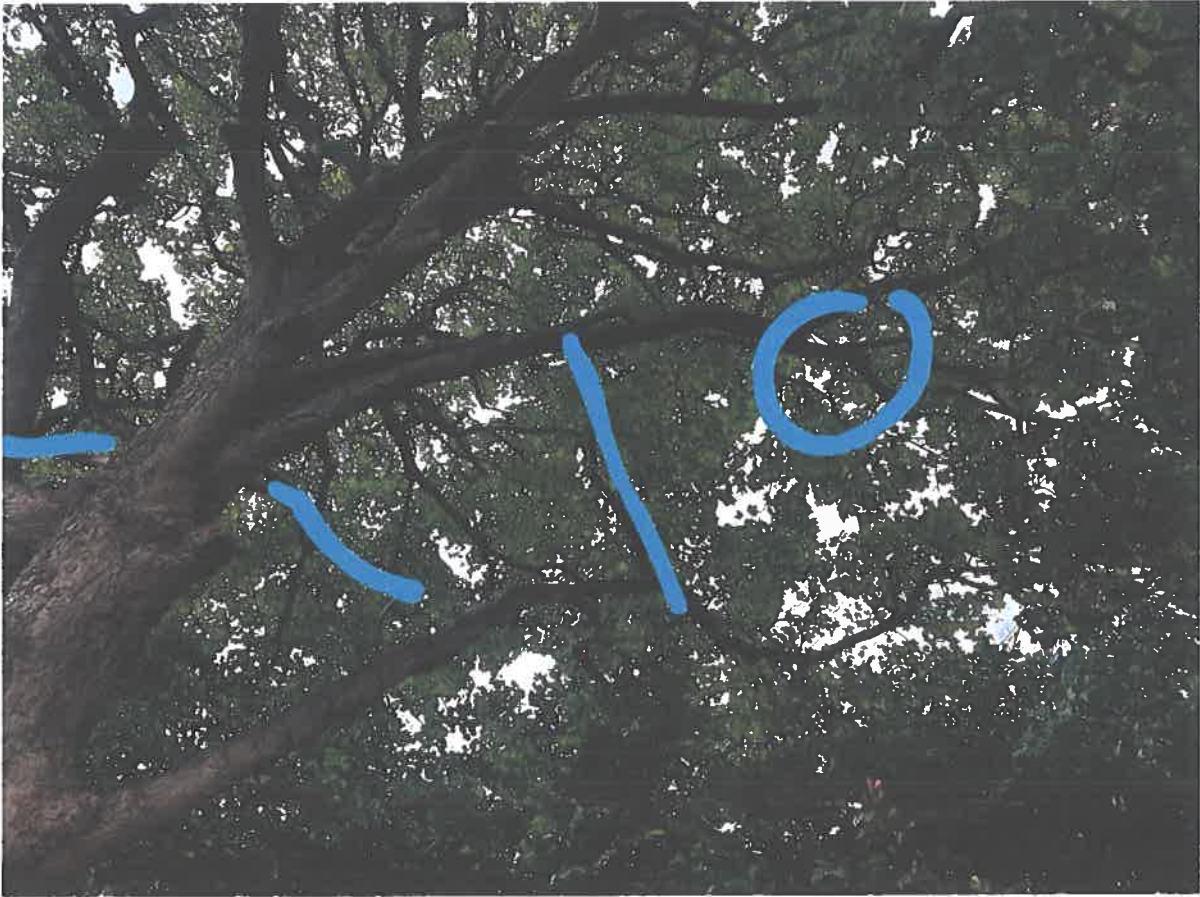
| <b>Primary Ascending Stems</b> | | <p><b>Ffb, decay, other plants, exudates, structural integrity</b></p> <p>High canopy. Foliage dense, clustered towards branch tips moderate vitality, commensurate with age and species. No evidence of any previous major branch failure or storm damage. Three medium sized dead branch stubs, 1.2m, 1.5m and 2m long in canopy – do not exceed 100mm diameter.</p> | | | | | |
| <b>Main Branches</b> | | <p>Two slender crossing / rubbing branches within canopy on east side over neighbouring garden.</p> | | | | | |

Figure 6 – Location of 3x Small dead branches and a small crossing / rubbing branch identified for removal. (Low priority)

| <b>Work Required</b> | | <p>T1 – Sycamore</p> <ul style="list-style-type: none"> <li>Remove 3 small pieces of deadwood –</li> <li>Remove smaller of two crossing / rubbing branches over neighbouring property</li> </ul> | | | | <b>Priority</b> | Within 24 Months |
