**The Swan, Three Mile Cross**

**Job No: 22102**

**Date: 15/07/2024**

**Client: Fraser's Retail**

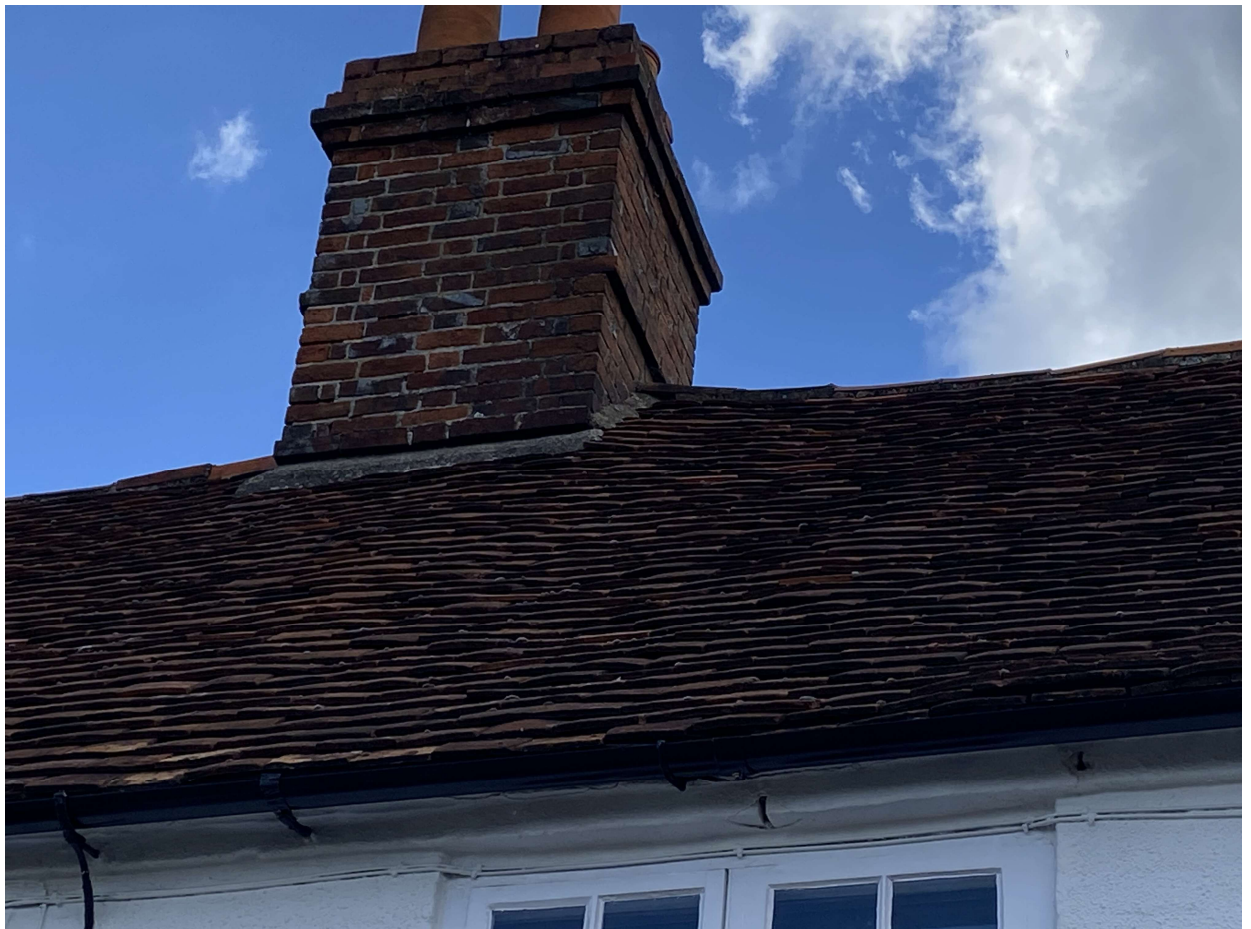
#### 3.1 Chimney stacks

Both stacks are surmounted by two chimney pots. The stacks are sealed to the adjacent tile coverings with render. Both stacks have previously been repointed with sand and cement mortar. The chimneys are reasonably straight and true with no signs of significant bulging or cracking. The brickwork is in good condition with no real signs of spalled brickwork.

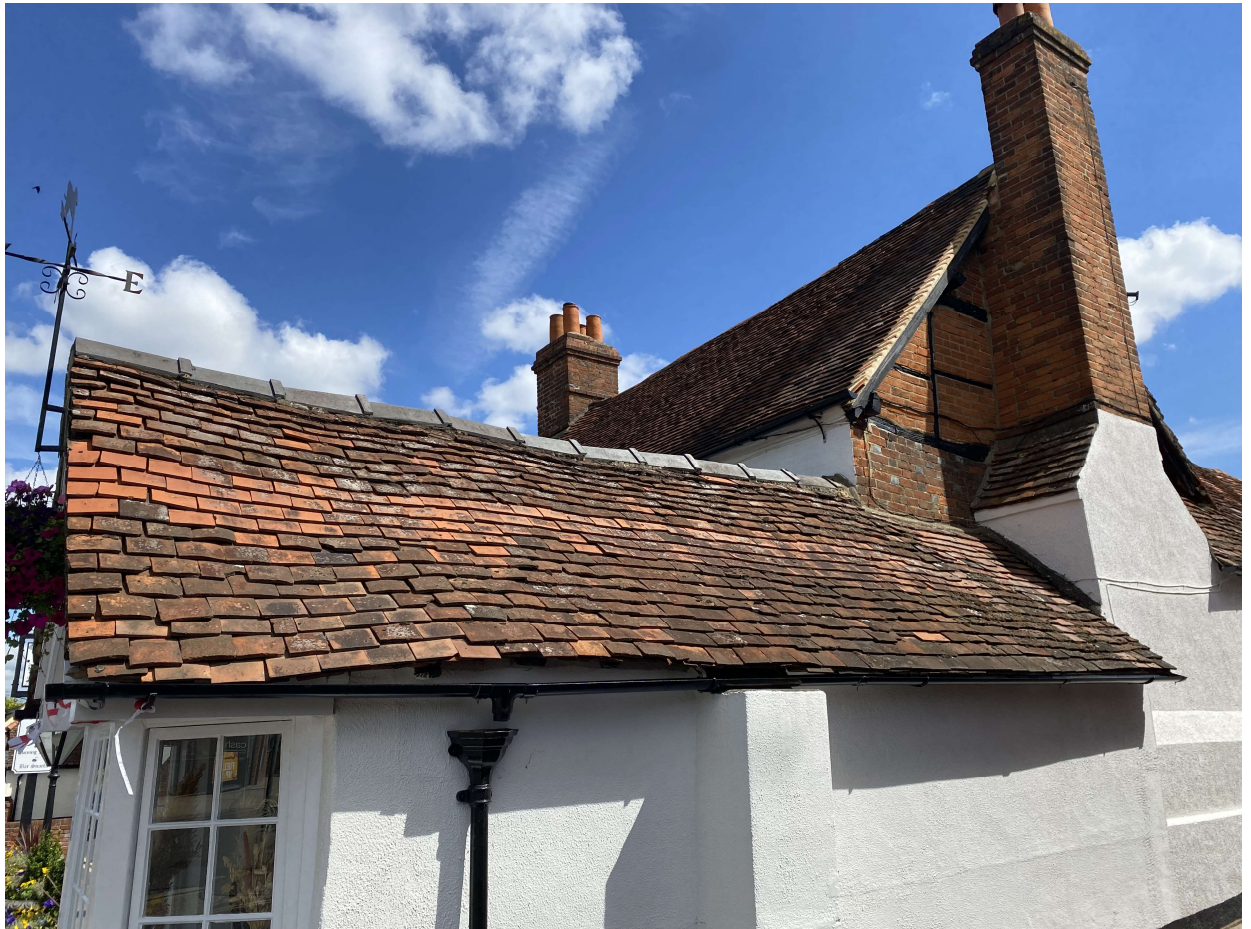
### 3.3 Secondary Roofs

There are several secondary roofs to the property including a flat felt roof over the rear extensions and a duo-pitched roof over the front porch canopy and the 19th century extension. We were unable to view the flat roof properly however from the edges that we saw it looked quite new and in good condition. The tiled pitched roof to the porch is in excellent condition and the 17th-century extension roof has a few slipped, missing and broken tiles, which will need replacement.

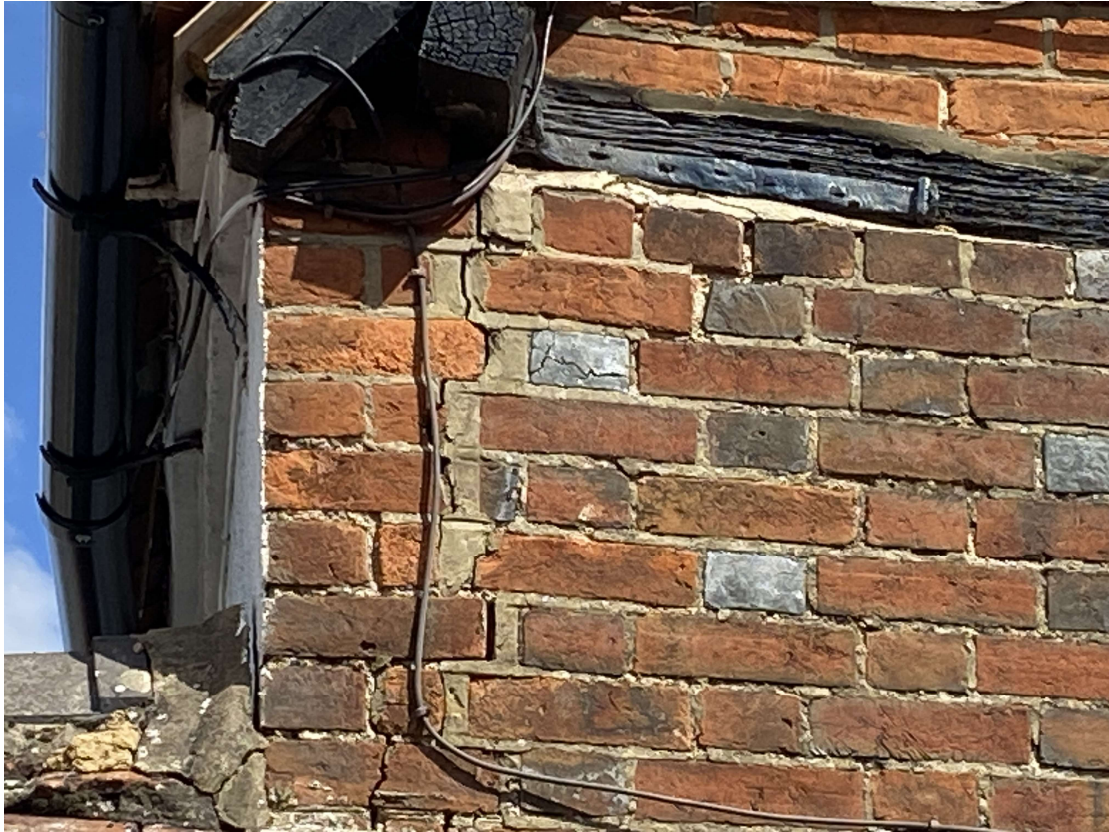
There is a small vertical crack in the gable wall of the property below the roof rafters. The crack is likely to be due to roof spread and it is noted that the vertical perp joints in this area are larger than other joints and they most likely have been continually repointed. There is also a metal strap used in this area to tie back the roof rafter to the rest of the timber frame. Although considered a structural issue it is not overly significant and can be mitigated with ongoing repointing. It is also noted that all unpainted brickwork has previously been repointed by sand cement mortar. With solid brick walls, it is important to use a lime mortar. A lime mortar is more flexible than a hard-based sand cement mix and allows the walls to "breathe". Unfortunately, a cement-based mortar has been used. Cement mortars cause the bricks to spall where moisture is forced out through the brick rather than the pointing. Removal of the hard cement mortar would be difficult without damaging the brickwork.

We don't believe that the new alterations and additions will impact the fabric of the original 16th-century main building as the works are in areas of modern construction. We would recommend that the boundary wall be demolished and then rebuilt. We would also recommend that the gable masonry should be stitch repaired with helifix ties to mitigate any further roof spread.

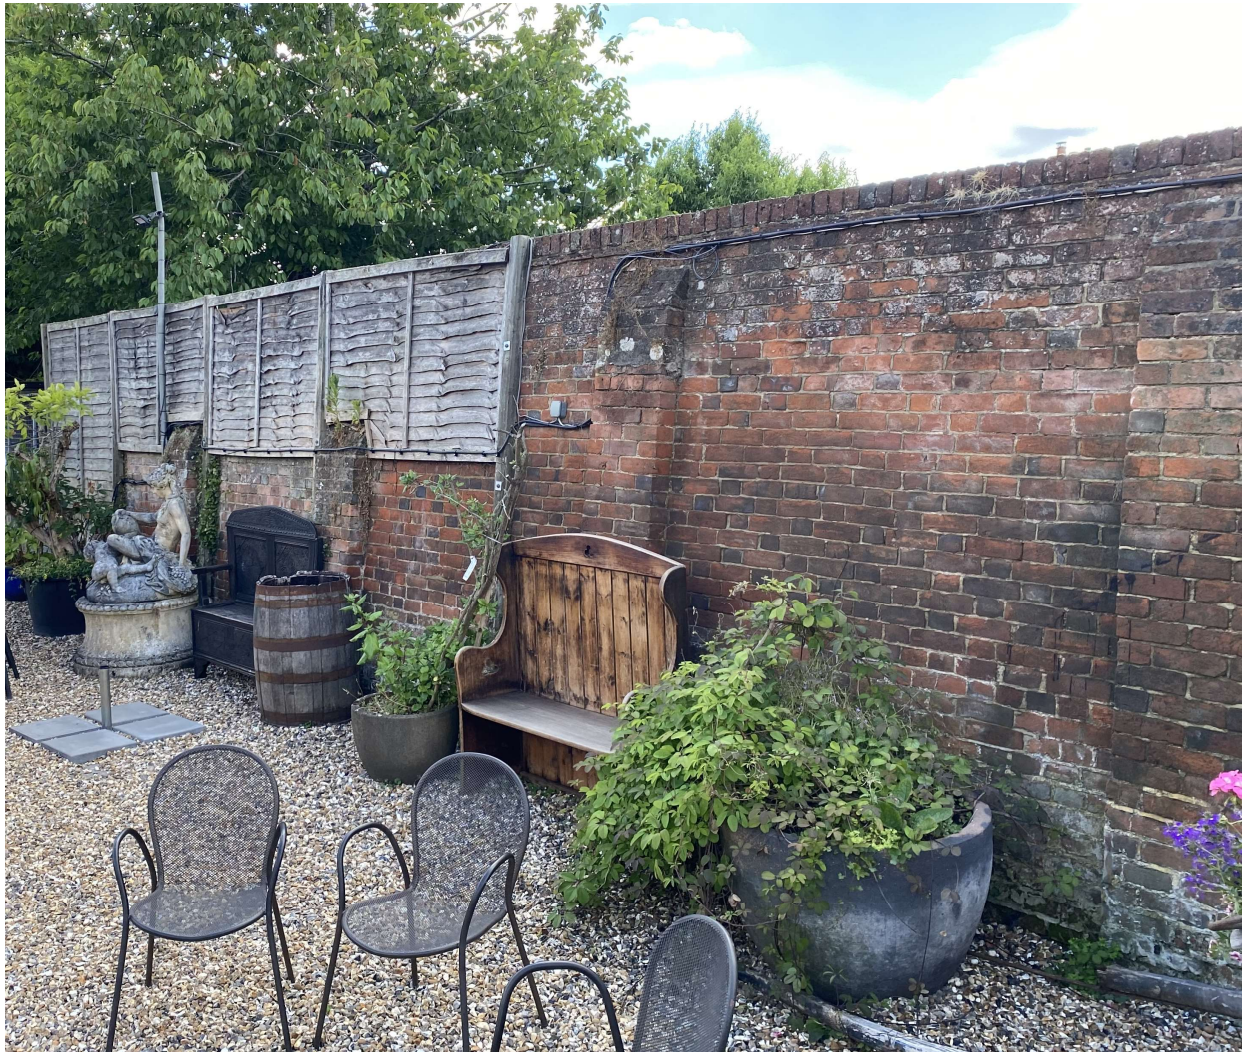
### 3.6 Other walls

The boundary wall along the east side of the property has a significant lean towards the neighbouring property. The lean is outside the middle third of the wall line and is therefore unstable. The wall is past the stage of being able to be supported with additional buttressing and will continue to lean until it eventually collapses.

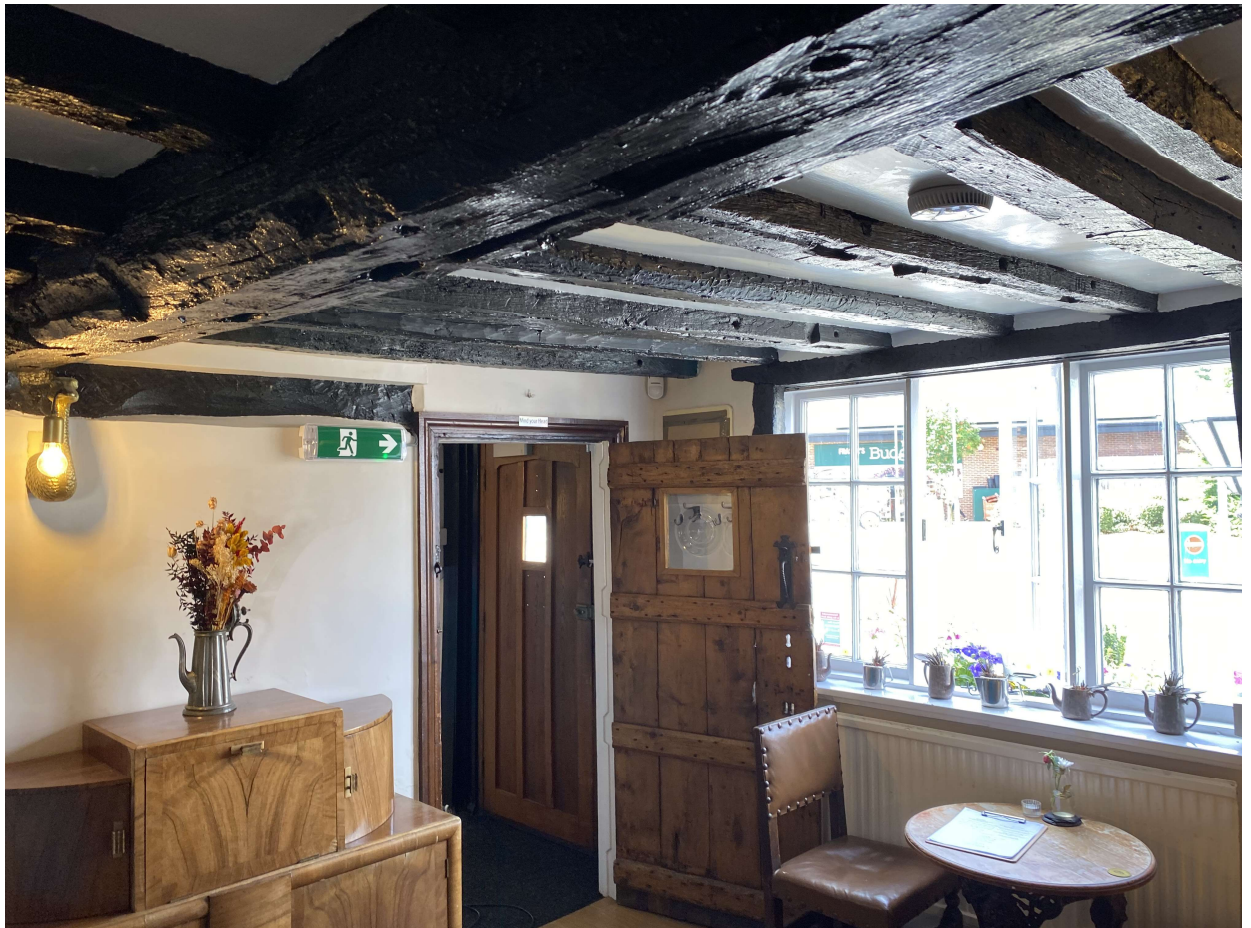
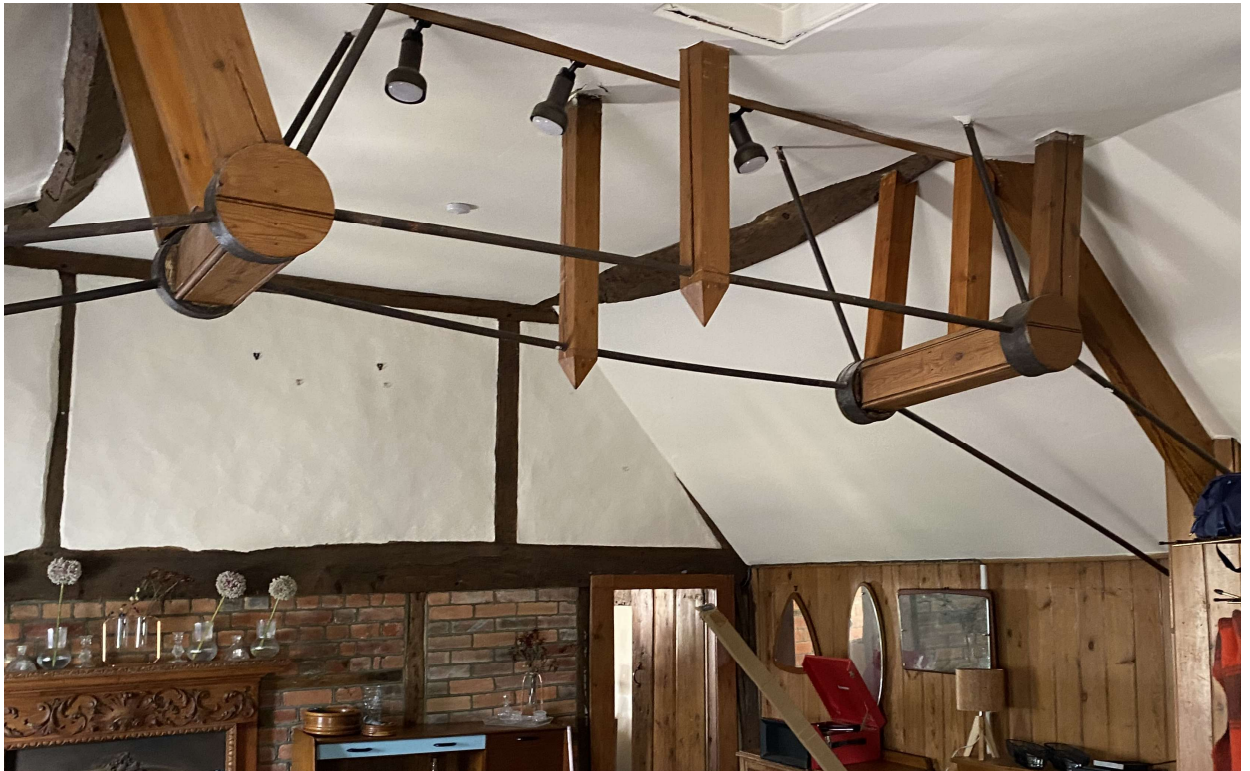
### 3.8 Internal walls and ceilings

The internal walls are part timber frame and infill brickwork. The timber frames and brick are exposed and are in a good state of repair and appear structurally satisfactory with no significant evidence of internal structural movement. The original ceilings would have been of lath and plaster (the traditional method of ceiling construction with plaster applied to narrow strips of timber) and it is unlikely that they have been replaced or over boarded with plasterboard. There are some timber partition walls at the 1<sup>st</sup> floor level which are also lath and plastered. The four number Queen trusses, three of which have infill brickwork, are in good state of repair with no signs of decay. One of the trusses has previously been structurally altered to increase the size of one of the rooms. The alterations seem to not have had any determinantal effect to the overall structural condition of the building.
