# Tree report P 080.003

**22 April 2025**

**Strowdes Estate  
Culham Lane boundary trees**

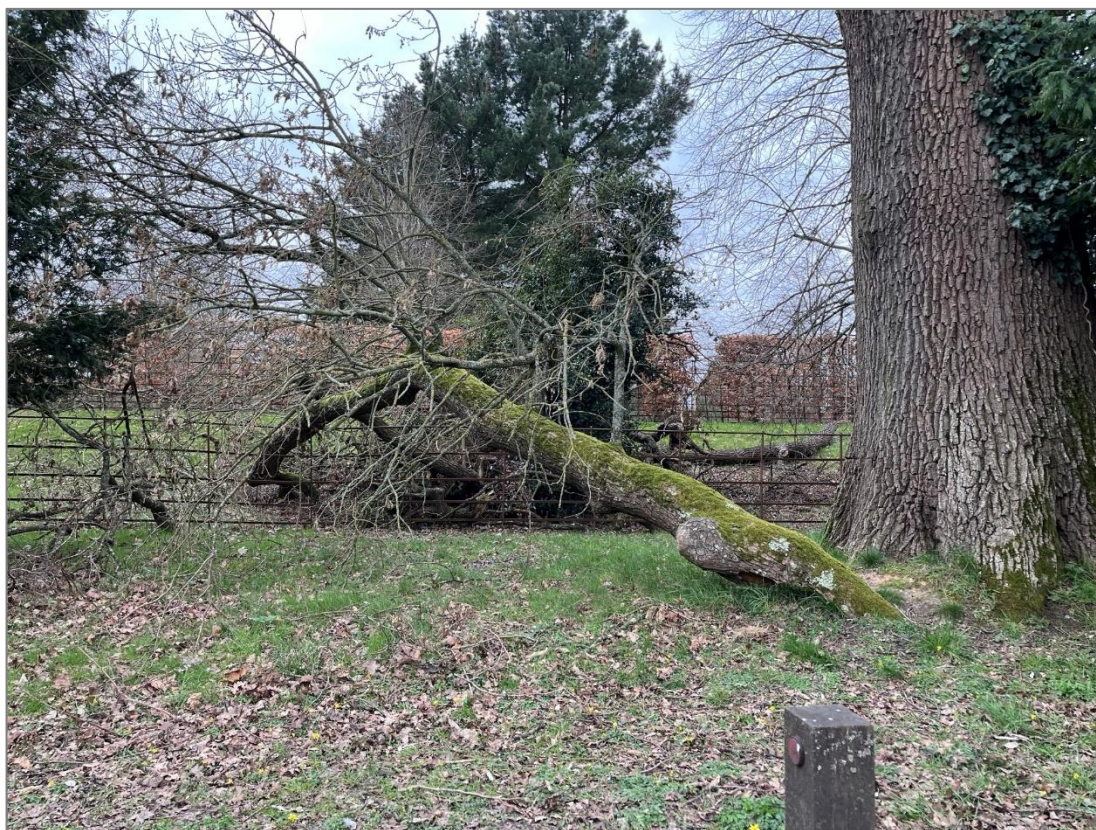
As discussed, we are very concerned about the safety of members of the public on foot, travelling in motor vehicles and our clients boundary fencing arising from the poor condition of a number of trees located on Local Authority property along Culham Lane. In recent months large limbs have detached from some of these trees, fallen onto the public footpath and resulted in damage to our client's boundary fencing (please see attached photo of the most recent occurrence).

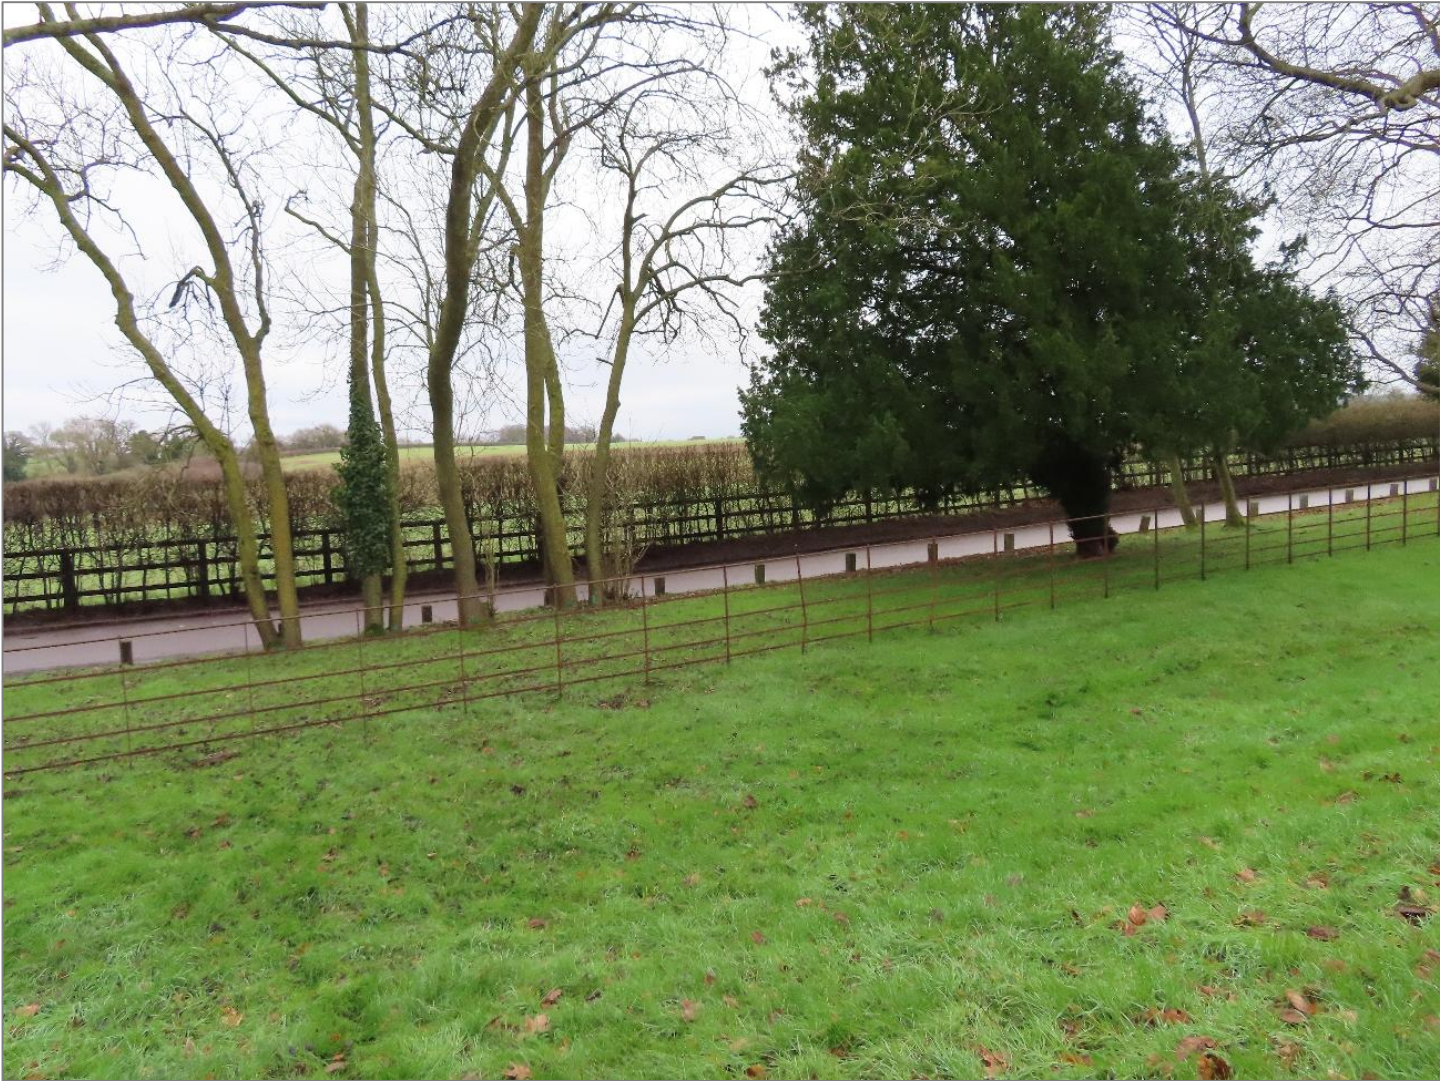
- 22 ash trees were assessed, and they were seen to be in varying states of health: using the Tree Council's classification<sup>1</sup> they ranged from **Class 2** (75% - 51% of the crown remaining), see photo 1, to **Class 4** (25% - 0% of the crown remaining), see photo 2,

**Photo 1**  
**roadside ash tree group, ash dieback class 2 to class 4**

- 16 For the purpose of this application the works proposed are
- 1 22 Ash to remove and stump grind (some are multi-stemmed)
  - 2 1 Sycamore to remove
  - 3 1 Sorbus Whitebeam to remove
  - 4 1 Oak to remove
  - 5 Deadwood and stub tidying on 1 Oak, 1 Sycamore,

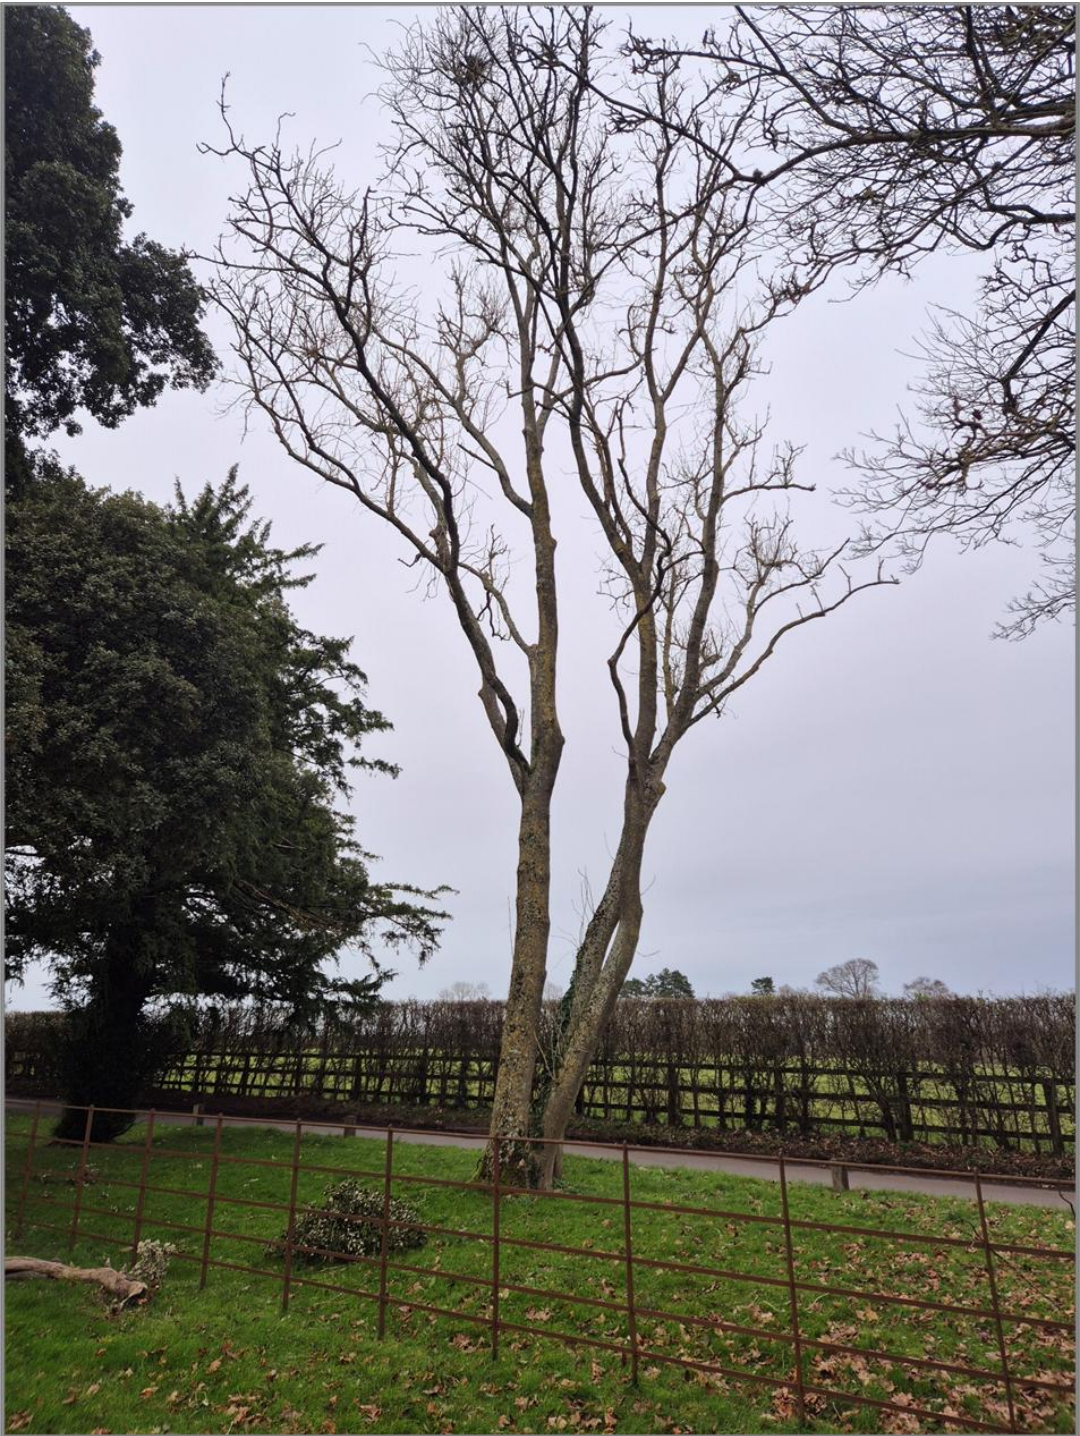
**Photo 2**  
**roadside ash tree, ash dieback class 4**

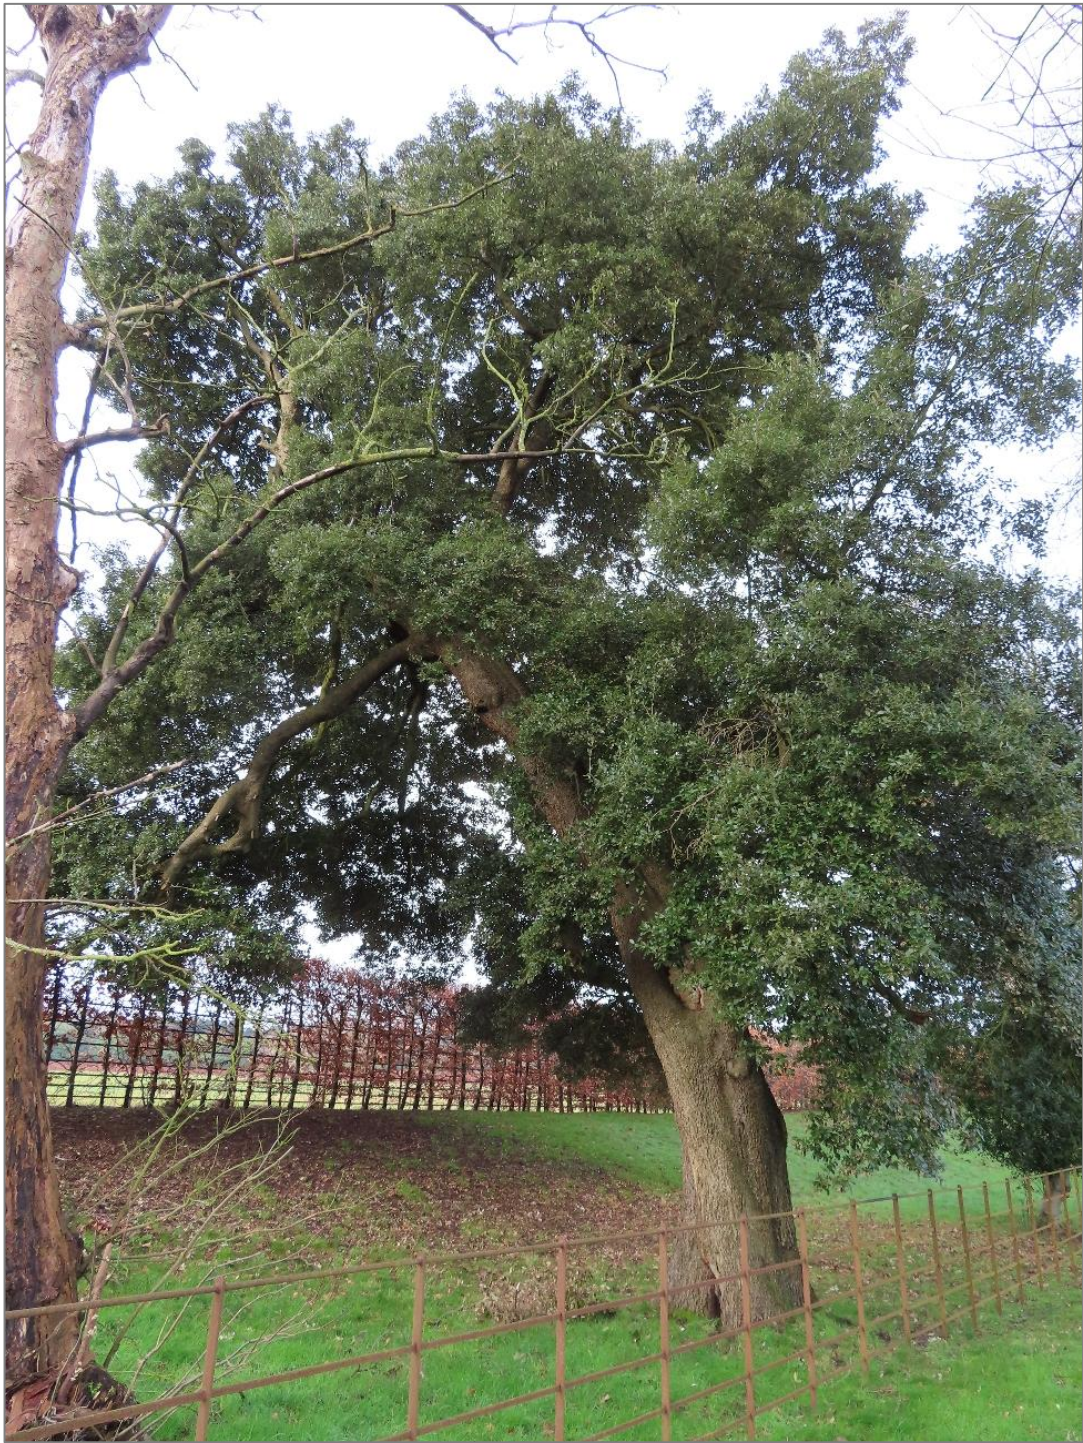
- of the several holm oak trees that were seen, one at least had extensive decay, see photos 3 to 6,
- the oak tree that had recently shed a limb had a collapsing and imbalanced crown with the bias of the weight now over the highway, see photo 7,

**Photo 3**  
**one of the several holm oak trees**

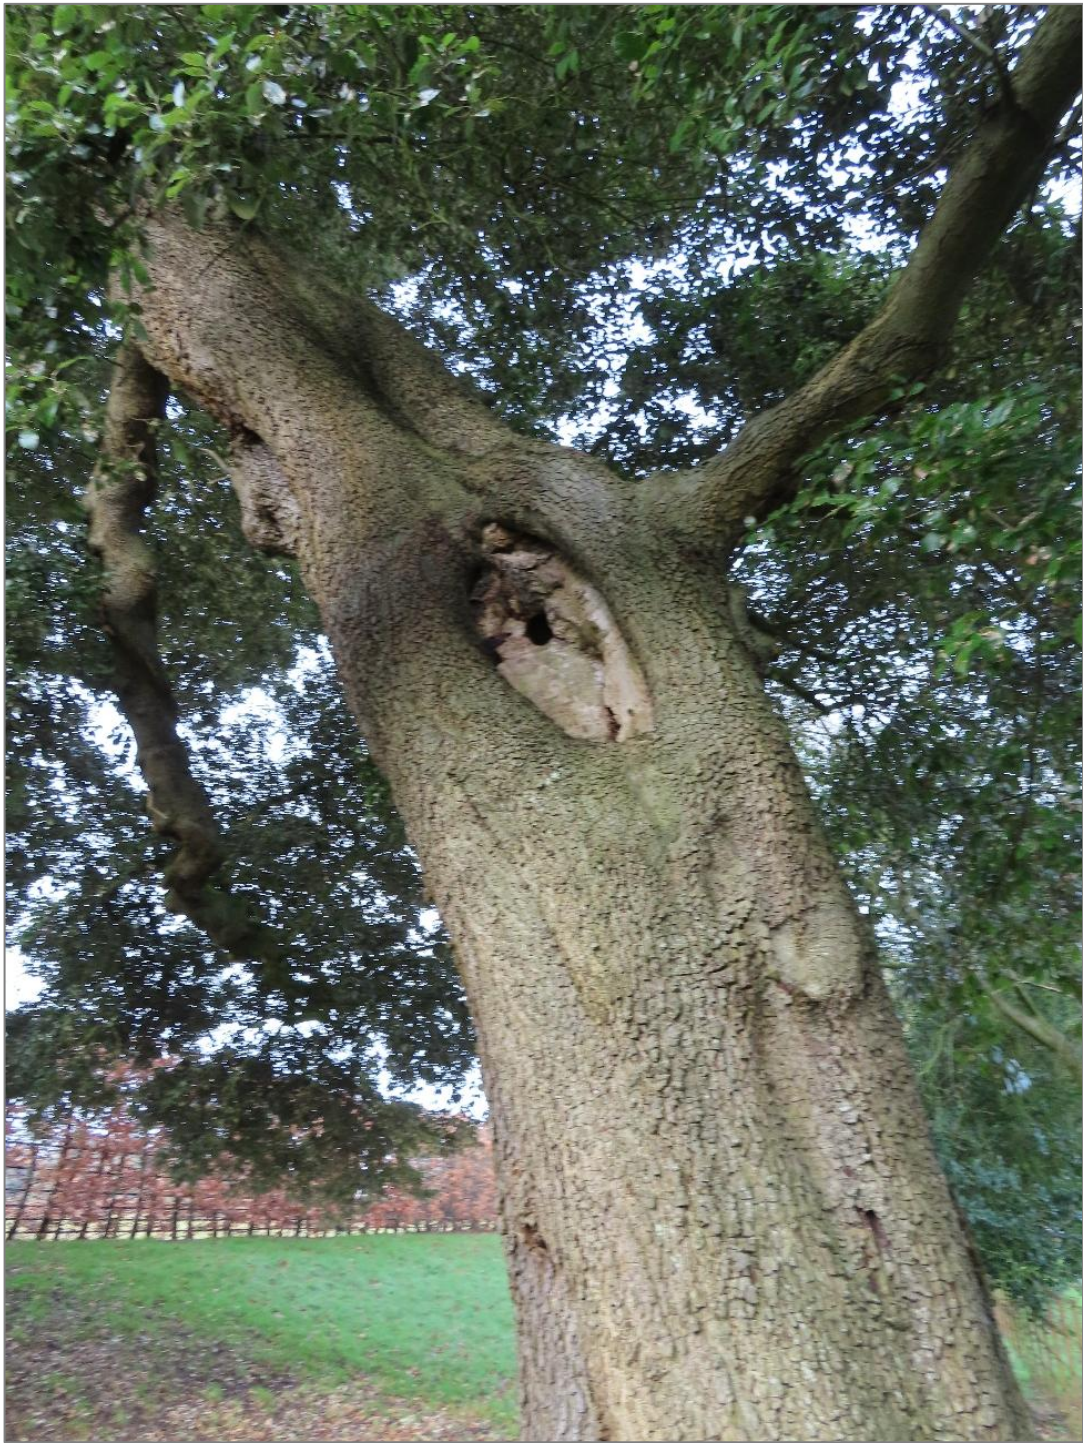
**Photo 4**  
**tear-out wound in close-up**

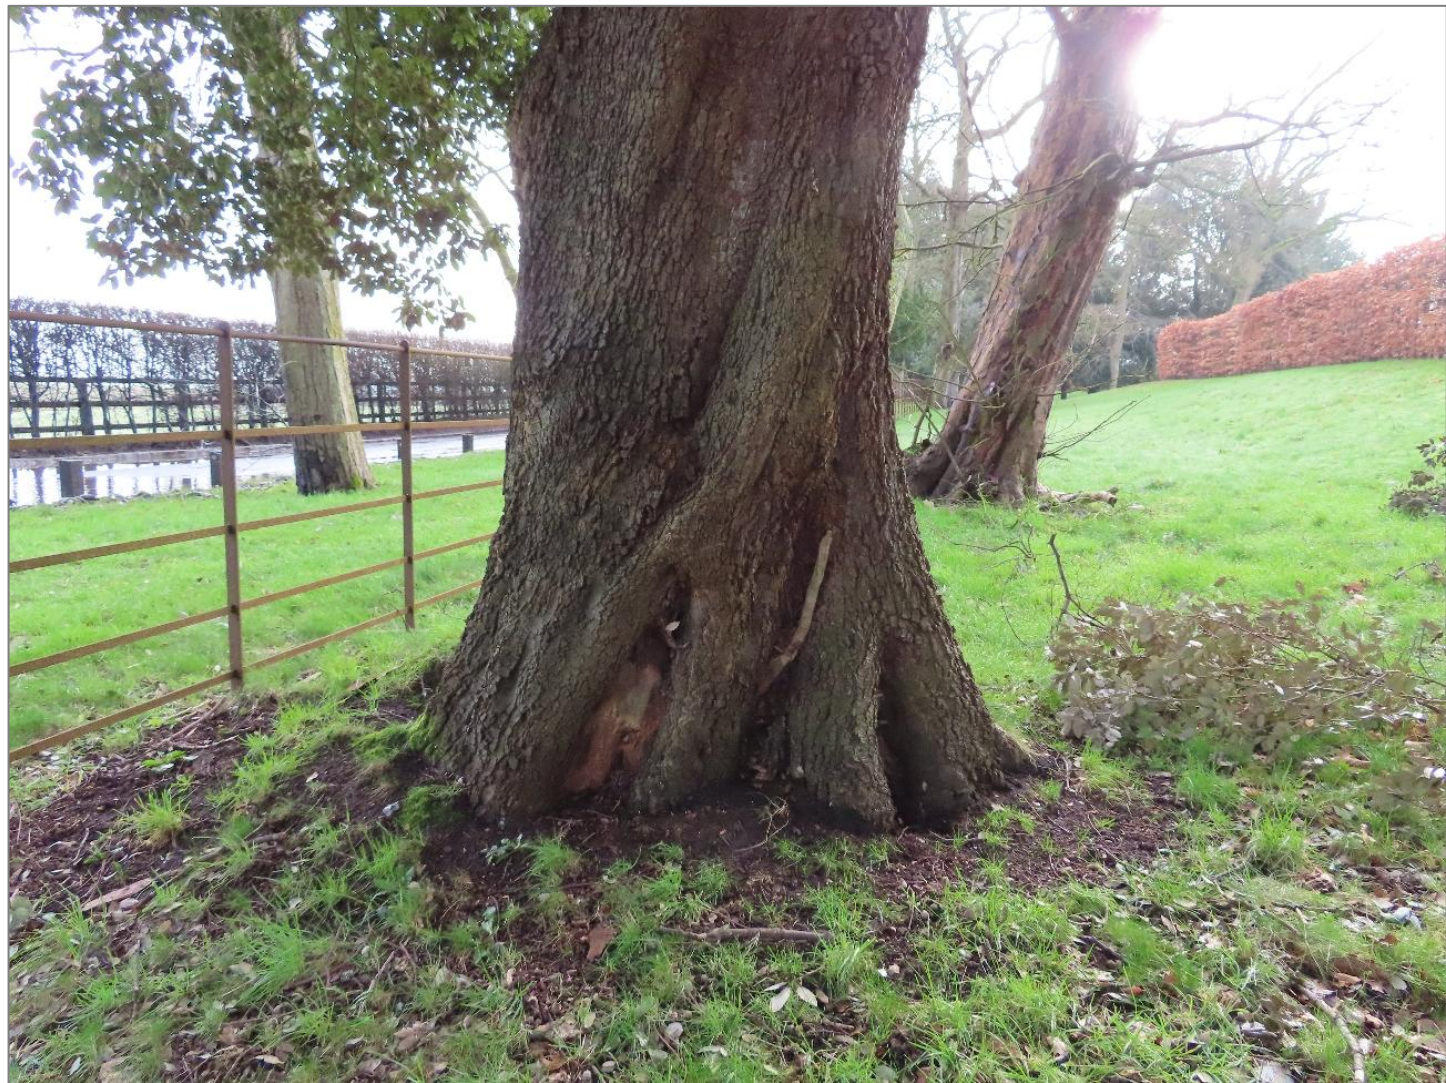
**Photo 5**  
**basal decay on the holm oak**

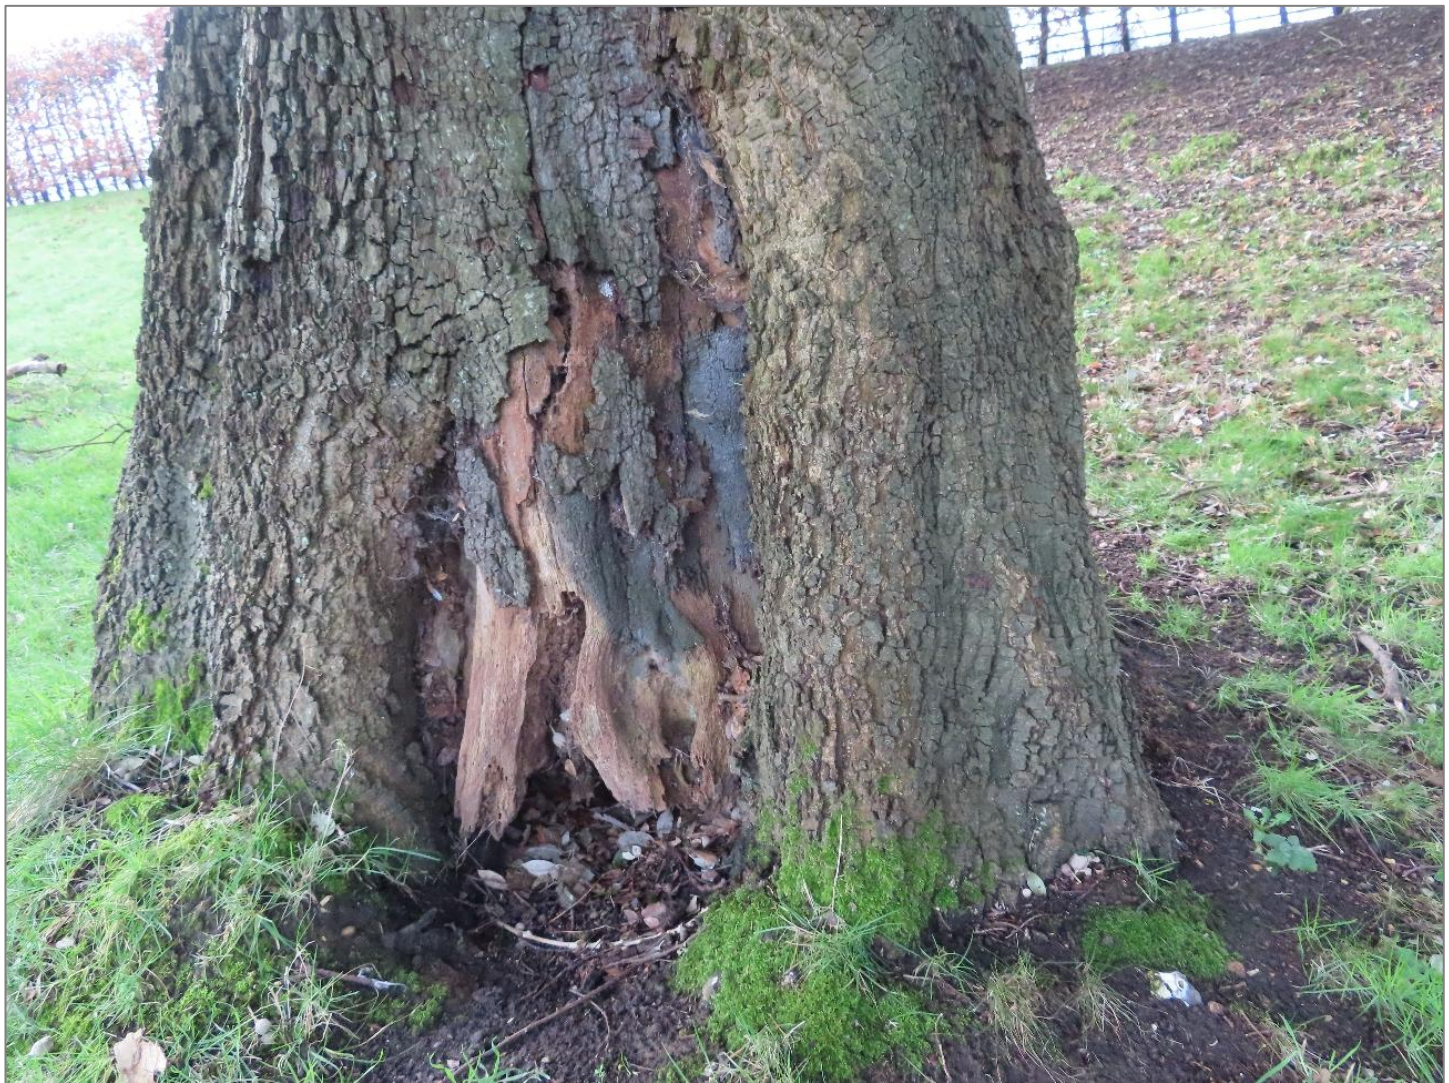
**Photo 6**  
**basal decay on the holm oak**

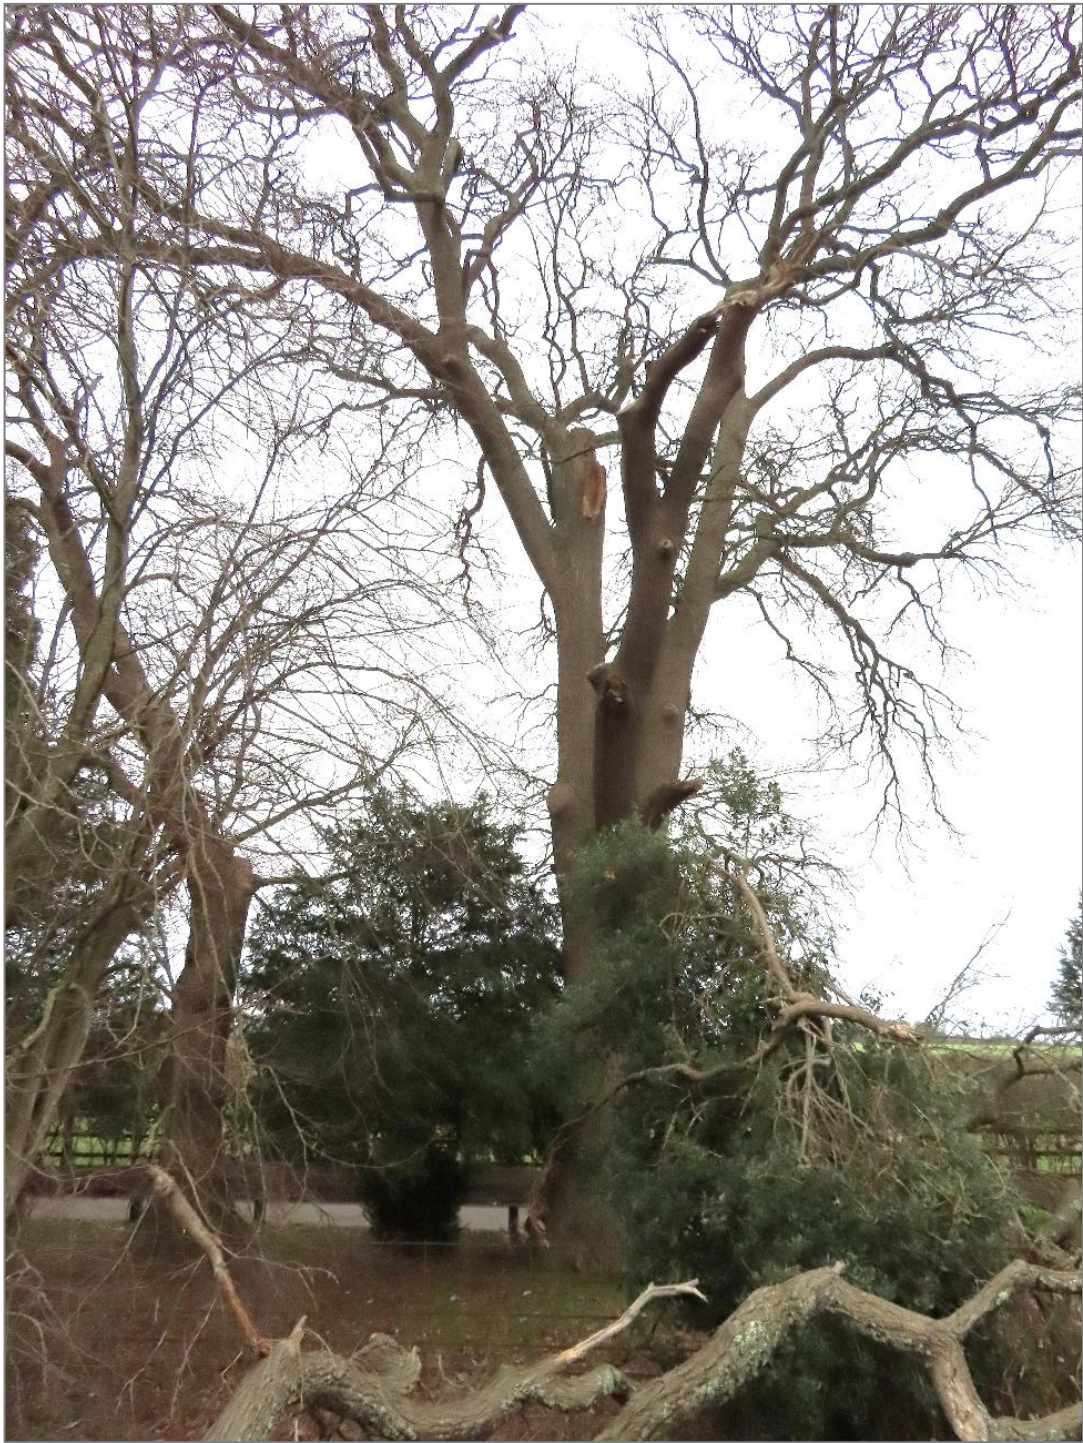
**Photo 7**  
**one of the roadside oaks, with a collapsing crown**

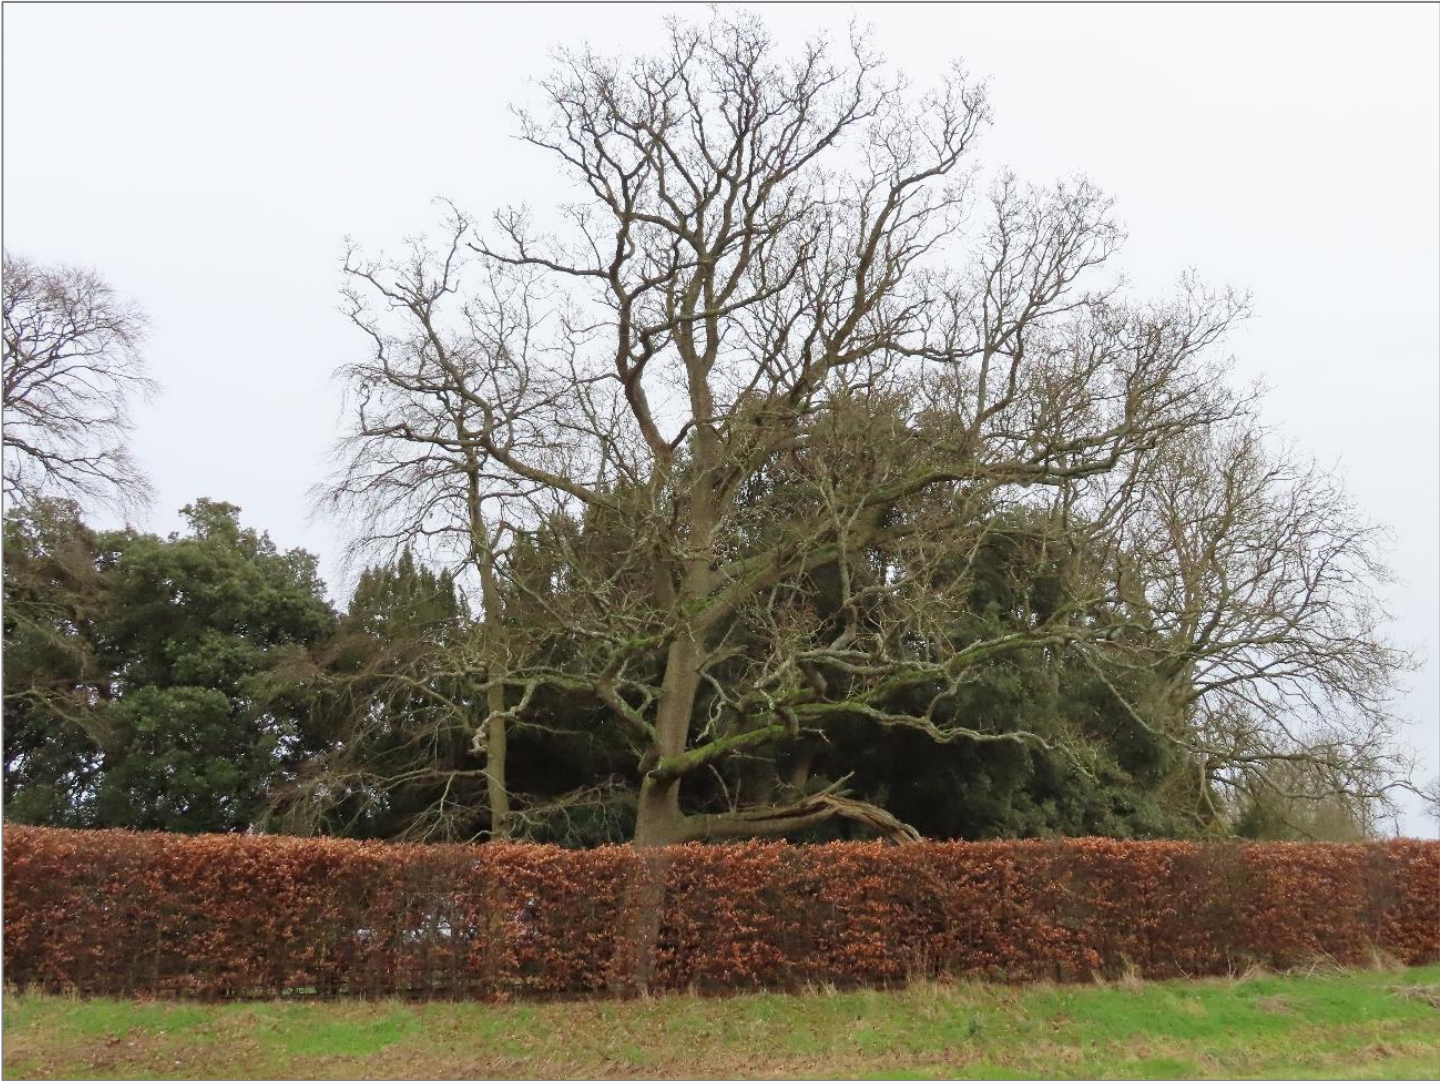
- a second oak had a split beam, and fallen limbs, see photos 8 and 9,
- there was an oak tree that had lost its leader with a potential column of decay suggesting that the limb attachments may be compromised, see photo 10,

**Photo 8**  
**oak tree with split beam**

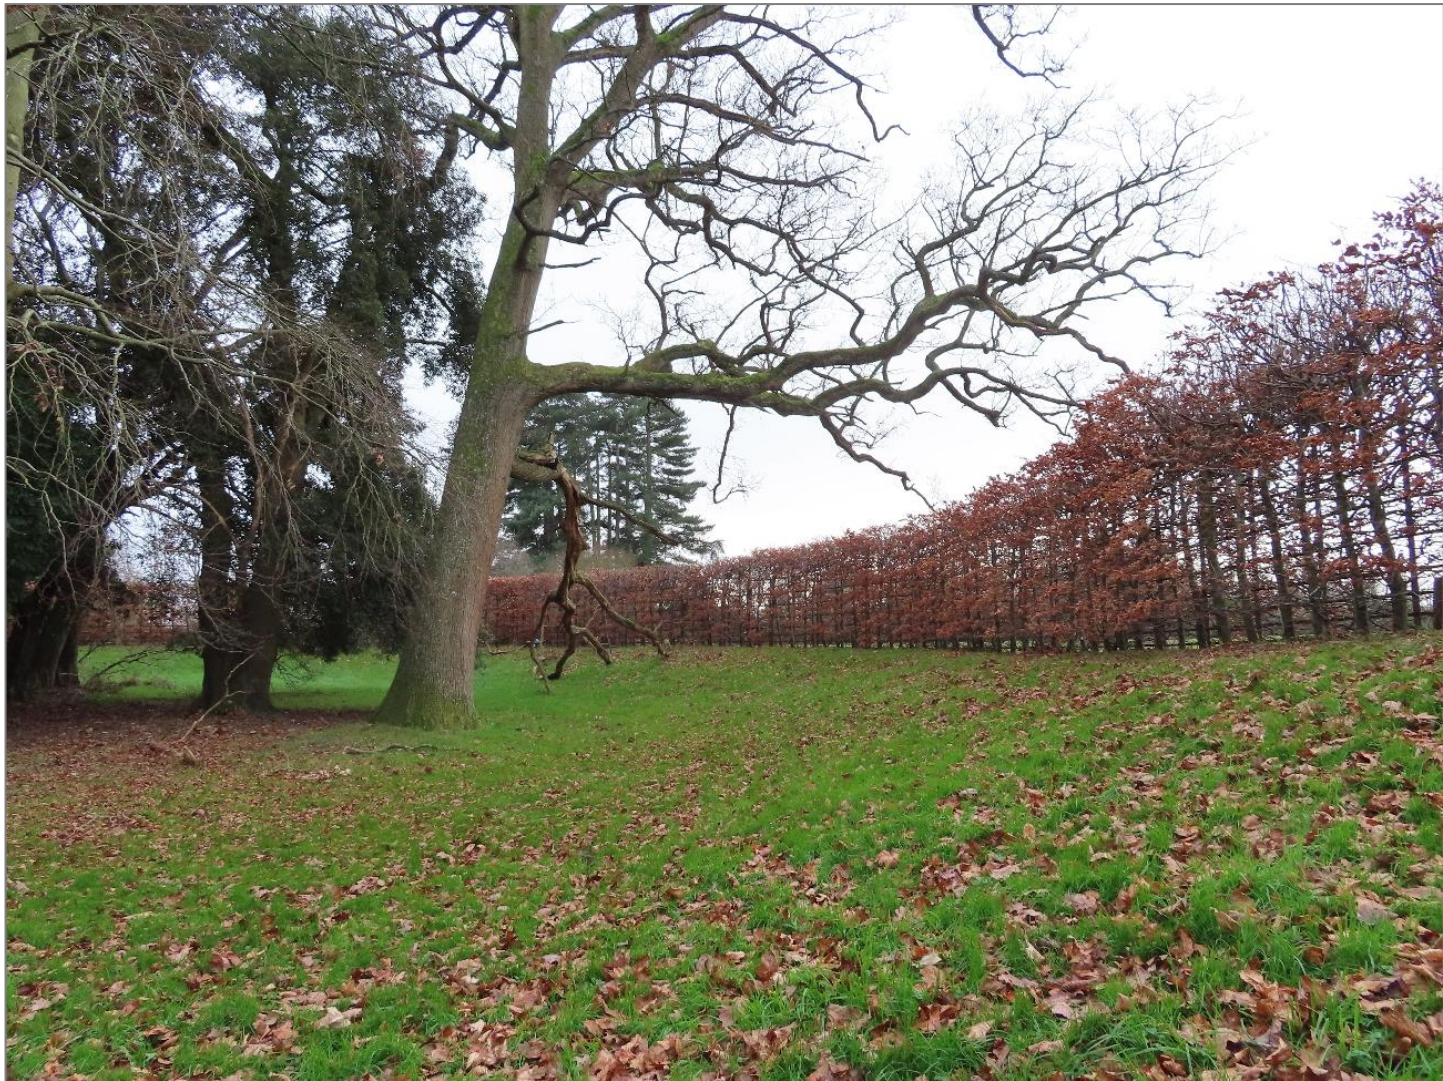
**Photo 9**  
**a second view of the split limb**

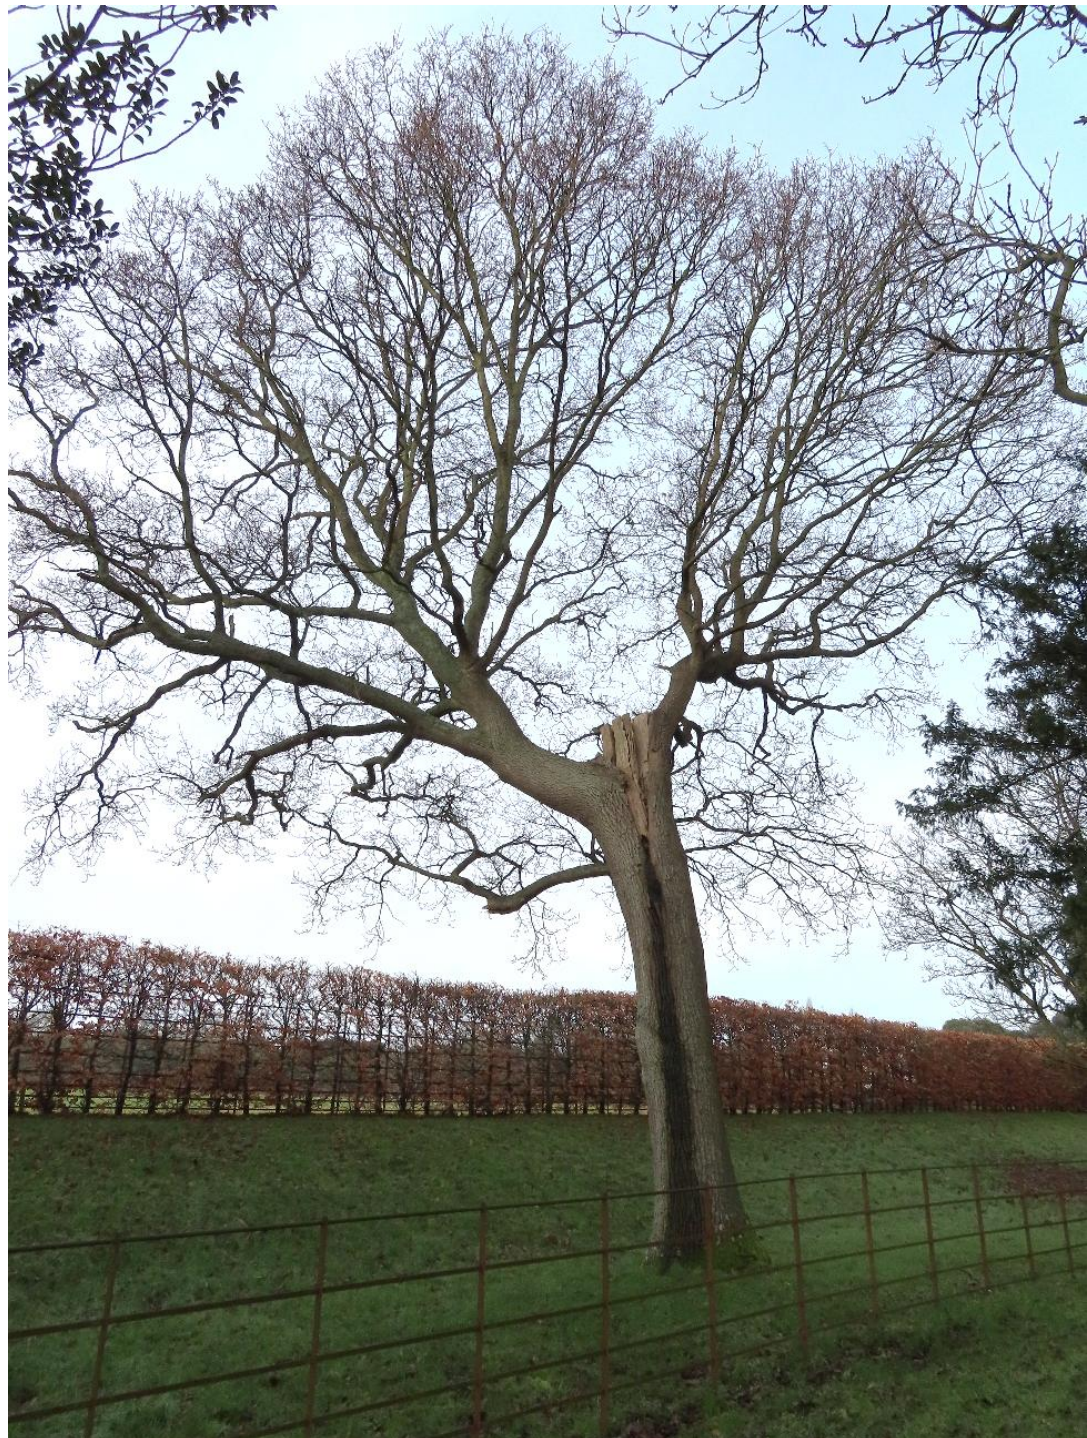
**Photo 10**  
**oak with lost leader and column of decay**

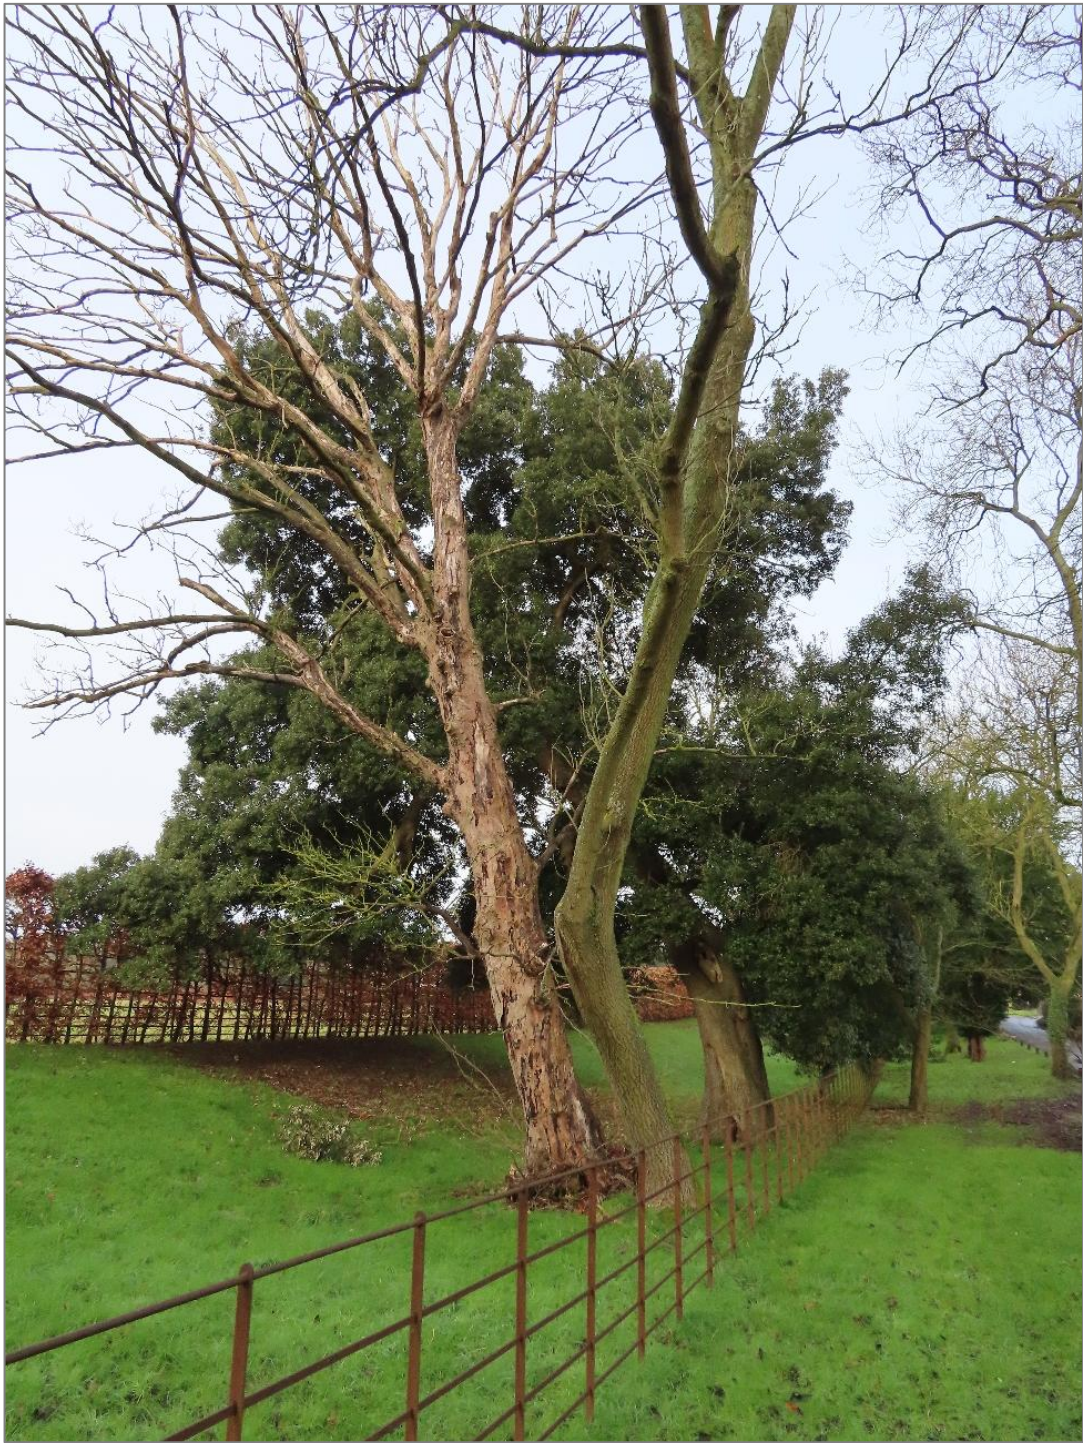
- a dead sycamore, possibly as a result of sooty bark disease, see photo 11,
- one roadside whitebeam missing a considerable amount of bark, see photo 12, and

**Photo 11**  
**dead sycamore and leaning ash tree**

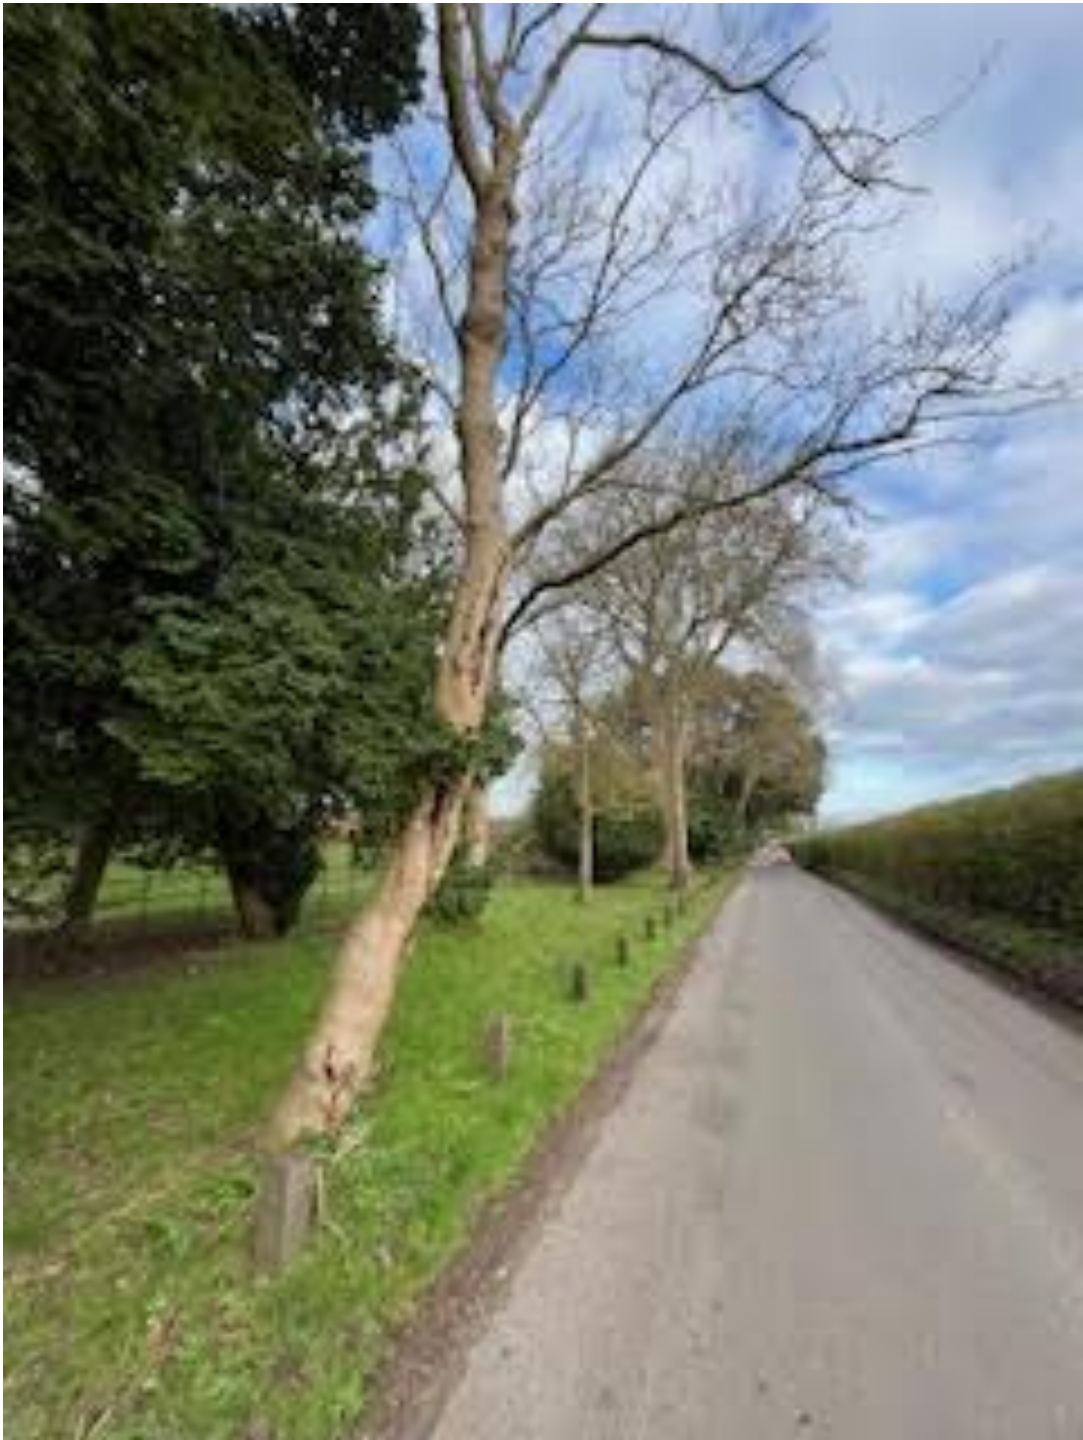
**Photo 12**  
**roadside whitebeam with extensive dieback**

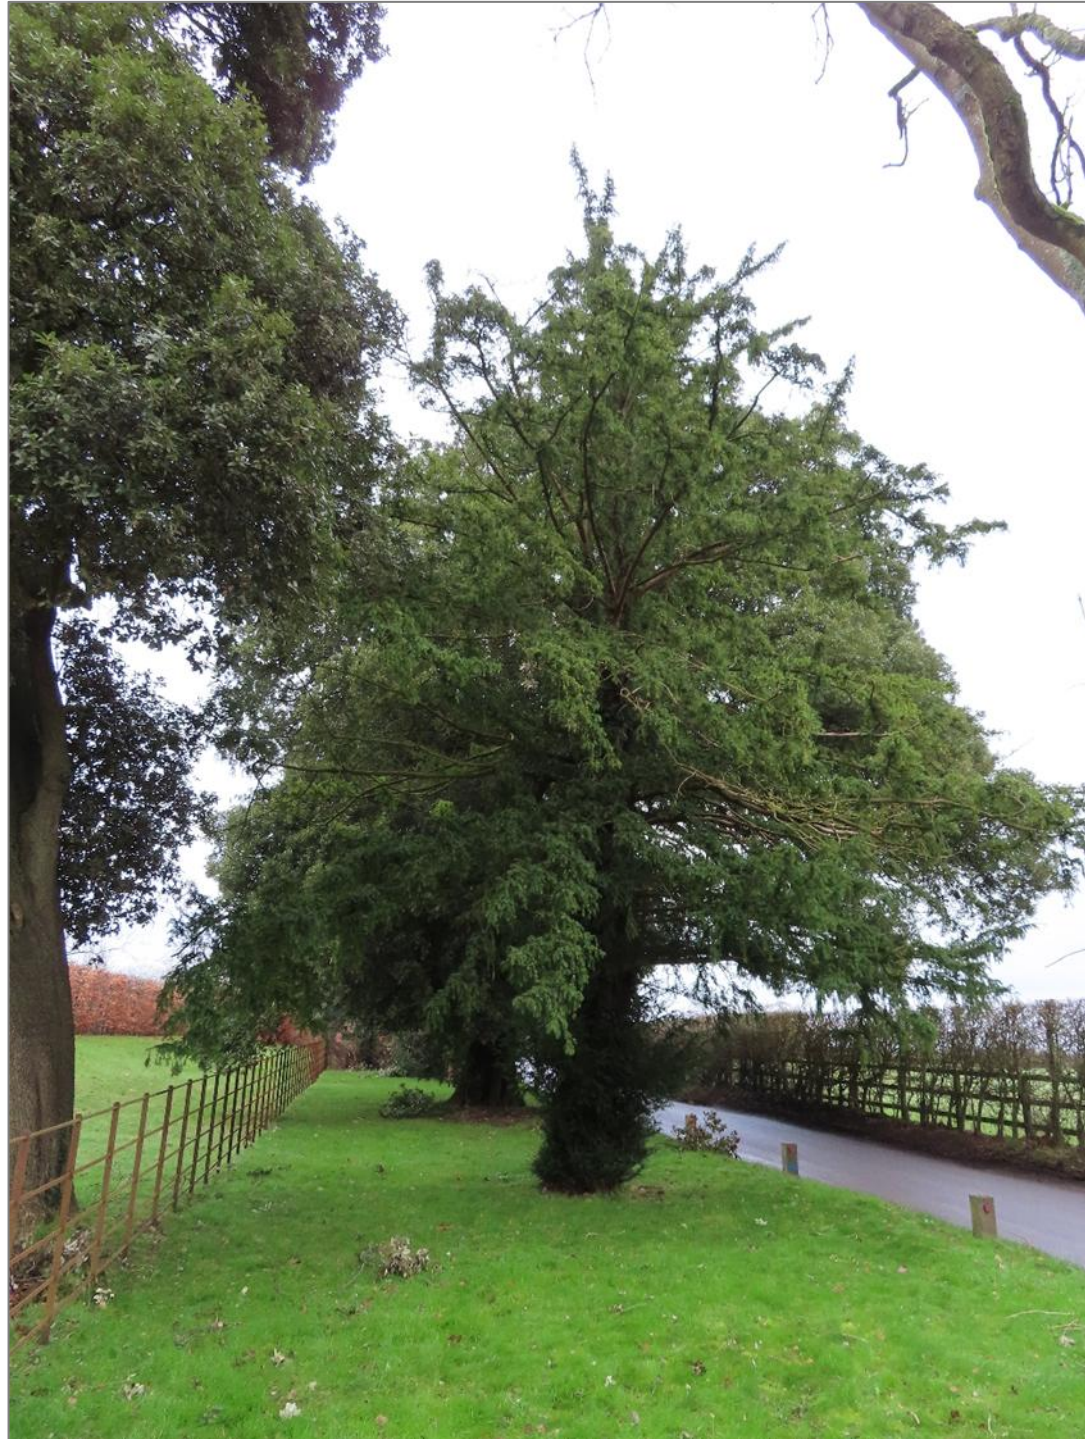
- one of the roadside yew trees had significant dieback, see photo 13.

**Photo 13**  
**roadside yew with extensive dieback**
