**Fulford-Dobson Associates Ltd**  
ARBORICULTURAL CONSULTANCY

## **ARBORICULTURAL REPORT**

Camp Mohawk  
Highfield Lane  
Wargrave  
Berkshire  
RG10 8PU

| Our ref | FDA1247 |

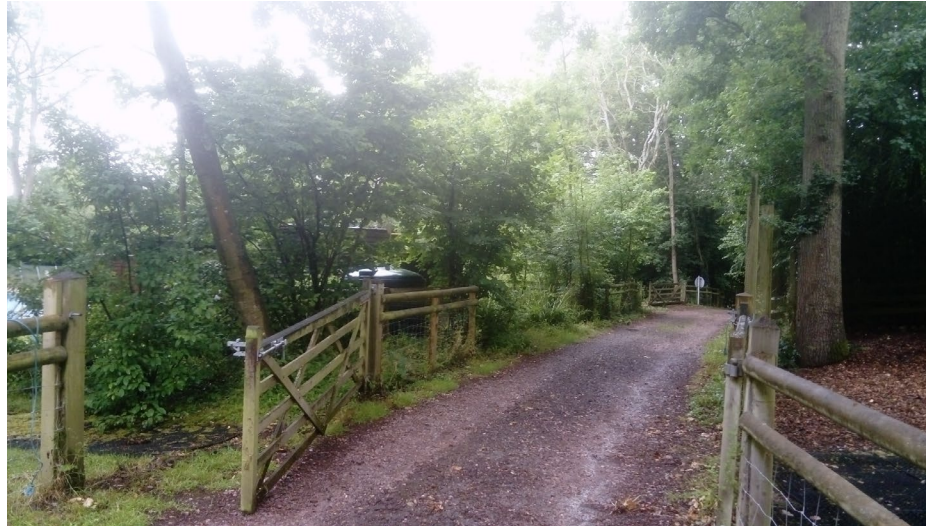
Figure 3. Main drive (looking west). Trunks of T1 right and T2 left.

| Tree no. | Species | Height (m) | Stem diameter (mm) | Crown spread (m) north east south west | Height (m) and direction of first main branch | Height clearance above ground level to canopy (m) | Age class | Physiological condition | Structural condition | General observations | Remaining contribution in years | Tree quality category | RPA radius of nominal circle (m) | RPA area of polygon m2 |
|---|---|---|---|---|---|---|---|---|---|---|---|---|---|---|
| T2 | Common ash ( <i>Fraxinus excelsior</i> ) | 13m | 300 | N2.5m<br>E6m<br>S6m<br>W3.5m | 5m | 5m | Early mature | | | Felled between 2020 and 2023 due to ash dieback. | | | | |

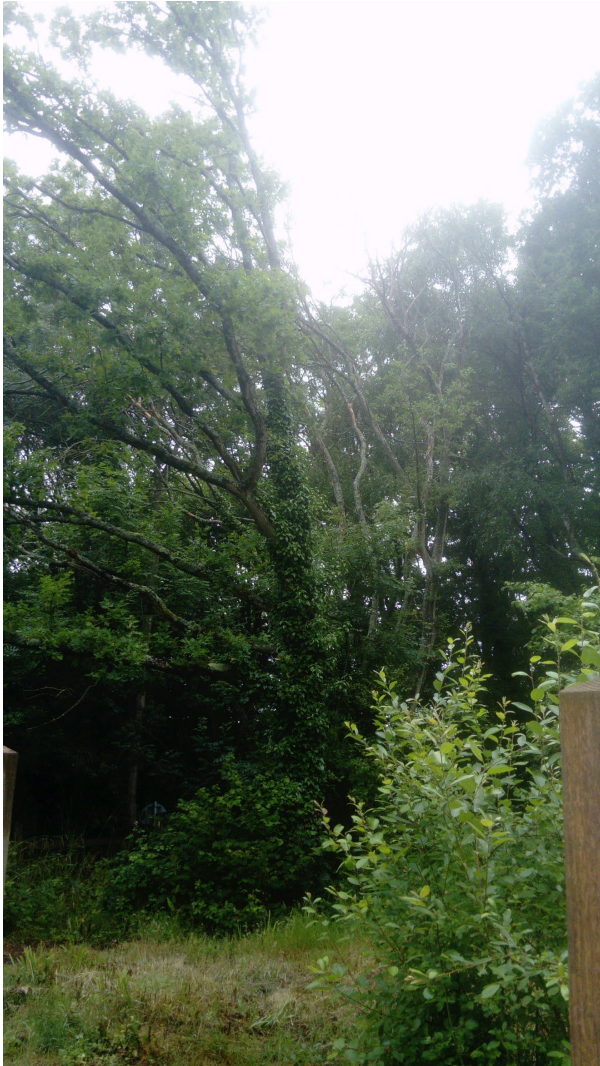
Figures 5. T8 and T9 (looking north).

| Tree no. | Species | Height (m) | Stem diameter (mm) | Crown spread (m) north east south west | Height (m) and direction of first main branch | Height clearance above ground level to canopy (m) | Age class | Physiological condition | Structural condition | General observations | Remaining contribution in years | Tree quality category | RPA radius of nominal circle (m) | RPA area of polygon m2 |
|---|---|---|---|---|---|---|---|---|---|---|---|---|---|---|
| T8 | English oak ( <i>Quercus robur</i> ) | 13m | 375 | E1.5m<br>S7.5m<br>W4.5m | 2.5m | 2.5m | Early mature | Fair | Poor | Very asymmetrical crown shape and ivy growing up trunk and into crown. | 10+ | C2 | 4.5m | 63.6m <sup>2</sup> |

| T9 | Common ash<br>( <i>Fraxinus excelsior</i> ) | 8.5m | 130 | S6.5m<br>W5m | 3m | 3m | Semi-<br>mature | Fair | Poor | Severely suppressed -<br>no future. | 10+ | C2 | 1.6m | 7.6m <sup>2</sup> |

| Tree no. | Species | Quality category | General condition | Reason for removal | Impact on landscape | Proposed mitigation |
|---|---|---|---|---|---|---|
| T8 | Oak | C2 | Very asymmetrical crown shape. | To enable access for machinery and space for deliveries & storage of building materials. | Negligible | Replacement planting of two standard silver birch in open glade to the south. |
| T9 | Ash | C2 | Poor, severely suppressed – no realistic future. | To enable access for machinery and space for deliveries & storage of building materials. | Negligible | |

| Tree no. | Species | Specification |
|---|---|---|
| T8 | Oak | Section fell to ground level and grind out stump. |
| T9 | Ash | Section fell to ground level and grind out stump. |

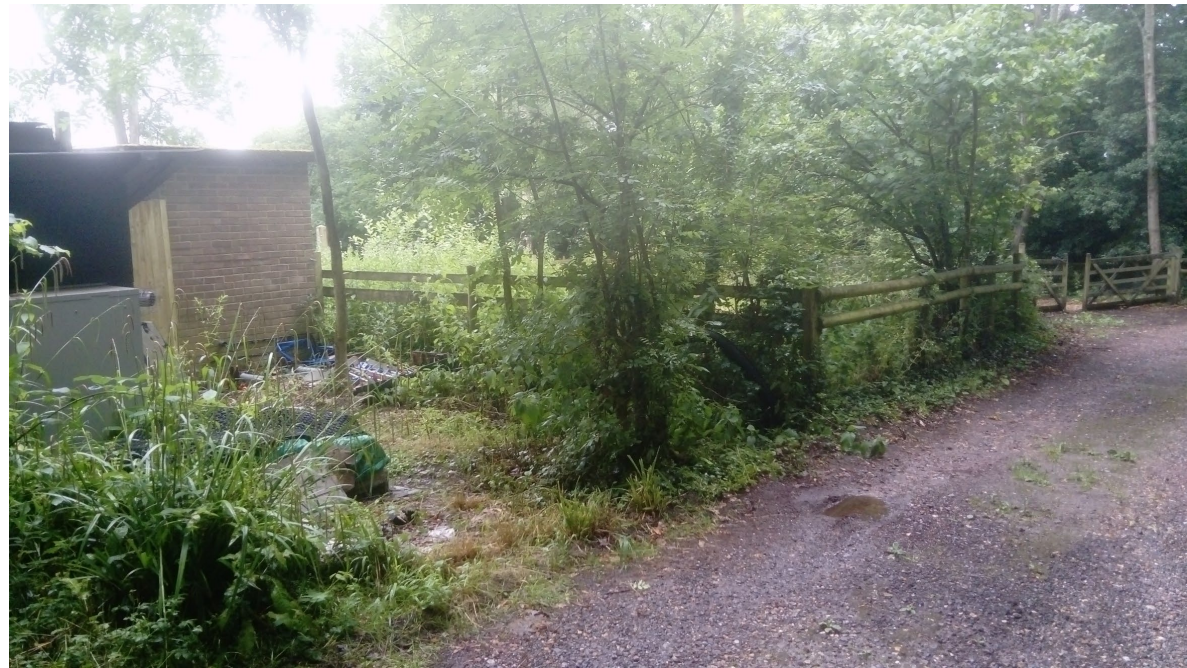
Figure 6. Rear of existing pool buildings. Trees (from right to left): - T14, T11, T12 and G15.

| Tree no. | Species | Quality category | General condition | Reason for removal | Impact on landscape | Proposed mitigation |
|---|---|---|---|---|---|---|
| T11 | Hazel | C2 | Fair condition but small with minimal landscape value. | To enable access for machinery and space for deliveries & storage of building materials. | Very low | |
| T12 | Ash | C2 | Fair but semi-mature, with minimal landscape value and close to proposed new changing facilities. | To enable access for machinery and space for deliveries & storage of building materials. | Very low | |
| G15 | Various | C2 | Small self-seeded young oak and ash | To accommodate new changing facilities. | Very low | |

| Tree no. | Species | Specification |
|---|---|---|
| T11 | Hazel | Section fell to ground level and grind out stump. |
| T12 | Ash | Section fell to ground level and grind out stump. |
| G15 | Various | Section fell to ground level and grind out stump. |

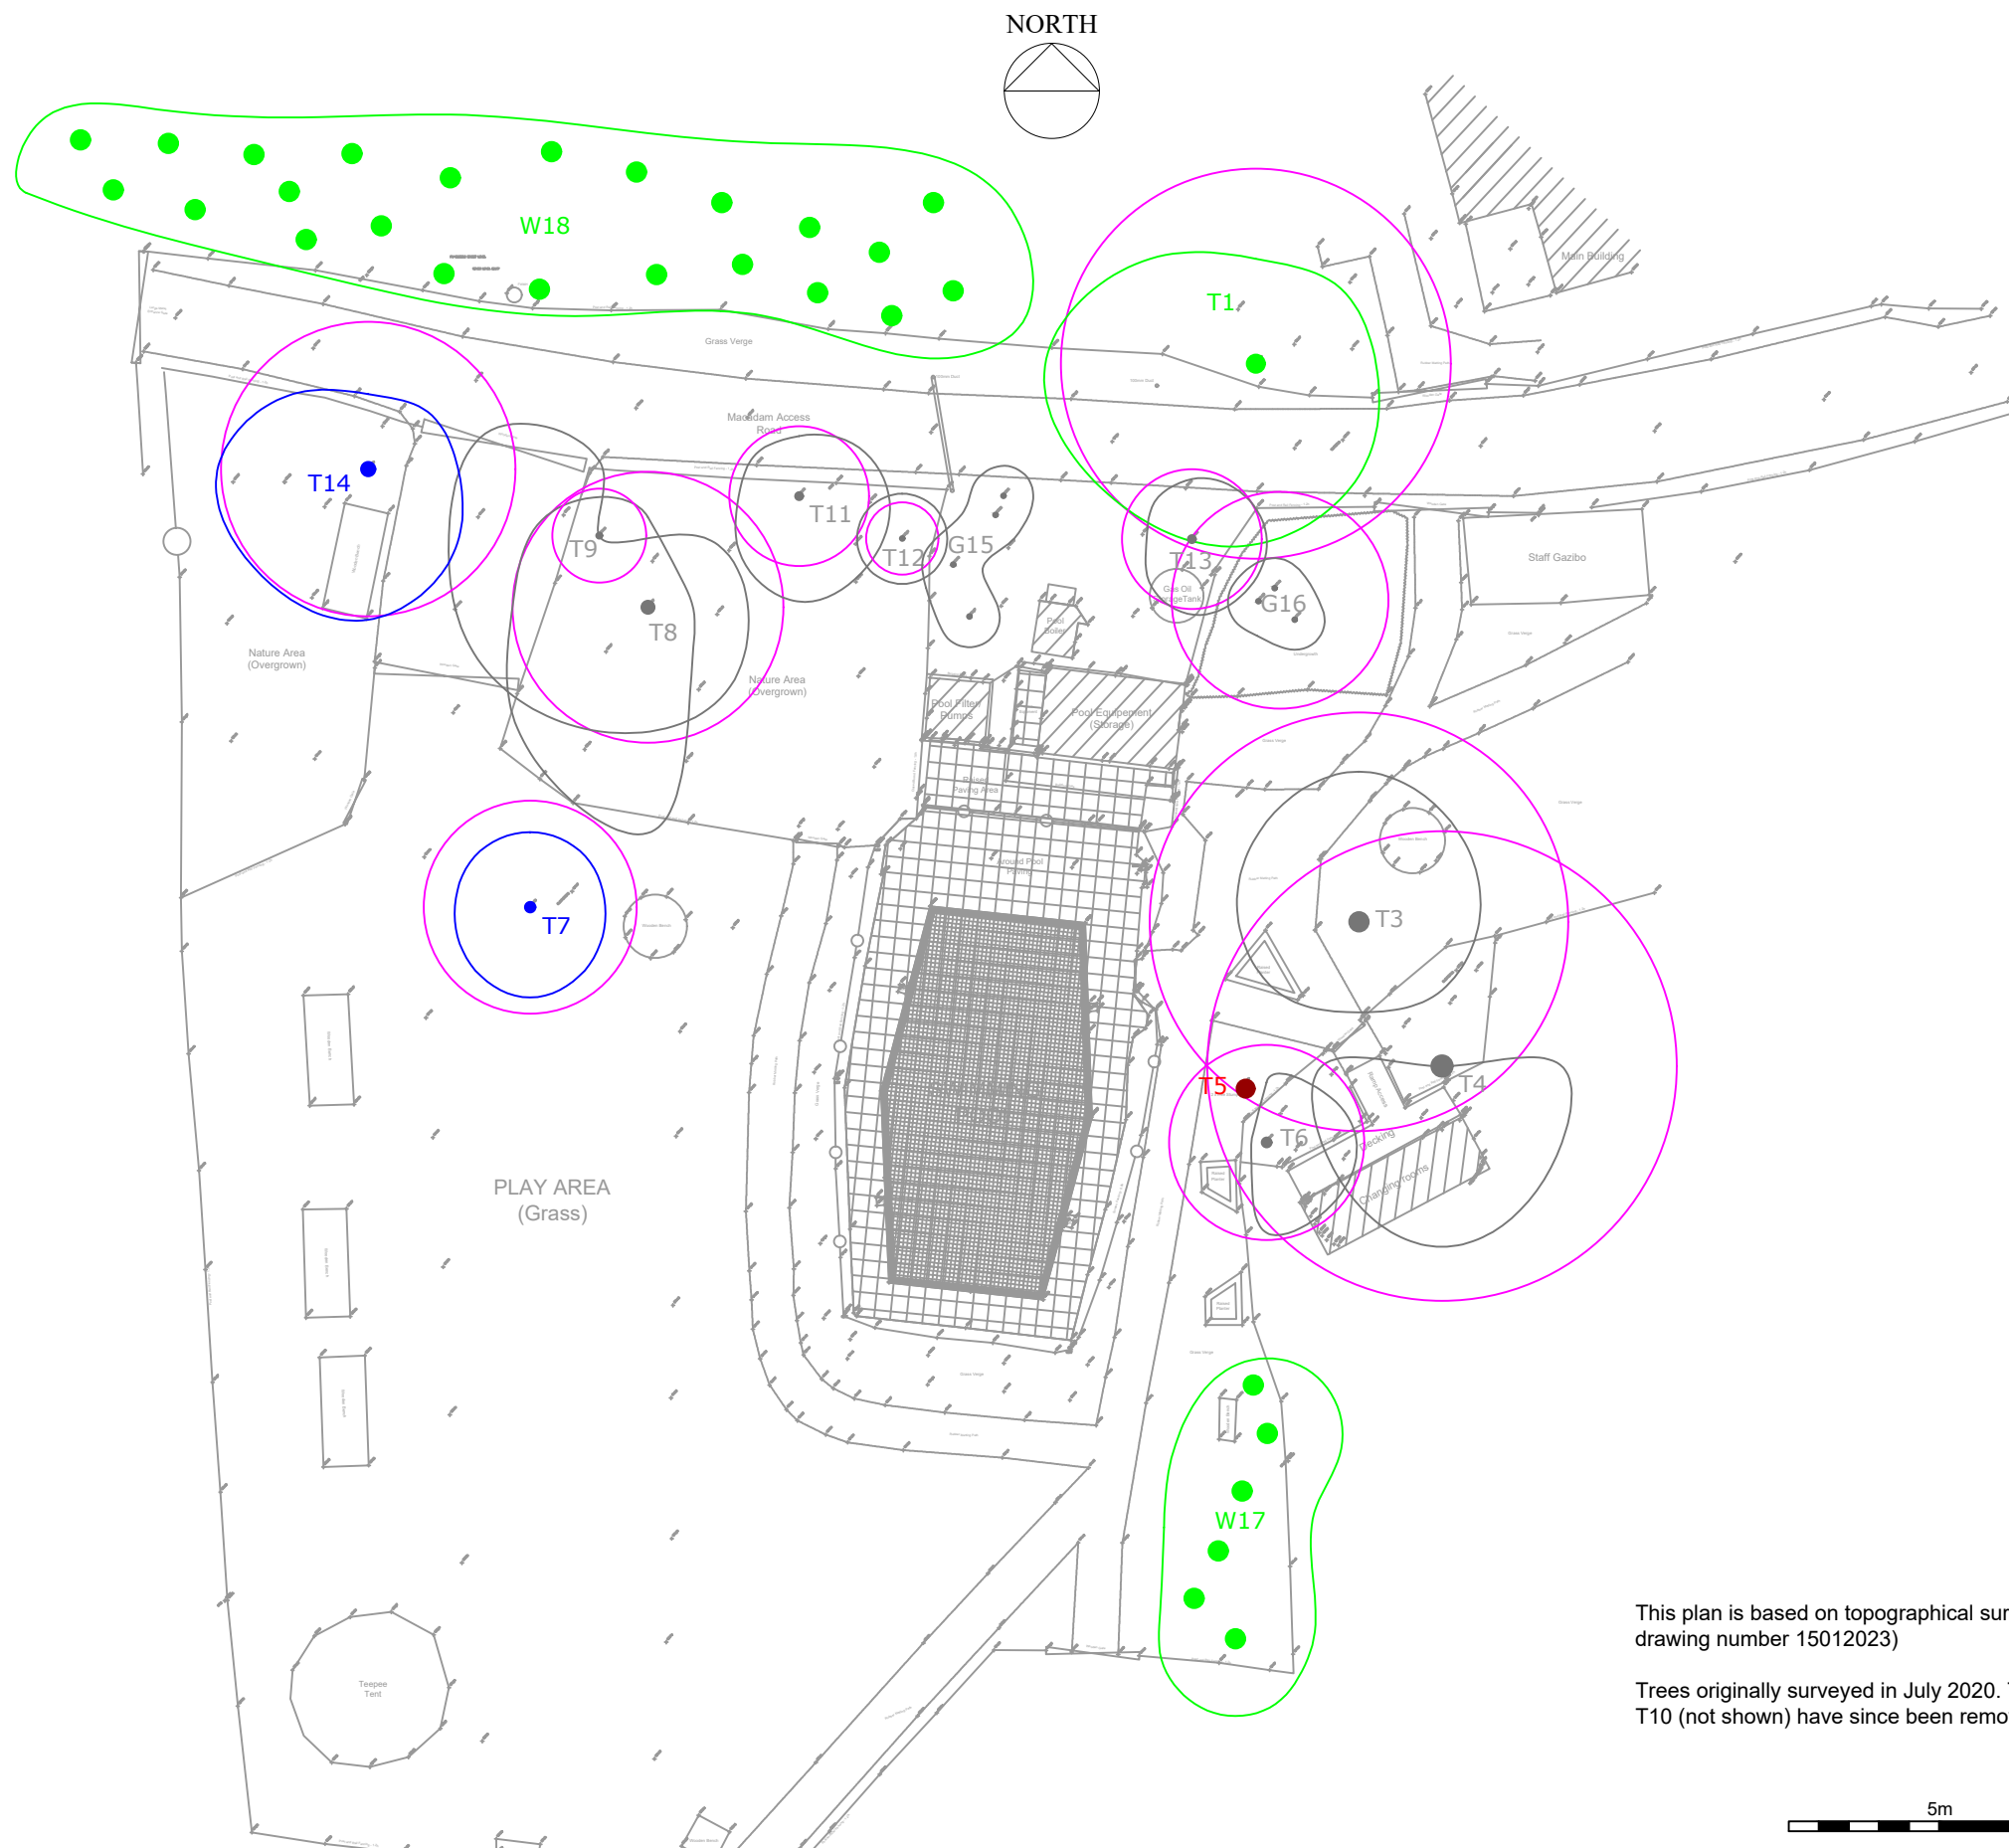
| Drawing no. FDA0933_01_TCP | |

Trees originally surveyed in July 2020. T2 & T10 (not shown) have since been removed

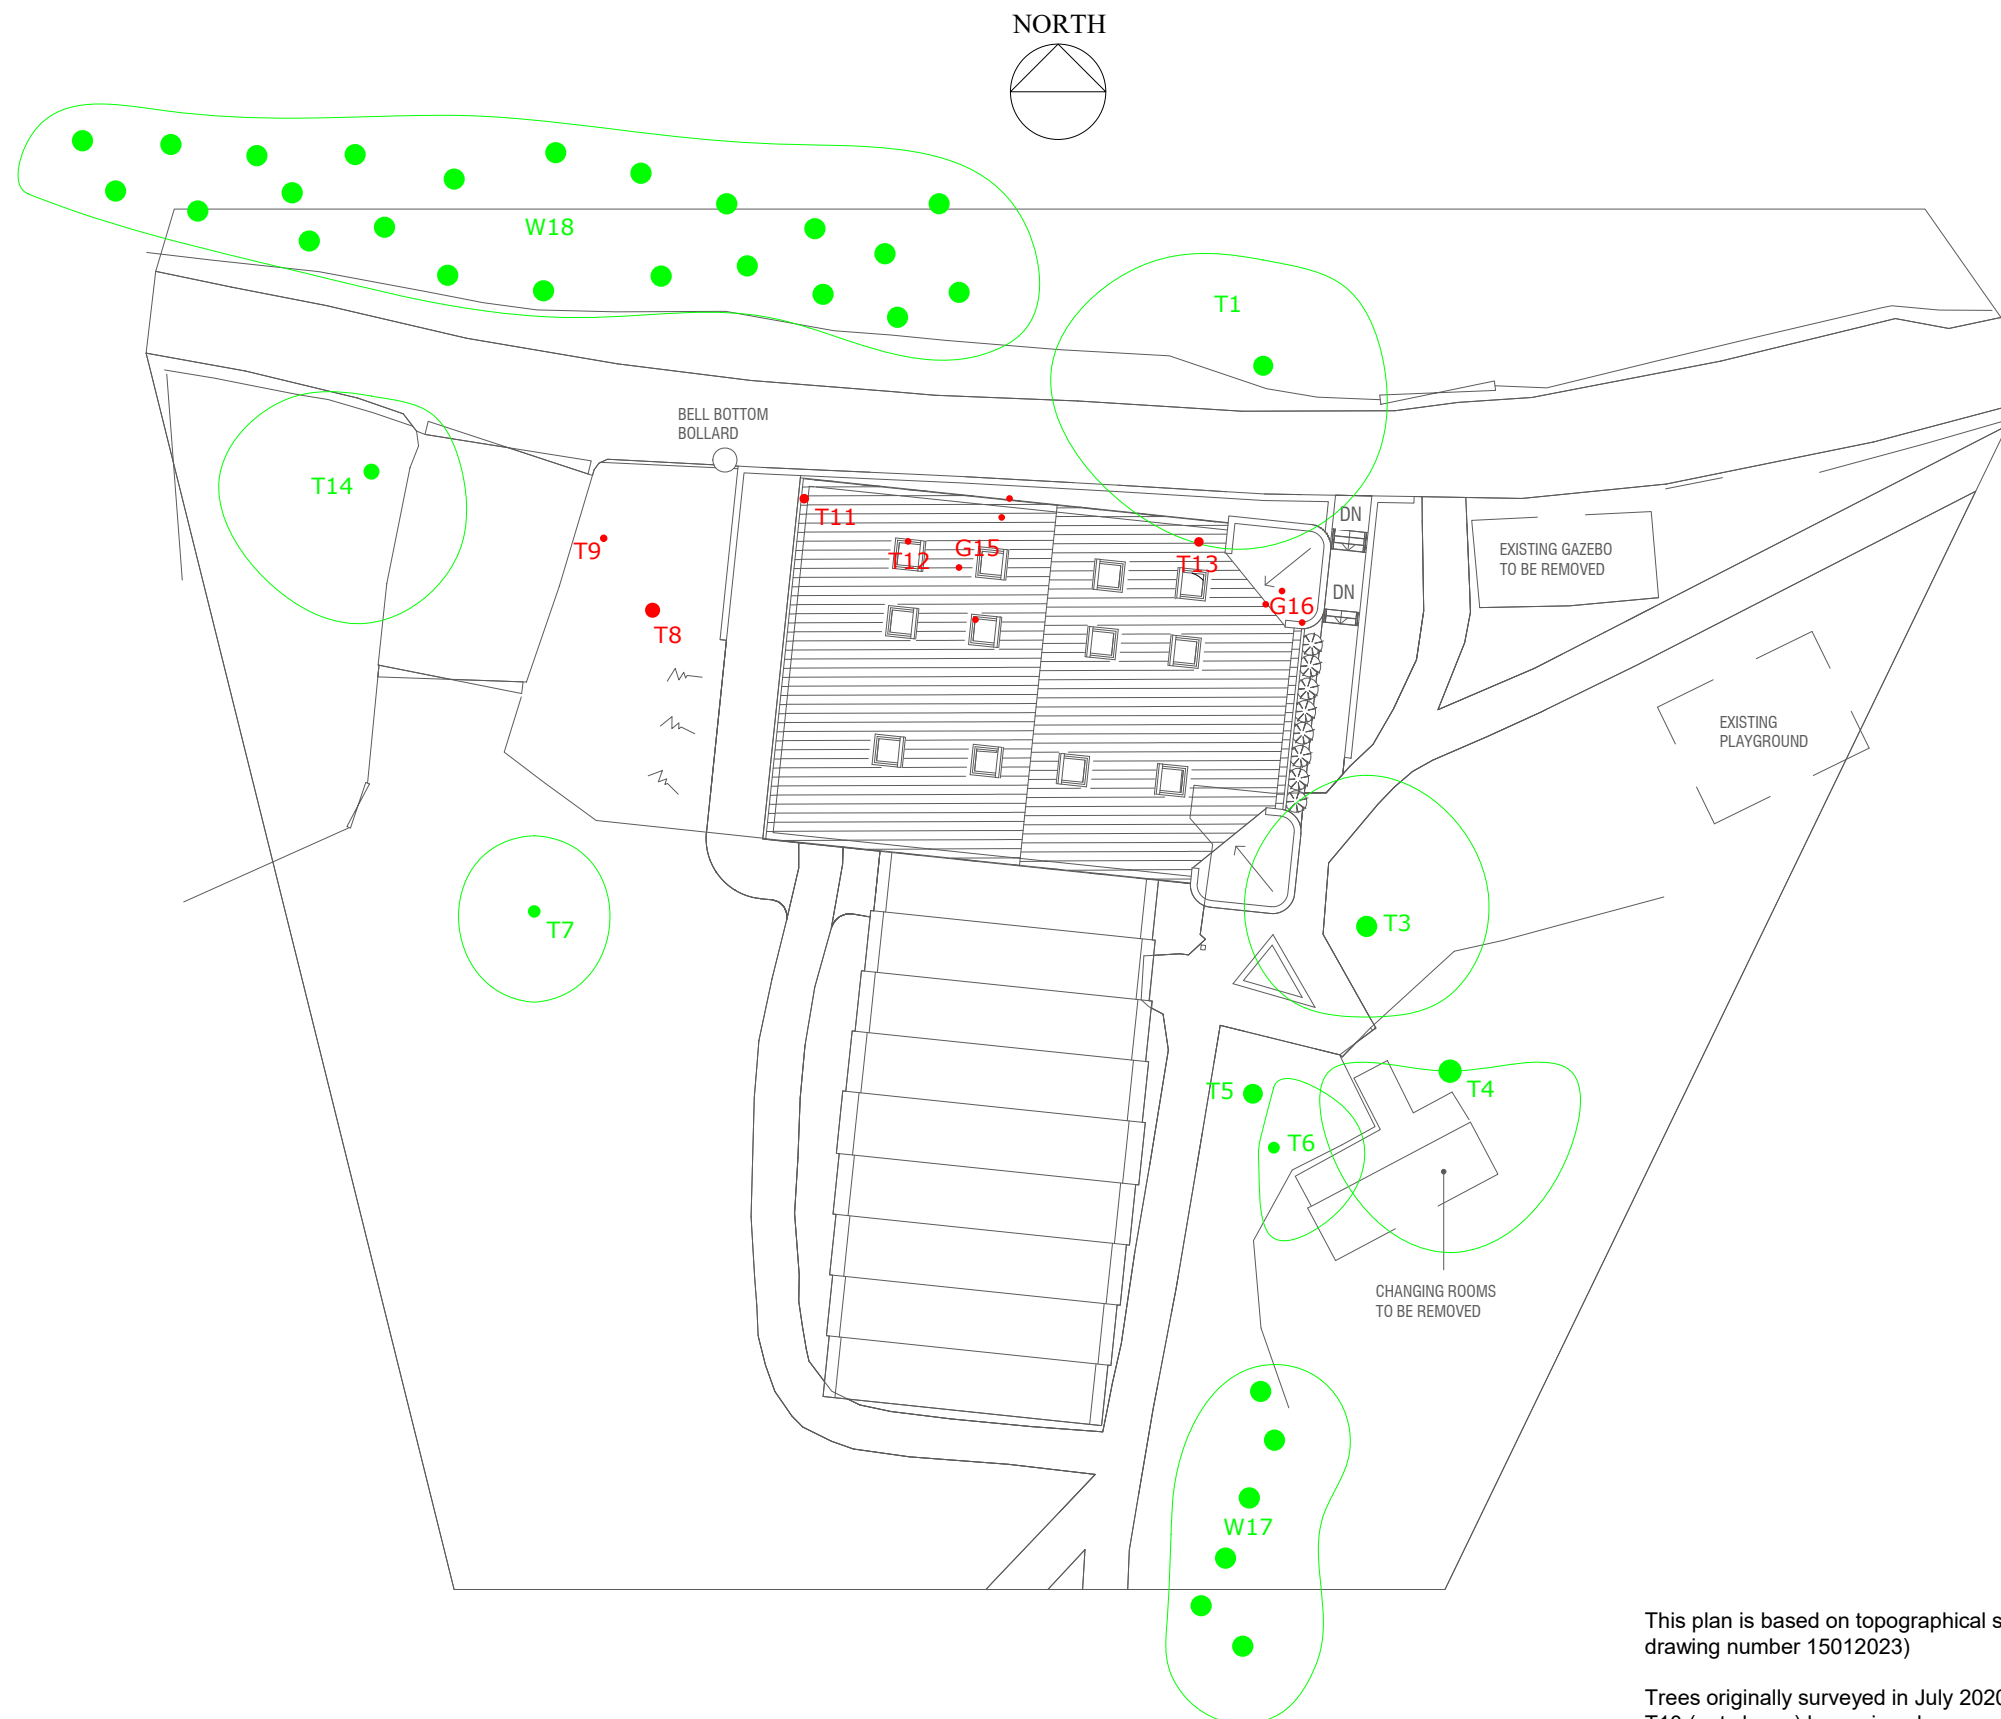
Drawing no. FDA0933\_02\_TRRP

Trees originally surveyed in July 2020. T2 & T10 (not shown) have since been removed
