## SUSTAINABLE DRAINAGE STRATEGY REPORT

| PROJECT | WOKINGHAM |
| PROJECT NUMBER | 25047 |
| CLIENT | Propco (Wokingham) Ltd |

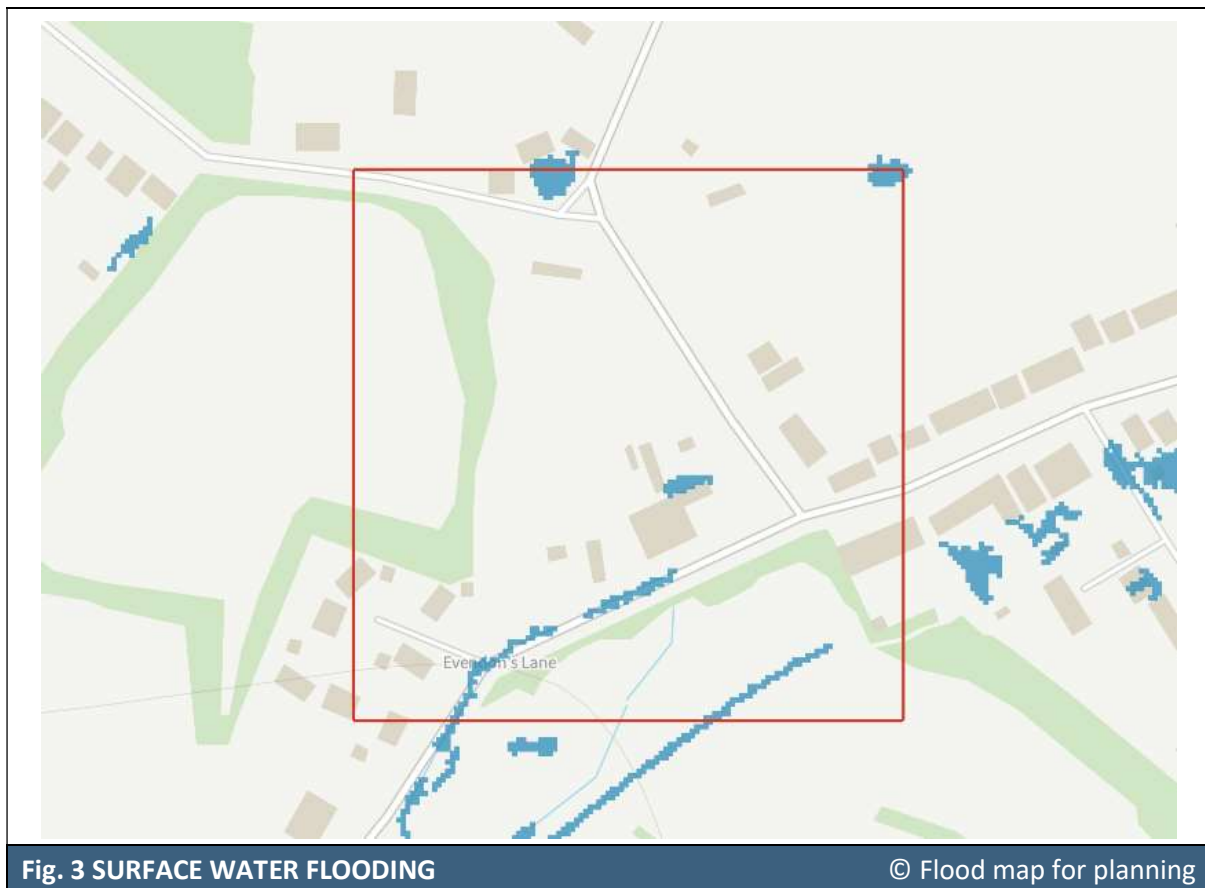
Figure 3 shows a small risk of surface water flooding on site although there is no suggested depth or velocity. It is considered that the potential surface water flooding shown on the mapping is attributable to the existing topography and a low spot within the site. Due to the proposals for the new building footprint, this risk will be mitigated on the completed development.

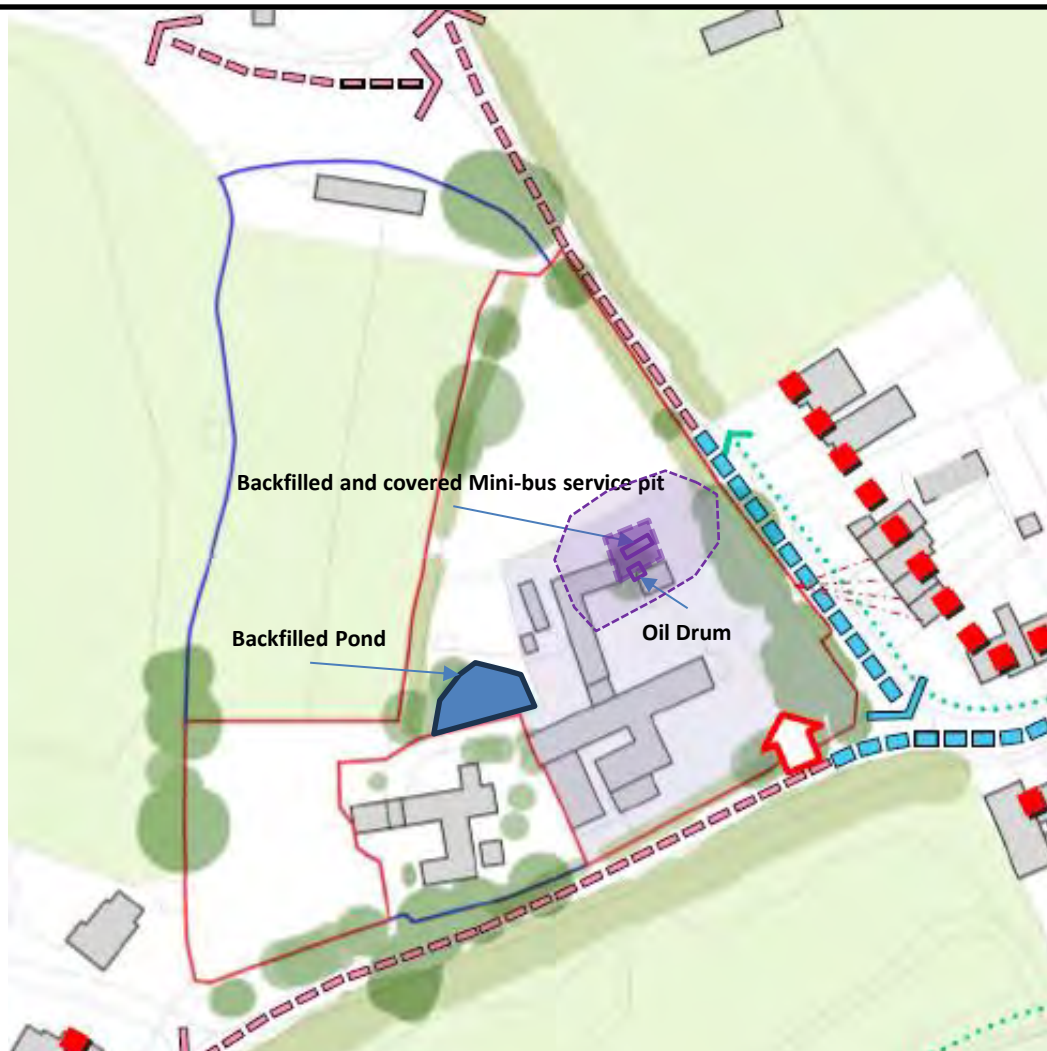
**TPH Contaminated  
Sources &  
Impacted Soils - Existing**

Assumed Area of TPH  
Impacted Soil  
(unverified)

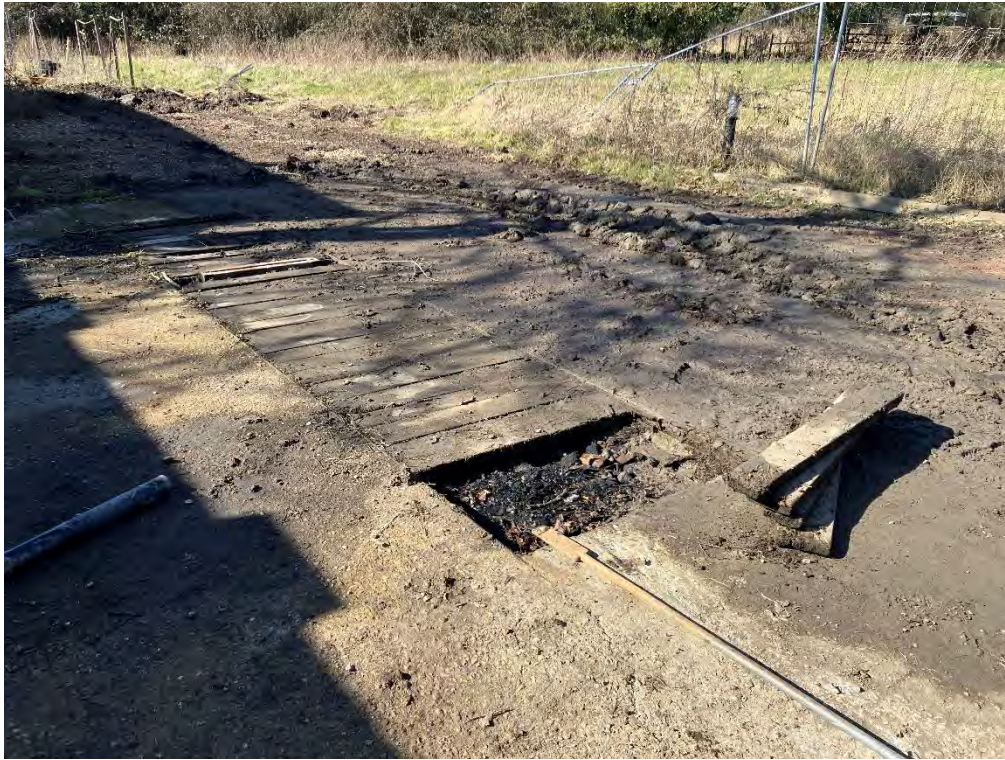
Within the partially demolished garage workshop area an unmarked 55-gallon drum was present with a strong hydrocarbon odour, considered to possibly be waste engine oil based on the staining on the drum and surrounding concrete floor slab. The floor slab appeared in good condition save the staining. The service pit was uncovered and seen to have been backfilled with a rubble and ash material through inspection in HA1.

View of the covered and backfilled vehicle service pit (HA1)

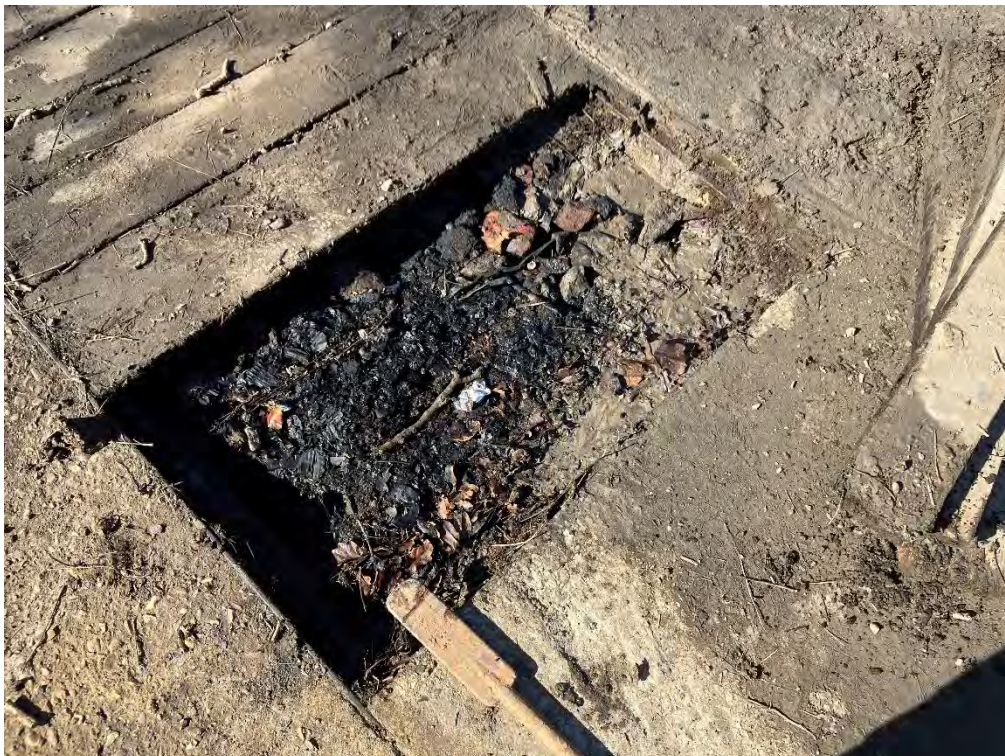
View of the backfilled materials

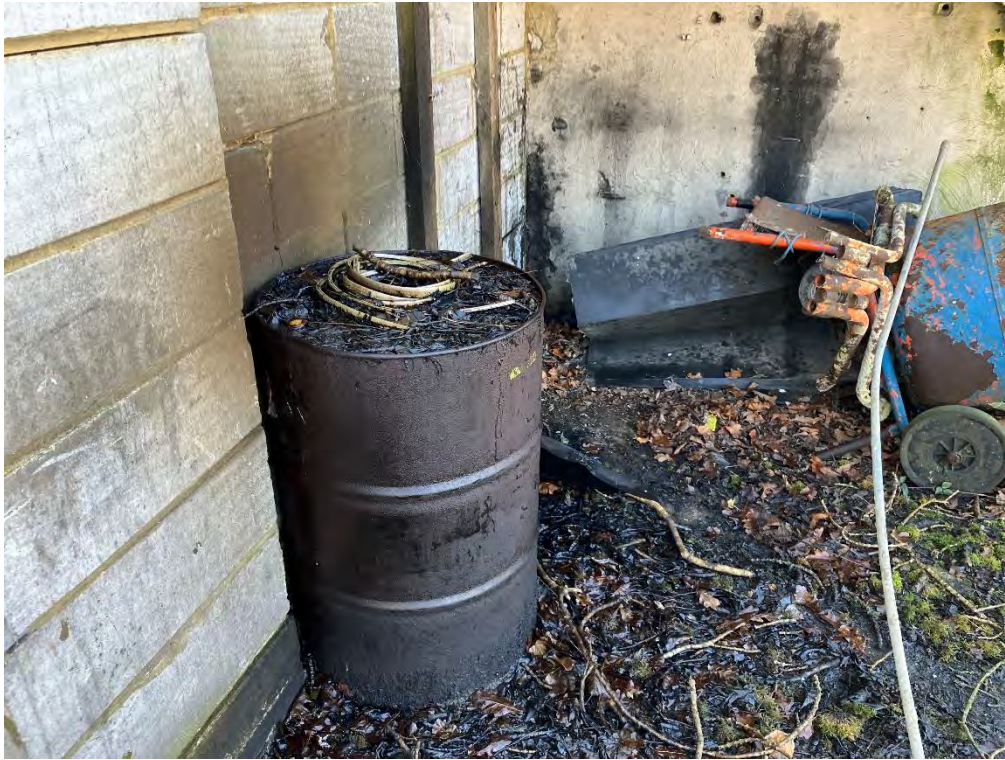
View of the adjacent unlabelled 55 gallon hydrocarbon drum

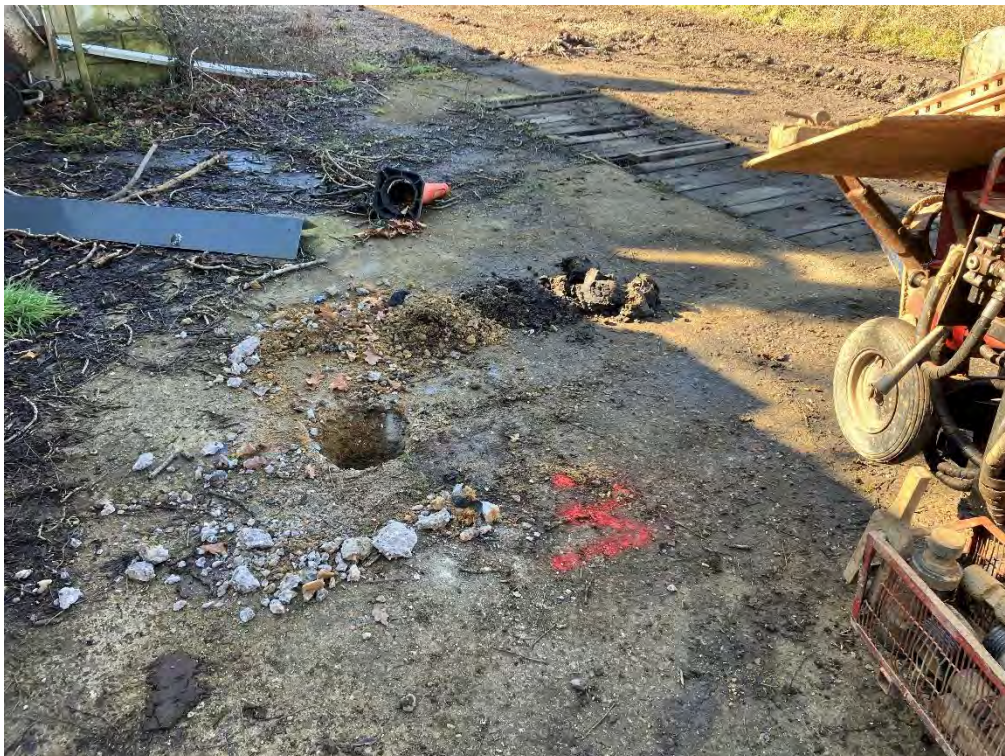
Equidistant position of borehole CT3 and excavated impacted near surface soils

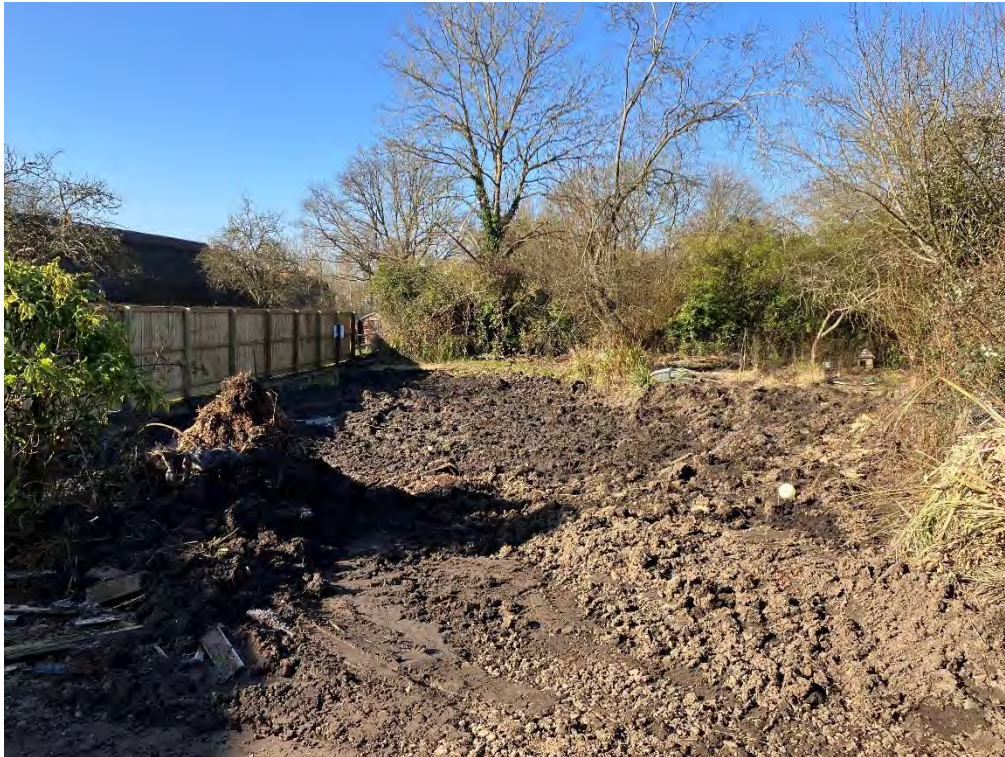
View of the recently backfilled pond (inaccessible) and foot access to western site area

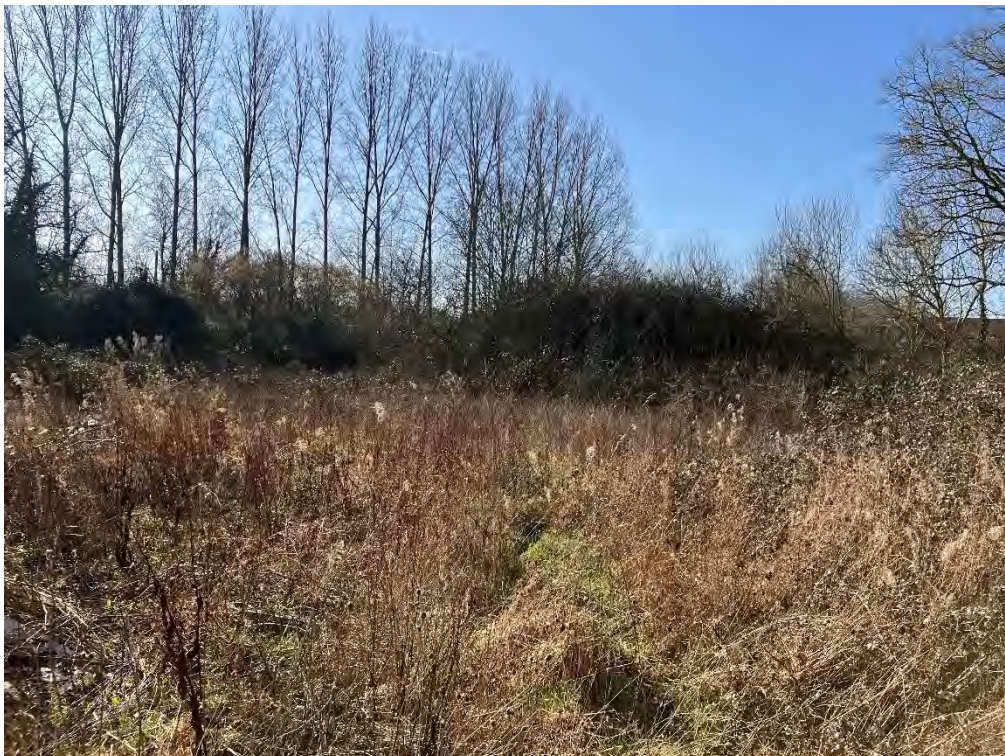
*Furthermore testing in SA3, positioned within the proposed SWALE SUDS feature identified a rise in groundwater level, occurring due to a groundwater seepage. As such calculation of an infiltration rate is not possible and the ground, is again considered to be effectively impermeable and groundwater should be expected to be as shallow as 0.70m in this area, and as shallow as 0.60m across the site as a whole.*

View of the proposed SWALE SUDS area (CT6/ SA3)
