**3 & 4 Market Place, Wokingham**  
RG40 1AL

**Replacement of Existing Sash Casements**  
For the Englefield Estate

**Design & Access Statement**  
incorporating  
**Historic Impact Assessment**

December 2025

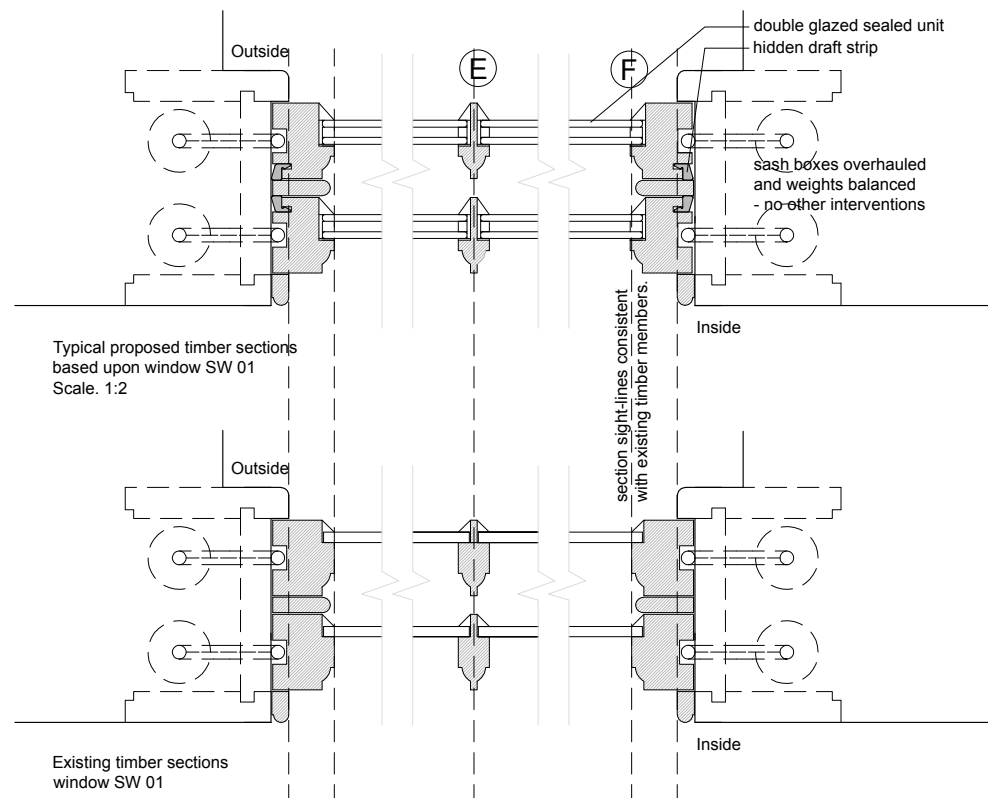
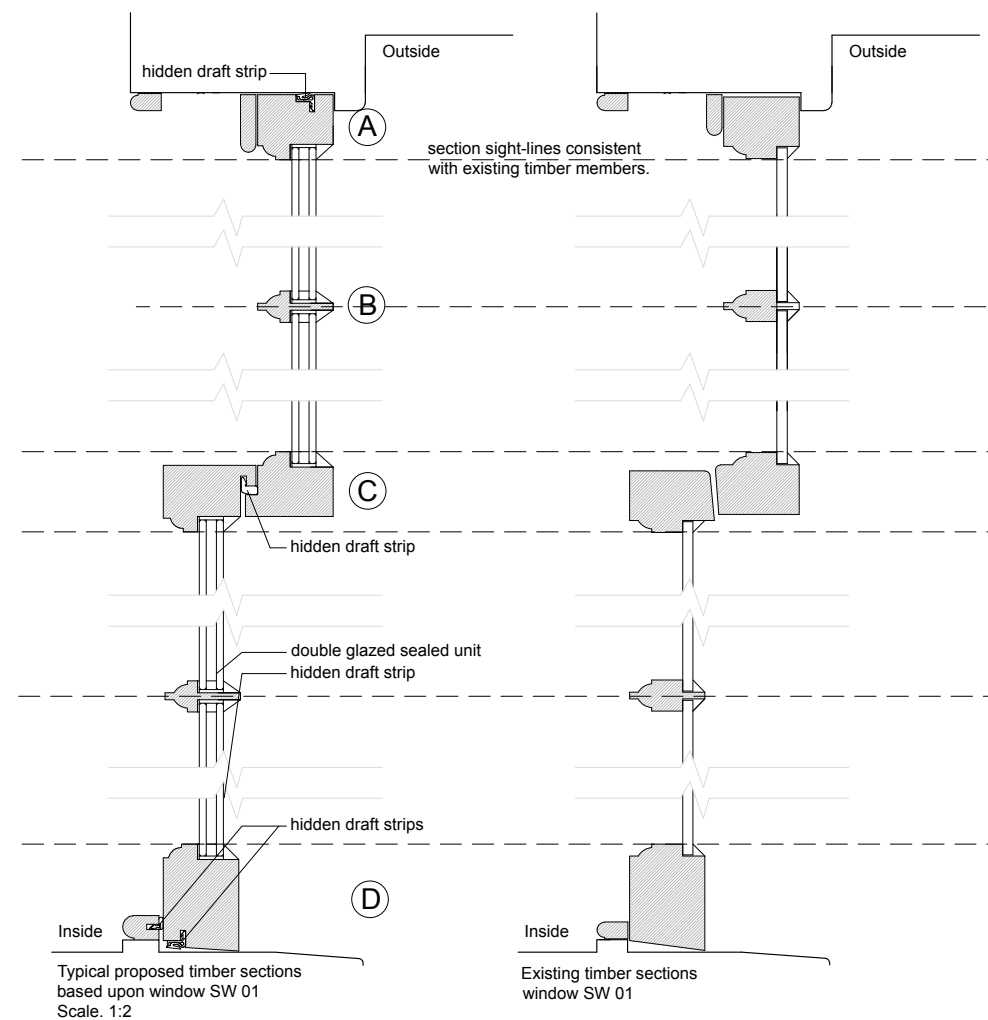
4. It is evident that the original casements have been redecorated and repaired many times in the past. In some areas the moulding profile has been lost - presumably as part of careless repair.

5. Although capable of being redecorated again, the casements are no longer a good fit within their frames. Although this could be partly remedied by the introduction of proprietary (remedial) draft-striping, this is unsympathetic and would spoil the delicacy of the frames.

- A. Window FW01: Part of moulding profile to the glazing bars has been lost - presumably caused by damage when raising the lower sash.
- B. Window FW02: Moulding profile to the glazing bars has been lost to the internal face. Now a simple squared-off section - presumably as part of a repair or, potentially, previous replacement.
- C. Window FW02: Moulding profile to the sash casement frame has been lost. (The broken sash cord can be simply renewed / replaced).
- D. Window SW01: Moulding profile to lower casement cill has been lost.

6. The existing frames are not in sufficiently good order to allow machining of rebated recesses to enable fitting of new hidden and captive draft stripping. The alternative is to replicate the existing timber profiles and incorporate these elements along with doubled glazed sealed units.
