# Arboricultural Assessment & Method Statement

for proposed fish passage improvements at

Emm Brook  
Woosehill, Wokingham

Reference: **MW.21.0124.AIA**

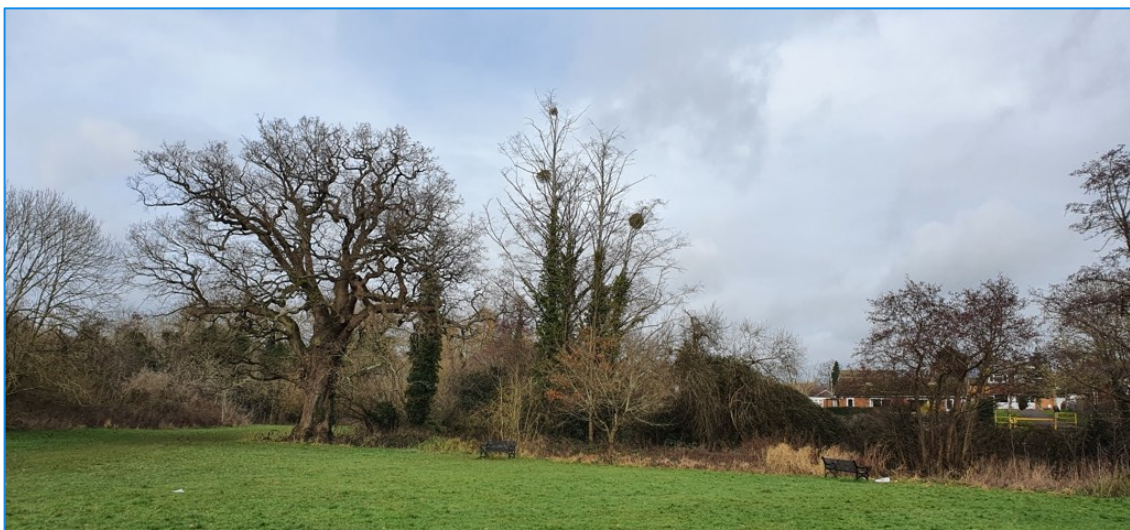
*Oak tree #09 to right. Aspect north*

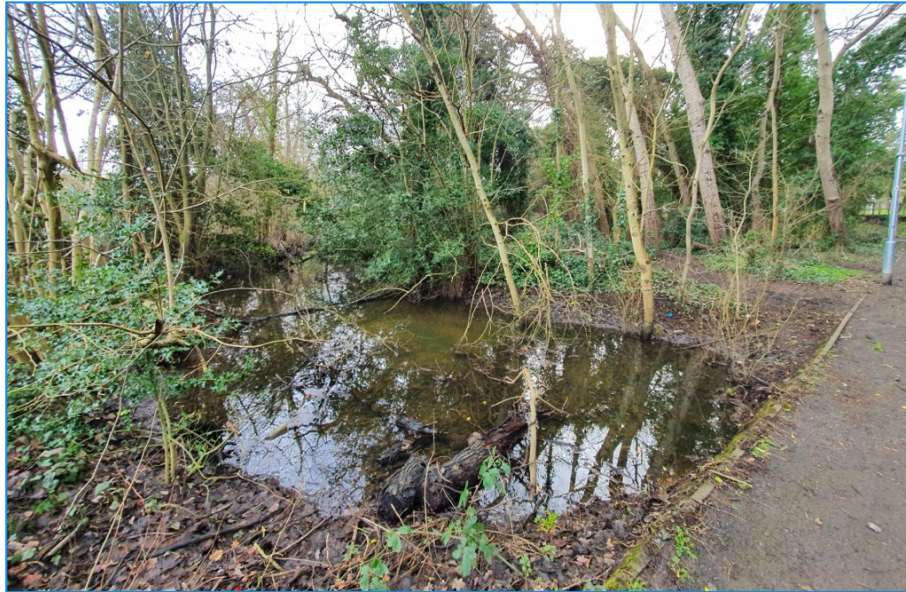
- 5.7. The more densely wooded patch to the north is becoming heavily ivy clad and has numerous small trees and seedlings. The mature trees within the group are of mixed quality with few of high individual arboricultural value.

*Example of the poorer quality trees in the northern area*

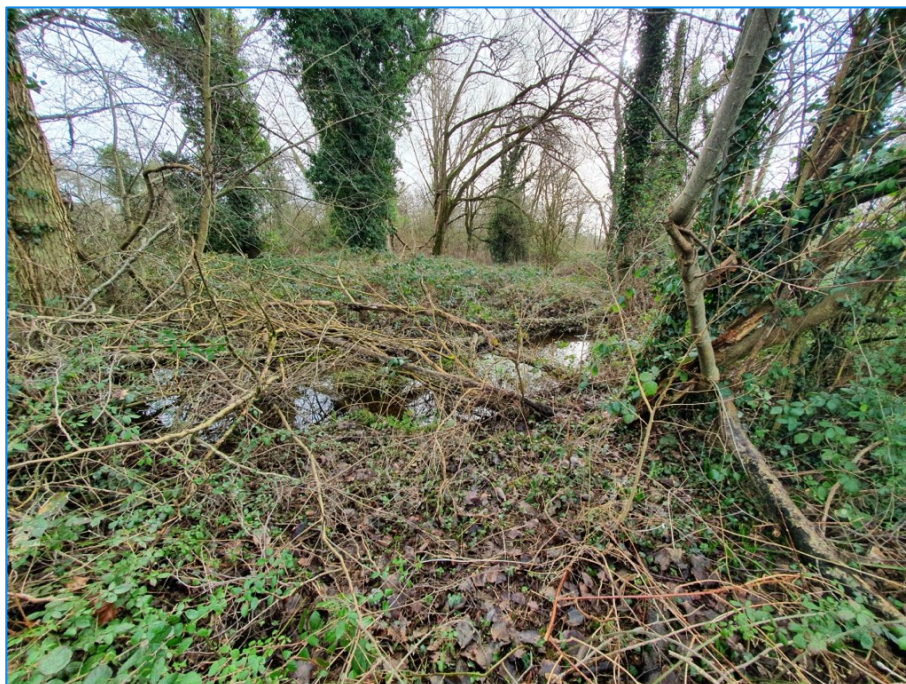
*An example of the scrub next to the brook that will be removed to allow plant access for silt removal*

- 5.13. It is also proposed to carry out strategic removal of some understorey and more scrubby trees in areas where they are especially dense and restrict light to the brook. These removals are not shown in detail, as decisions will be made regarding which plants are removed as work progresses. If deemed necessary by the local planning authority, more detail on these removals could be supplied under an appropriately worded planning condition.
