# **Preliminary Roost Assessment**

Former Arborfield Studios  
(Parcels W, Y and Z)

**Report on Behalf of:**  
Crest Nicholson Operations Ltd.

**PEG659-02C**

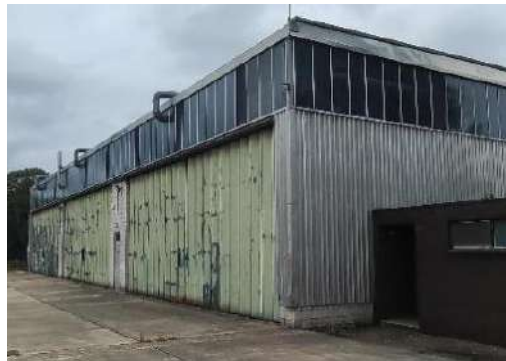
| Building Reference | Bat Suitability | PRFs Identified | Evidence of bats | Building Description | Photographs |
|---|---|---|---|---|---|
| B1 | Low | <p>Weep holes in the mortar on single storey extension (B1a)</p> <p>Gaps behind fascias throughout the metal clad section.</p> | None | A large metal industrial unit with tall sliding doors on the southern aspect. The building is flat roofed with windows and rooflights throughout. There is no internal void or underlining and the internal conditions are brightly lit. A small brick extension adjoins the eastern aspect with a flat roof. | |

A minimum of one bat emergence survey visit is recommended for buildings B1, B5, B15, B16, B18, and B24.

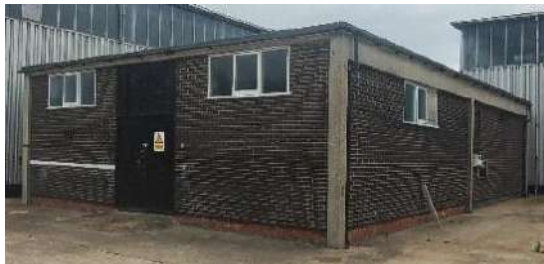
| Building Reference | Bat Suitability | PRFs Identified | Evidence of bats | Building Description | Photographs |
|---|---|---|---|---|---|
| B4 | Confirmed Roost | <p>Gap behind a timber boarded window.</p> <p>Gap in mortar internally on the SE corner of the room.</p> <p>Gaps around the main access door provide potential bat access.</p> | 6 bat droppings likely from pipistrelle species identified within the building on the eastern aspect. | Single-storey brick utility structure with a flat roof and timber framed windows on the north and western aspects. Internally the space is split into 2 rooms with 50% of the floor space given to each. The rear room was not accessible. | |

A minimum of three bat emergence survey visits are recommended for buildings B4, B8, and B27

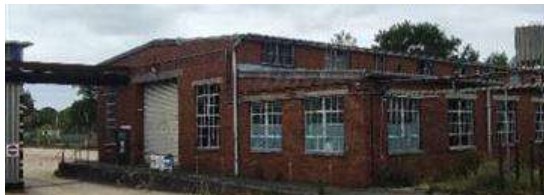
| Building Reference | Bat Suitability | PRFs Identified | Evidence of bats | Building Description | Photographs |
|---|---|---|---|---|---|
| B5 | Low | <p>Gaps behind barge boards on the western aspect.</p> <p>Gaps around vent pipes on the northern aspect.</p> | None | Large single-storey industrial unit constructed of brick, with a shallow pitched, concrete sheet roof. A lower mono-pitched section is present to the rear which is partially segregated internally creating separated workspaces. No roof void present and internal conditions are bright with no roost potential. | |

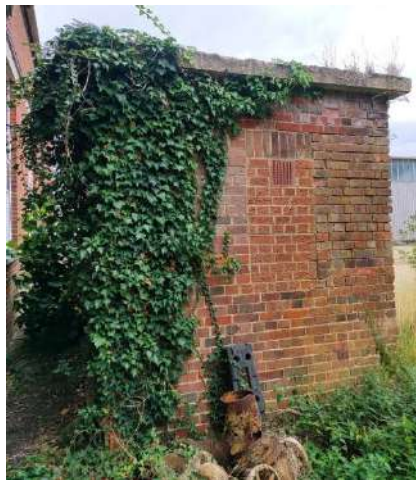
| Building Reference | Bat Suitability | PRFs Identified | Evidence of bats | Building Description | Photographs |
|---|---|---|---|---|---|
| B8 | Confirmed Roost | <p>Gaps in mortar above the bricked-up windows internally.</p> <p>Gap in the mortar on the external northern wall</p> <p>Gap around the doorframe externally.</p> | Old bat droppings found beneath gap in mortar above the northern window internally. | Small brick structure with a flat concrete roof and a single doorway, the door was left open, and the building is empty with no apparent usage. Ivy was present on the exterior, though not dense. The internals were partially dark with the only windows being bricked-up. | |

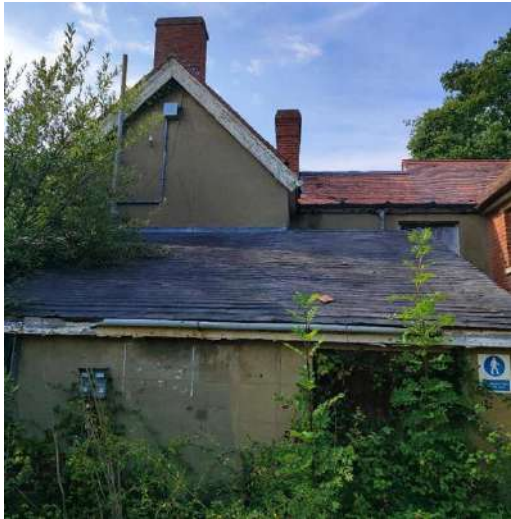
| Building Reference | Bat Suitability | PRFs Identified | Evidence of bats | Building Description | Photographs |
|---|---|---|---|---|---|
| B9 | High | <p>Missing and slipped roof tiles</p> <p>Gaps in cladding tiles on the northern gables</p> <p>Gaps in mortar rake on the single storey lean-to.</p> | None | A Two-storey detached brick residential dwelling out of use and in disrepair. The building has two storeys with a clay-tiled, multi-pitched roof. Lots of tiles are loose and missing and the windows are boarded up. A single storey lean-to extension is present on the southern aspect and tile-clad dormers on the northern aspect. Internal access not possible due to structural safety. | |

A minimum of three bat emergence survey visits are recommended for buildings B9, and B10.

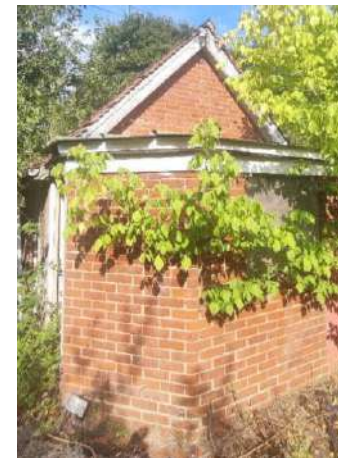
| Building Reference | Bat Suitability | PRFs Identified | Evidence of bats | Building Description | Photographs |
|---|---|---|---|---|---|
| B10 | High | <p>Missing and slipped roof tiles throughout.</p> <p>Gaps behind UPVC flashing on the single storey section.</p> | None | <p>Single-storey small, detached outhouse to the south of B9. A single storey structure with a pitched clay tiled roof and in a state of disrepair. Attached is a single-storey toilet block with a flat, felt and timber roof.</p> <p>Internally the structure is in disrepair with a single large room and boarded windows. A plastered ceiling creates a roof void with no access point, though holes in the ceiling show no underlining or insulation present.</p> | |

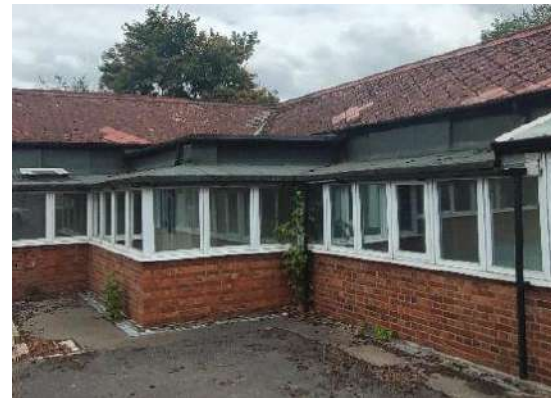
| Building Reference | Bat Suitability | PRFs Identified | Evidence of bats | Building Description | Photographs |
|---|---|---|---|---|---|
| B11 | Moderate | <p>Missing roof tile on the rear of the dormer.</p> <p>Potential gaps under the eaves visible internally.</p> | None | <p>Long horseshoe shaped converted stable constructed of brick with a pitched, composite-tiled roof.</p> <p>Internally, it is separated into offices and welfare rooms. A void roof is present to the northwest end of the building, the rest of the structure has a false ceiling obscuring access to the true roof void. A lean-to style walkway with a shallow, mono-pitched felt and timber roof is present along the front aspect, with internal doors leading to all rooms.</p> | |

A minimum of two bat emergence survey visits are recommended for buildings B11, B12, B19, and B29

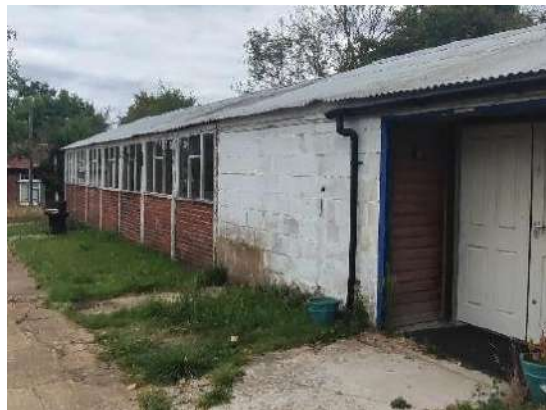
| Building Reference | Bat Suitability | PRFs Identified | Evidence of bats | Building Description | Photographs |
|---|---|---|---|---|---|
| B12 | Moderate | Gaps in mortar at both gable rakes | None | Single-storey brick-built structure with a corrugated sheet roof and large glass windows. The building was in use as a carpentry workshop and internal conditions were bright showing a fully clad ceiling. Internal access was not possible. | |

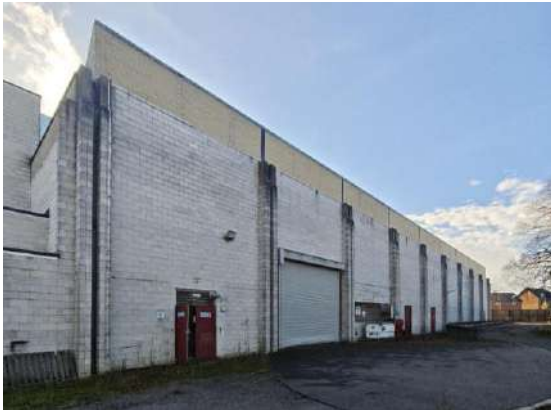
| Building Reference | Bat Suitability | PRFs Identified | Evidence of bats | Building Description | Photographs |
|---|---|---|---|---|---|
| B27 | Confirmed Roost | <p>Hole in soffit box on southern aspect</p> <p>Broken cladding on inset section of southern aspect</p> <p>Gaps behind plastic fascia on all aspects</p> <p>Lifted cladding</p> <p>Lifted metal fascia on edge of roofing in multiple locations.</p> | None (Historic) | <p>The structure is a large building constructed primarily of breeze blocks, with sections featuring metal and wooden cladding. Windows, doors, and shutters are installed throughout. The roof is flat and finished with bitumen felt across its entirety, incorporating large skylights and roof windows. Roof access is available internally via a fire escape. Overall, the building is in good condition and well sealed, with the exception of the timber and metal cladding, which form the main PRF elements of the structure.</p> | |

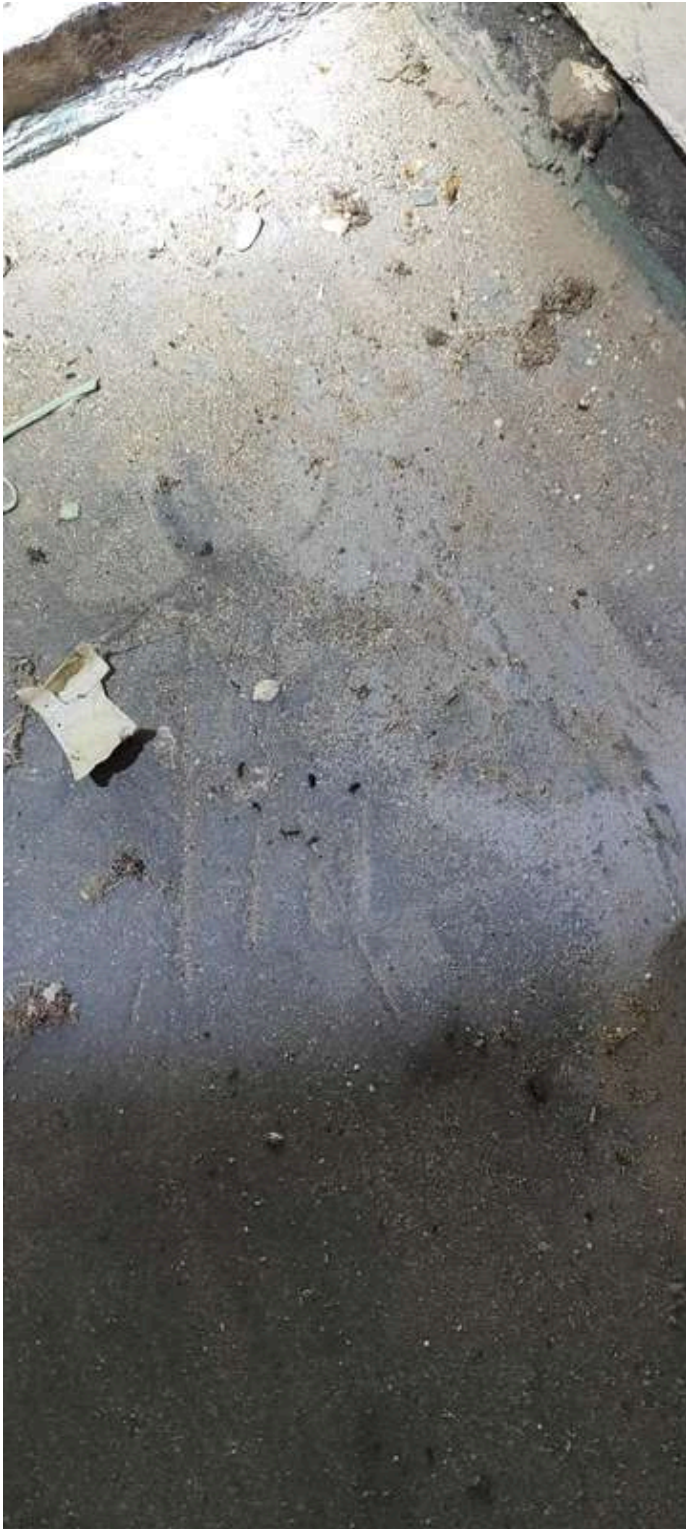
| <b>Description of Bat Evidence</b> | 6 droppings in the back left corner of the room and a single one found along the east wall. |

Droppings located in the building likely over a year old.

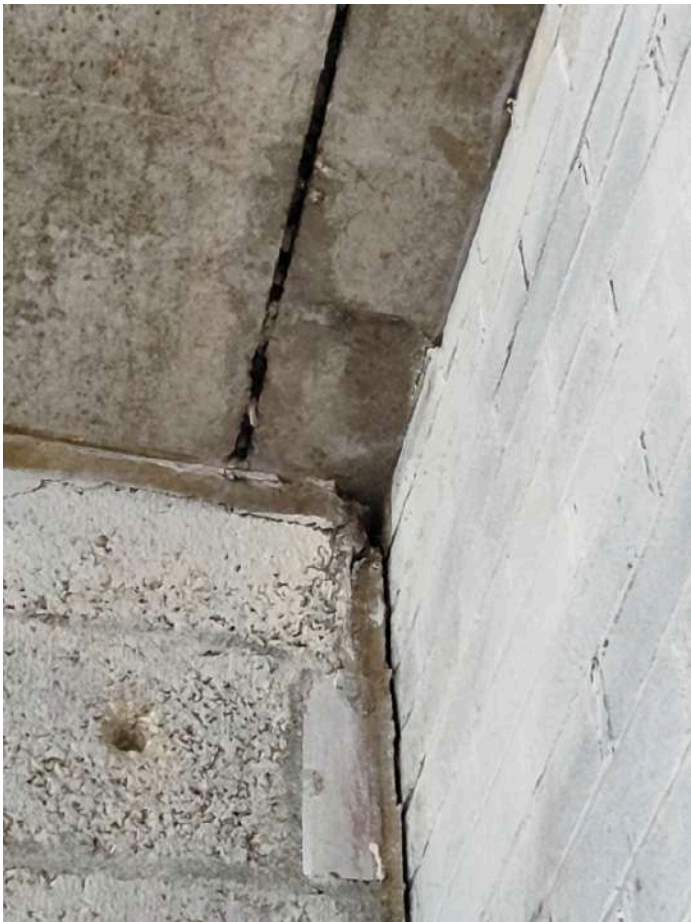
| Description | A small gap in the mortar on the southeastern top corner of the room internally. Droppings were found beneath the feature. |

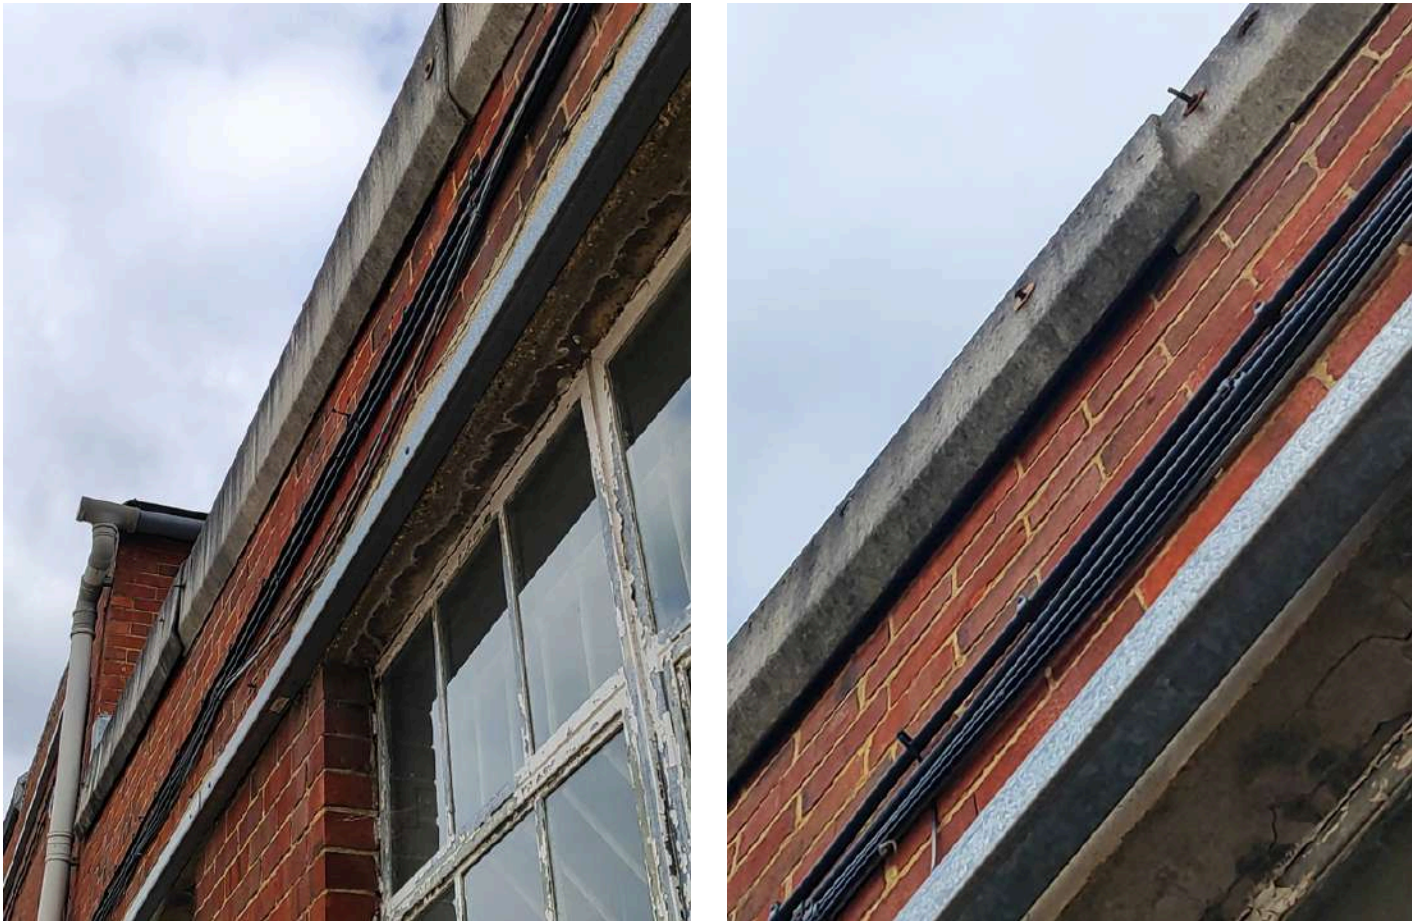
| Description | A gap where the barge board is peeled away from the wall on the western aspect of the lower roof section. |

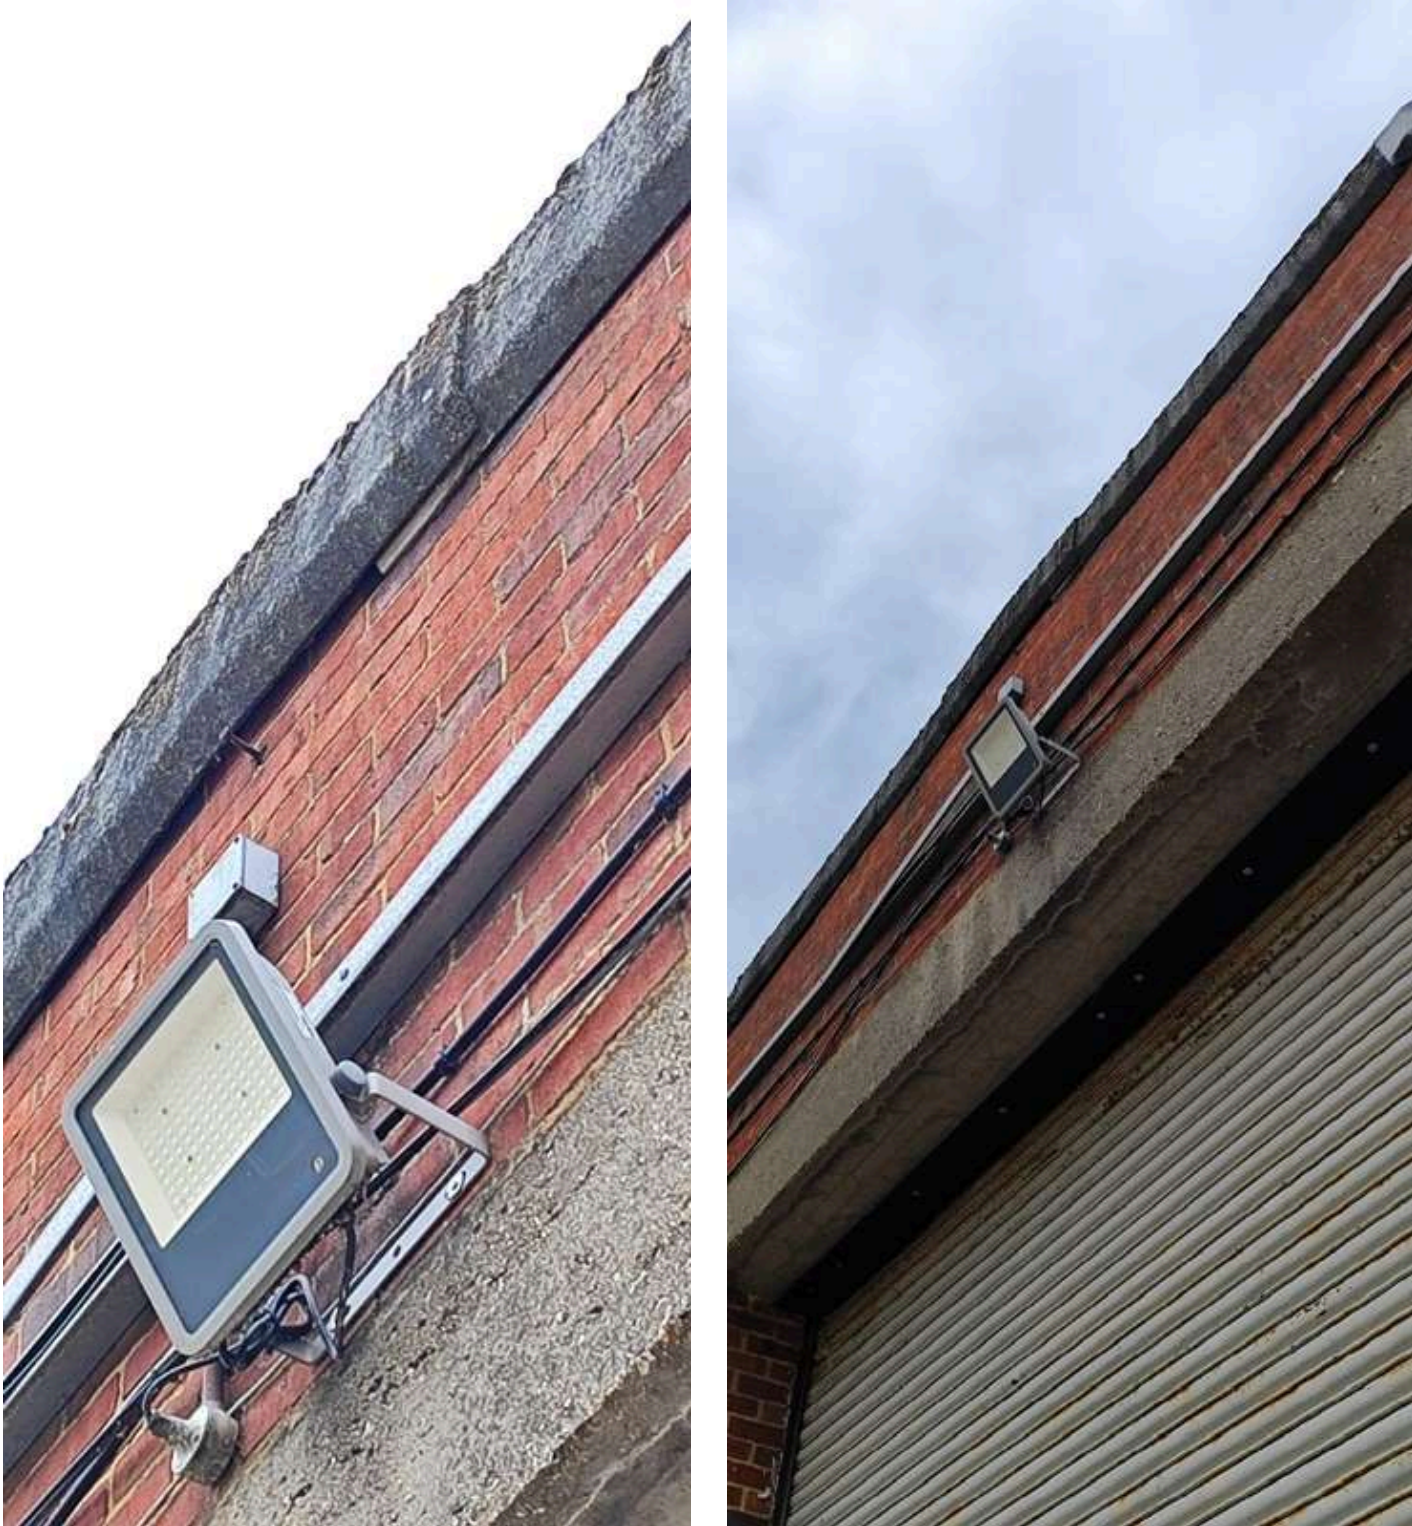
| Description | Gaps are present behind the barge boards on the western aspect of the taller section. |

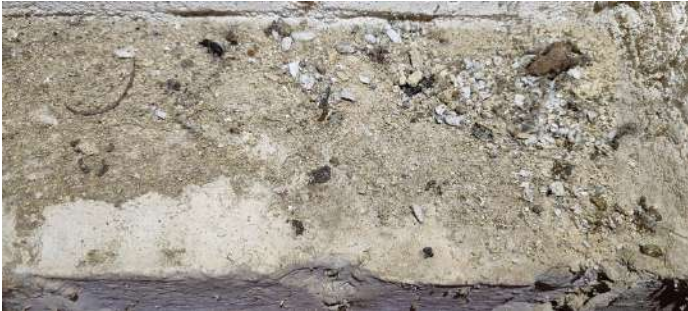
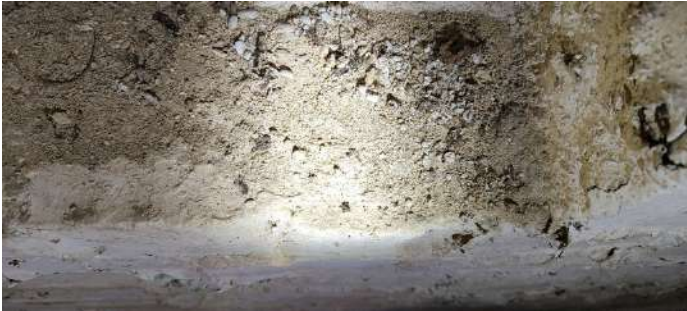
| Description of Bat Evidence | 4 old droppings were found on the windowsill beneath a sealed window. |

| Further Notes | Droppings located beneath window. |

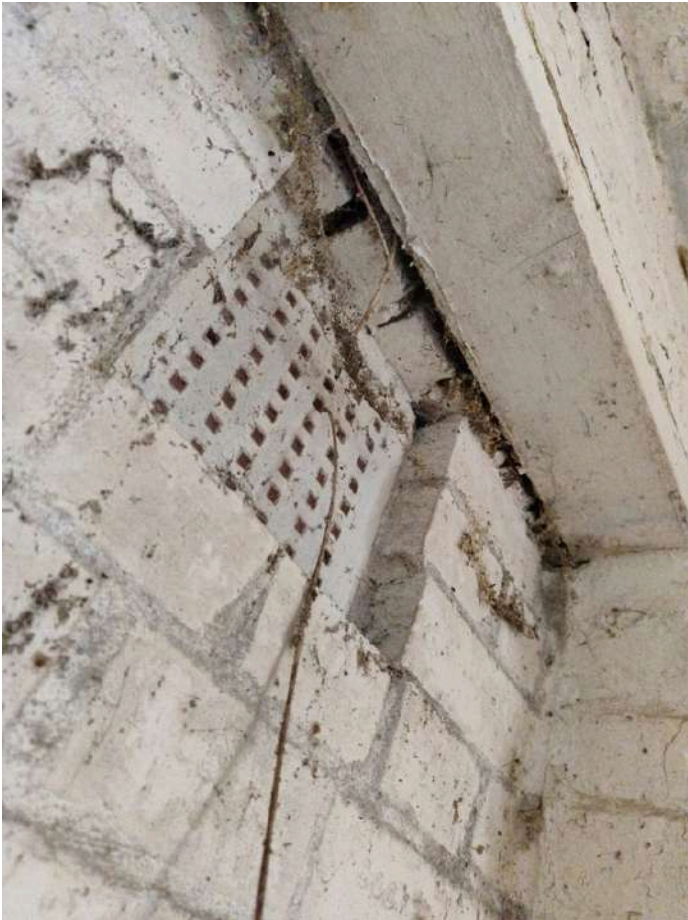
| Description | An internal gap above a blocked window leading to cavity wall. Old bat droppings found beneath feature. Taken for DNA sampling. |

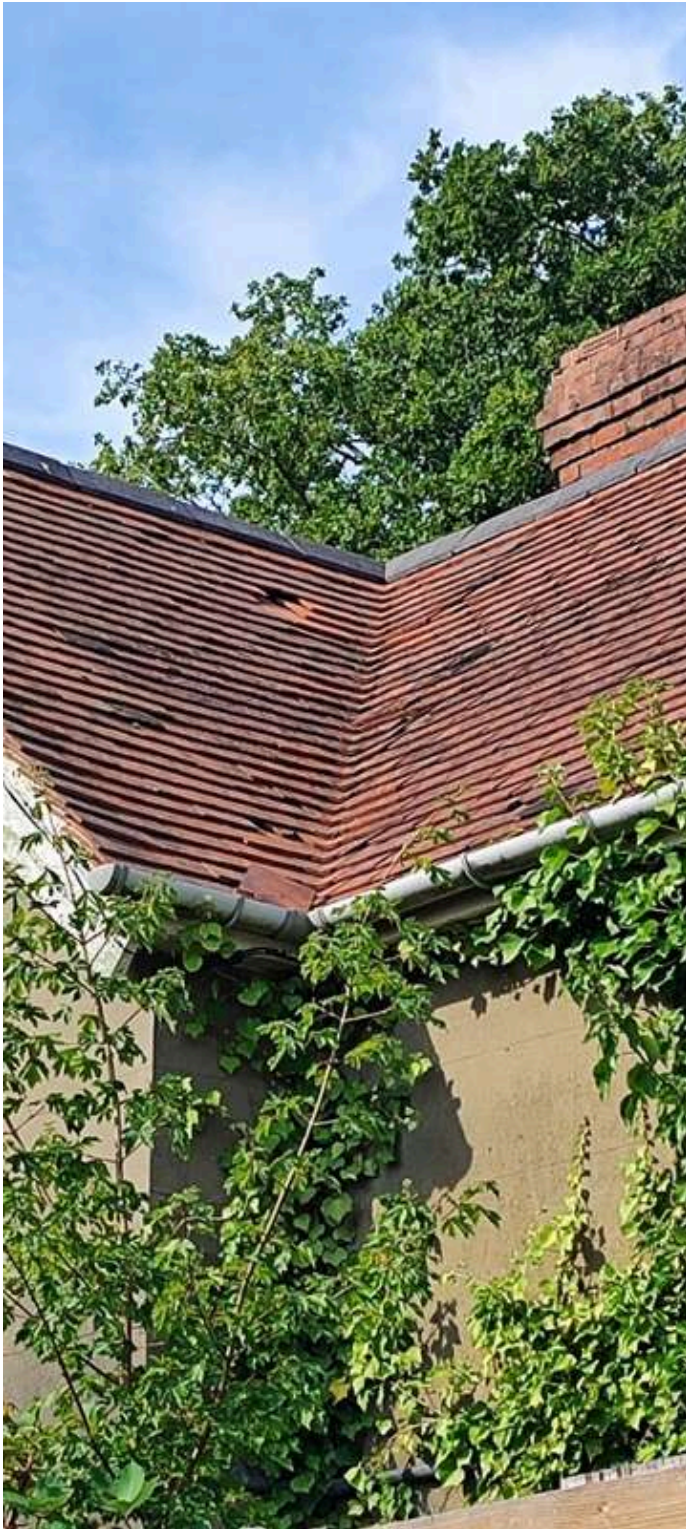
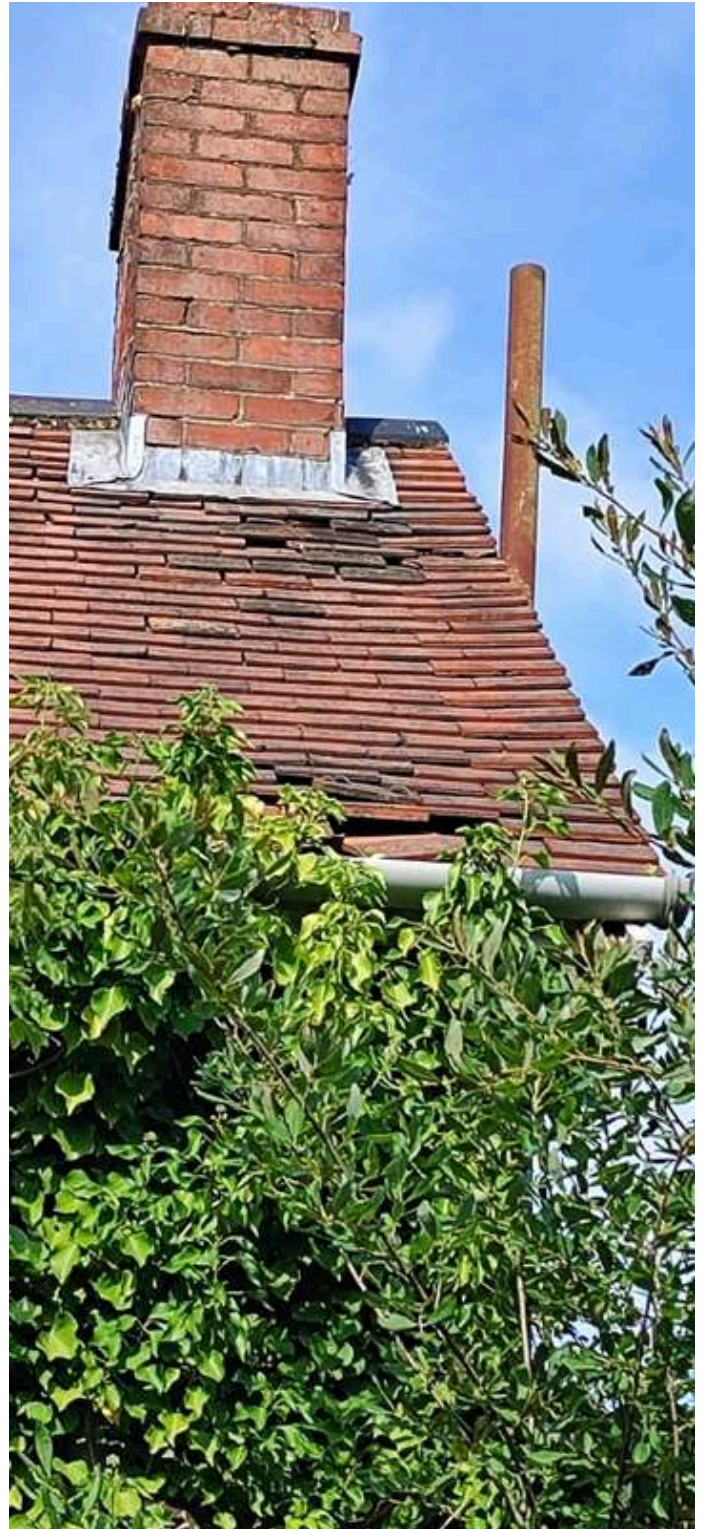
| Description | There are missing roof tiles throughout the property |

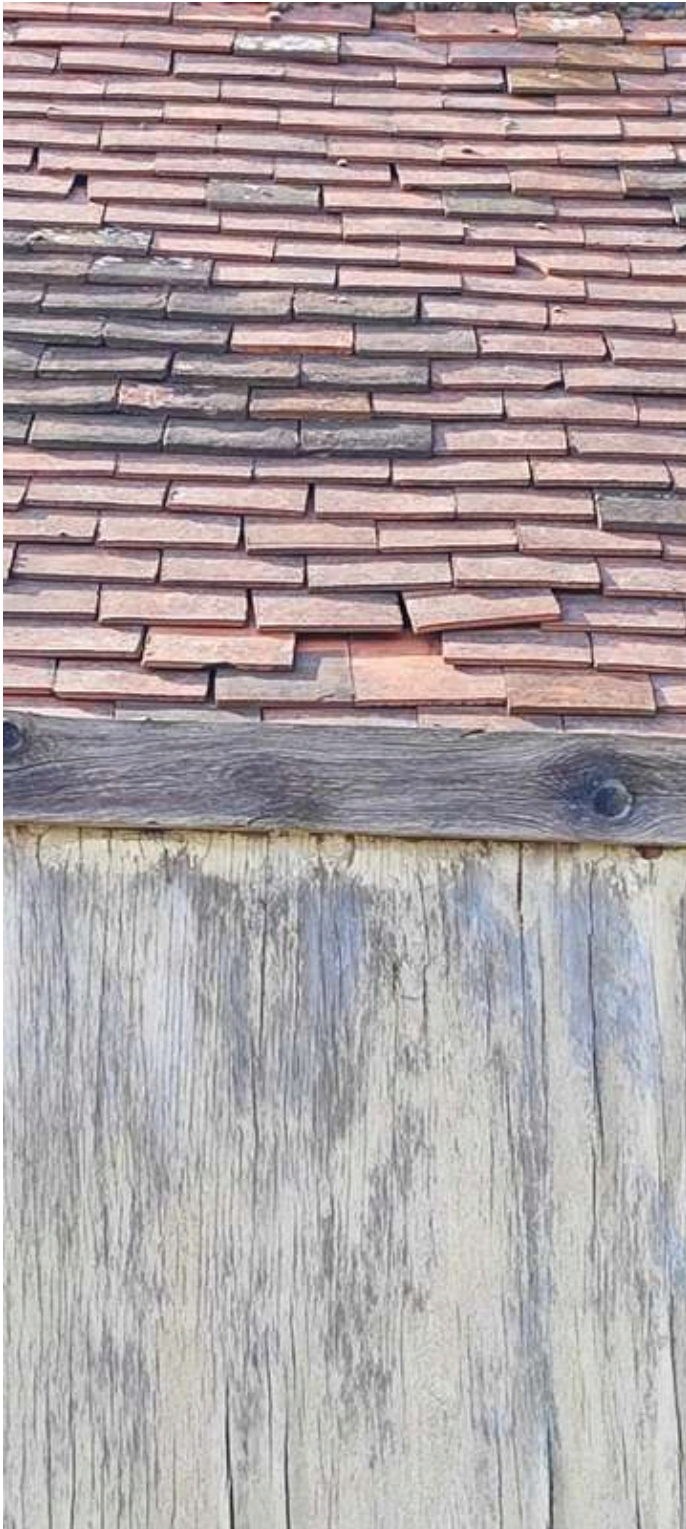
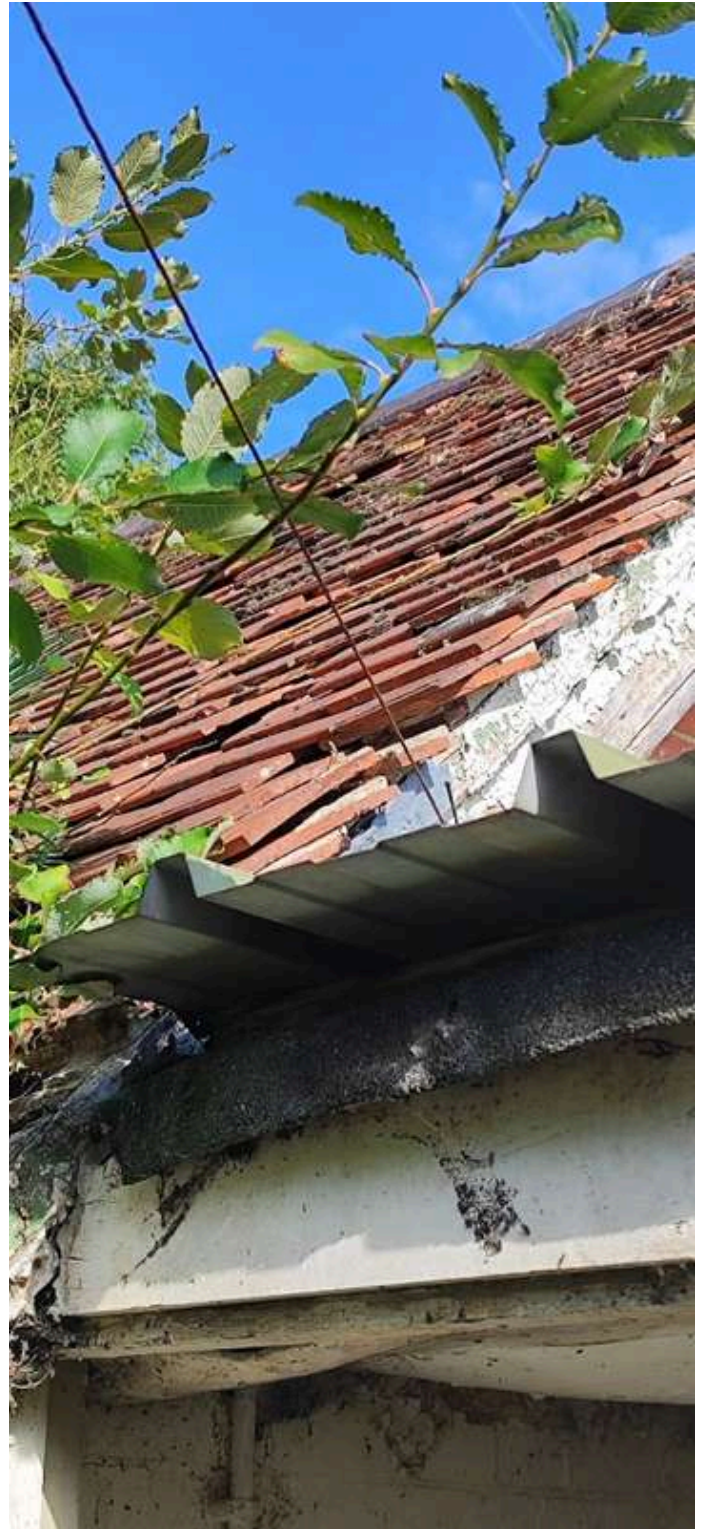
| Description | Missing or slipped roof tiles are present throughout the roof, giving access to the roof space. |

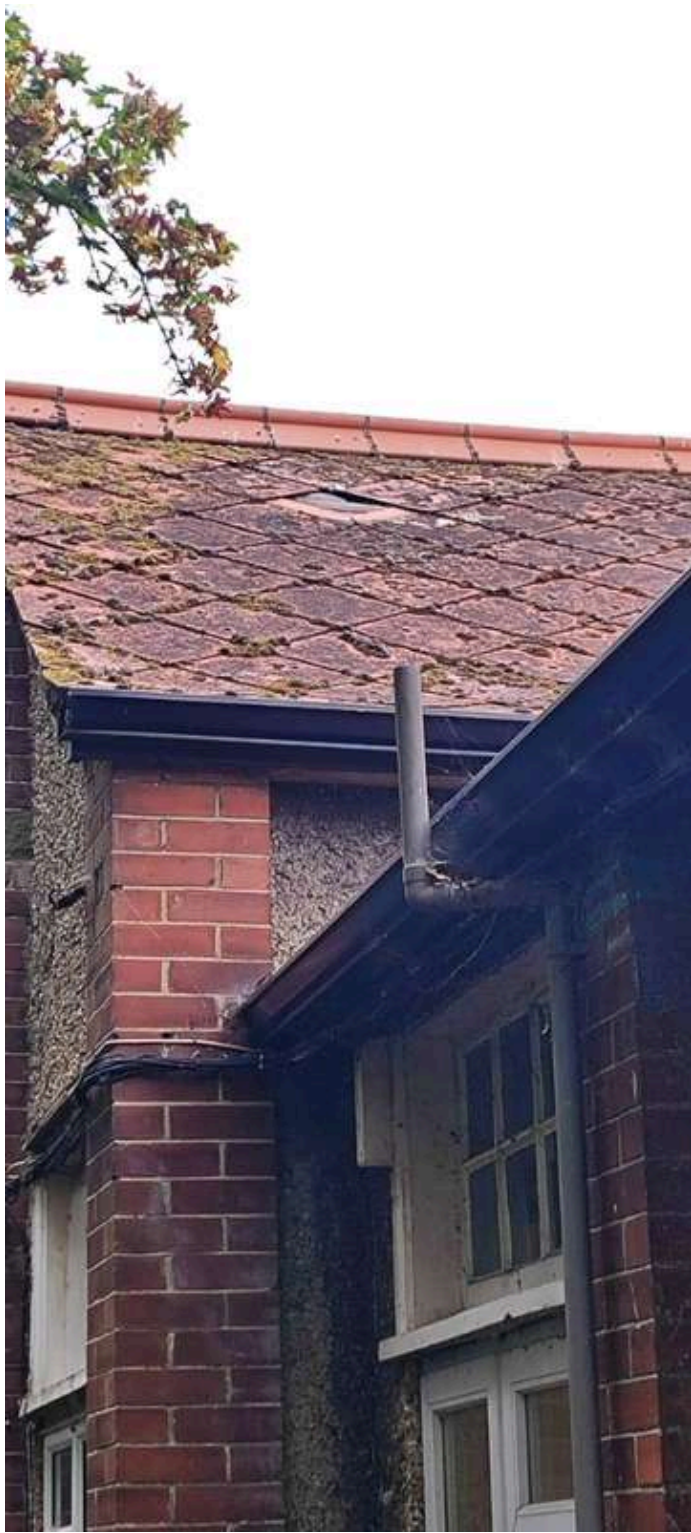
| Description | A missing roof tile on the rear of the building dormer. |

| Bat Roosting Potential | Moderate |

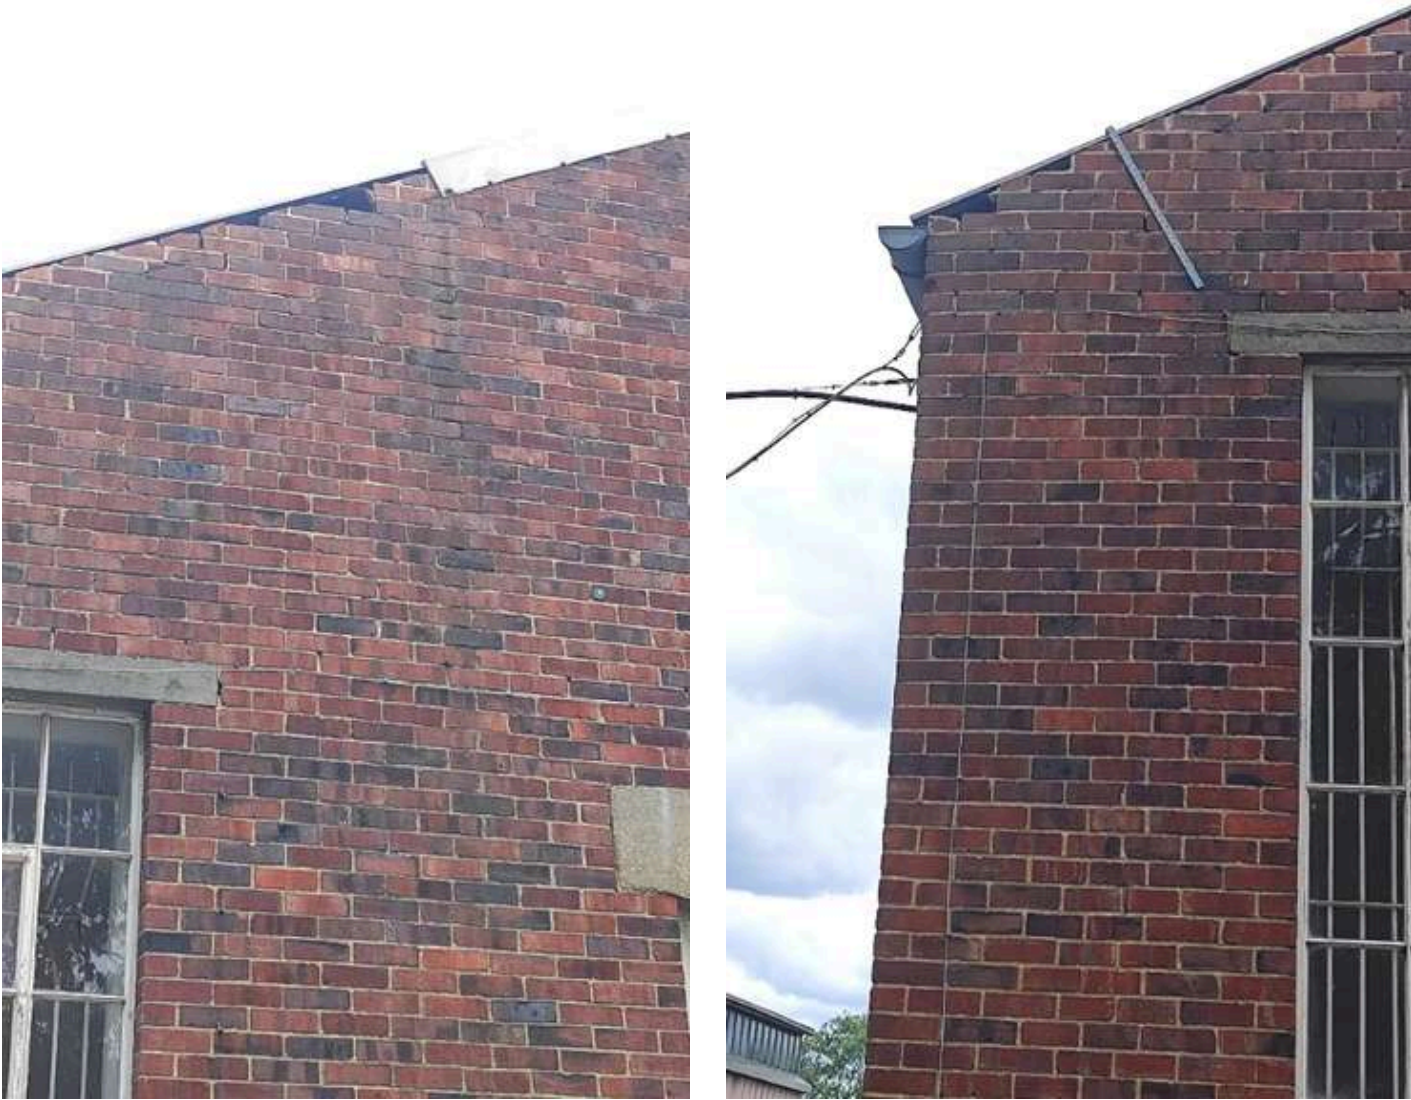
| Description | Missing bricks and gaps in the mortar on the northwestern corner of B15 at rakes where the barge boards are missing. |

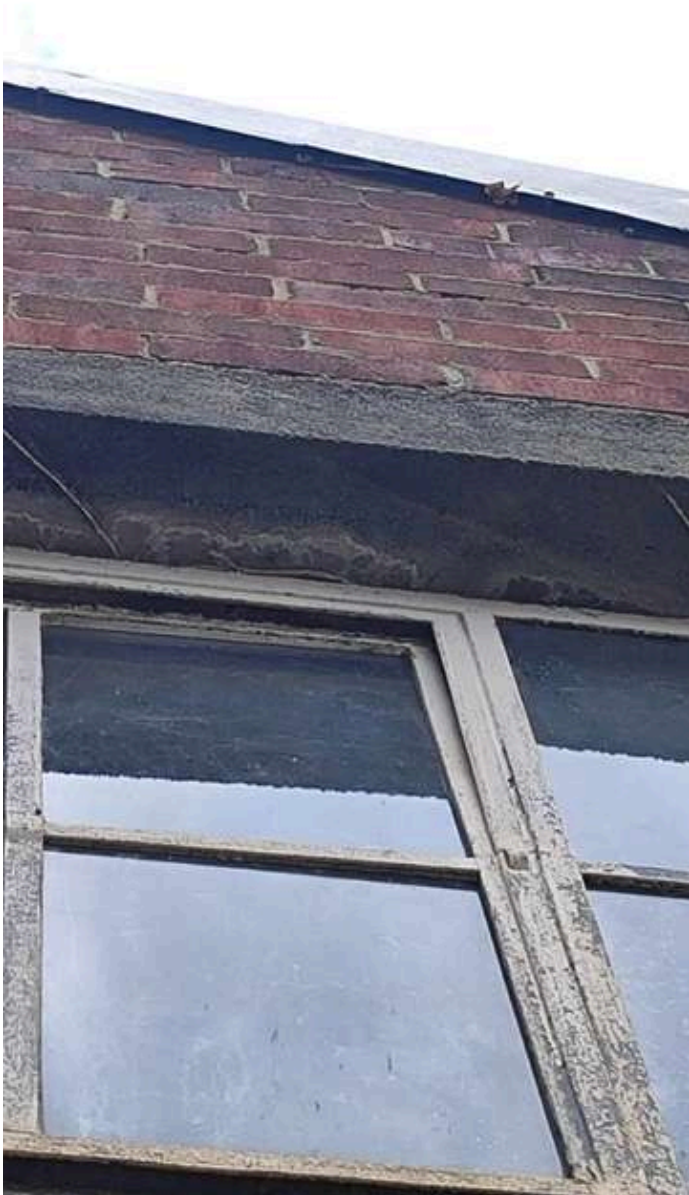
| Description | Gaps are present behind the loose barge boards on the western gable. |

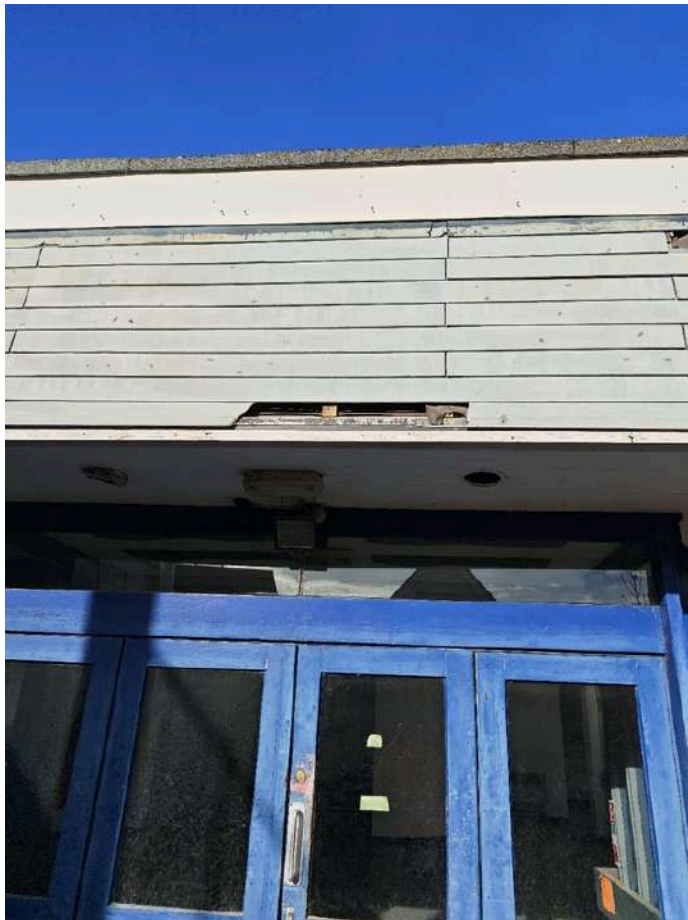
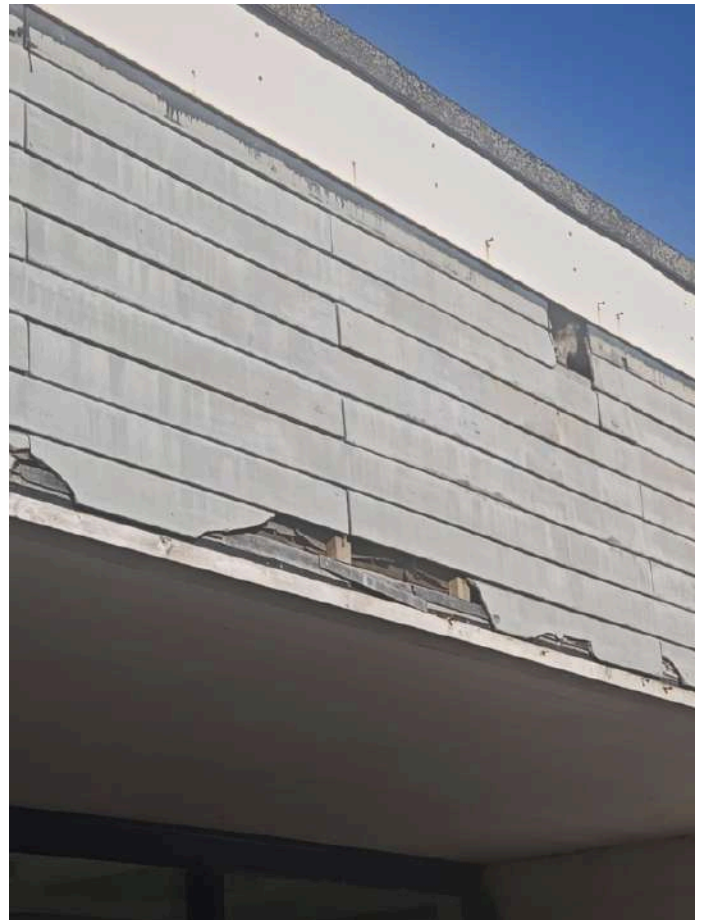
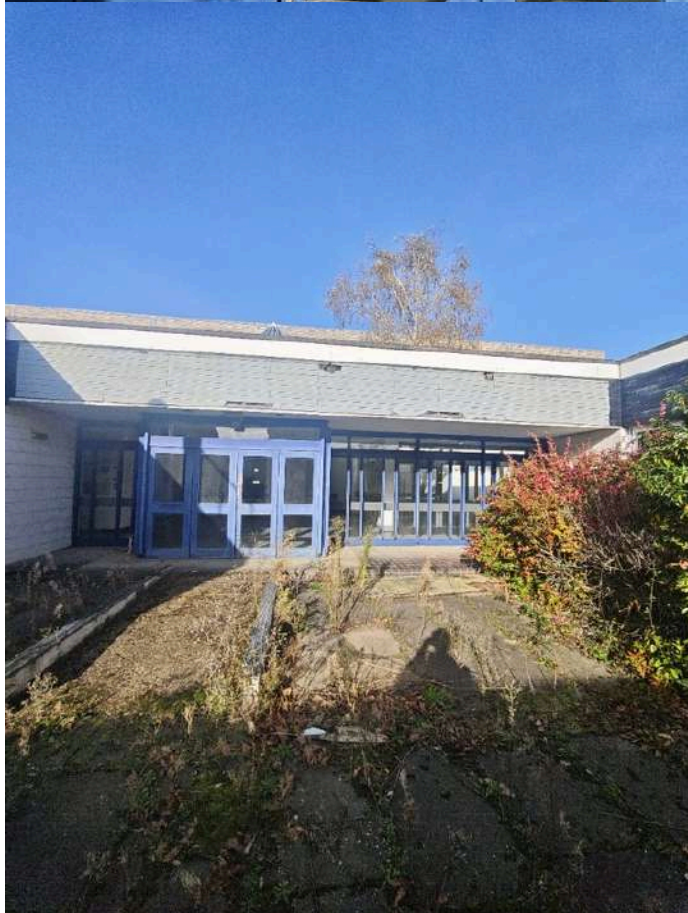
| Description | 4 areas of broken cladding against above the rear door. The gaps lead to the cavity behind which is felted. |

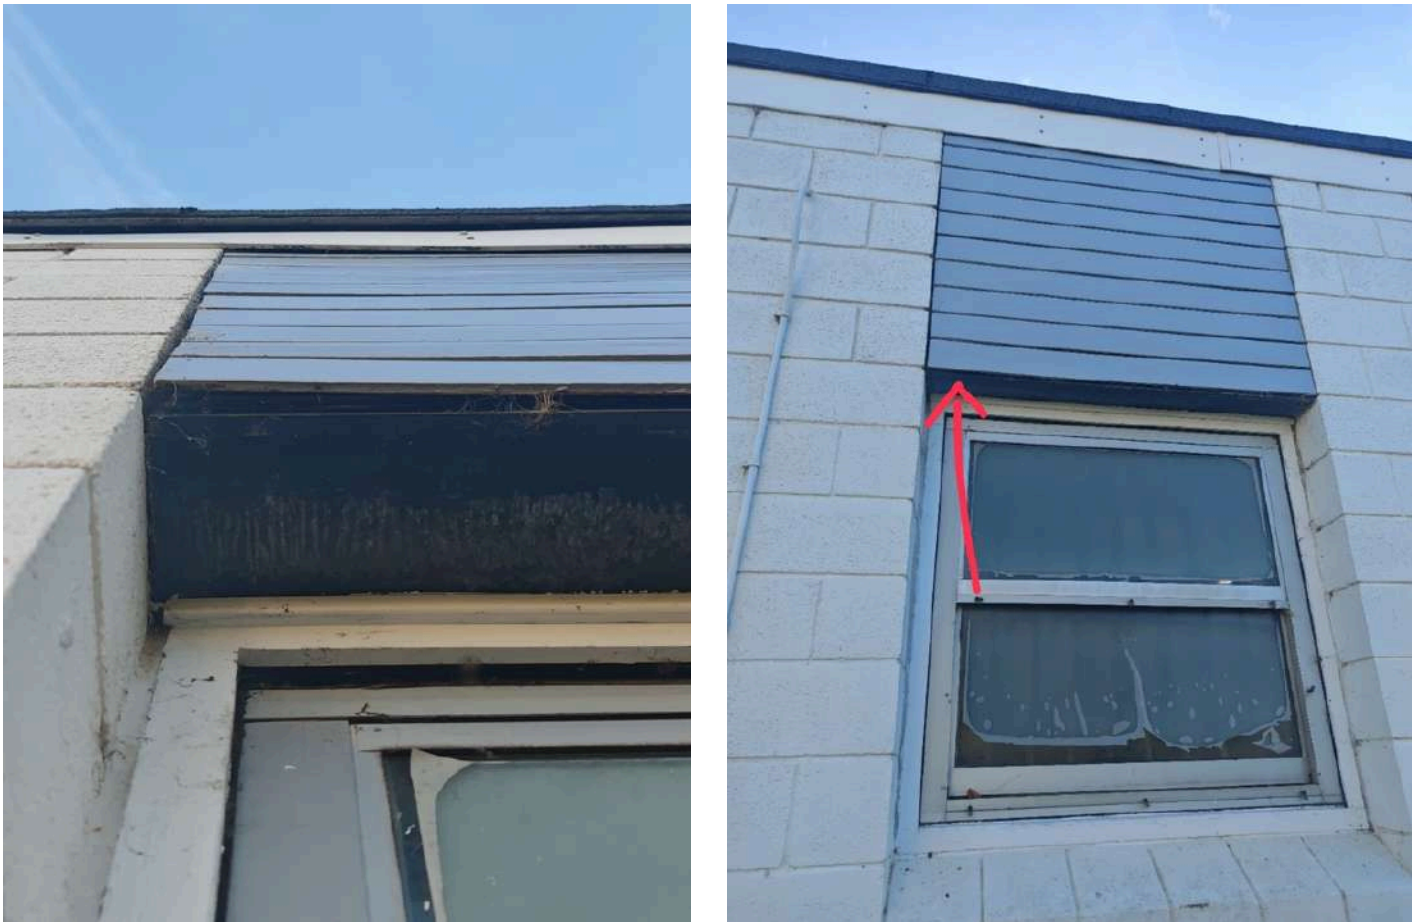
| <b>Description</b> | A small gap in the corner of some cladding above a window. |
