# **Preliminary Roost Assessment**

Former Arborfield Studios  
(Parcels W, Y and Z)

**Report on Behalf of:**  
Crest Nicholson Operations Ltd.

**PEG659-02C**

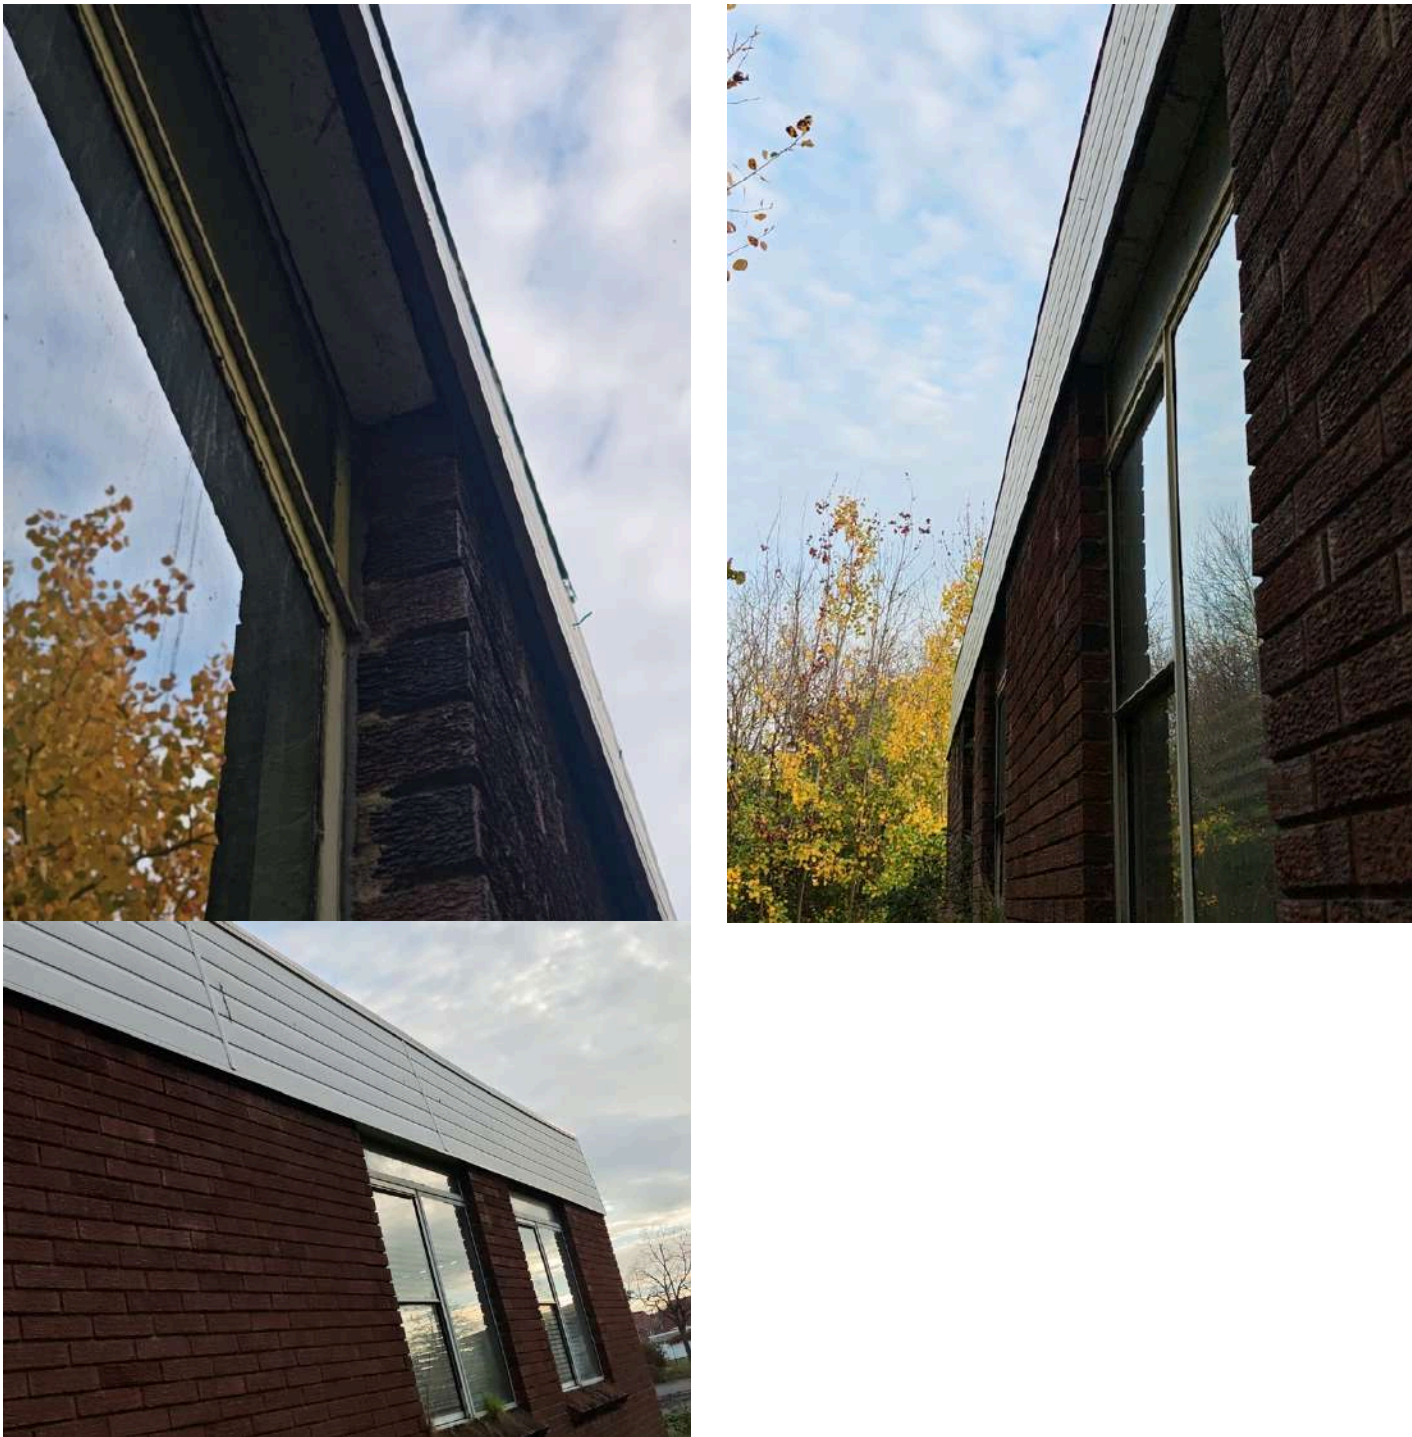
| Description | Gaps are present all the way around the building where the cladding meets the wall. Gaps are also present in the timber boxes above the windows. These could support individual bats. |

| Bat Roosting Potential | Moderate |
