ROAVR | GROUP

**Project:** 25\_5837\_02\_07  
**Site:** Hutts Farm Cottage, Blagrove Lane RG41 4AX  
**Client:** Bob Ryan

| Report Type: | Tree Survey, Arboricultural Impact Assessment & Arboricultural Method Statement |
| Site Address: | Hutts Farm Cottage, Blagrove Lane RG41 4AX |

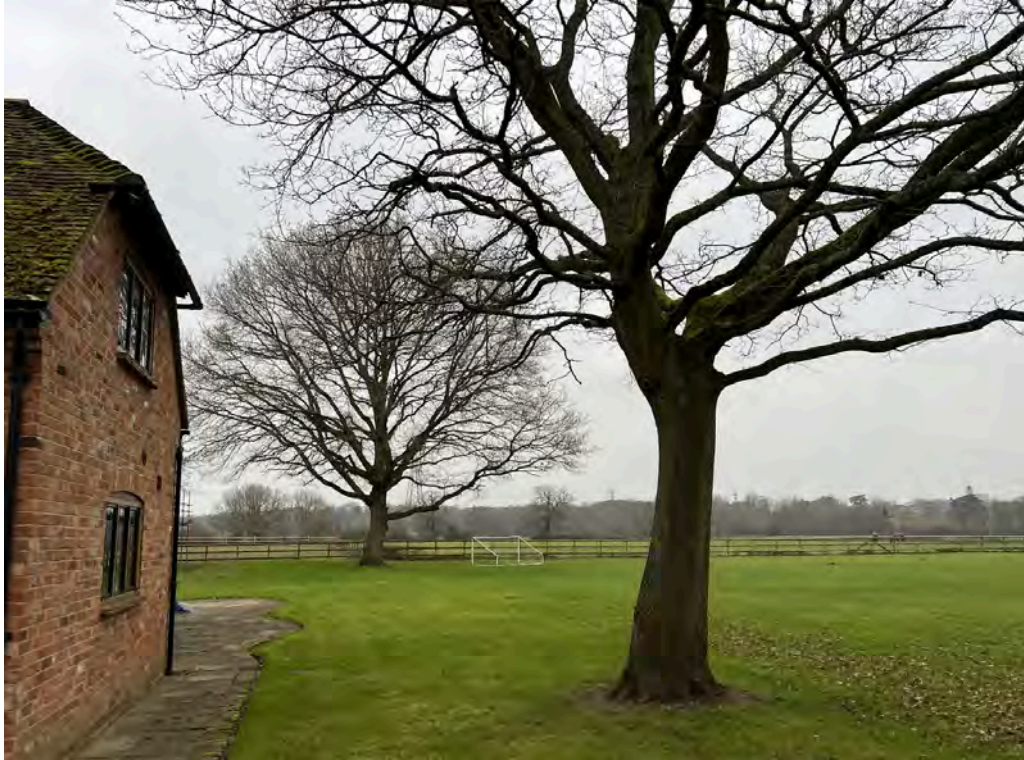
*Photographic plate showing T1 (left) and T2 (right). (ROAVR, 2024)*

- All planting within the RPAs of T1 and T2 must be carried out by hand to avoid root disturbance
- No mechanical excavation or rotovation is permitted
- Individual planting pits should be carefully opened using hand tools, avoiding any significant roots
- If roots over 25 mm diameter are encountered, their positions must be preserved, and planting adjusted accordingly
- Mulching should be applied around the base of the new hedgerow to conserve soil moisture and suppress weeds

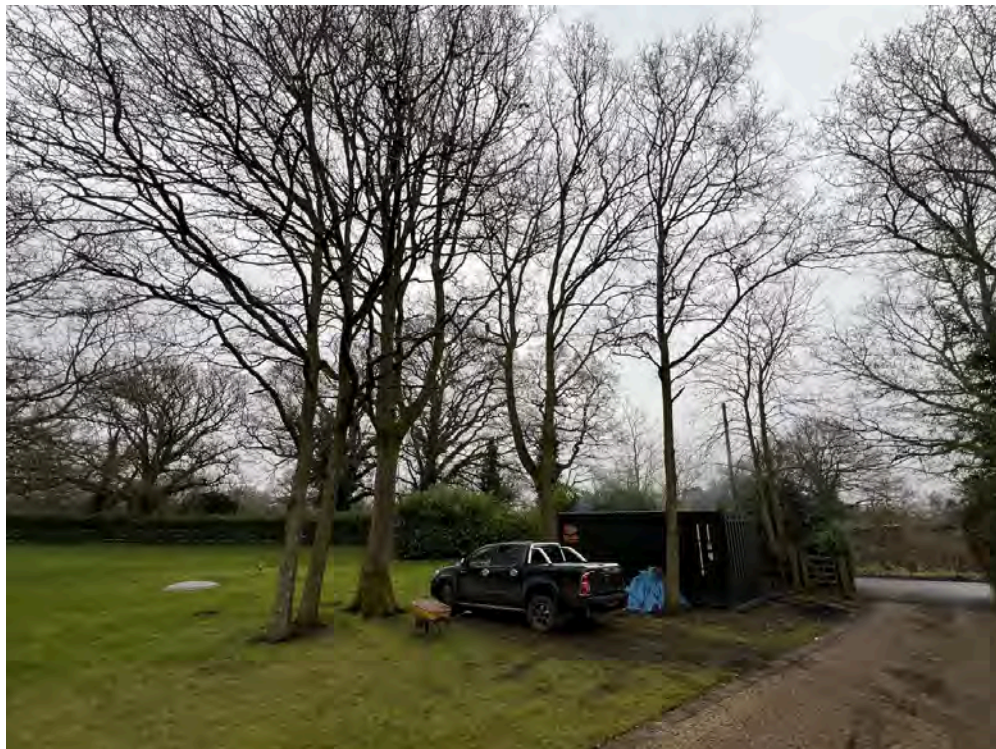
*Photographic plate showing T3 (left through to T7 (right). (ROAVR, 2024)*

| Tree Number | Species | Age Class | DBH | Height (crown height) | N | E | S | W | Condition | Life Expectancy | Physical Description | Comments | Managment Recommendations | RPA offset from stem. | Category Rating |
|---|---|---|---|---|---|---|---|---|---|---|---|---|---|---|---|
| 3 | Quercus robur (Common Oak) | M | 200,210 | 13(4) | 1.5 | 1.5 | 5 | 5 | Good | 20+ | Stem divides at ground level. | None | None | 38.05 | B1 |

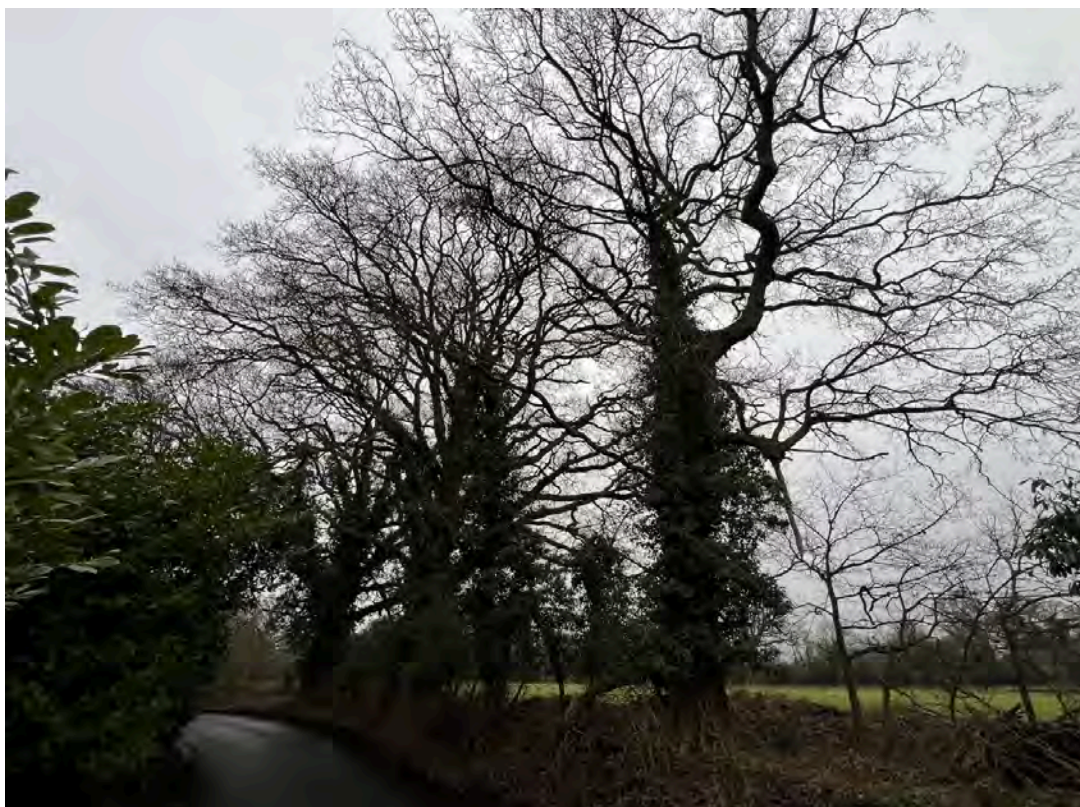
*Photographic plate showing T15 (right) through to T18 (left). (ROAVR, 2024)*

| Tree Number | Species | Age Class | DBH | Height (crown height) | N | E | S | W | Condition | Life Expectancy | Physical Description | Comments | Managment Recommendations | RPA offset from stem. | Category Rating |
|---|---|---|---|---|---|---|---|---|---|---|---|---|---|---|---|
| 15 | Quercus robur (Common Oak) | M | 650 | 13(3.5) | 5 | 5 | 8 | 8 | Good | 40+ | Ivy on tree. Broken branches in crown. | None | None | 191.16 | A1 |
| 17 | Quercus robur (Common Oak) | M | 1300 | 19(4) | 10 | 13.5 | 13.5 | 13.5 | Good | 40+ | Ivy on tree. Broken branches in crown. | None | None | 706.95 | A1 |
| 18 | Quercus robur (Common Oak) | M | 1200 | 19(4) | 13 | 13 | 8 | 13 | Good | 40+ | Ivy on tree. Broken branches in crown. | None | None | 651.53 | A1 |

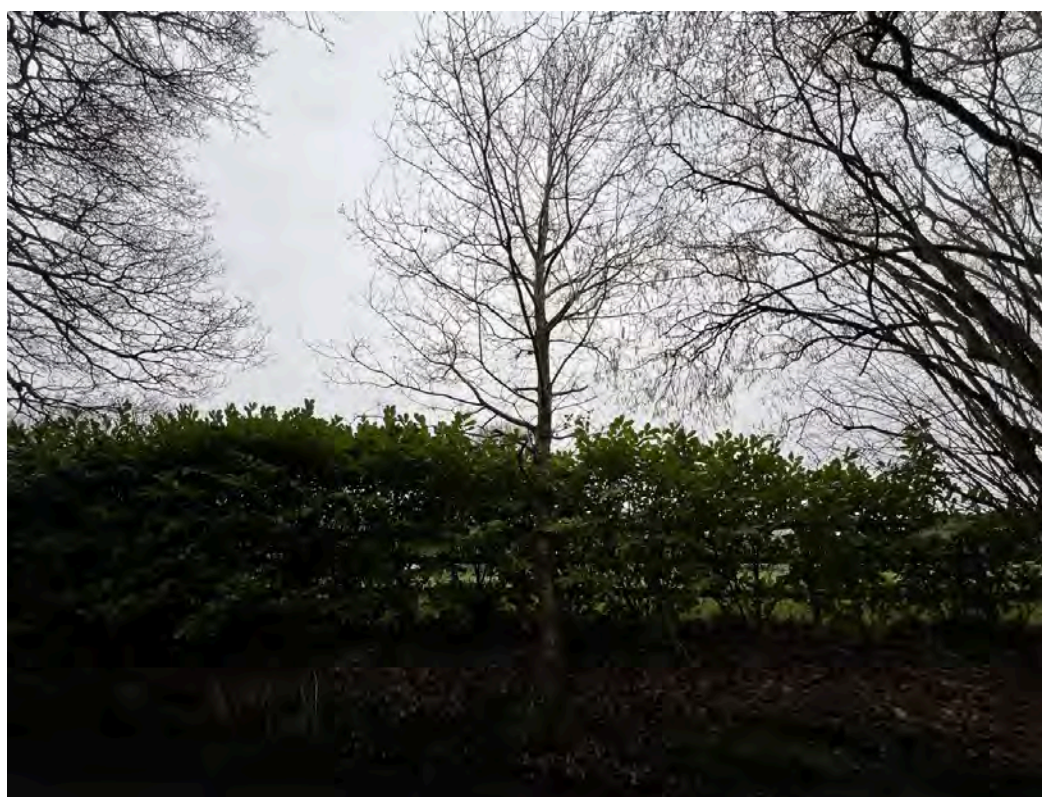
*Photographic plate showing T22 (centre). (ROAVR, 2024)*

- T22 (*Quercus robur* – Category B1): This specimen is required to be removed to facilitate the proposed new vehicle access. There is a direct conflict between the retained tree and the alignment of the entrance, and the tree is not suitable for retention within the current design context.

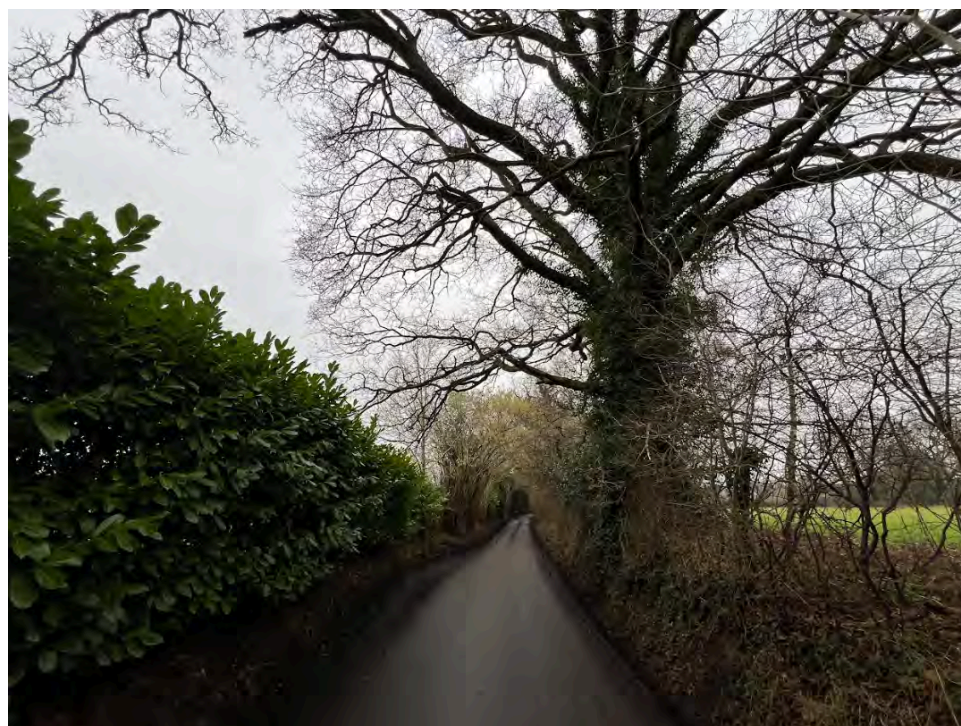
*Photographic plate T21 (right), Belgrove Lane (centre) & H1 (left).*

- Hedgerow 1 (H1 – Category C3): Is to be removed for visibility splays and access. This section possesses minor landscape value and its loss is appropriately mitigated through compensatory replanting elsewhere on site.

The amended access position still encroaches into the RPA of T21 (Quercus robur – Category A1), which is located off-site. However, the extent of encroachment is now extremely minor and significantly reduced compared to the previous layout. The intrusion is limited to a very small peripheral section of the RPA and does not extend towards the stem. T21 sits approximately 0.5 metres above the level of Belgrove Lane, with existing tarmac surfacing between the tree base and the proposed access location. Given the level difference, separation distance, and existing hardstanding, the likelihood of significant root presence within the affected area is low.

- All excavation within the RPA to be carried out by hand under arboricultural supervision
- Roots  $\leq 25$  mm diameter may be pruned back to suitable pruning points using clean, sharp secateurs
- Any roots greater than 25 mm diameter must be retained and worked around where feasible

- No-dig construction methodology
- Cellular confinement system (e.g. Cellweb) laid over a suitable geotextile membrane
- Permeable surface finish to allow infiltration of water and oxygen to the soil
