Photos of building to be demolished

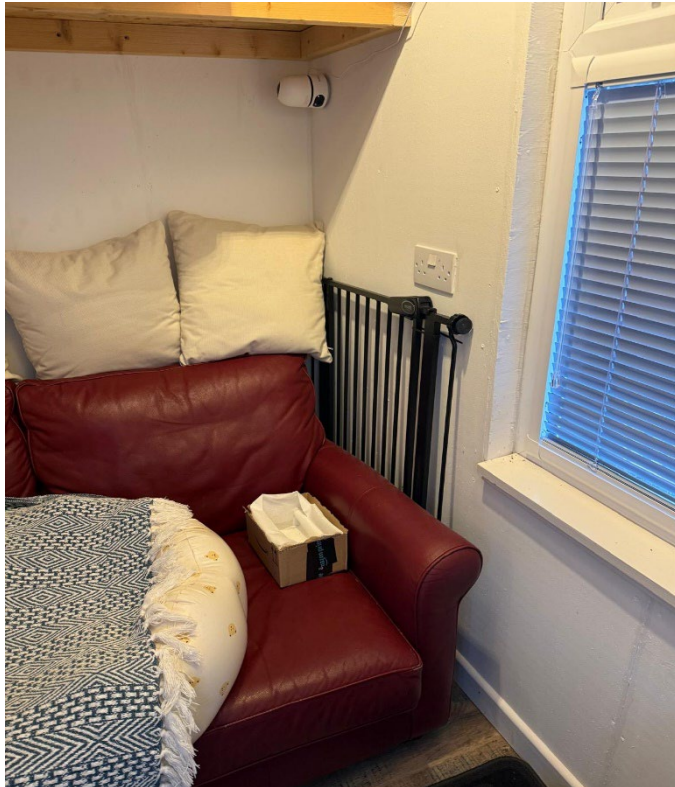
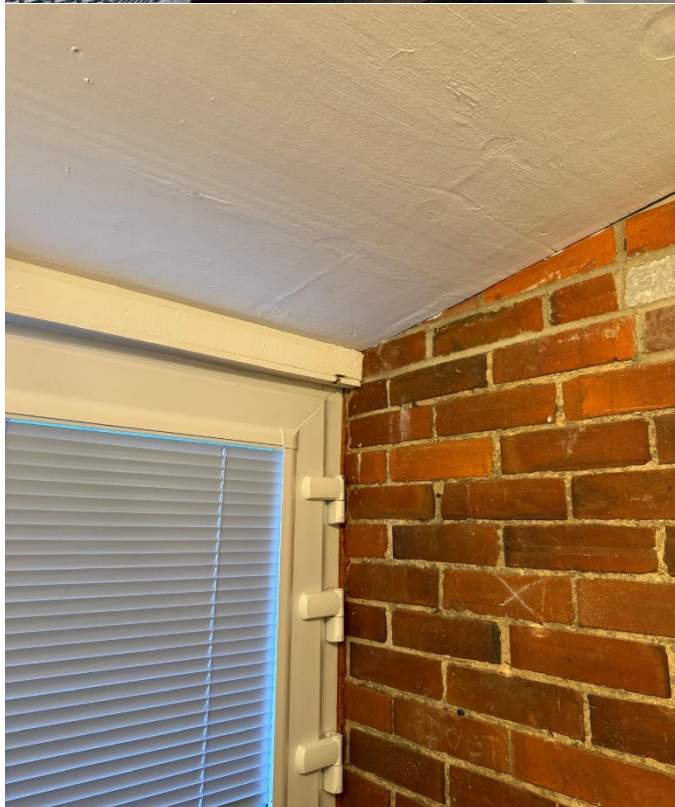
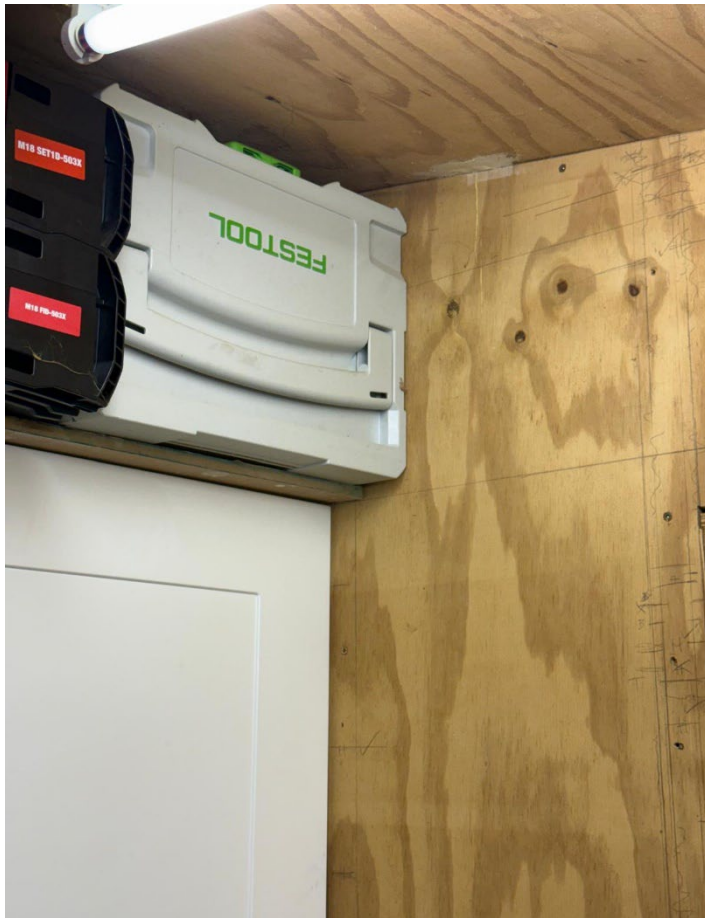
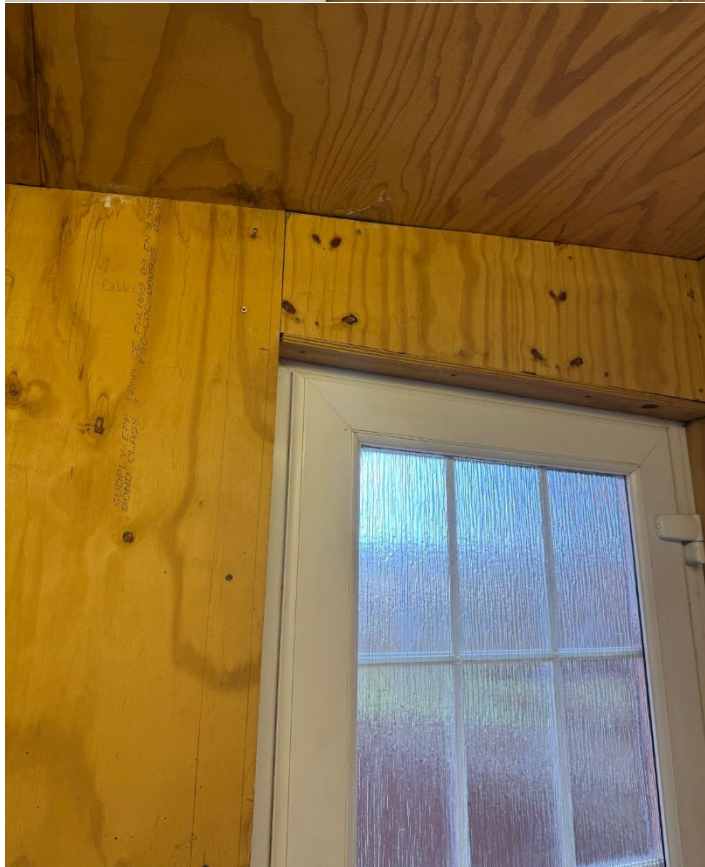
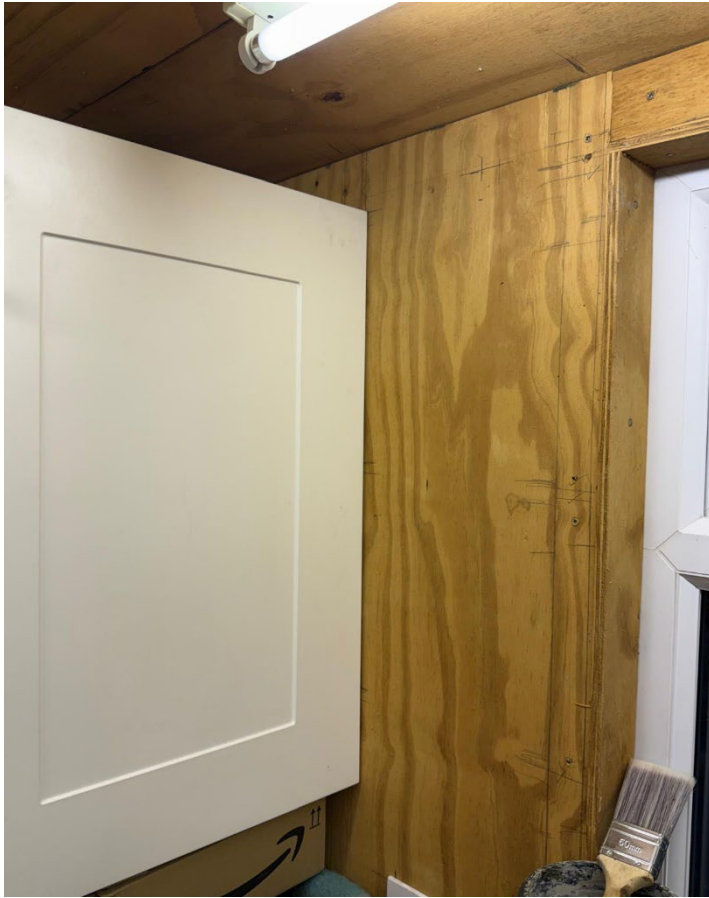
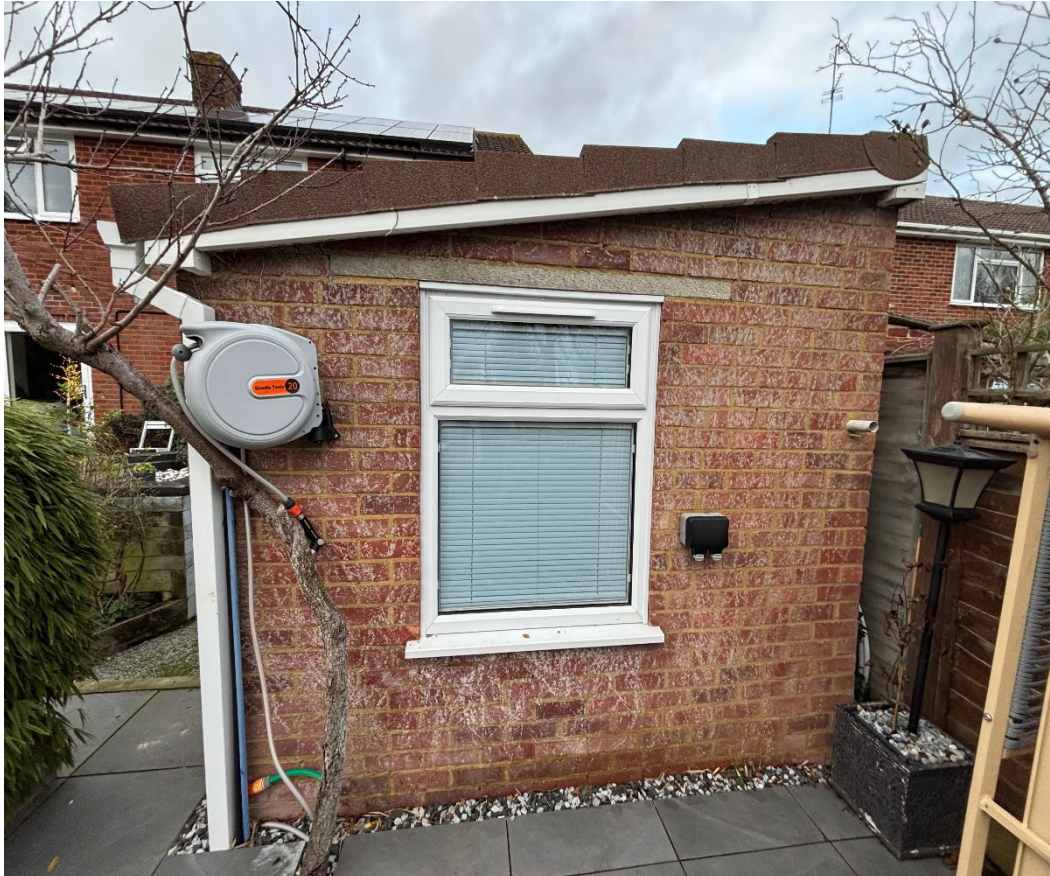
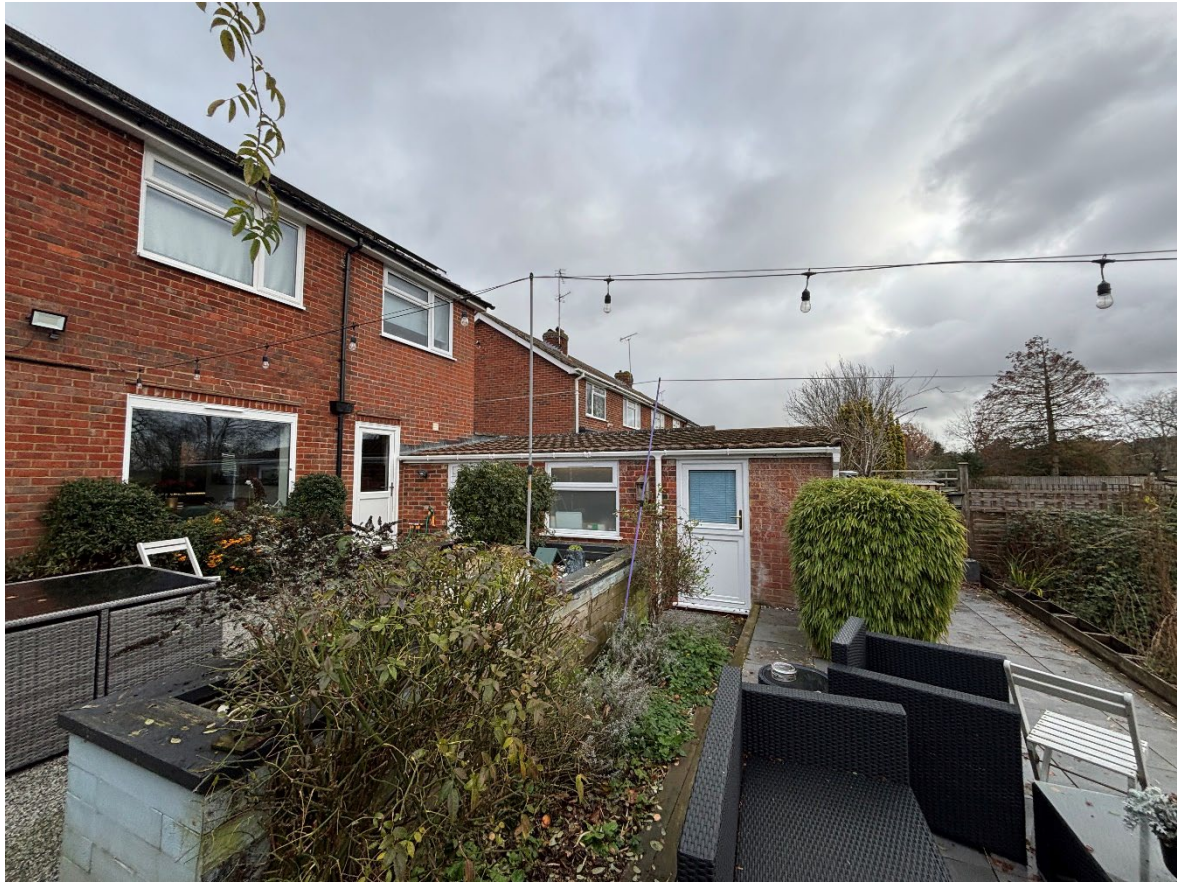
As you can see from the attached photos all the roof is sealed and was replaced approximately 8 years ago and the internals have been fitted out to create workshop and small storage room.

So no ecology report will be required for this planning application.
