**Arboricultural Implications  
Assessment  
for a proposed development  
at  
Billingbear Golf Club  
The Straight Mile  
Wokingham  
RG40 5SJ  
Rev C**

**Client: Lewandowski Architects  
First Floor  
Rafts Court  
Brocas Street  
Eton  
SL4 6RF**

**Date**  
09/12/2025

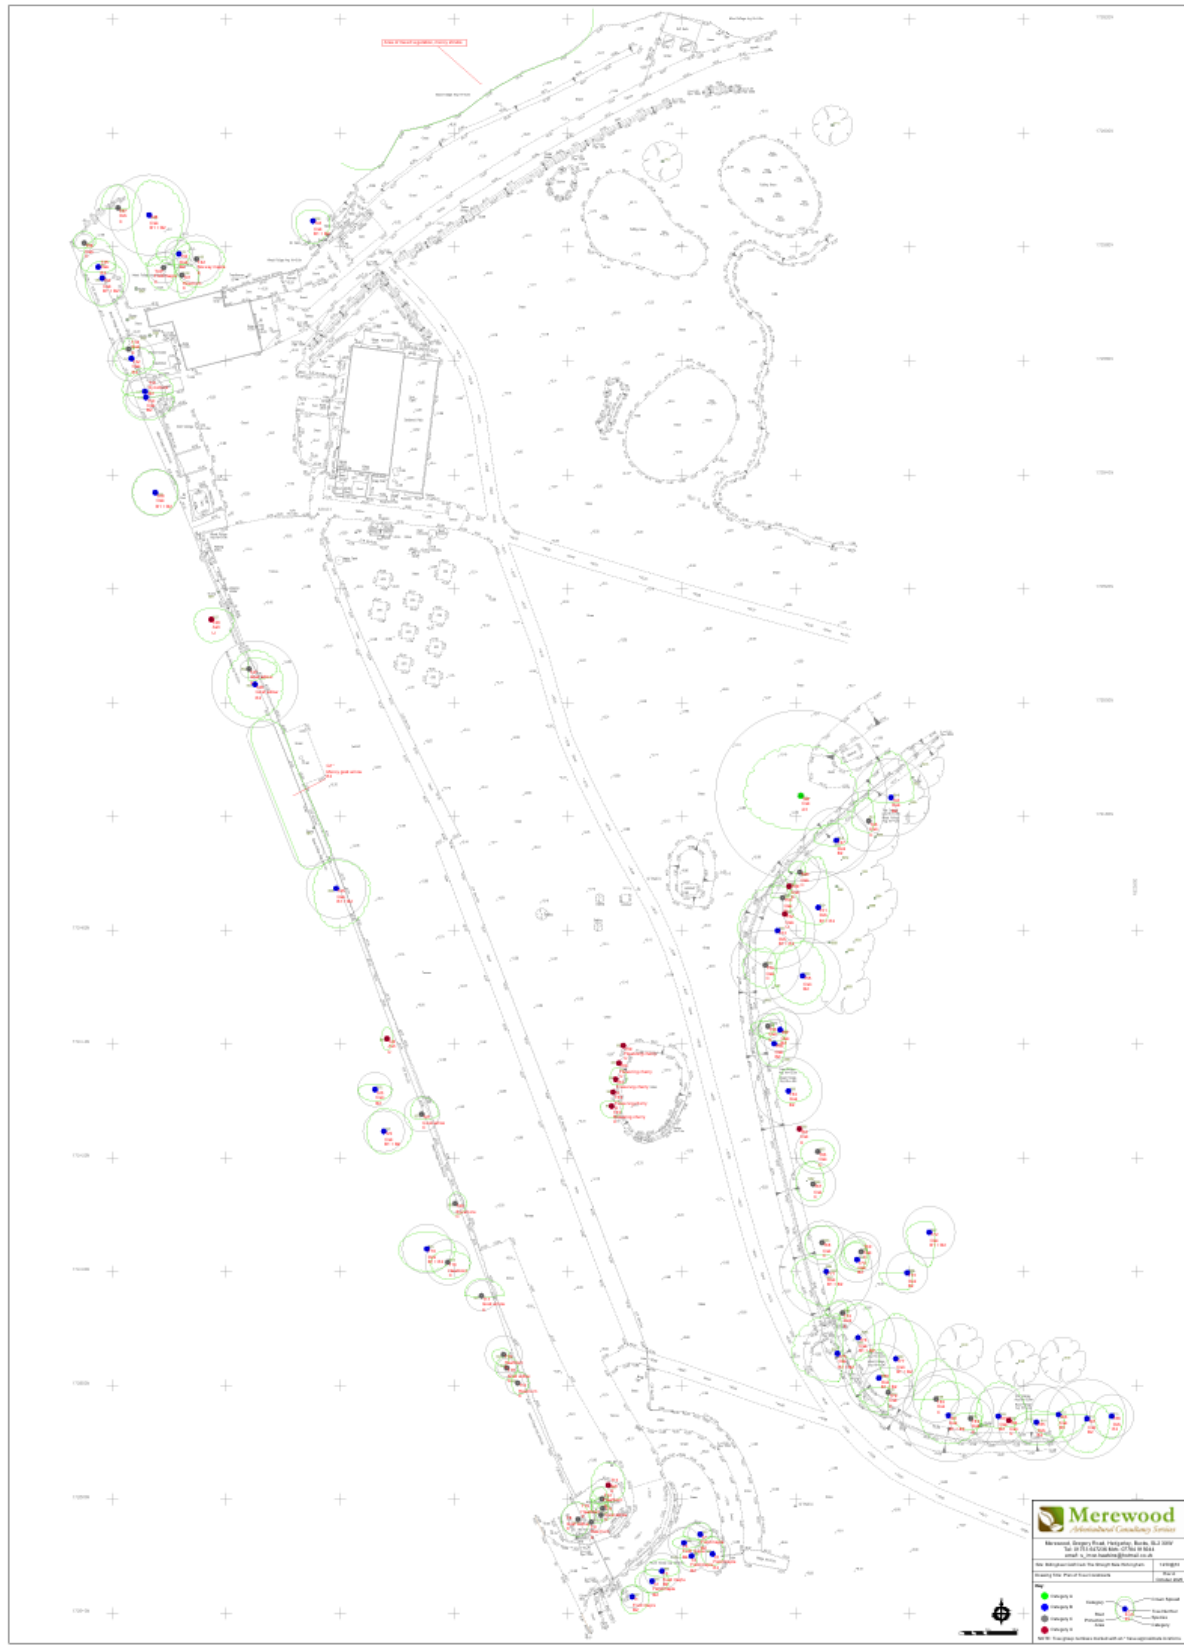
### Plan of Tree Constraints

2.1.2 The survey has revealed that of the 88 trees surveyed and 1 group of trees, 1 is category 'A' 43 are category 'B' plus 1 category 'B' group; 32 are category 'C' and 12 are category 'U' trees.

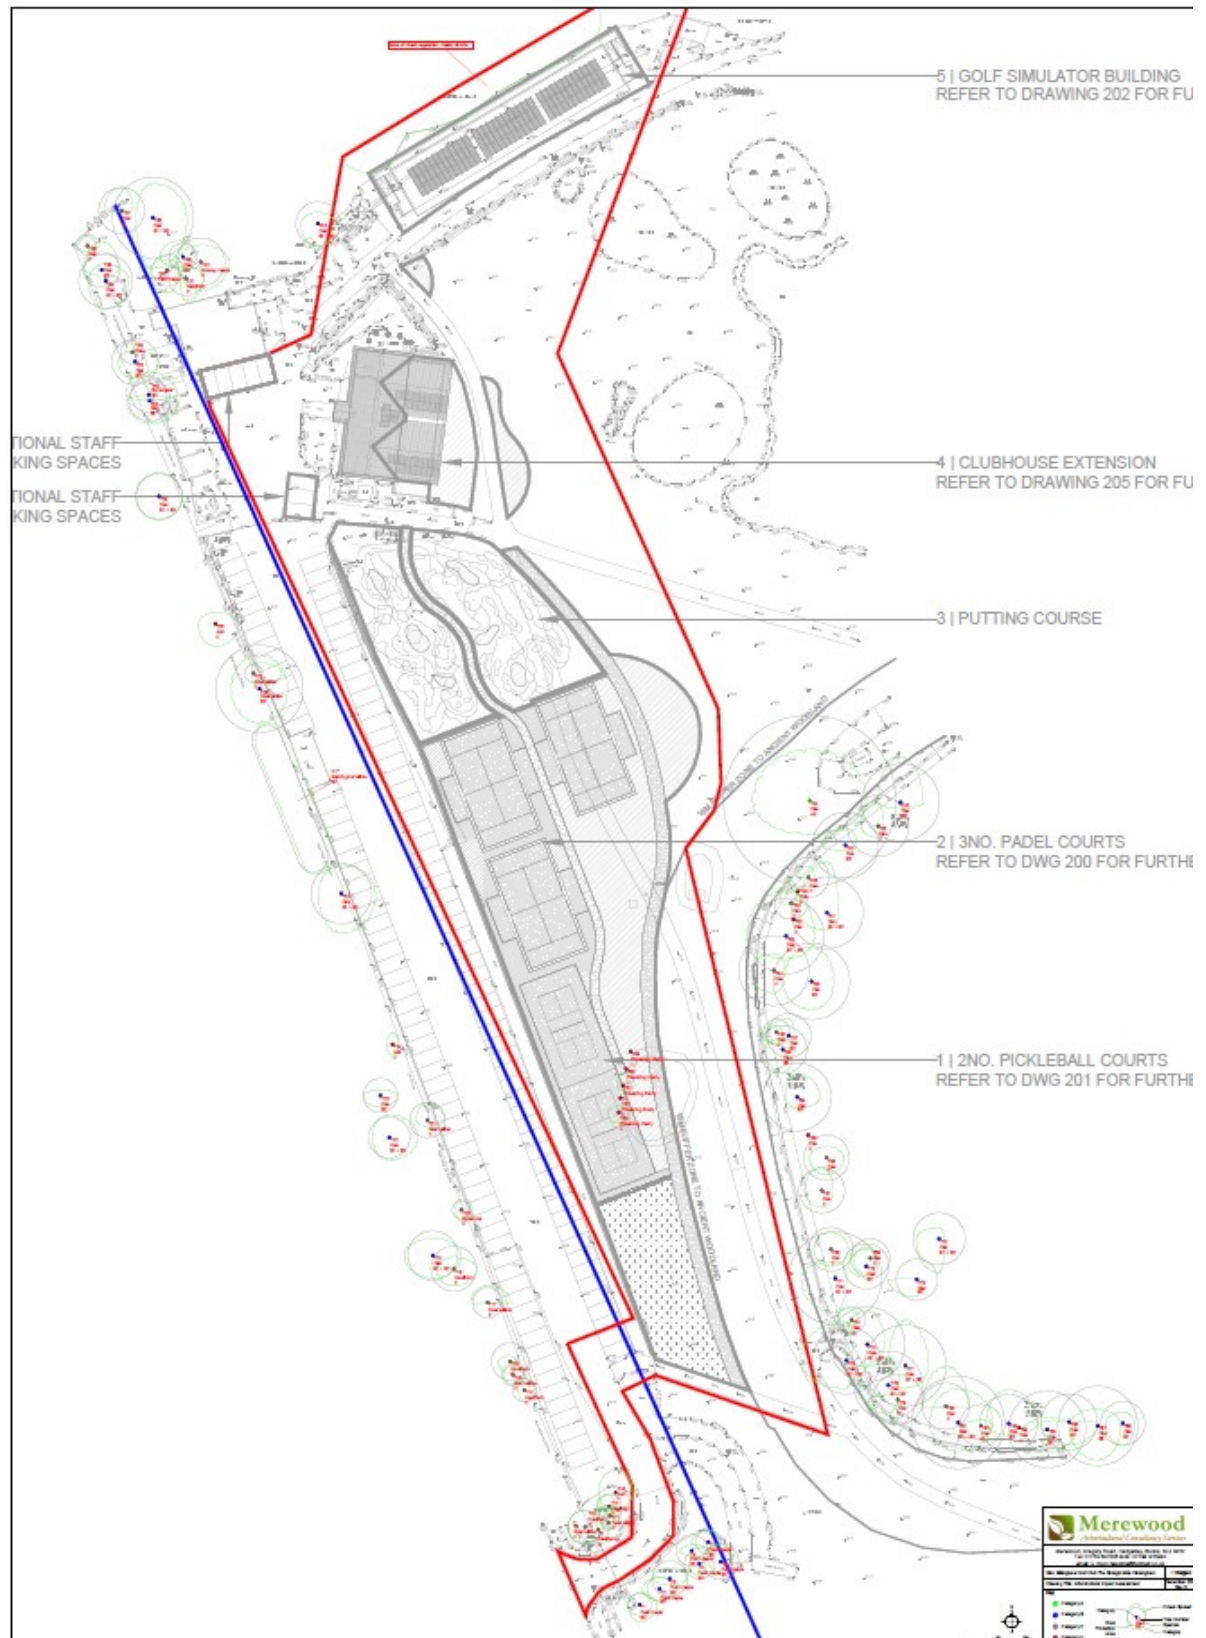
### Impact Assessment Plan

3.4.1 The impact assessment plan shows that there is plenty of space around the site for the movement of plant machinery. In order to help control the movement of all machinery and other building site activity, robust protective fencing will be put into place to protect the root areas of the trees.

- 3.5.1 The Impact Assessment Plan shows the 15m buffer from the edge of the woodland, demonstrating that the nearest proposals (the provision of the additional car parking spaces and a revised path for use by golfers accessing the course) still remain outside of the zone.
- 3.5.2 The tree protection plan (see method statement) illustrates where fencing will be placed to prevent any machinery or works spilling over onto the buffer zone.
- 3.5.3 Whilst the golf course will remain open, the ancient woodland will continue to be separated from the fairways by the existing ditch in any event.

- 3.6.1 The proposed excavations for the new buildings (and the existing clubhouse) will all take place outside the RPA's of the retained trees and there are no issues thereby arising from this.

3.2.1 The proposed development results in the removal of the five poor quality flowering cherries (T59 – 63). These are all category 'U' trees that would have to be removed anyway.
