# Hartley Court House

DESIGN & ACCESS, AND HERITAGE STATEMENT

LISTED BUILDING CONSENT

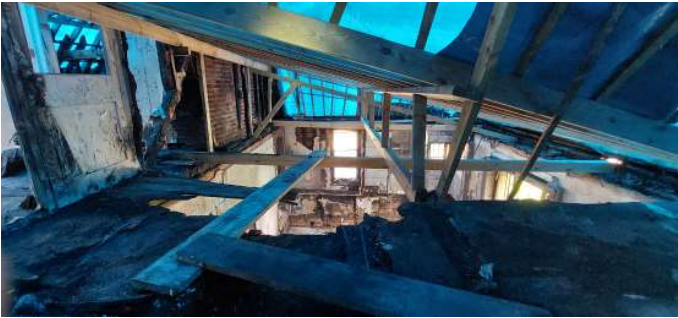
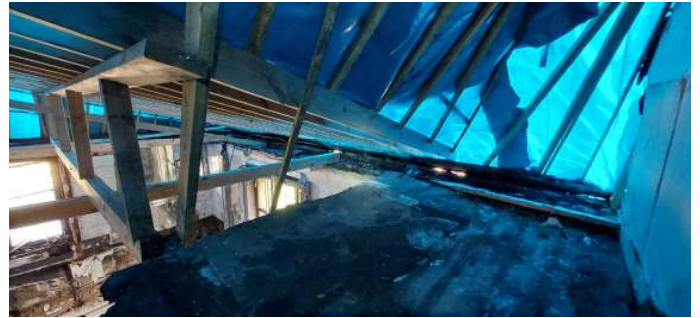
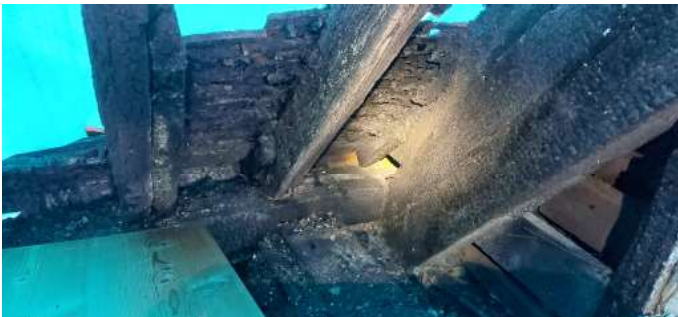
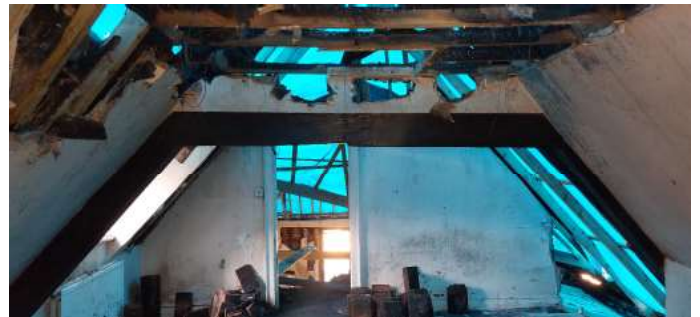
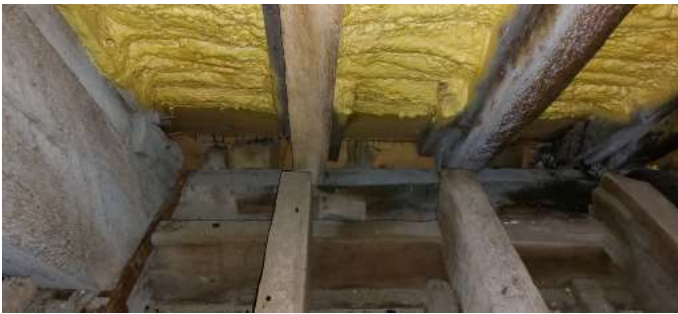
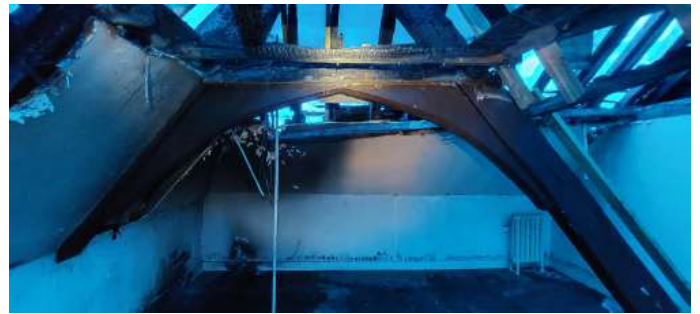
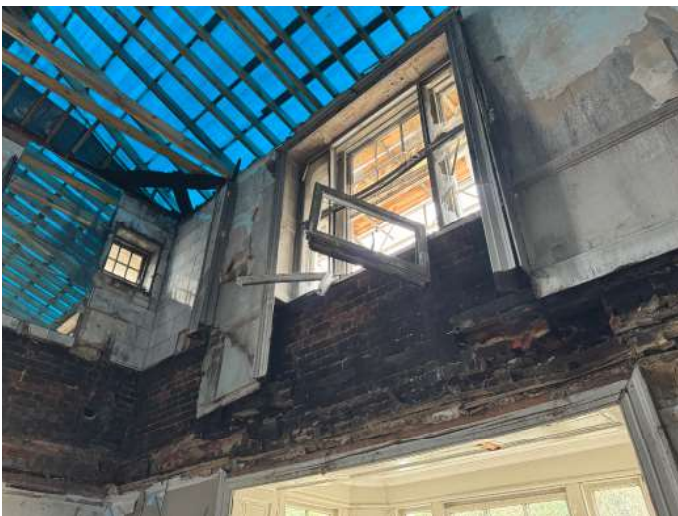
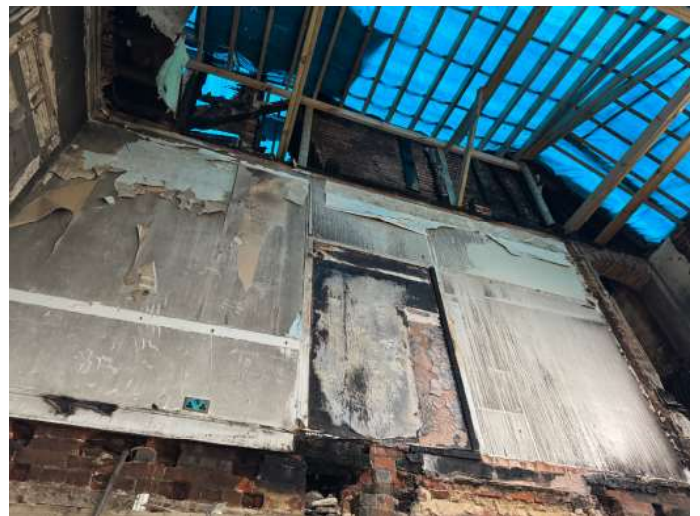
Figure 3. Collection of Site Survey Photographs 09.02.26

On 09th February 2026 a survey of the roof space was undertaken by James Taylor of JETArch Design Ltd. Photographic evidence of the rooms at ground through to second floor was collected, and dimensions taken of existing roof timbers. This included wall plates, joists, rafters, ridge boards, purlins, ties and attic walls. The aim of this was to collate a record of the existing timbers that would need to be replicated and provide a template for the restoration of the roof.

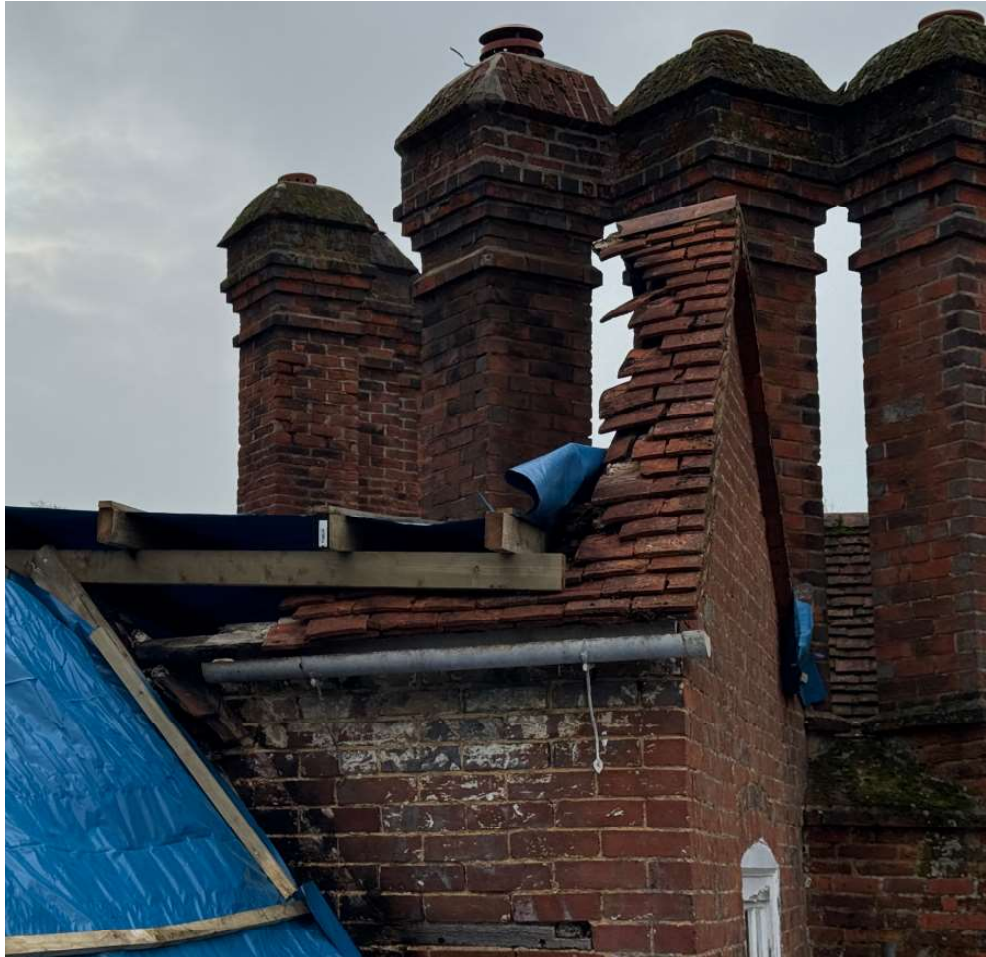
Facing brickwork to gable end of room SF3. The window to the staircase is visible. Note how the flank wall between SF3 and SF2 is a single skin brickwork wall and so exhibits a running bond. This is the gable noted in the structural engineers' report as needing supporting.

1. Carefully rebuild gable wall reusing the existing bricks laid in a lime mortar.

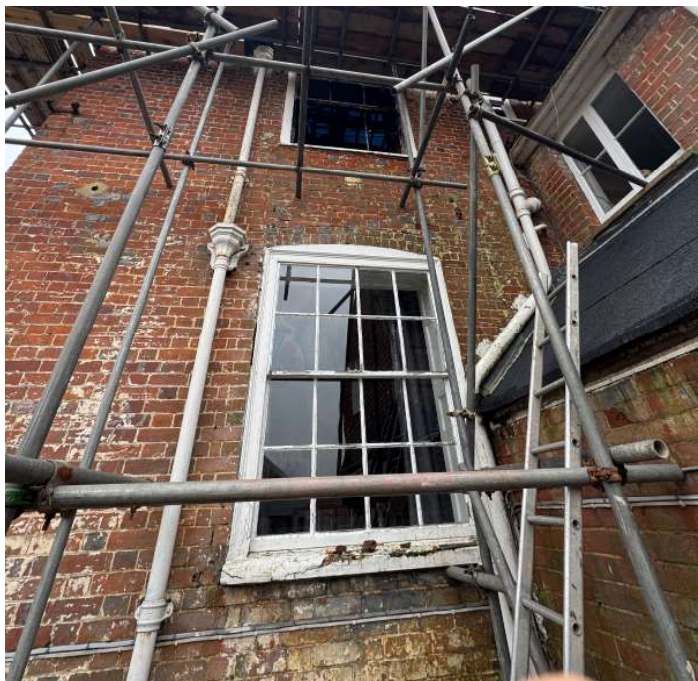
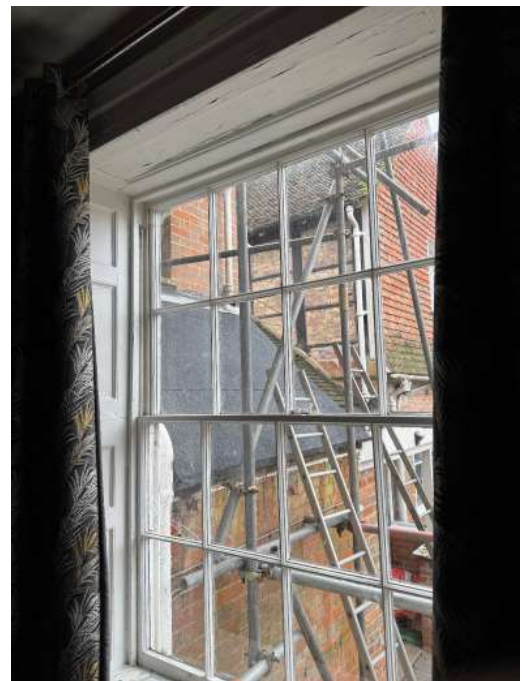
Here is the sash window to room GF5 from the exterior and then interior. The windows that require replacement will use the existing windows as a template. Under a previous application to the property some of the windows were replaced from UPVC back to timber sash windows. The same window supplier would be recommended for this application.

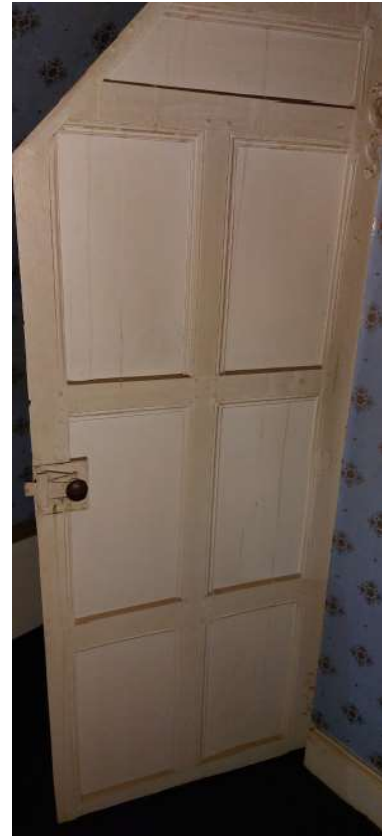
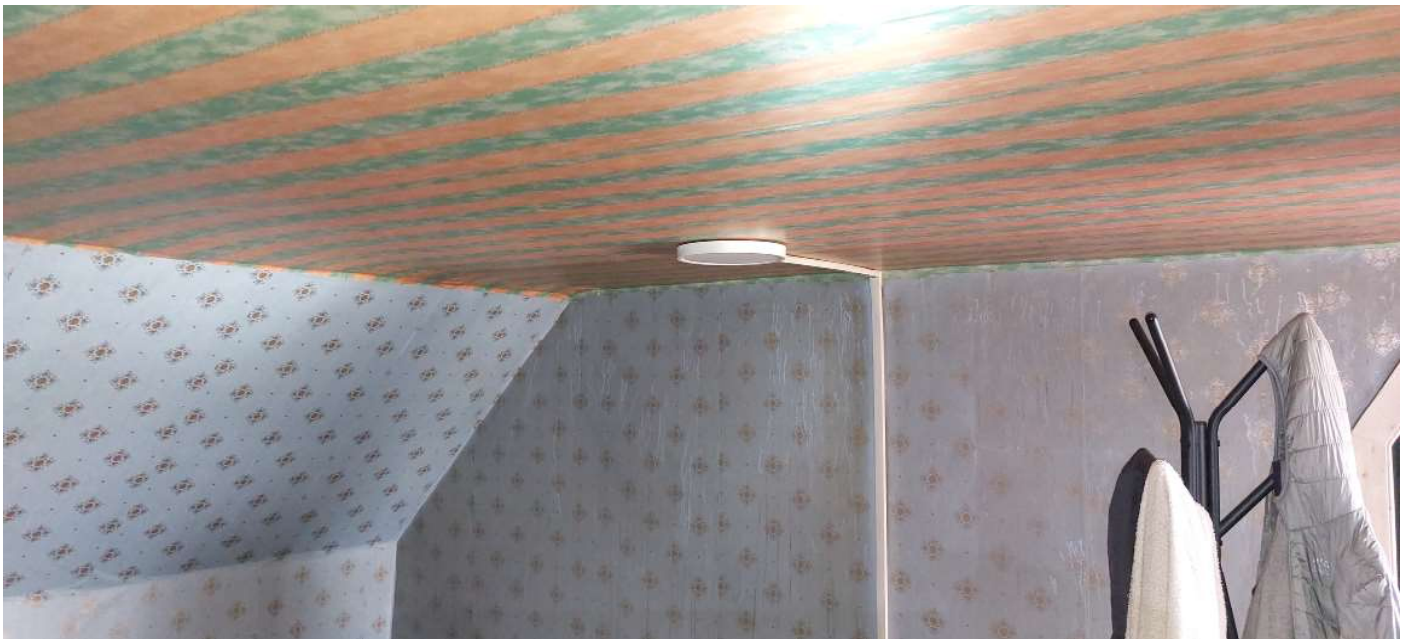
Undamaged ceilings to room SF7 showing sloping ceilings following rafter lines, and flat ceilings boarding the underside of ties.

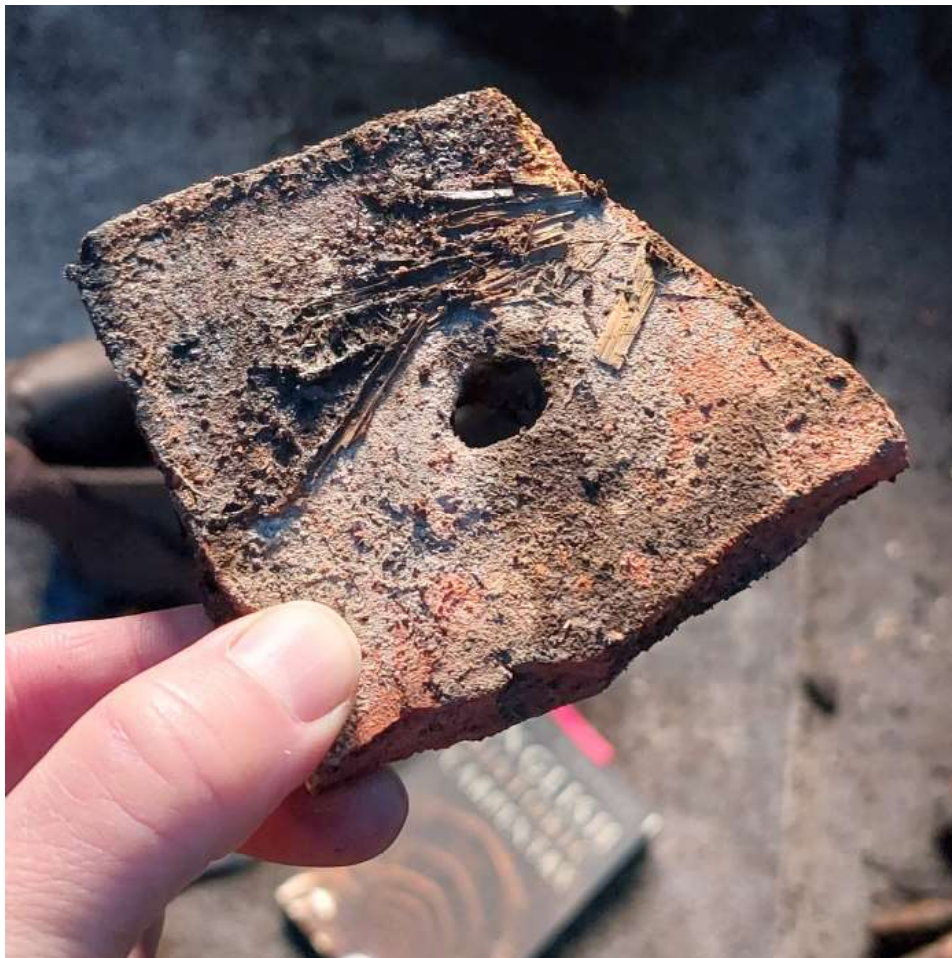
A selection of roof tiles has been rescued and stored to one side, however there are nowhere near enough to cover the roof. Closest matches will need to be found, however the existing tiles do not exhibit any makers marks and so the best fit would be a heritage reclaimed clay tile.

Figure 6. A broken tile from the roof. Evidence of torching can be seen with a mortar and straw mix

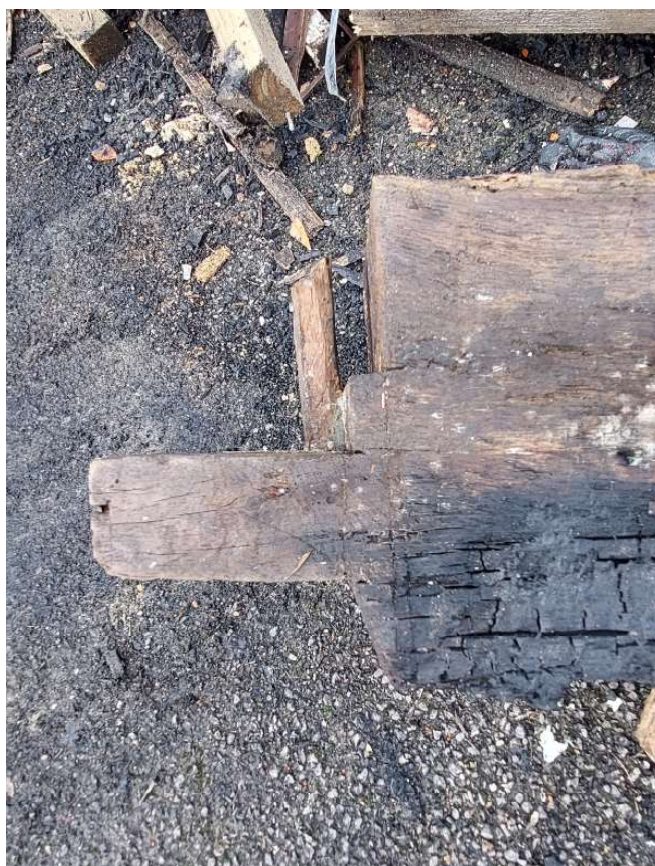
Figure 7. Tenon detail to floor beam

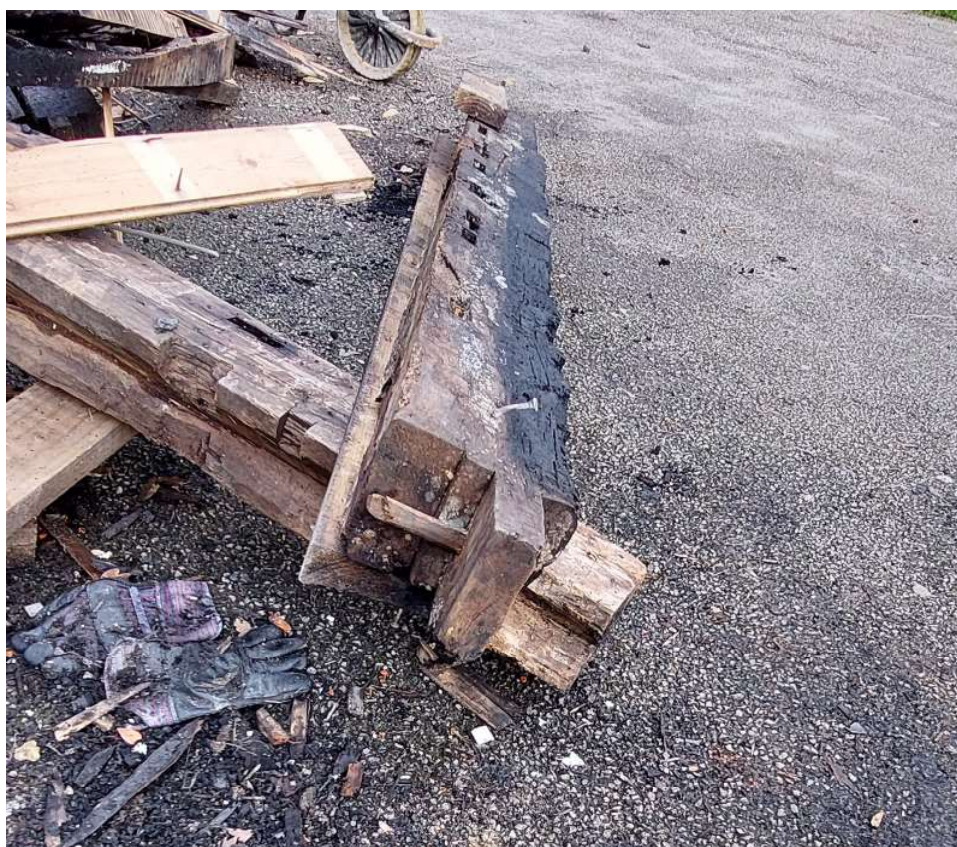
Figure 8. Tenon detail to floor beam
