**Intersurgical Ltd,  
Molly Millar's Bridge**

**SMA Ref: 7351/CMP**

| DOCUMENT CONTROL | | | |
|---|---|---|---|
| Document Title | Construction Management Plan | | |

**ASBESTOS REFURBISHMENT SURVEY REPORT**  
**&**  
**OUTLINE MANAGEMENT PLAN**

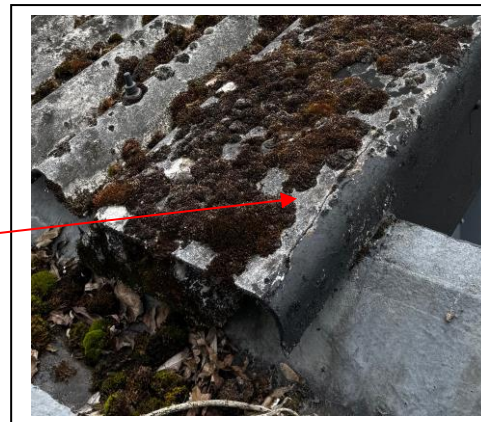
Asbestos cement eaves capping piece

| Data Sheet Ref | Location | Room | Description / Product Type | Condition | Approx. Quantity | Photo Ref | Sample Ref / Presumed / Strongly Presumed | Material Assessment Score | Recommended Action | Priority Score |
|---|---|---|---|---|---|---|---|---|---|---|
| 001 | Roof | N/A | Asbestos cement eaves capping piece. | Good | 30lm | P2 | S1 | 4 | <b><u>Chrysotile Asbestos</u></b><br>Any proposed works (including removal) to be carried out by a specialist competent contractor. If retained material should be monitored on an annual basis and any party likely to disturb it should be made aware of its asbestos content. | |

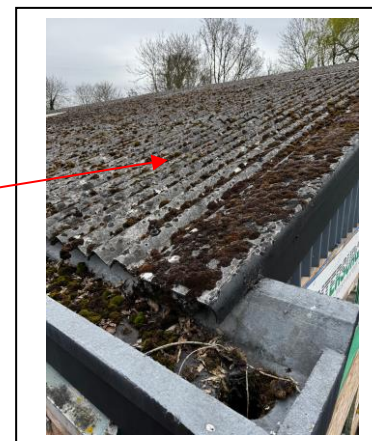
Asbestos cement corrugated roof sheets

| Data Sheet Ref | Location | Room | Description / Product Type | Condition | Approx. Quantity | Photo Ref | Sample Ref / Presumed / Strongly Presumed | Material Assessment Score | Recommended Action | Priority Score |
|---|---|---|---|---|---|---|---|---|---|---|
| 002 | Roof | N/A | Asbestos cement corrugated roofing sheets. | Good | 700m <sup>2</sup> | P3 | S2 | 4 | <b><u>Chrysotile Asbestos</u></b><br>Any proposed works (including removal) to be carried out by a specialist competent contractor. If retained material should be monitored on an annual basis and any party likely to disturb it should be made aware of its asbestos content. | |
