**Fritch Plate  
Details**

01/06/25

Sussex Lodge

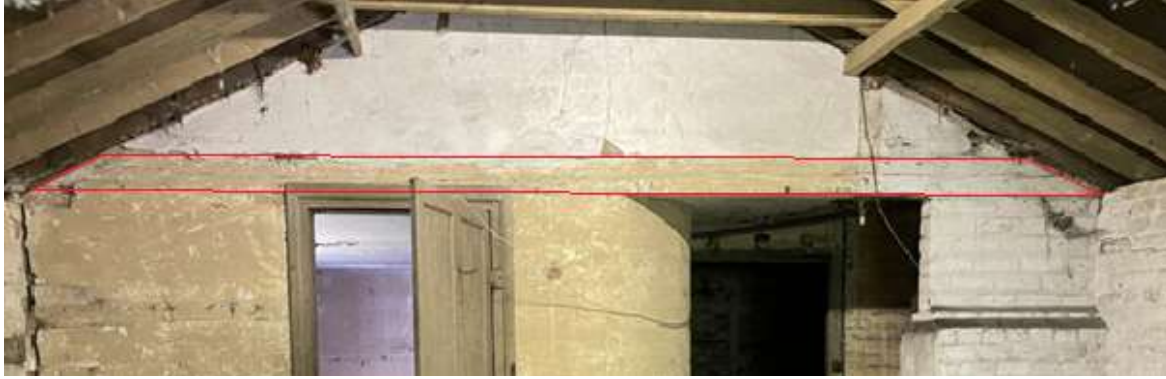
The existing timber beam spanning from east to west is fundamental to the roof structure, however its structural integrity cannot be guaranteed. The structural engineer's solution requires steel flitch plates to be bolted either side of this beam to provide the necessary supports, as per the below design drawings.

The red line on the photo above indicates the position and shape of the northern flitch plate. The other plate will be the same shape on the southern side of the beam.

These plates will be made from 20mm thick, 150mm high unfinished steel, bolted through the timber beam every 300mm.

The plates and bolts will be left exposed.

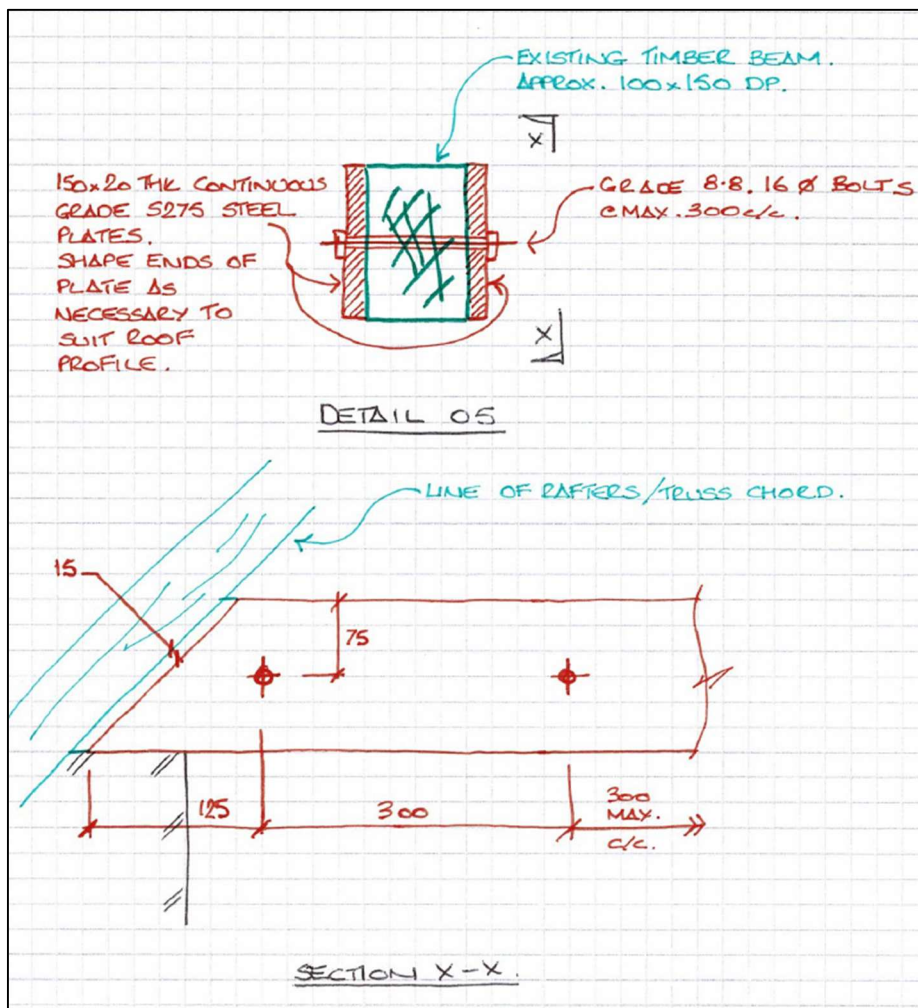
Detail 05 – Shows a section through the beam and flitch plates

Section x-x – Shows the eastern end of the flitch plate and how it will interact with the rafters and wall - as viewed from the north (ie the left hand end of the photo above)

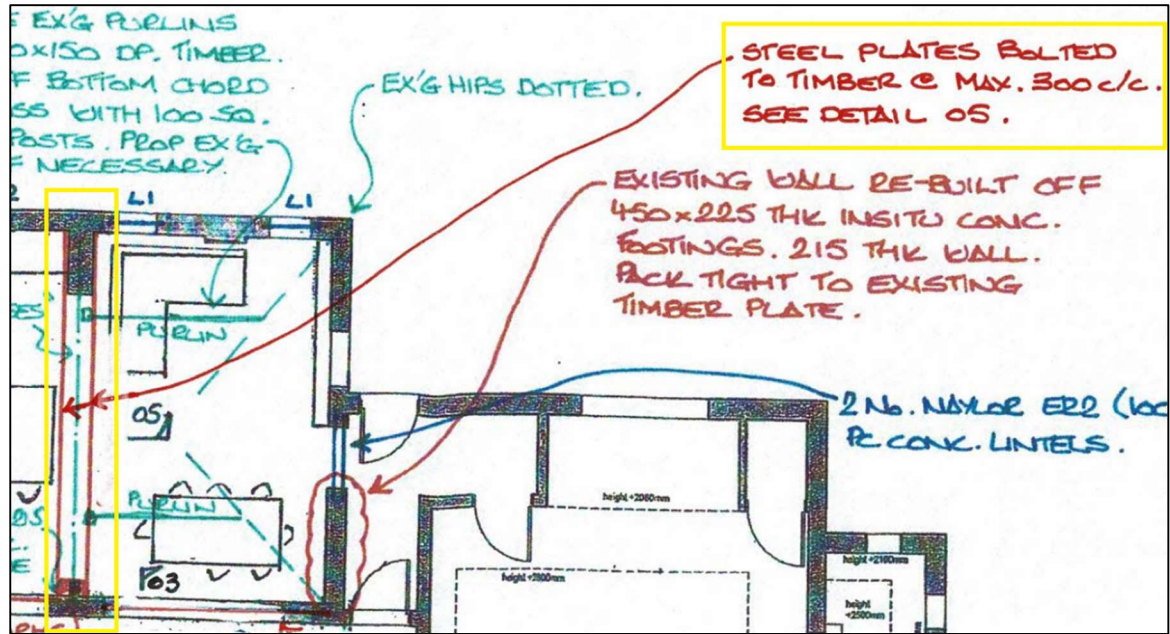
Highlighted yellow – the details of the flitch plates as identified on the engineer's designs.
