155 Barkham Road  
Wokingham  
Berkshire  
RG41 2RS

# Preliminary Bat Roost Assessment

*Report prepared by Vicky Potts; reviewed by John Wenman*  
Ref: R3337/b

**January 2023**

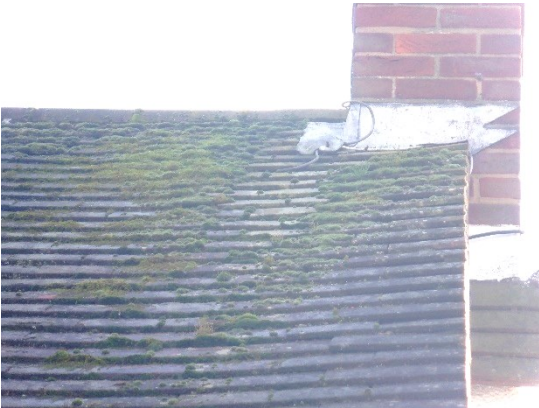
- 4.2.2** The flat roof tiles were mostly all in place with occasionally lifted tiles including on the verges towards the western side of the house, on the hipped roof to the front of the house, at the joins of the dormer windows with the main roof and on the dormer window at the eastern side of the house, providing potential roosting opportunities for bats (**Photographs 3, 4 & 5; Target notes 1, 2 & 3**). The ridge and hip tiles were all in place and mostly fully mortared in place, apart from a few gaps where the hip tiles were loose on the front dormer window (**Photograph 6; Target notes 4 & 5**). The lead flashing was tightly fitted around the chimney on the western side of the house (**Photograph 7; Target note 6**). The overhanging uPVC soffits were sealed to the rendered walls at the eaves (**Photograph 8; Target note 7**). The verge mortar was tight to the brickwork on the half-hipped roof to the front of the house (**Photograph 9; Target note 8**). The walls of the flat roofed dormer windows were clad with hanging tiles that were mostly tight apart from on the corner (**Photograph 10; Target note 9**). The pitched roof dormer windows were also clad with hanging tiles that had numerous gaps including at the eaves and where the tiles were lifted in particularly at the corners (**Photographs 11 & 12; Target note 10**).

3. Lifted tiles on the verge at the rear of the house.

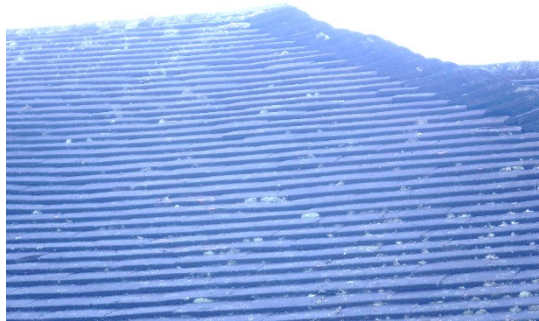
4. Gaps under some uneven roof tiles on the hipped roof to the front of the house.

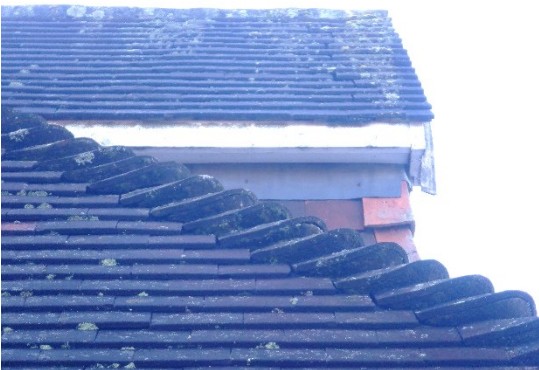
5. Lifted roof tiles on the dormer window to the eastern side of the house.

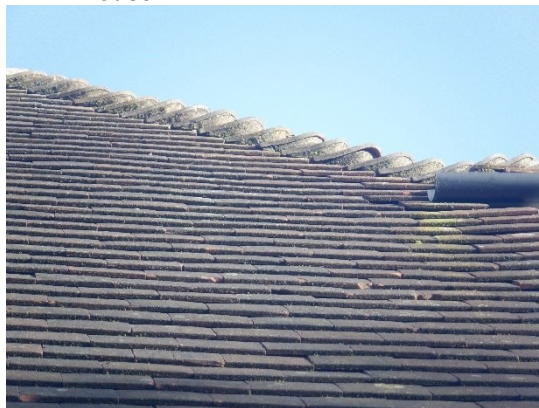
**5.2.1** The proposals will have an impact on the features across the roof with bat roost potential i.e. gaps behind hanging tiles, under uneven roof tiles and where the mortar was missing from under the hip tiles. If roosting bats are present, the changes to the property could therefore result in the permanent damage of bat roosts and may disturb and/or harm any bats present at the time of works.

6. A few gaps under the hip tiles to the front of the house.

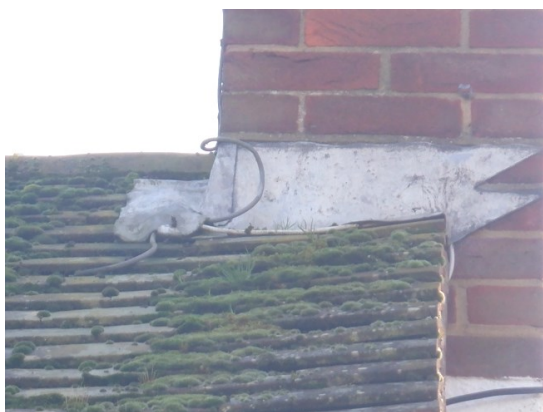
**7. Lead flashing tight around the chimney.**

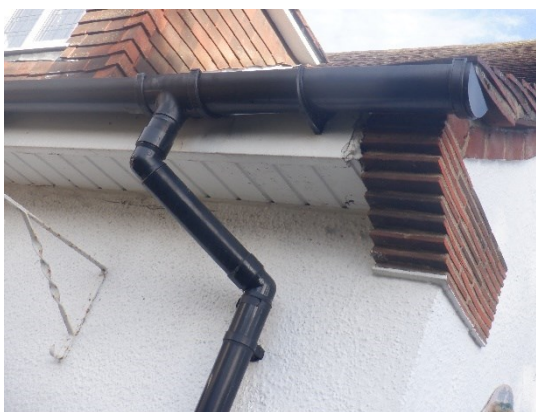
**8. Upvc soffits tight at the eaves to the sides of the house.**

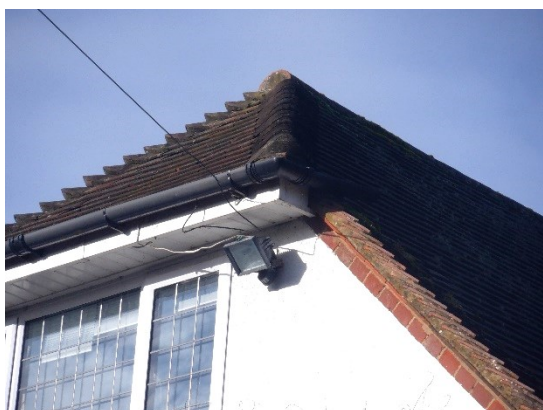
**9. Verge mortar tight to the brickwork at the front of the house.**

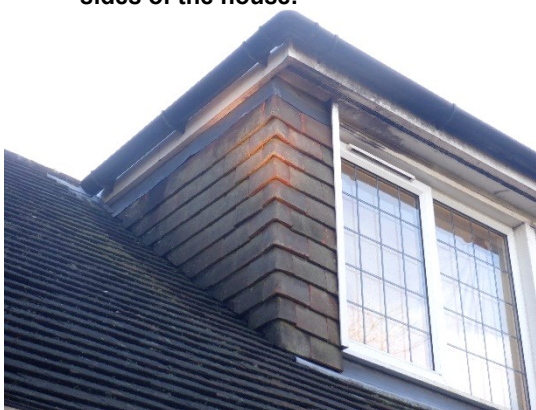
**10. Flat roof dormer windows clad with hanging tiles that were mostly tight apart from at the corners.**

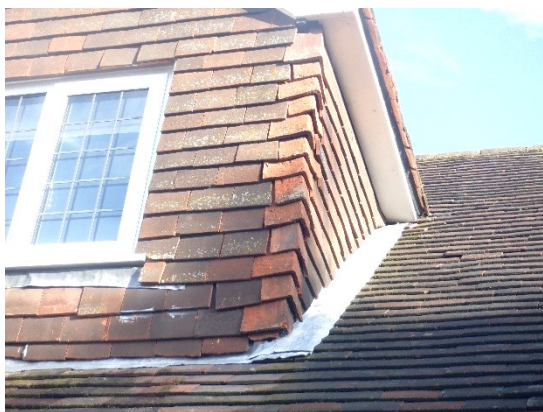
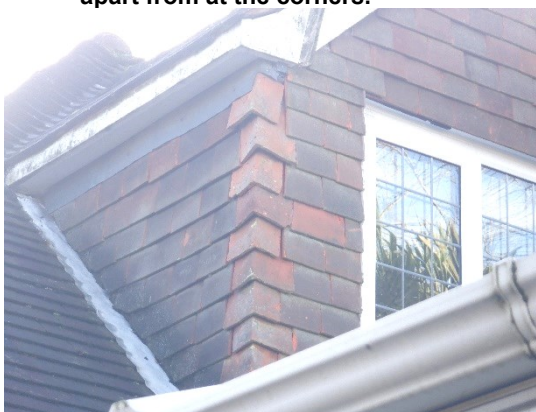
**11. Numerous gaps behind the hanging tiles on the pitched roof dormer windows.**

**12. Numerous gaps behind the hanging tiles on the pitched roof dormer windows.**

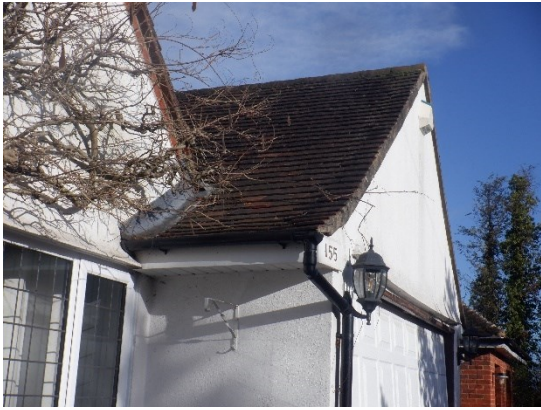
- 4.2.3** The roof and ridge tiles on the pitched roofed garage were in place and mostly tightly fitted, although a few were lifted along the verge to the front of the garage (**Photograph 13; Target note 11**). The soffits were tight to the rendered walls along

**13. Roof and ridge tiles tight in place and tightly fitted, with a few gaps along the verge of the garage.**

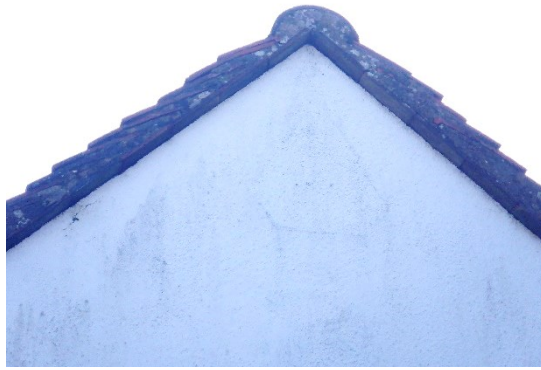
the eastern side of the garage (**Target note 12**). The verge mortar was intact and tight to the rendered walls at the eaves (**Photograph 14; Target note 13**).

**14. Verge mortar intact and tight to the rendered walls at the eaves of the garage**

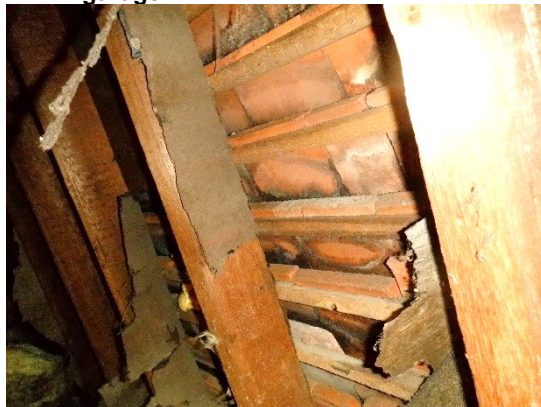
**16. Internal view of the roof space lined with paper backed felt, which had numerous large tears.**

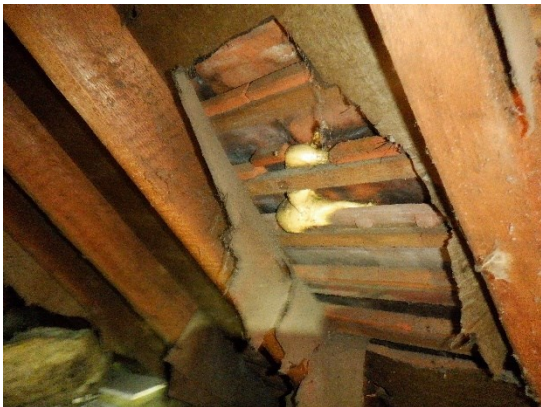
**17. Large tear in roofing felt exposing the undersides of the roof tile.**

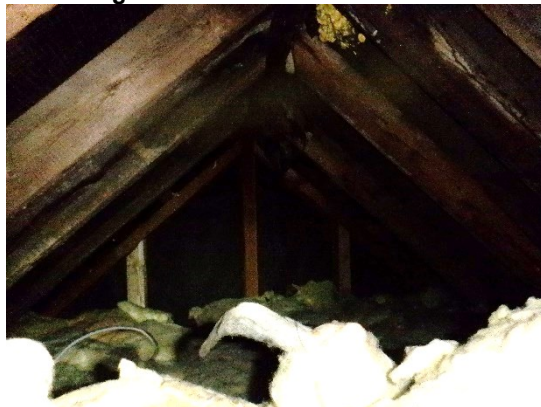
**18. One of the dormer windows tightly lined with bitumen roofing felt.**

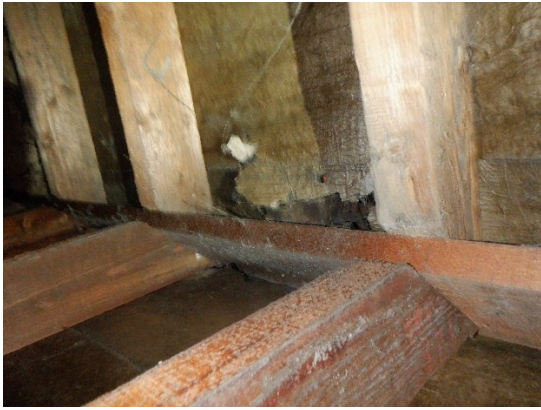
**19. The heavily cobwebbed ridge.**

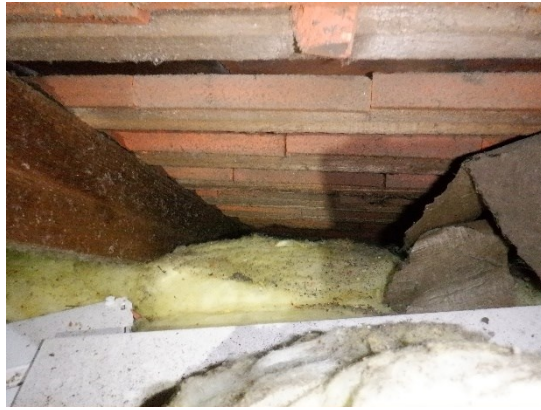
**20. Eaves filled with fibreglass.**

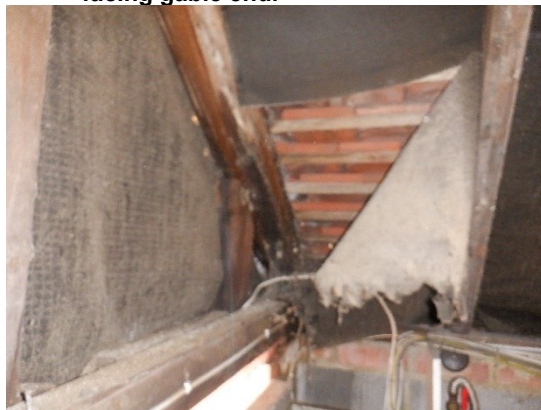
**4.3.2** The interior of the garage comprised of a single skin brickwork wall to the external eastern side and a block work wall to the western side (**Photograph 23; Target notes 19 & 20**). The roof was lined with bitumen felt, which was loose in places (**Photograph 24; Target note 21**). The ridge was cobwebbed (**Photograph 25; Target note 22**).

**24. Roof of the garage with loose felt in places.**

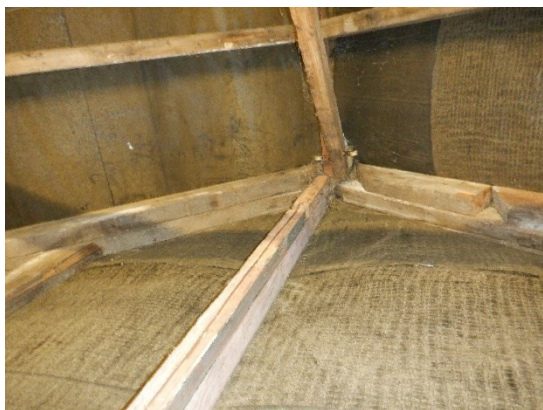
**25. Cobwebbed ridge of the garage.**
