## HYDE END ROAD

## PLANNING SUBMISSION (ARBORICULTURE)

**Prepared for:** Bloor Homes (Southern) and the University of Reading

**Issued:** February 2026

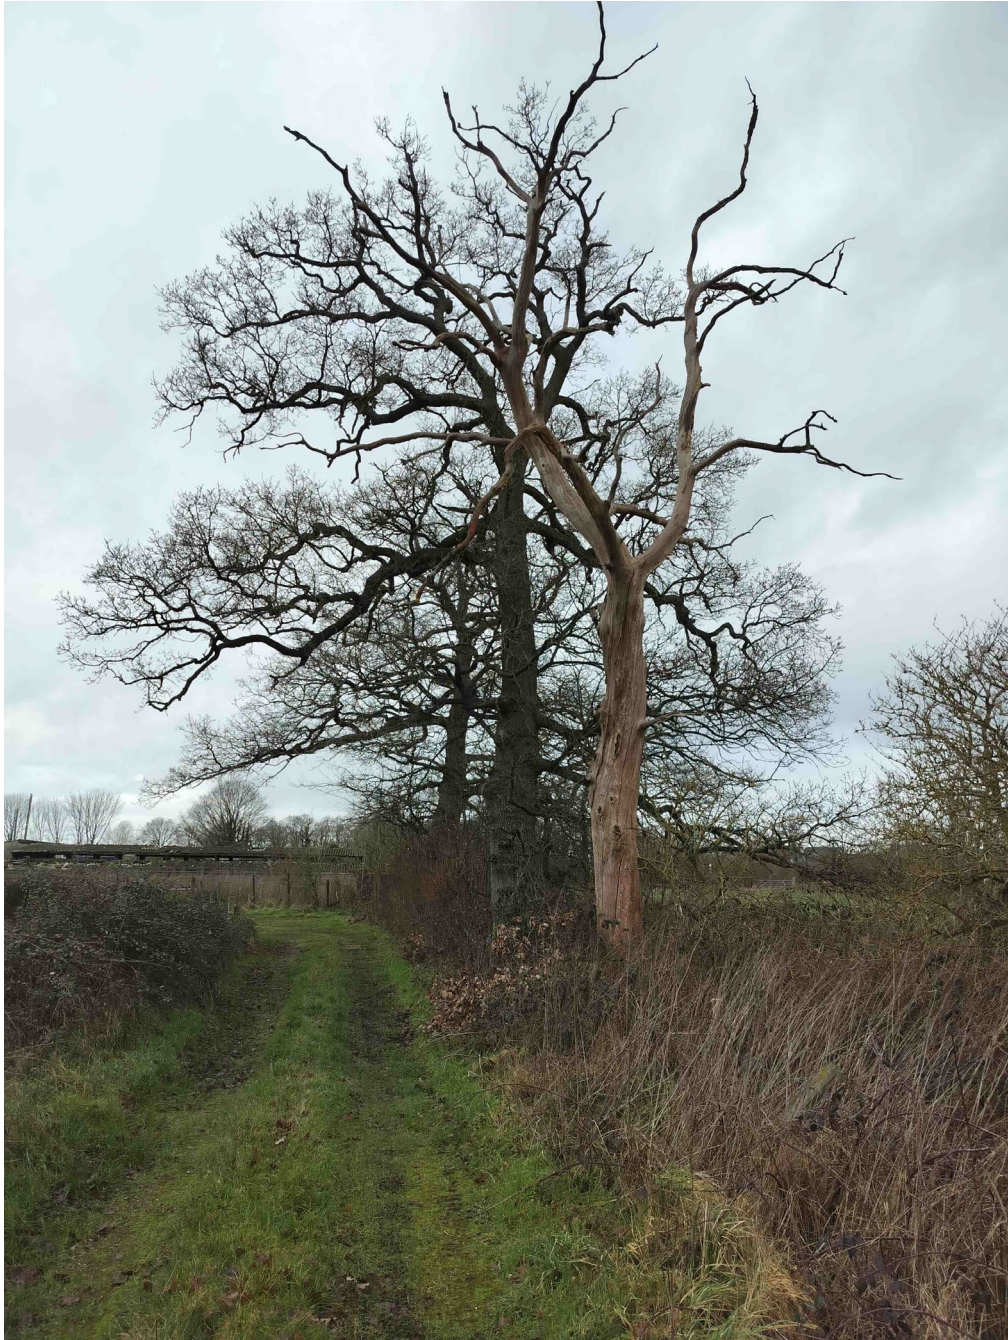
3.4 Photograph 1 below shows the track within the area of concern, viewed from the east looking west along the track it can be seen that the track comprises historically compacted stone, which has now become largely captured by grass and it is assumed offers an opportunity for shallow rooting by the trees. Accordingly, the method on the TPP seeks to remove a portion of the stone surface effectively breaking it up and providing new topsoil cover so that subsequent vegetation can become established but without 'stripping' the ground.

*Photograph 1 – View west along former track to be removed, trees 9005 (foreground), 9004 (mid-ground) and 9003 (background).*
