## BS:5837 ARBORICULTURAL REPORT

ARBORICULTURAL SURVEY, IMPACT ASSESSMENT &  
METHOD STATEMENT

37 COMMONS ROAD  
WOKINGHAM  
BERKSHIRE  
RG41 1JJ

Ref: AIA/AMS 06414/ 2024

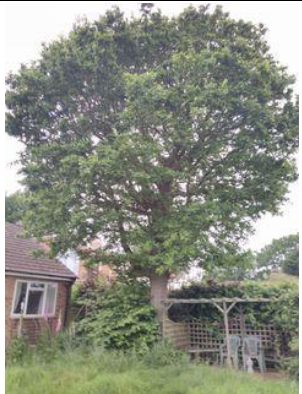
| Ref. | Species | Structure | Measurements | Spread | General Observations | Retention Category | RPA | Summary | Photo |
|---|---|---|---|---|---|---|---|---|---|
| T001 | Pedunculate oak<br>(Quercus robur) | Tree | Height (m): 10<br>Stem Diam(mm): 540<br>Crown Clearance (m): 3.5<br>Life Stage: Mature<br>Rem. Contrib.: 40+ Years | N:5<br>E:4.5<br>S:5<br>W:5 | Base and lower trunk obscured by dense vegetation. Small tree with compact canopy maintained by regular pruning. | B1,2 | Radius: 6.5m.<br>Area: 133 sq m. | Physiological Condition: Good<br>Structural Condition: Fair<br>Public Amenity Value: Moderate<br>Inspection Limitations: Dense vegetation | |

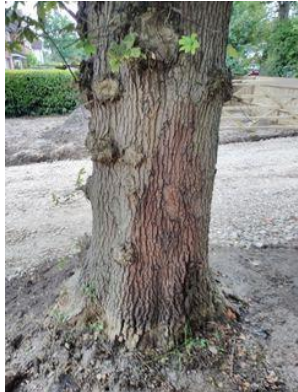
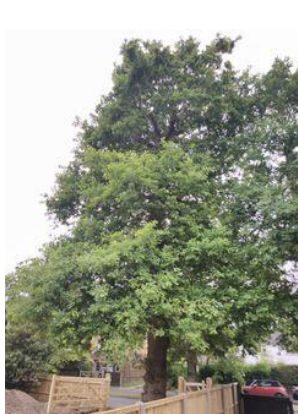
| Ref. | Species | Structure | Measurements | Spread | General Observations | Retention Category | RPA | Summary | Photo |
|---|---|---|---|---|---|---|---|---|---|
| T005 | Pedunculate oak<br>(Quercus robur) | Tree | Height (m): 11<br>Stem Diam(mm): 650<br>Crown Clearance (m): 2<br>Rem. Contrib.: 20+ Years | N:3.5<br>E:3.5<br>S:3<br>W:3 | Offsite tree. May be affected by current grounds works at front of neighbouring property. Canopy formed of mature epicormic growth on trunk. Foliage dense, good vitality. | B1 | Radius: 7.8m.<br>Area: 191 sq m. | Physiological Condition: Good<br>Structural Condition: Fair<br>Public Amenity Value: Good<br>Inspection Limitations: Access | |

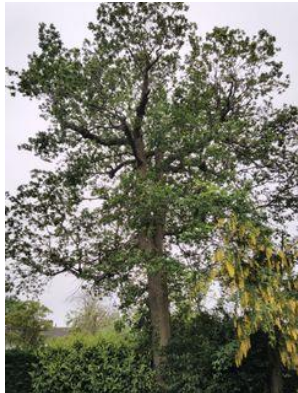
| Ref. | Species | Structure | Measurements | Spread | General Observations | Retention Category | RPA | Summary | Photo |
|---|---|---|---|---|---|---|---|---|---|
| T008 | Pedunculate oak (Quercus robur) | Tree | Height (m): 10<br>Stem Diam(mm): 630<br>Crown Clearance (m): 5<br>Life Stage: Mature<br>Rem. Contrib.: 20+ Years | N:4.5<br>E:5.5<br>S:4.5<br>W:5 | Base and lower trunk obscured by vegetation. Ivy on lower trunk. Missing bark on north side at base. Lesions / fermenting exudates on trunk from 1.5-4m. Possible split in wood fibres. Main stem forms above 5m. Fork satisfactory. Previously topped crown. Poor form. Decay pockets in old pruning cuts. Foliage density normal. Minor deadwood through crown. | B1 | Radius: 7.6m.<br>Area: 181 sq m. | Physiological Condition: Fair<br>Structural Condition: Fair<br>Public Amenity Value: Good | |
