## **ARBORICULTURAL IMPACT ASSESSMENT FOR LAND ADJACENT TO HIGHLANDS AVENUE WOKINGHAM**

**Prepared on behalf of:  
Mr & Mrs Pike  
Highlands House  
Highlands Avenue  
Barkham  
RG41 4SP**

**Ref: PB/AIA-24/08.22**

**24 August 2024**

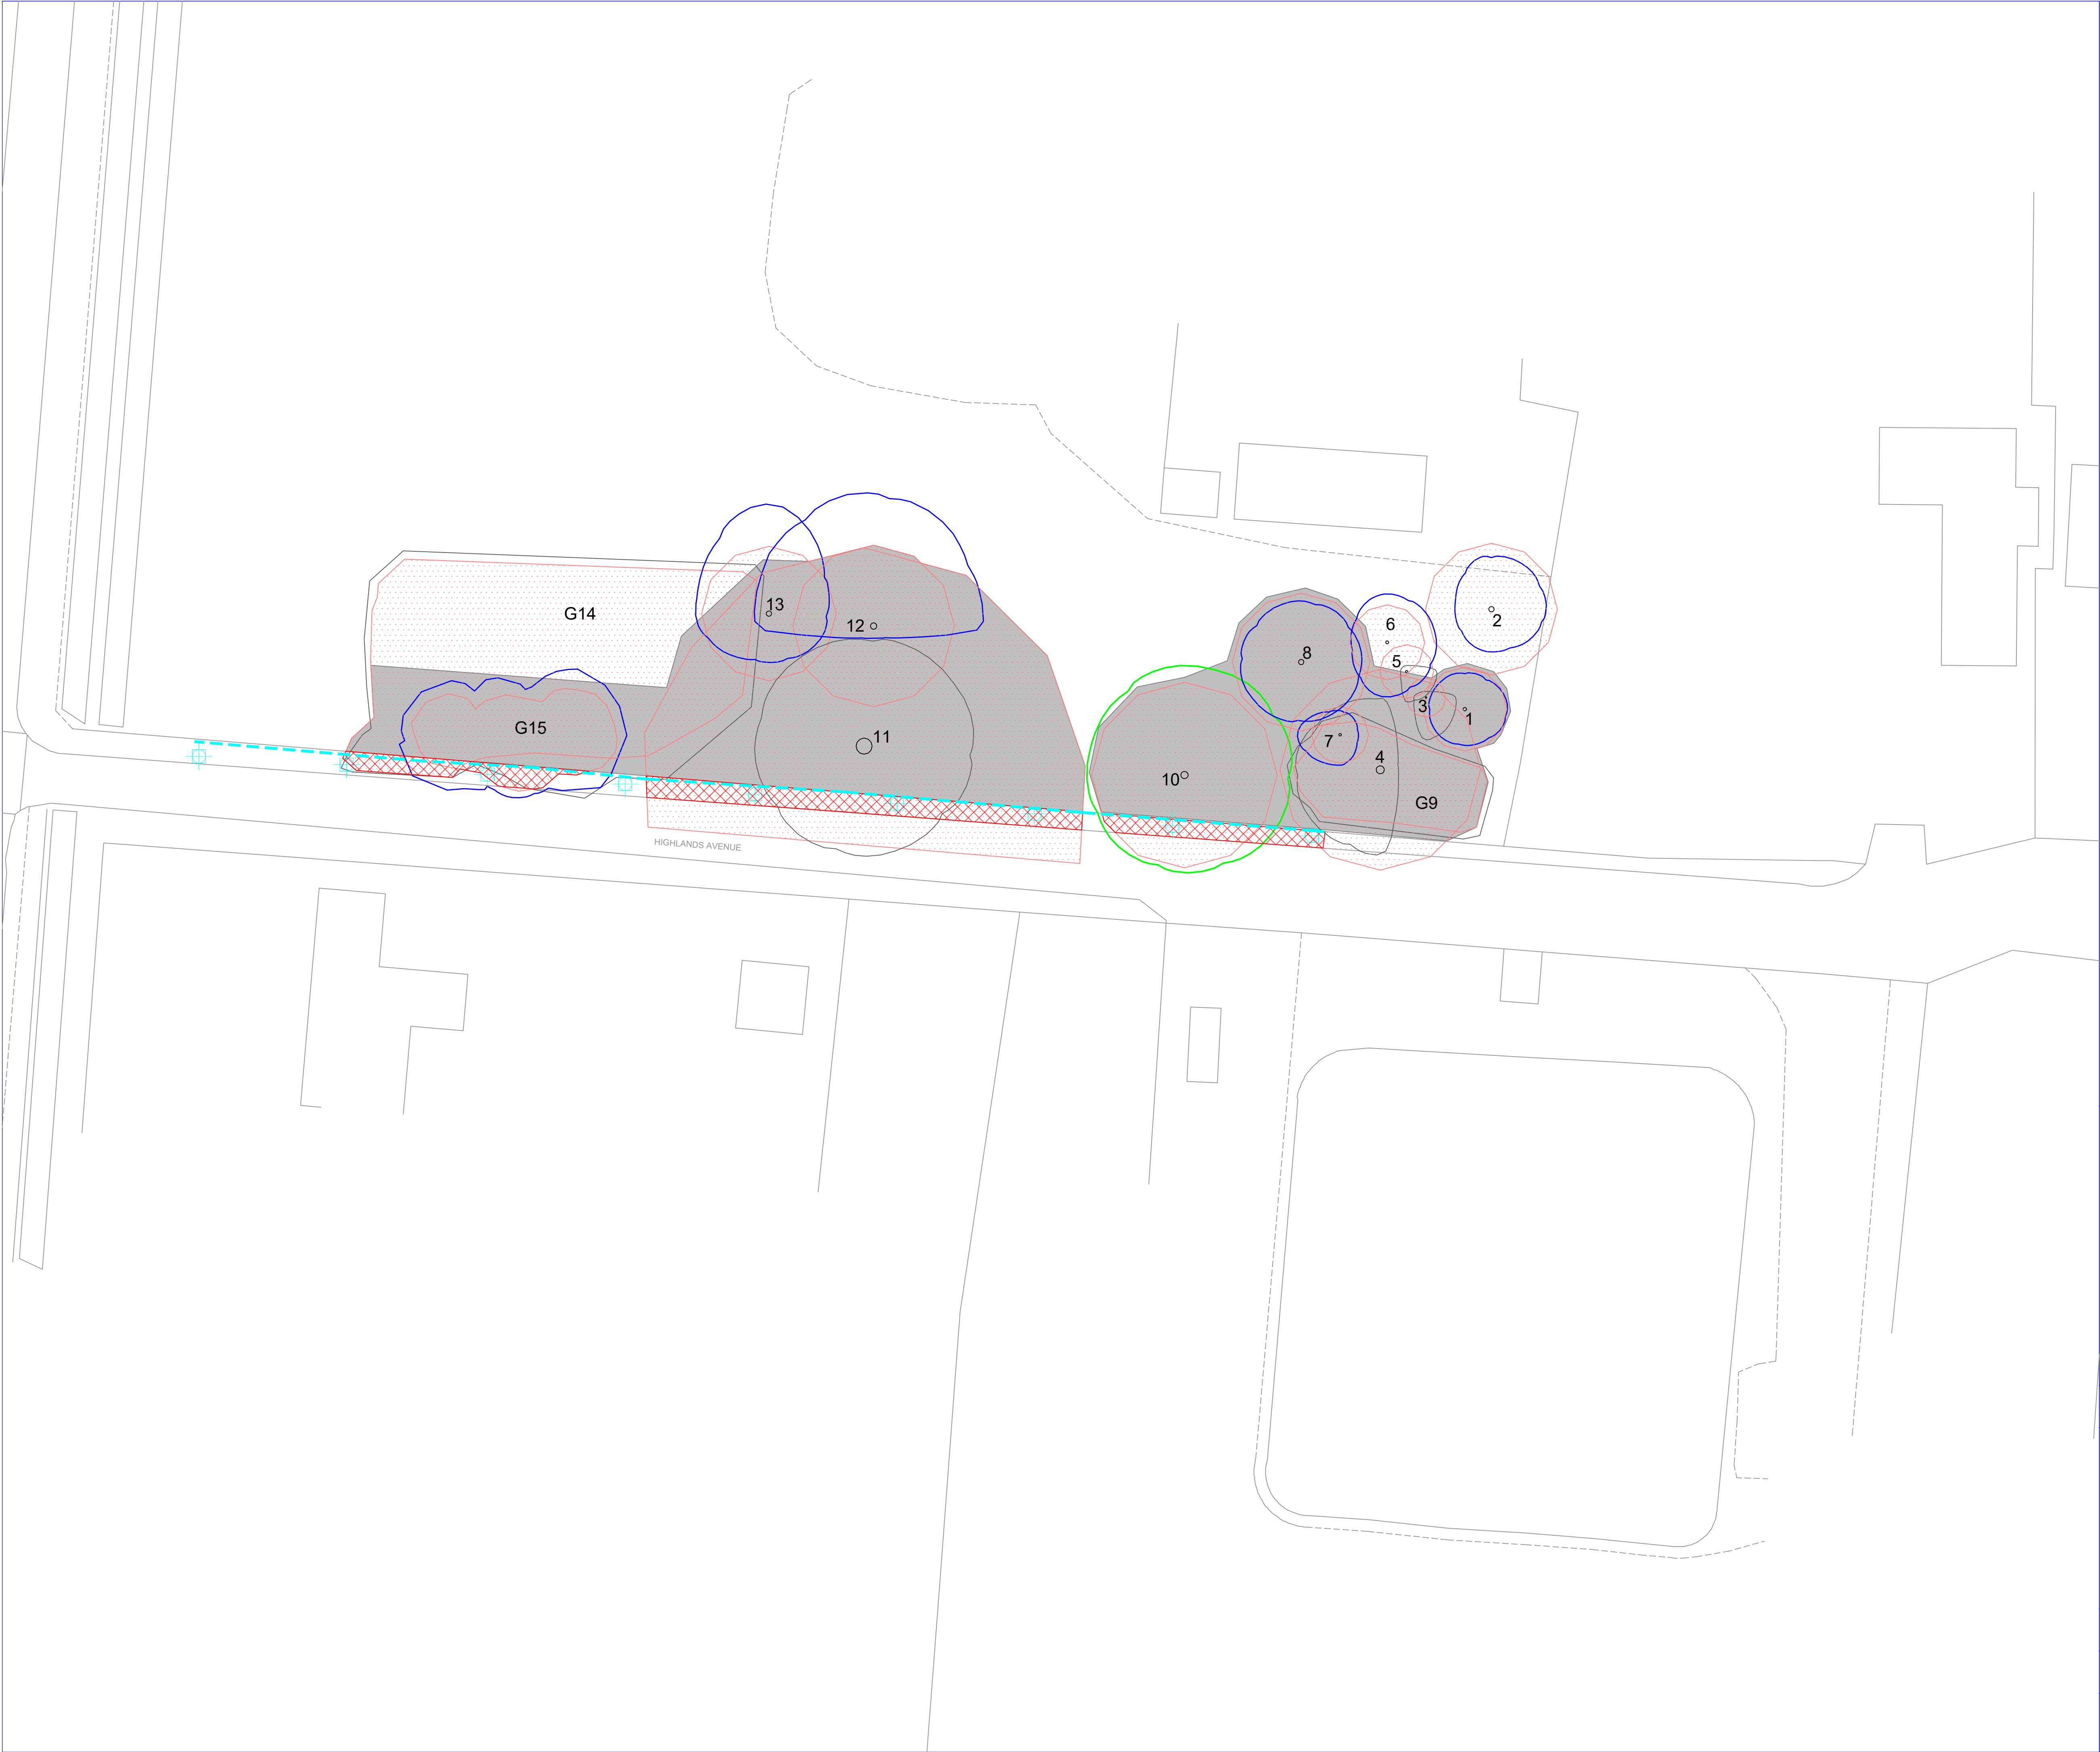
| Drg. No. | PB/TPP-24/08.22 | Rev. | |

- 5.2.1 The excavation work during the installation of the underground cabling and concrete pads within the RPA of the retained trees could not be verified at the site inspection on 14 March 2024, but it is probable in our opinion that there may have been minor RPA incursions of T4, T10, T11, G14 and G15 during the excavation and installation of underground cabling and lighting columns as shown on the tree protection plan ref. PB/TPP-24/08.22.

- It will first be necessary to relieve any soil compaction that may have occurred over the RPAs of T1, T4, T7, T8, G9, T10-T13, G14 & G15 as shown on tree protection plan ref PB/TPP-24/08.22 as 'Proposed soil amelioration' showing the minimum area, using a Terravent system, or the Vogt GeoTech Injector or a similar soil probe.

- The soil beneath the canopies of T1, T4, T7, T8, G9, T10-T13, G14 & G15 as shown on tree protection plan ref PB/TPP-24/08.22 as 'Proposed soil amelioration', showing the minimum area, must then be covered with a combination mulch of organic products including:

- 10.1 We recommend that tree protection measures and mitigation as set out on the tree protection plan ref PB/TPP-24/08.22 are implemented.
