**Document 11**  
**Arboricultural Impact Assessment**  
**Prepared by RSK**

**Proposed Redevelopment of  
existing Dobbies Garden Centre at  
Grovelands, Reading**

**Stage 1-3 Arboricultural Impact Assessment  
and Method Statement Report.**

**2482533**

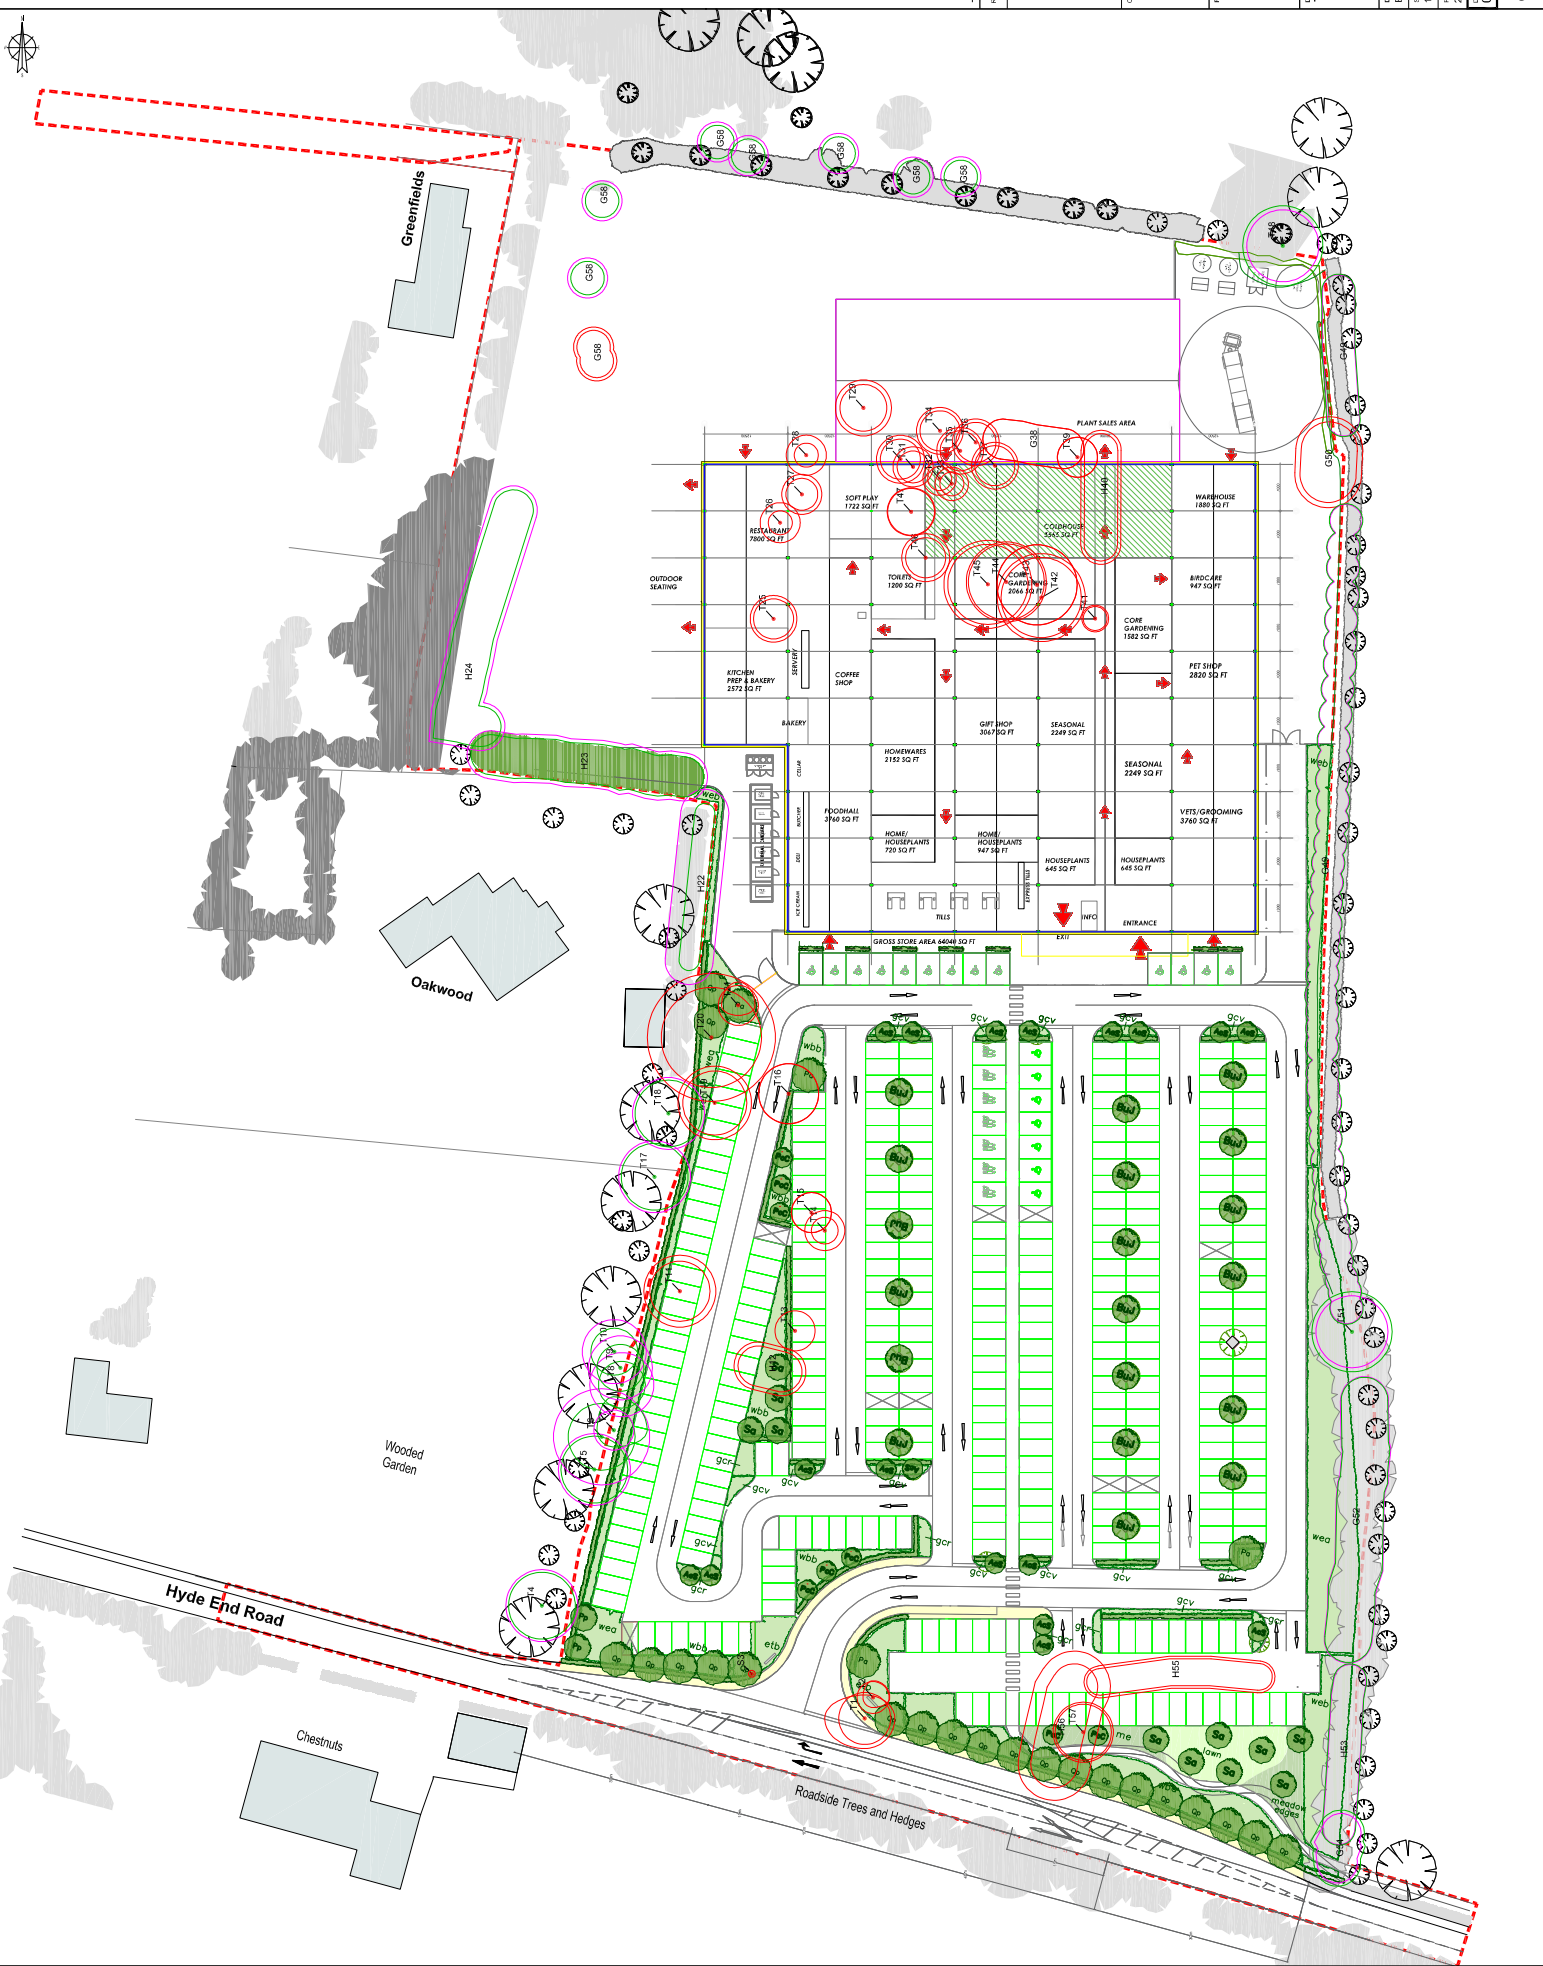
## **APPENDIX 4: FIGURE 2 TREE RETENTION REMOVAL PLAN**

The removal of T1 and T2 is required to facilitate construction of the new entrance into the site from Hyde End Road. T1 is situated within the proposed new highways footpath and whilst T2 is within an area to be landscaped post development levels changes and engineering works to form the new entrance would jeopardise its retention and as it is a low value category C specimen its removal and replacement is considered to be pragmatic.

It is noted that a significant quantity of new tree planting is indicated along the Hyde End Road frontage of the site and this will adequately mitigate the loss of these specimens.
