# L017 Arborfield Trunk Main

Tree Survey Report

Morrison Water Services

Project number: 60738809

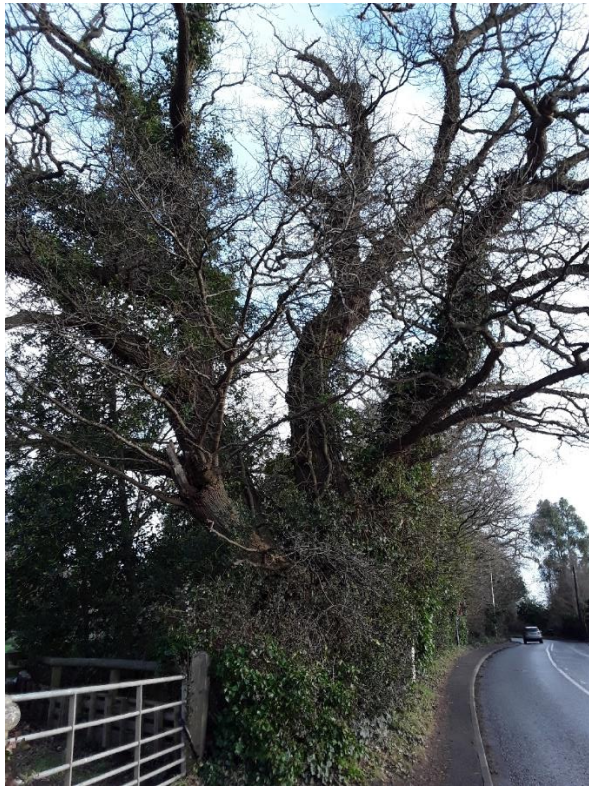
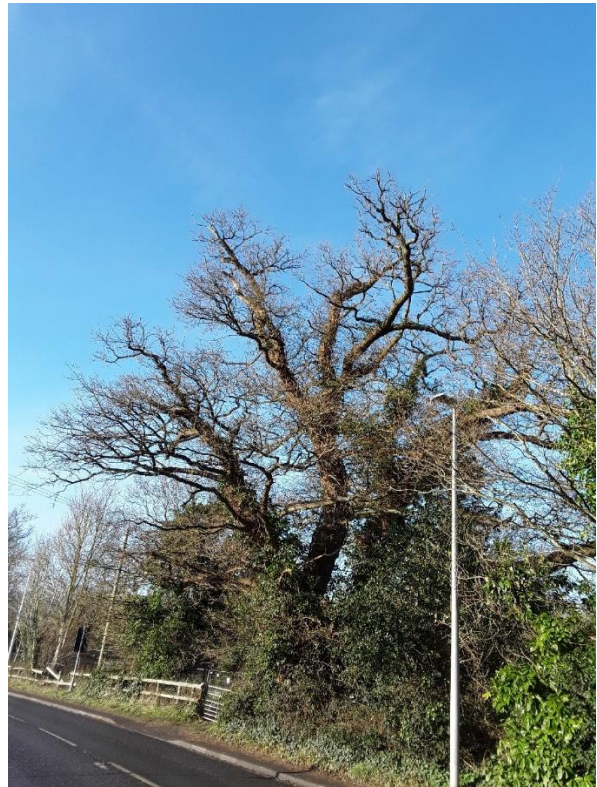
crown architecture and veteran features associated with the ancient life stage (crown retrenchment, extensive decay and previously failed major stems).

Figure 4: T102, identified as ancient.

Figure 5: T102, identified as ancient.

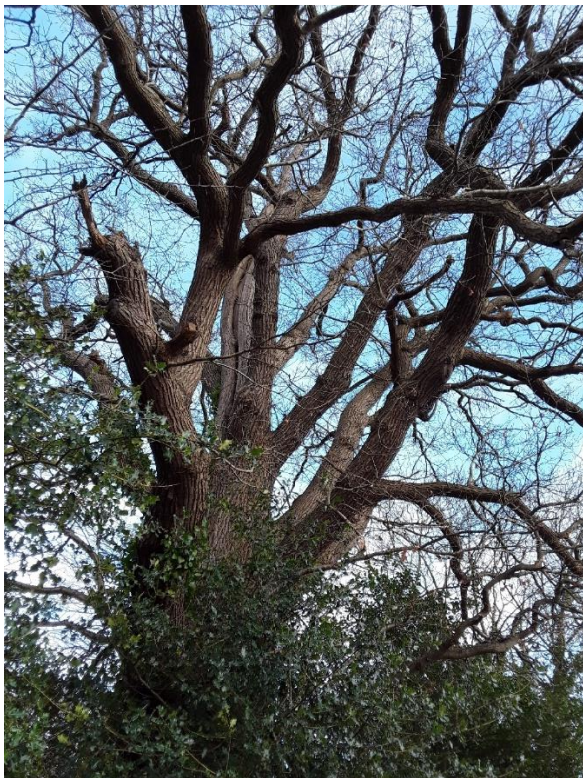
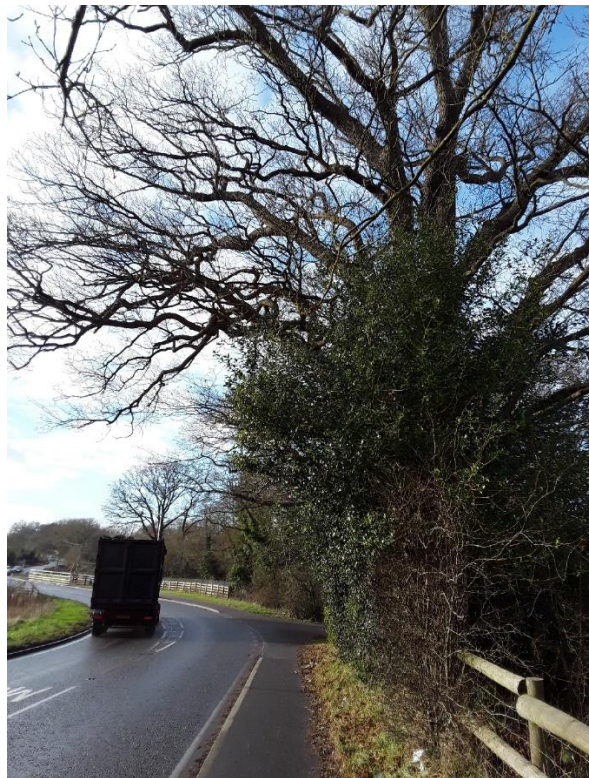
T109 was identified as veteran due to displaying discernible characteristics including stem decay, large sections of deadwood and previous large limb failures.

Figure 6: T109, identified as veteran.

Figure 7: T109, identified as veteran.

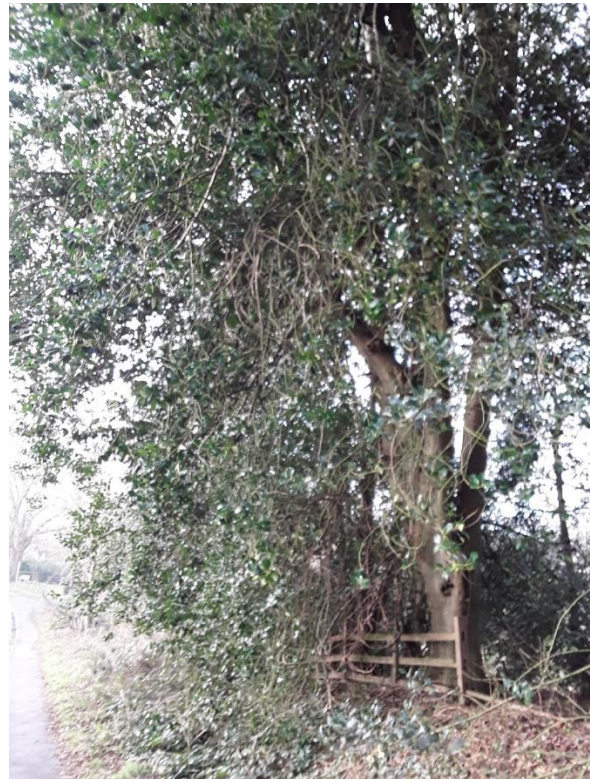
**Figure 9: T134, identified as ancient.**

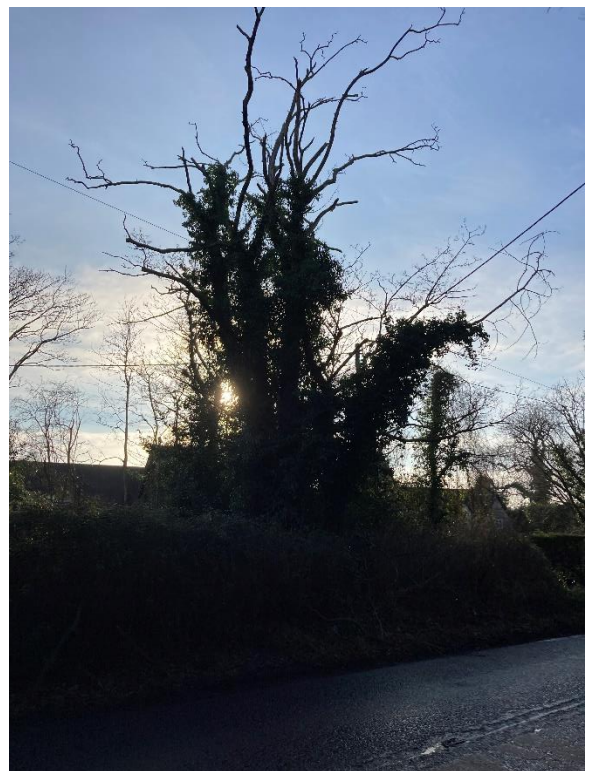
There were ten tree features (including seven individual trees T66, T68, T88, T92, T108, T222, T241 and three stumps) recorded as very low quality (Category U) and are considered unsuitable for long term retention. It is recommended that all preliminary tree work recommendations are undertaken within the recommended timescales which are detailed in the Tree Survey Schedule included as Appendix B of this report. Furthermore, T88 was anonymously reported to WBC on 17<sup>th</sup> January 2025 due to its poor condition, being considered highly likely to fail, and proximity to the highway.

**Figure 11: T88, Category U tree along southern edge of Barkham Road.**
