## Baseline Habitat Condition Assessment (BHCA)

205 Nine Mile Ride, Finchampstead, Wokingham RG40 3QB

25<sup>th</sup> February 2026

*The demolition of one existing dwelling and the construction of three houses.*

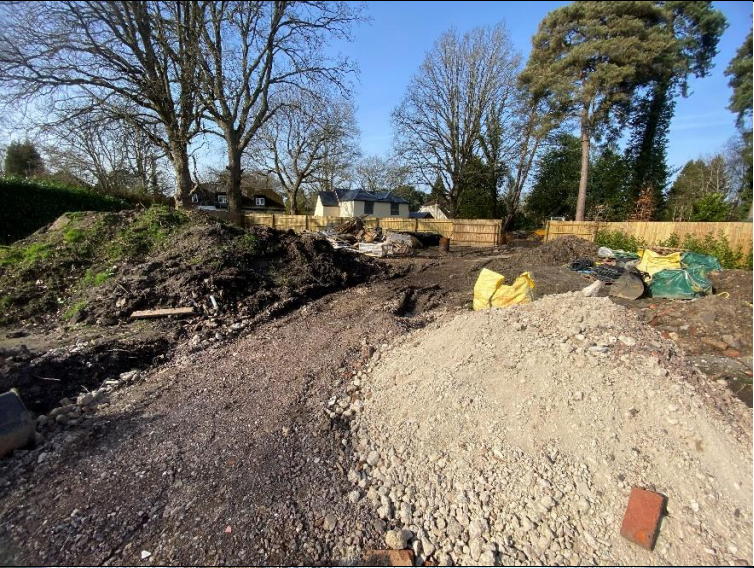
The dominant habitat on site is bare ground with ruderals. The bare ground habitat is a result of the commencement of development works on site. It includes rubble piles, soil piles, stacks of wooden pallets, and log piles. The following species were identified within the bramble scrub:

In accordance with the Statutory Biodiversity Metric Condition Assessment Matrix, the bare ground with ruderals habitat has been assessed as being in **poor** condition, as there is a limited number of plant species present, the vegetation cover is sparse, and the structure of the habitat is simple and lacks variation.

| Photo | Description |
|---|---|
| | <p>Photo 1: The bare ground with rubble and soil piles to the north of B1, facing northwest.</p> |

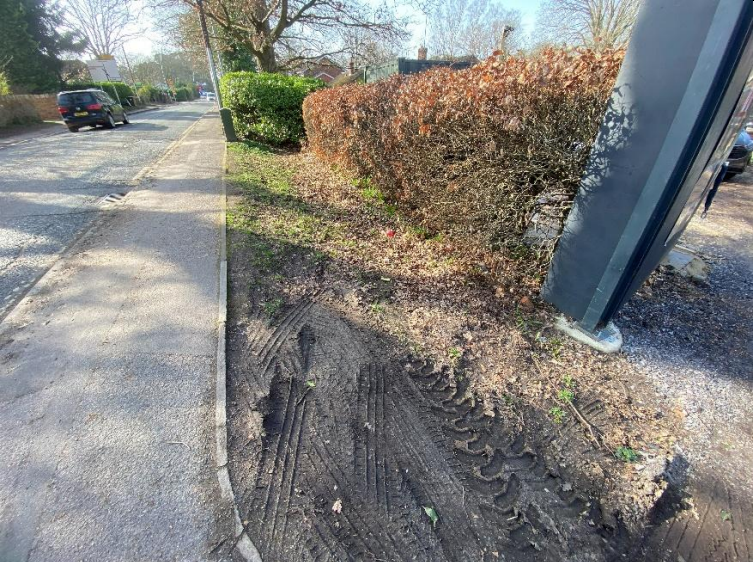
At the south of the site is a small parcel of vegetated garden. Physical damage is evident and present on more than 20% of the parcel as a result of the development works. Due to intensive management and physical damage the sward height is relatively short <3cm.

| Photo | Description |
|---|---|
| | <p>Photo 2: The small, damaged parcel of vegetated garden to the south of the site, facing west.</p> |

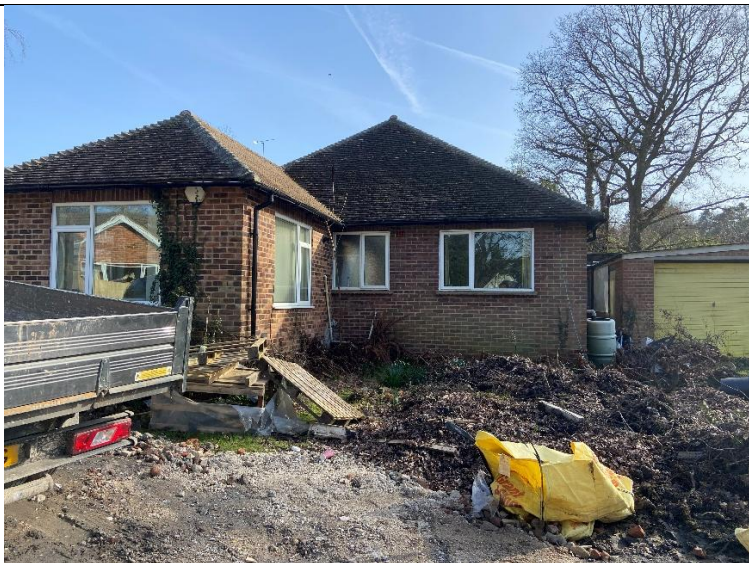
Photo 3: B1 in the centre of the site, facing south.

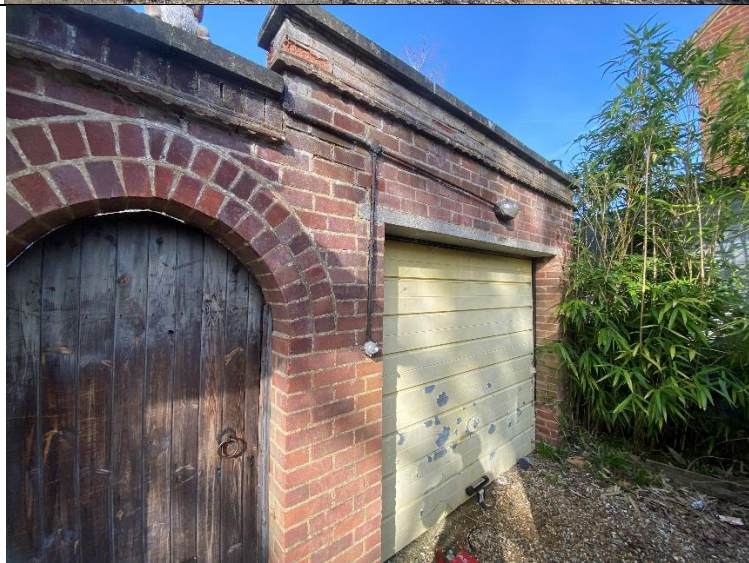
Photo 4: B2 to the east of B1, facing northeast.

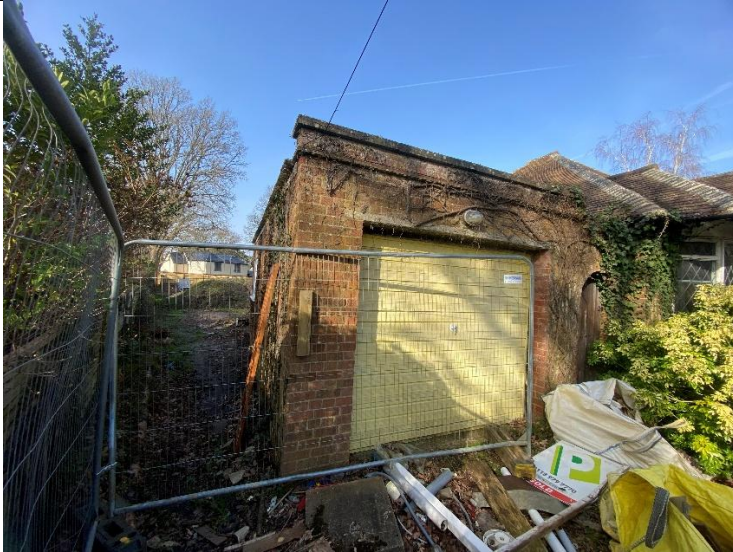
Photo 5: B3 to the west of B1, facing northeast.

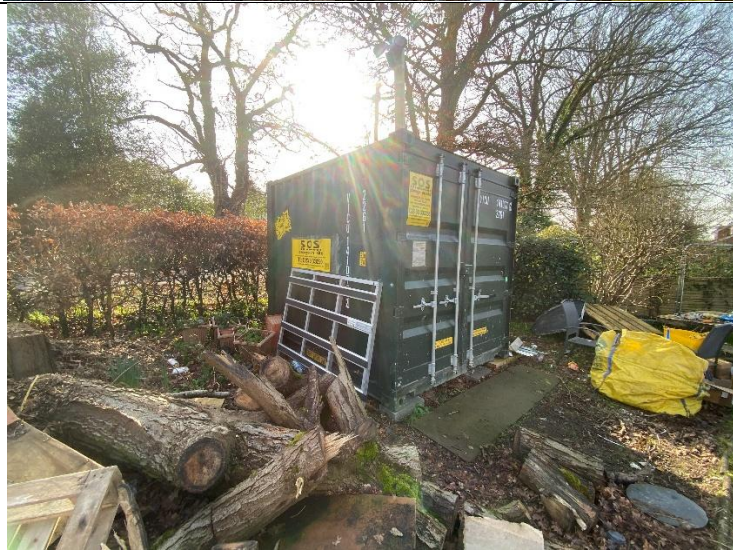
Photo 6: The small shipping container located on the bare ground at the south of the site, facing southwest.

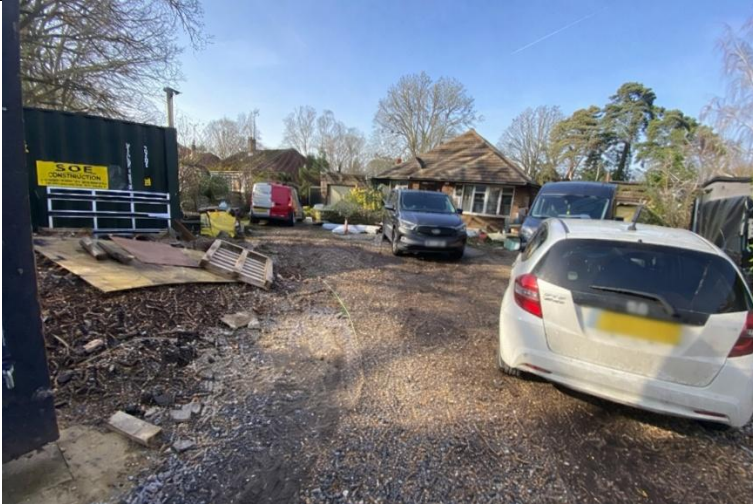
Photo 7: The gravel driveway at the south of the site, facing northwest.

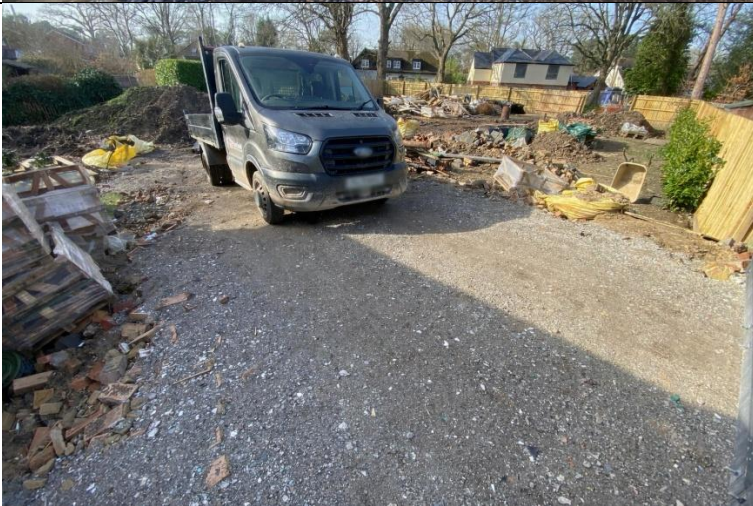
Photo 8: The crushed concrete access ramp at the east of the site, facing northwest.

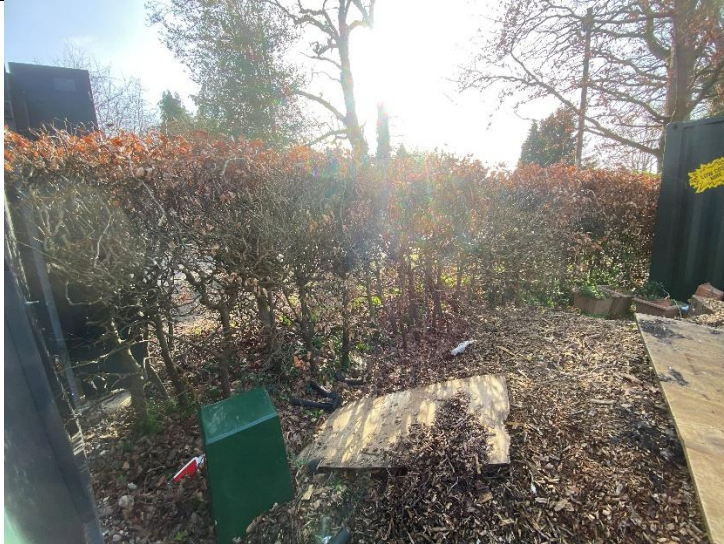
Photo 9: H1 located along the southern site boundary of the site, facing southwest.

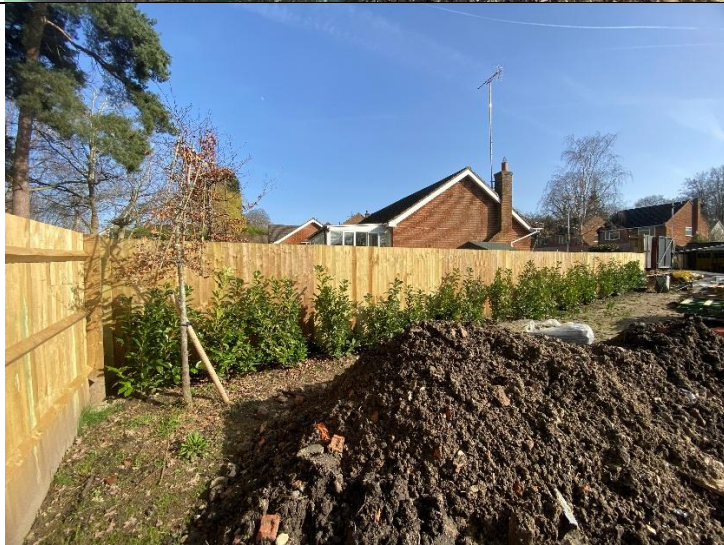
Photo 10: H2 located along the northeastern site boundary of the site, facing east.

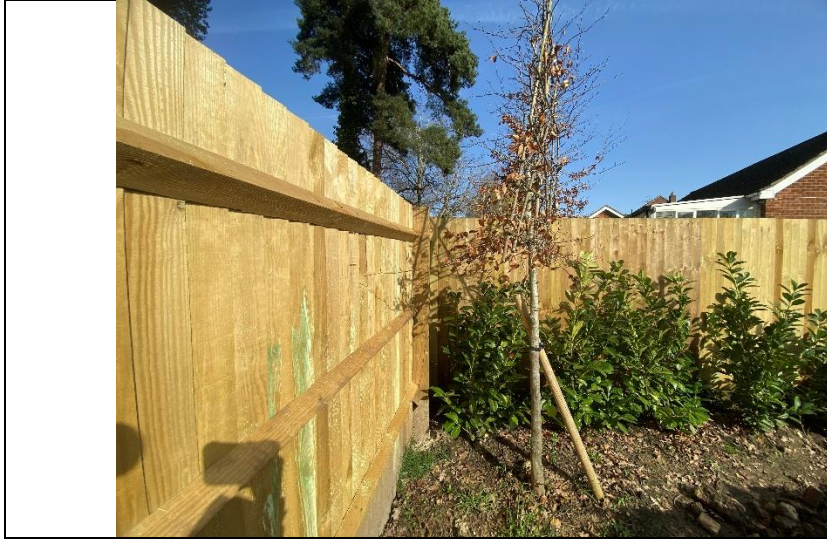
Photo 11: T1 located in the northeastern corner of the site, facing east.

| Condition Assessment Criteria – Scattered trees - T1 | | | Criterion passed (Yes or No) | Notes/Justification |
|---|---|---|---|---|
| D | There is little or no evidence of an adverse impact on tree health by anthropogenic activities such as vandalism or herbicide use. There is no current regular pruning regime, so the trees retain >75% of expected canopy for their age range and height. | | No | Evidence of anthropogenic activities identified: a bamboo trellis has been placed within the canopy of T1. |
