Ref: LAS\_746  
Date: 05.06.24

**Site: Land adjacent to Warren Lodge Care Home, Finchampstead**

## **Arboricultural Statement**

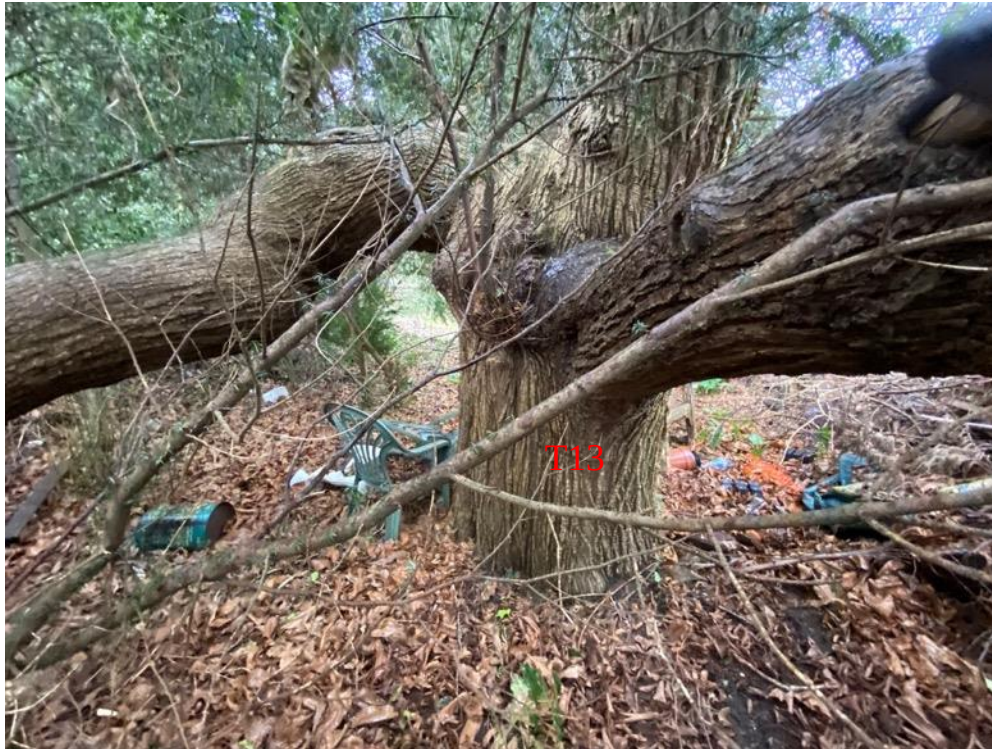
- 3.11 During the survey it was clear T13 (Sweet Chestnut) had veteran tree characteristic (i.e. splits, crack, hollows, past limb loss and crown retrenchment). However, the two lime trees (T1 and T14) appear to be large mature trees and lack the clear veteran characteristics that T13 have. In addition, the stem sizes of T1 and T14 in terms of girth are lower than what Wokingham Veteran Tree Association suggest veteran trees should have as a minimum.

| Ref no. | Species | Ht. (m) | Stem | | RPA radius | RPA area | Category Grading | Crown Spread (m) | | | | | | | | Life stage | ULE | Physiological Condition | Structural Condition | General Observations and Notes |
|---|---|---|---|---|---|---|---|---|---|---|---|---|---|---|---|---|---|---|---|---|
| T13 | Sweet chestnut | 11.0 | 1 | 1150 | 13.8 | 598 | B3 | 4.0 | 2.0 | 5.5 | 7.0 | N/A | - | N/A | 1.0 | V | 10+ | Fair | Poor | Northern limb large cavity on top side by union with decay, limb is hollow. North limb touches floor and appears to be left as deadwood. South limb kinks west and then upright forming canopy away from main stem. Main stem has limited remaining canopy with past branch loss and poor form. Woodpecker holes suggest stem is hollow. Has veteran characteristics. |

Photo 1: View looking west at the stem of T13 which has veteran characteristics.

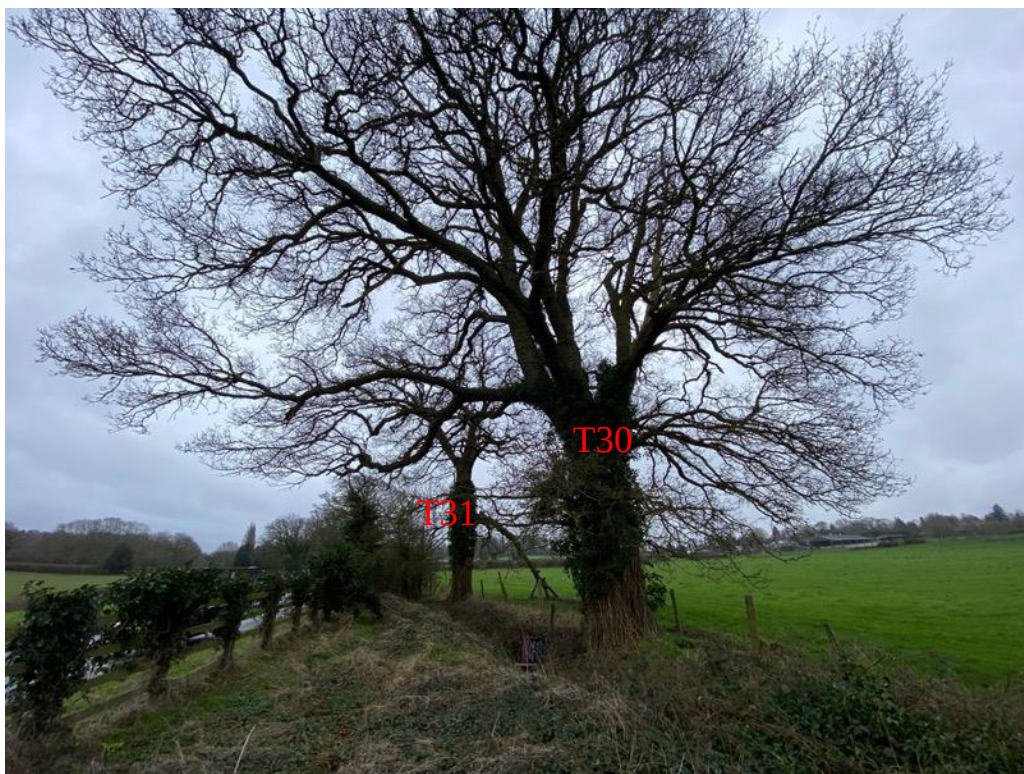
- 3.12 During the survey a large oak tree was inspected (T30) at the south of the site. It has a very large stem size, above the minimum expected of a veteran tree. It is considered that T30 is a potential future veteran tree.

| Ref no. | Species | Ht. (m) | Stem | | RPA radius | RPA area | Category Grading | Crown Spread (m) | | | | | | | | Life stage | ULE | Physiological Condition | Structural Condition | General Observations and Notes |
|---|---|---|---|---|---|---|---|---|---|---|---|---|---|---|---|---|---|---|---|---|
| T30 | Oak | 19.0 | 1 | 1380 | 15.0 | 707 | A3 | 9.0 | 10.0 | 9.0 | 6.0 | N/A | - | N/A | 2.0 | M | 40+ | Good | Fair | Large oak, large dead limb north west side, large wound on stem north side with exposed heartwood with some decay partially occluded, minor moderate crown deadwood, ivy on stem. Potential future veteran. |

Photo 2: View looking south at T30.

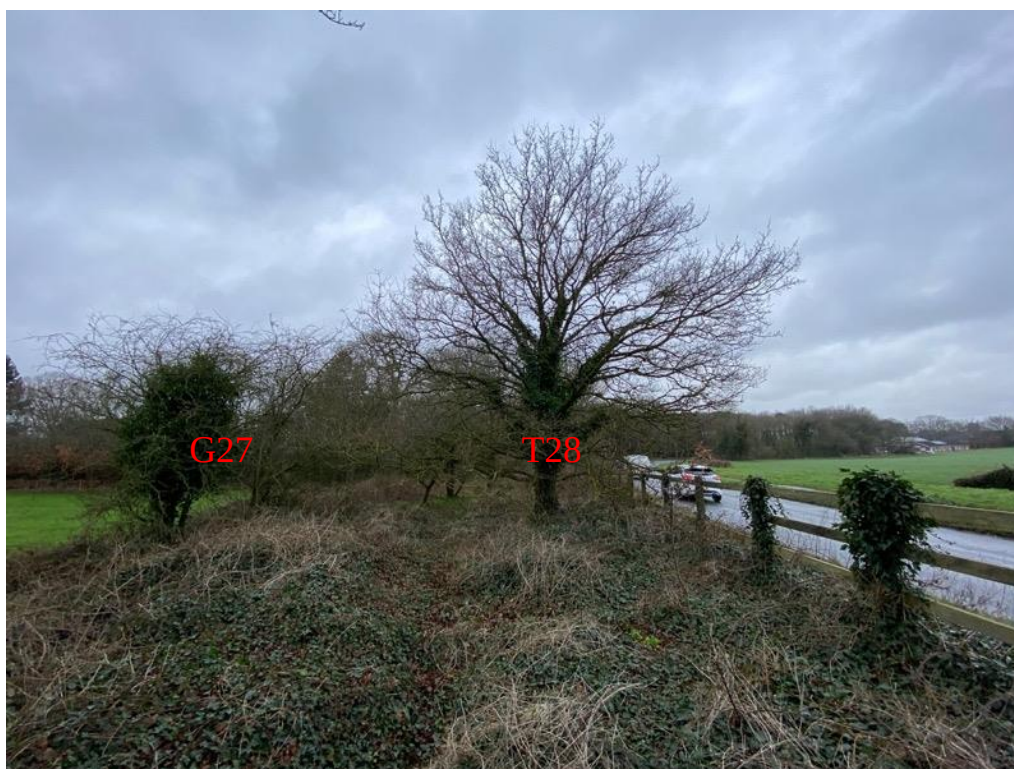
| Ref no. | Species | Ht. (m) | Stem | | RPA radius | RPA area | Category Grading | Crown Spread (m) | | | | | | | | Life stage | ULE | Physiological Condition | Structural Condition | General Observations and Notes |
|---|---|---|---|---|---|---|---|---|---|---|---|---|---|---|---|---|---|---|---|---|
| T28 | Oak | 10.0 | 1 | 520 | 6.2 | 122 | B1 | 5.0 | 4.5 | 4.0 | 5.0 | N/A | - | N/A | 1.0 | EM | 20+ | Fair | Fair | Squat shape, ivy on stem, dense crown structure. Small area of black staining on stem north side typical of canker. |

Photo 3: View looking north at T28.

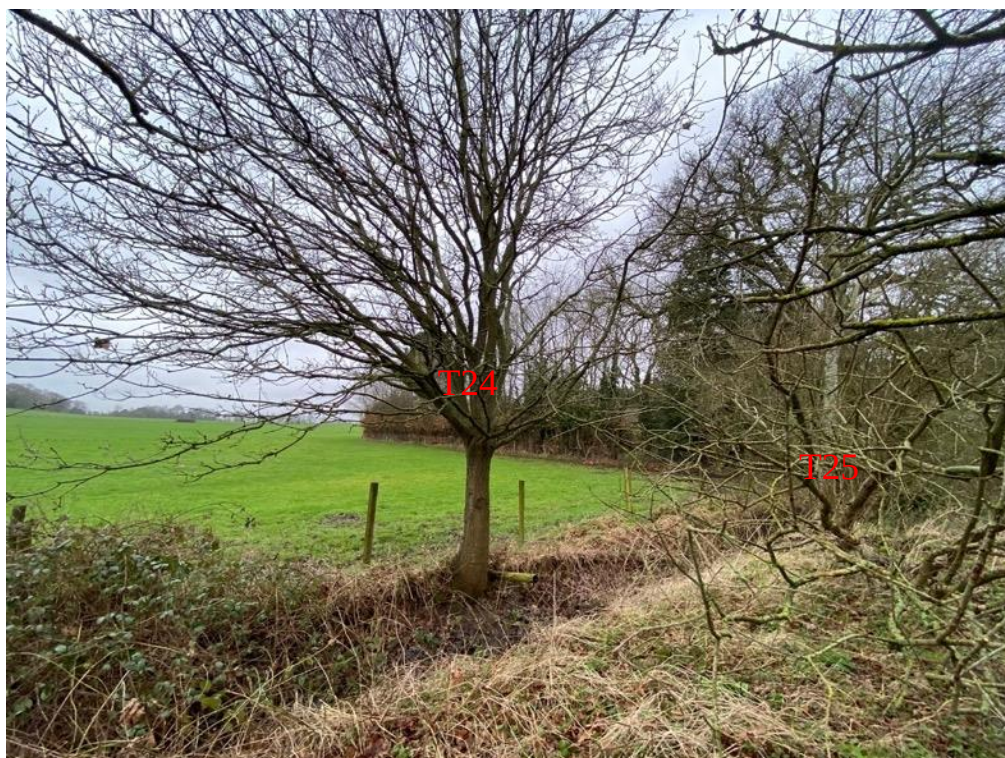
Photo 4: View looking west at T24.

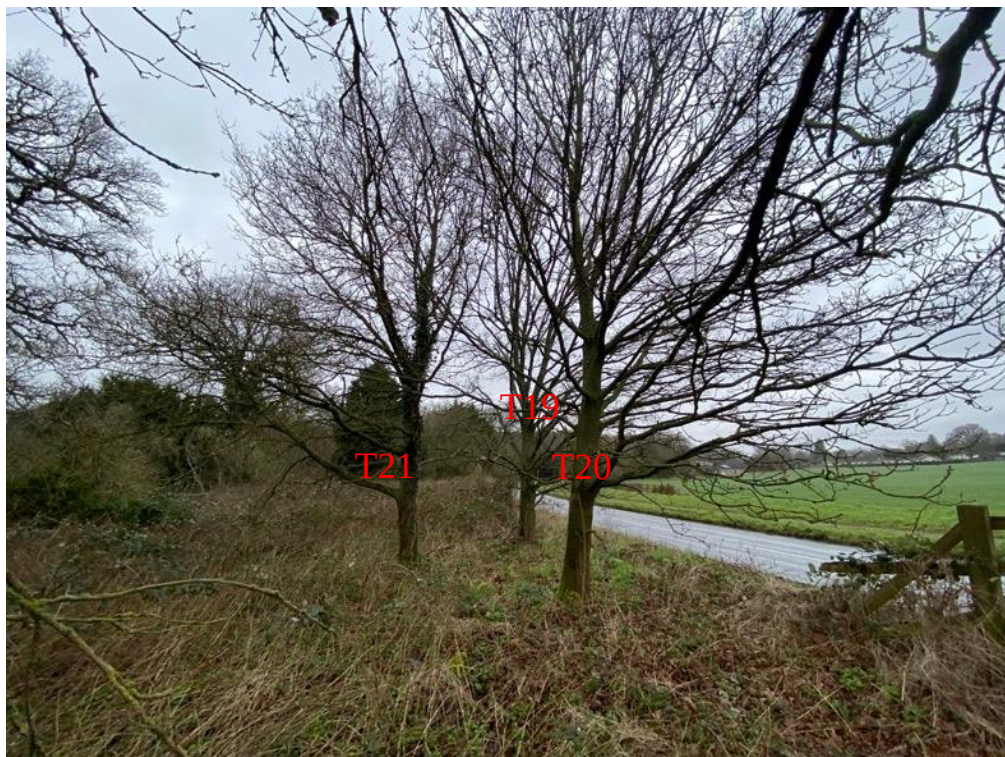
Photo 5: View looking north at T19-T21.

- 5.2 Proposals will require the removal of twelve survey items, namely T17, T18, T19, T20, T21, T25, T26, G27, T32, T33, G34 and T35.
- 5.3 The majority of survey items to be removed are assessed as Category C or U, therefore should not be viewed as a constraint to development. T19, T20 and T21 are assessed as Category B with their value being as a group. However, all are on the young side of the age spectrum and could be replaced within the short to medium term.
- 5.4 Overall, from a tree retention/loss perspective proposals would retain all the larger mature trees of moderate and higher quality, including all TPO trees.

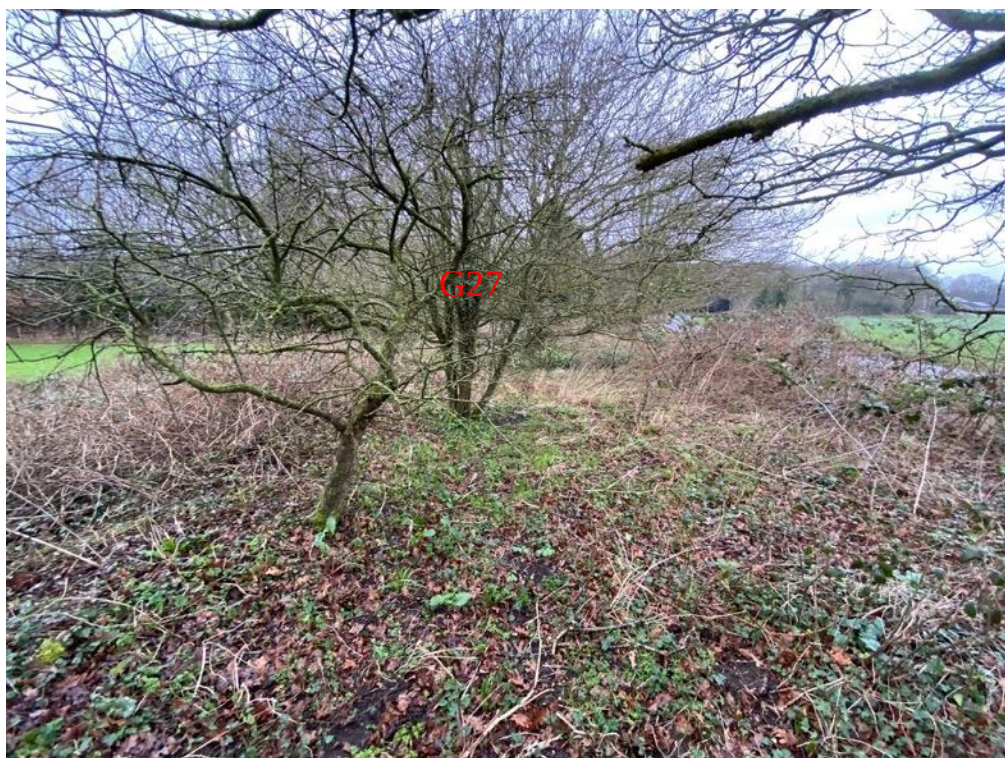
Photo 6: View looking north at G27.

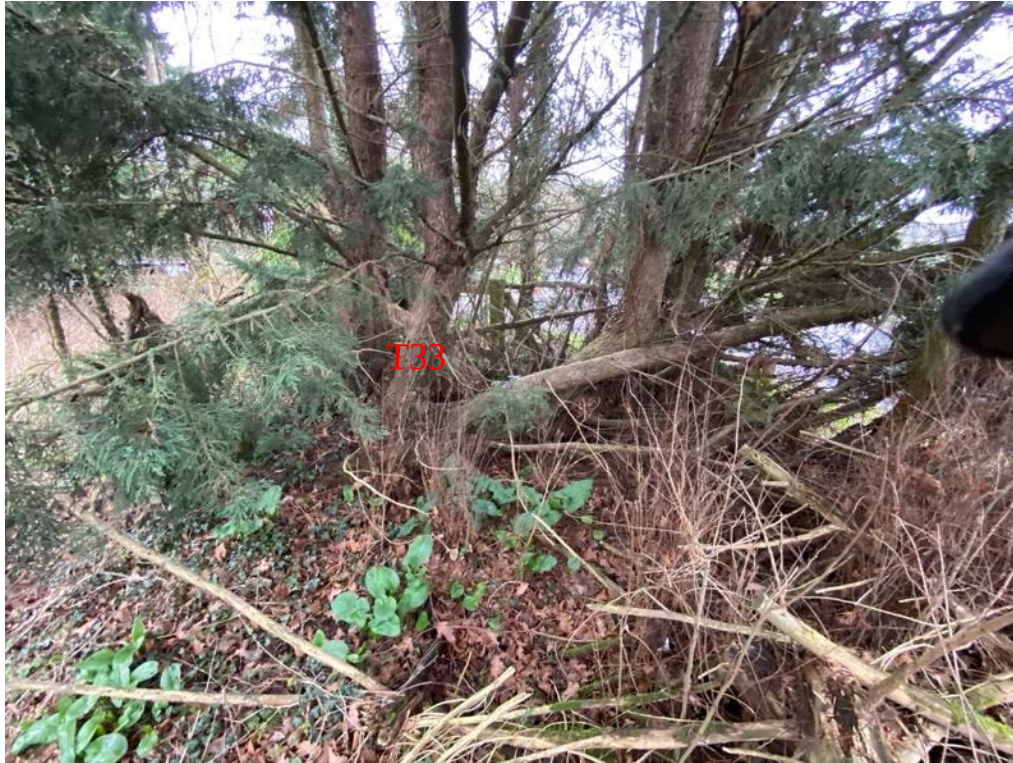
- 2.7 On the northern boundary of the site is a large multi-stemmed cypress (T35) which has had some branch failures. Next to T35 is a small oak (T36) which is in poor condition.
- 2.8 To the north east corner is a group of dead elm (G34) that need removing as they are by the highway. To the south east of G34 is a cypress tree (T33) that has previously failed/blown over and been pruned back to the site boundary from the highway. The branches of T33 have then grown upright from the failed stem to form the canopy/tree.

Photo 8: View looking north at T33

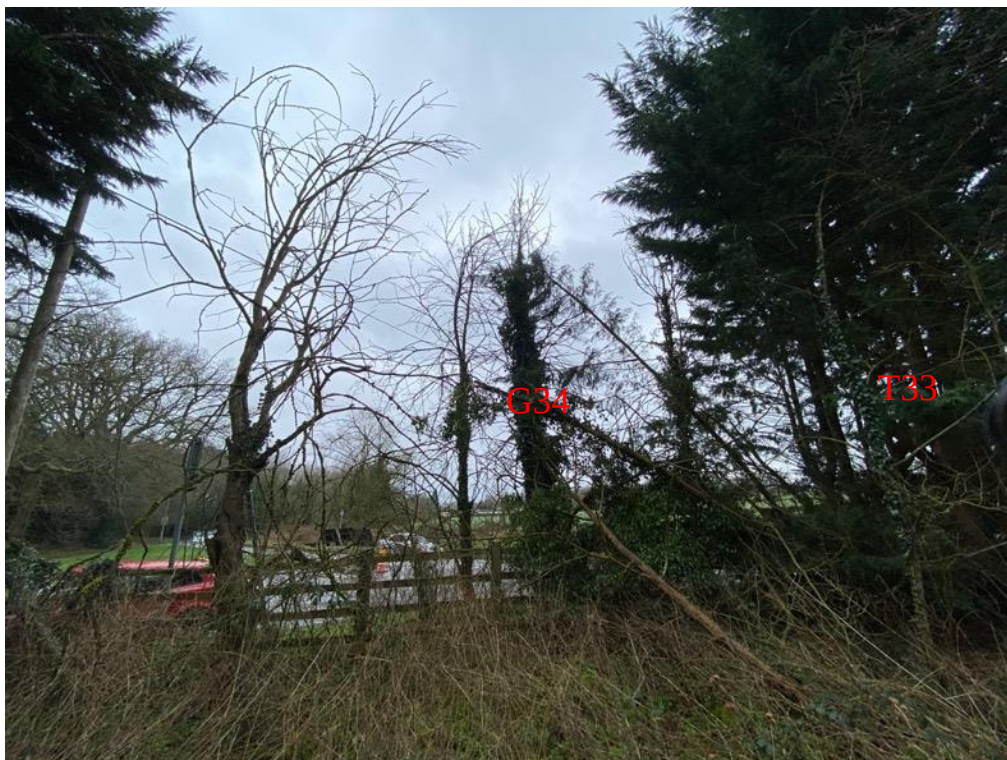
Photo 9: View looking north at G34.

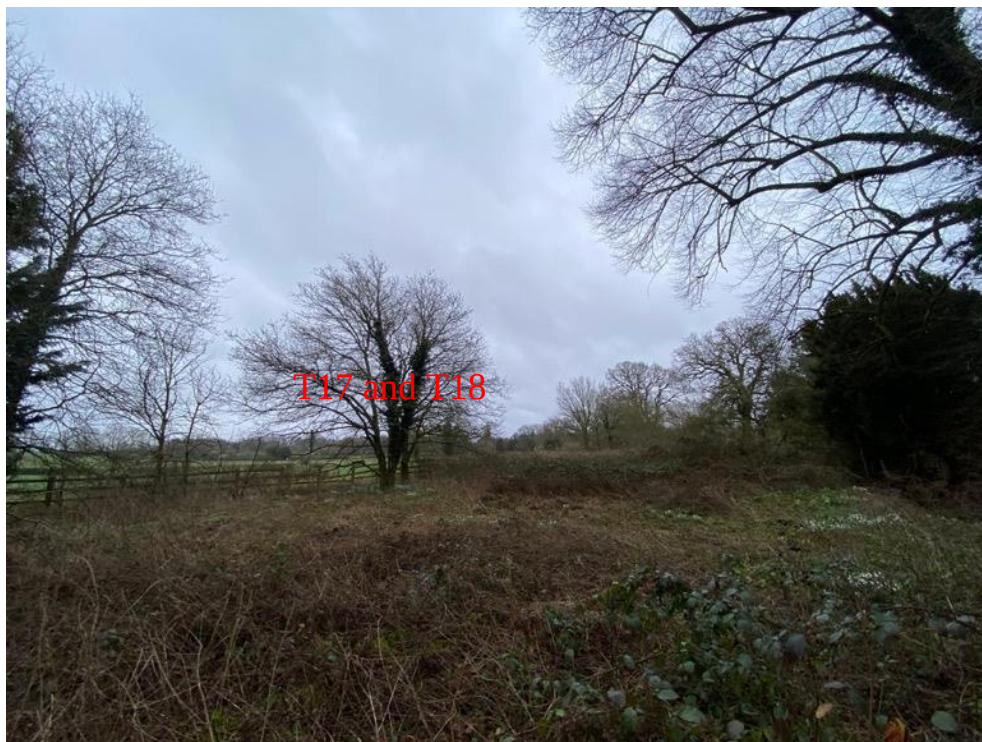
Photo 10: View looking south-east at T17/T18.

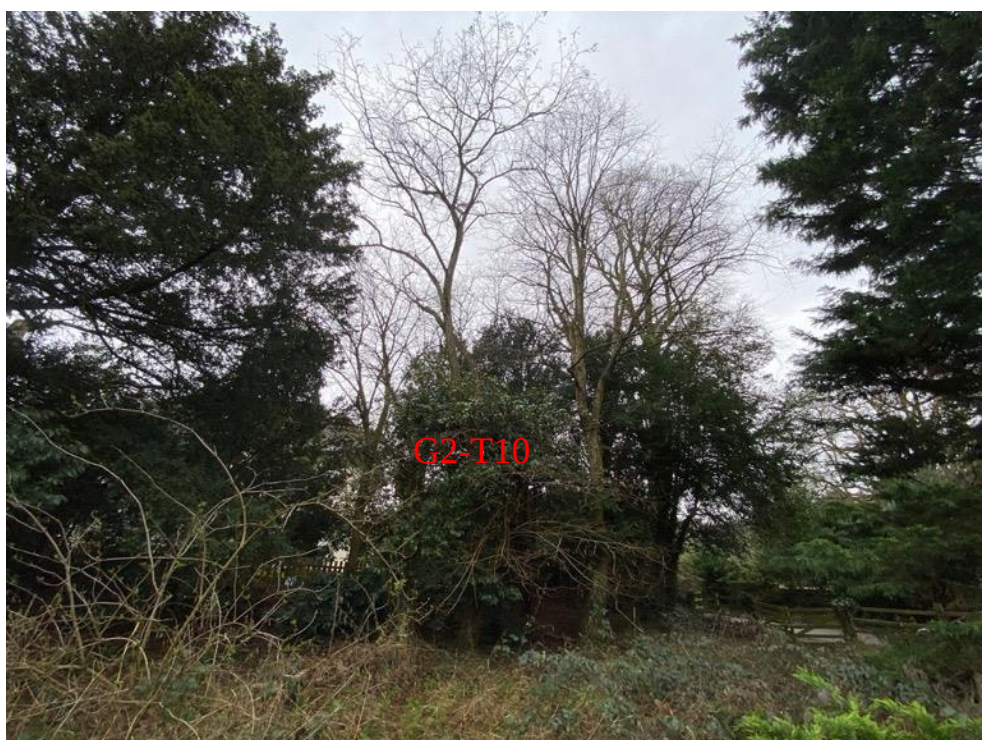
Photo 11: View looking north-west at G2-T10.

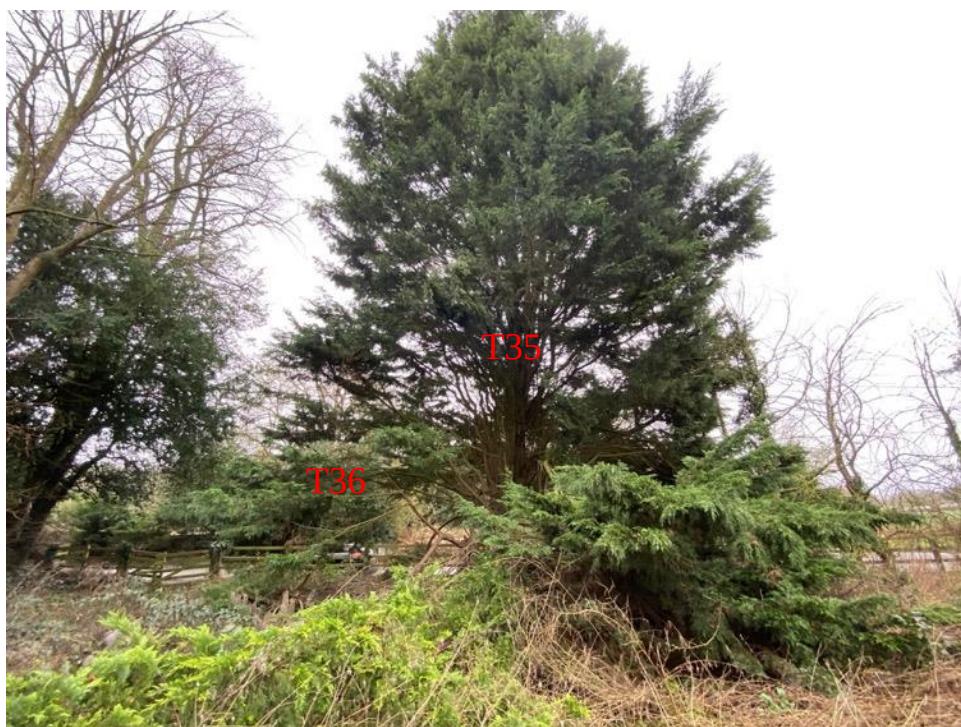
Photo 12: View looking north at T36.

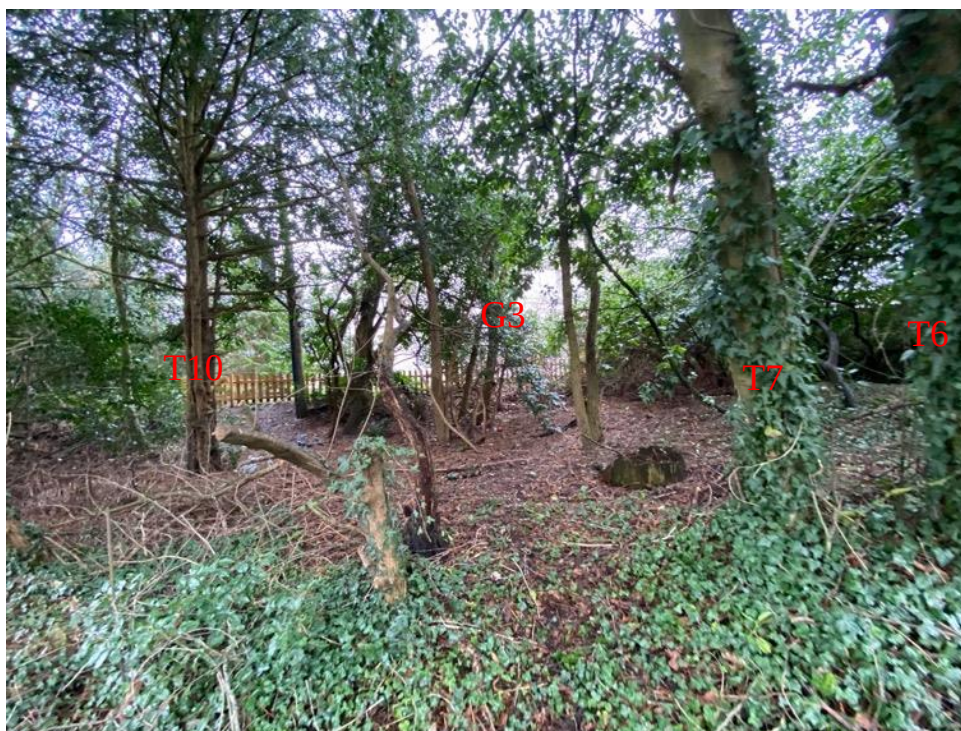
Photo 13: View looking west at G3

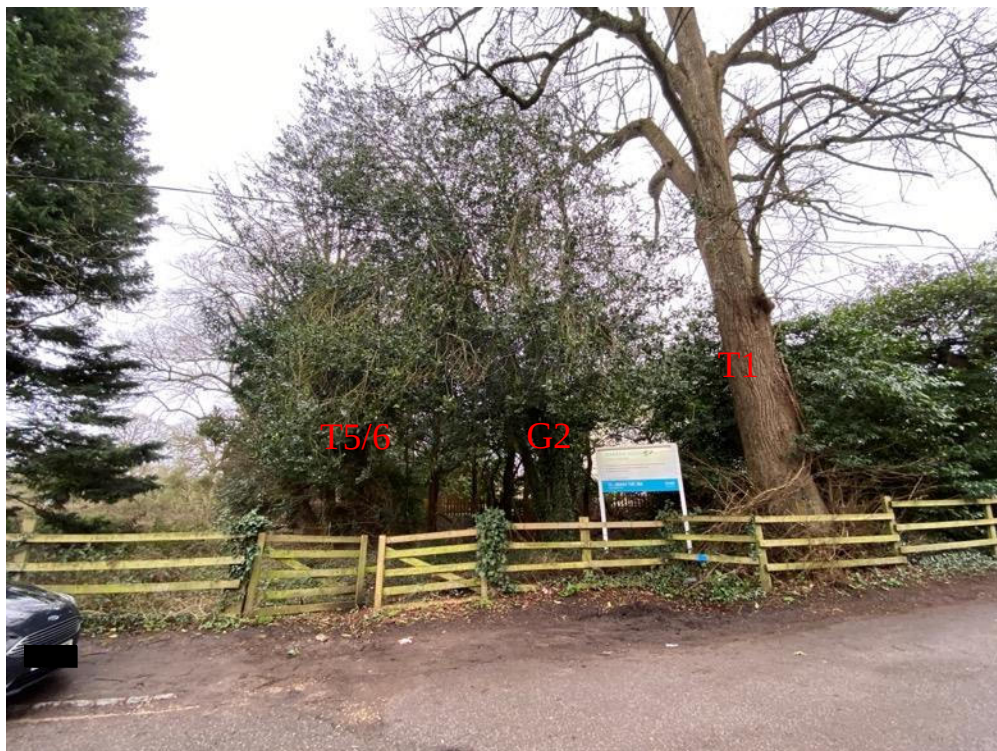
- 5.17 However, the two lime trees (T1 and T14) that are also identified on the Wokingham Veteran Association Maps, appear to be large mature trees and lack the clear veteran characteristics that T13 have. In addition, the stem sizes of T1 and T14 in terms of girth are smaller than what Wokingham Veteran Tree Association suggest veteran trees should have as a minimum. As such, T1 and T14 are not considered to be veteran trees. However, veteran buffers are graphically shown to illustrate what it would look like. As can be seen on the TPP, the location of the caravan and touring van pitches avoid veteran buffers. The existing site access and proposed drive using the existing access is within the veteran buffer of T1, but this is unavoidable as this is where the existing access is located. If the access is upgraded to a gravel surface using a no dig methodology, no significant impacts are envisaged to T1.

Photo 14: View looking south at T1.

- 6.8 In relation to T1 and T22, new gravel surfacing is to be installed using the following method:

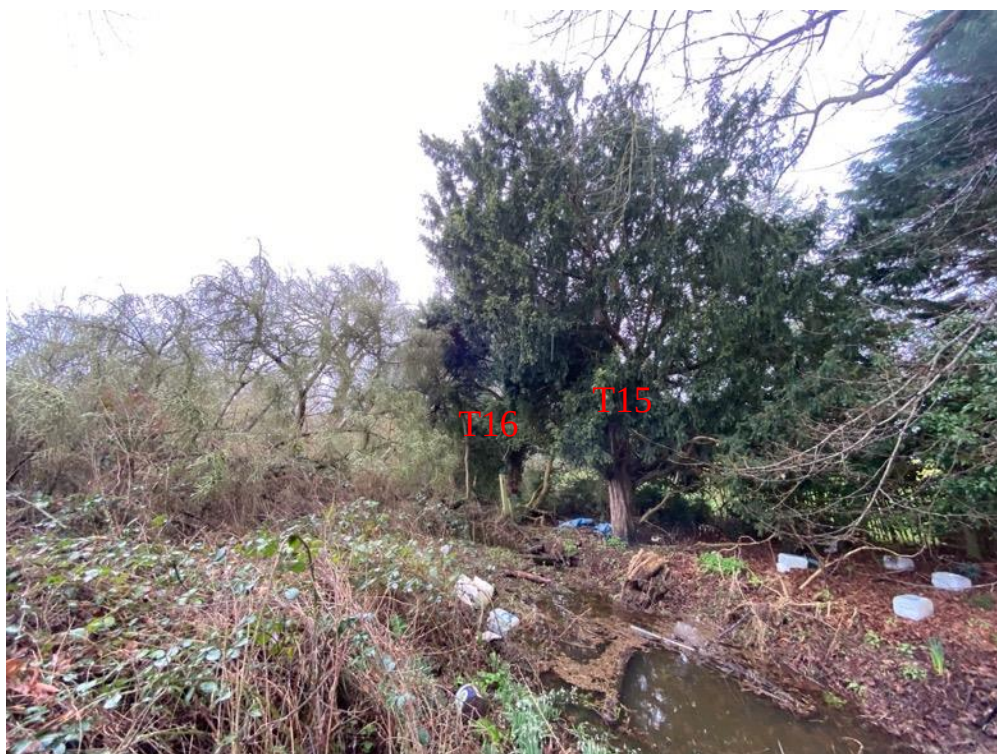
Photo 15: View looking south at T15 / T16.

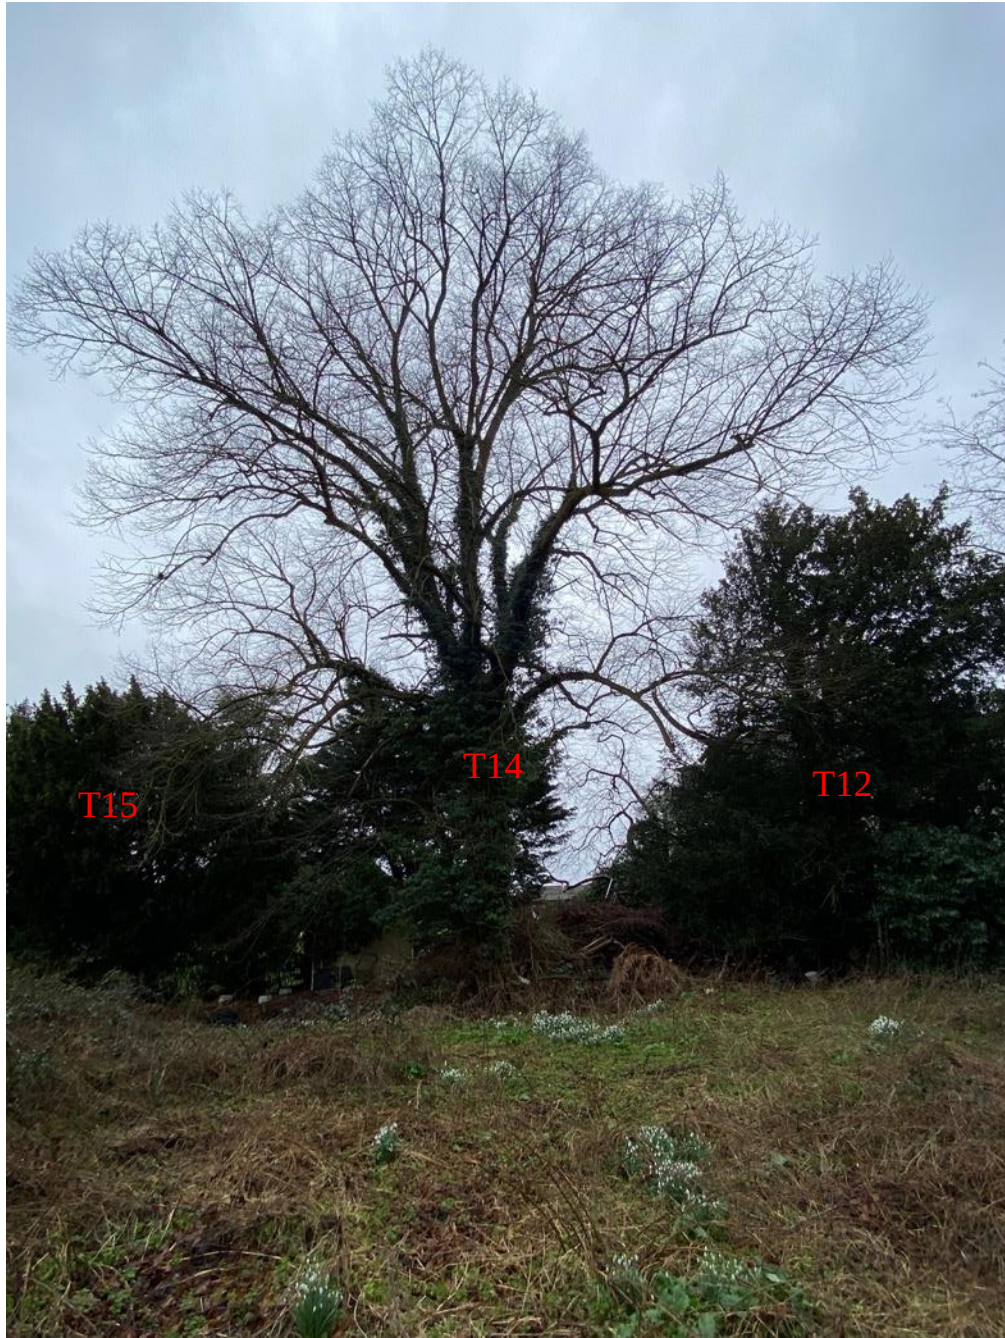
Photo 16: View looking west at T14.
