# BS5837 Arboricultural Impact Assessment & Method Statement

Sonning House, Pearson Road, Sonning, Wokingham, RG4 6UL

Client: Woldon Architects

Job Reference: 03925Rv3

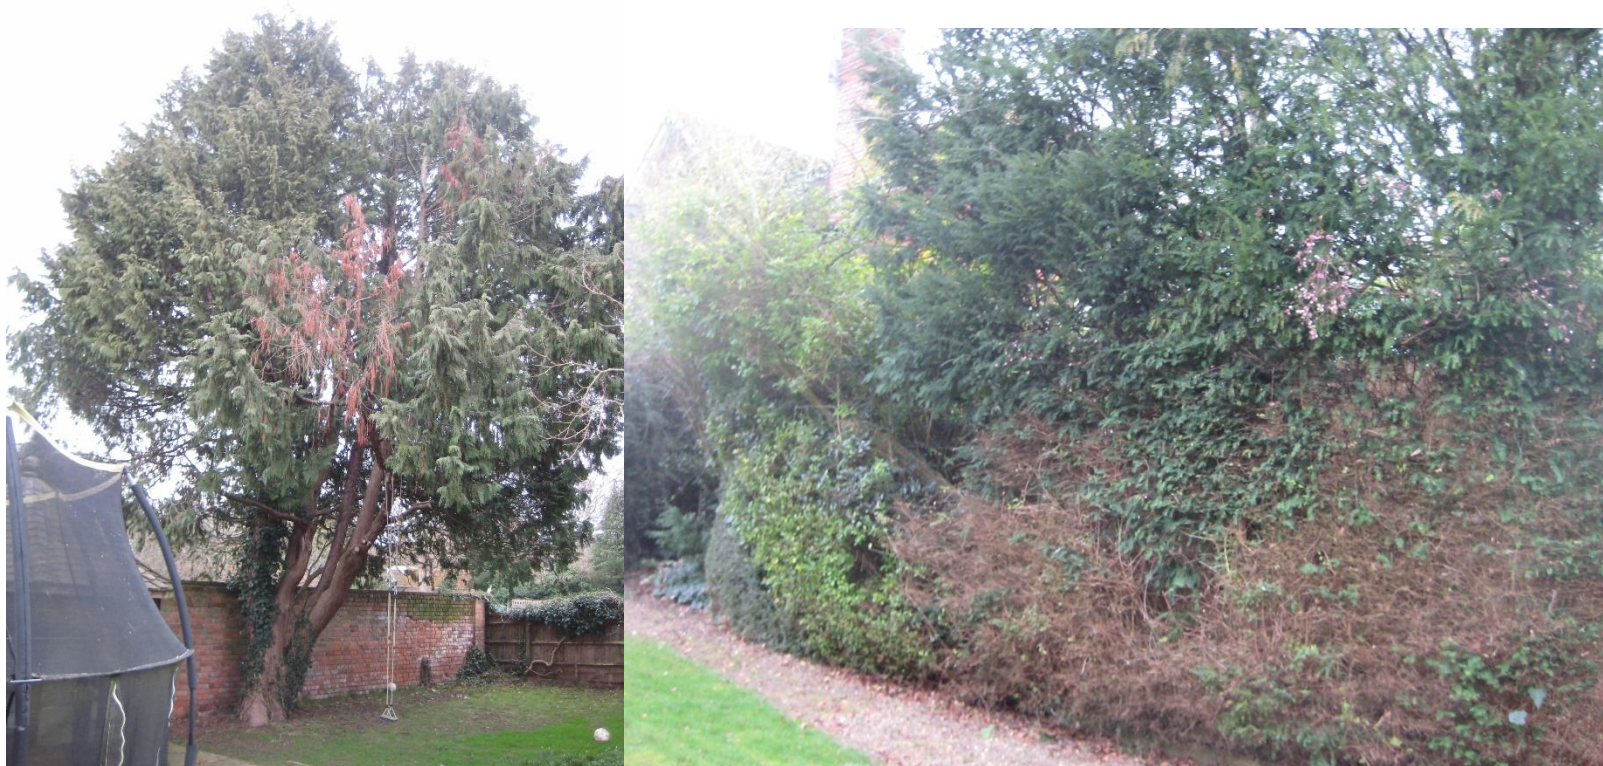
- 5.3.1 The proposal requires the following works. Please note we are advised that T2 (Yew) has been removed since our original survey. The largest tree shown for removal is T8 (Cypress). This tree has a number of weak basal stem unions and an area of existing canopy die back:

**Fig 7 – T8 (left) with dieback evident. SG1 (right).**

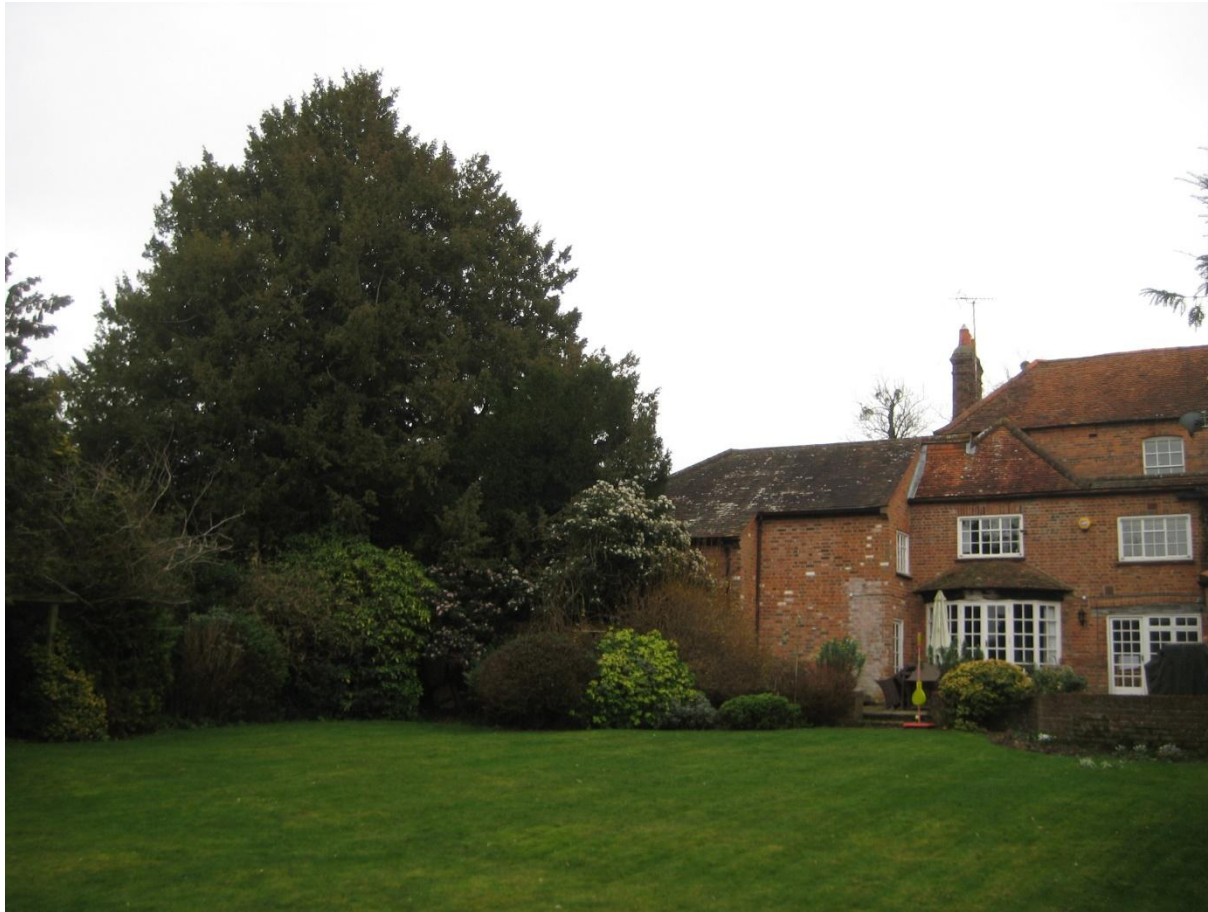
**Image 1** – looking towards T3 and SG2 and the rear of the main property.

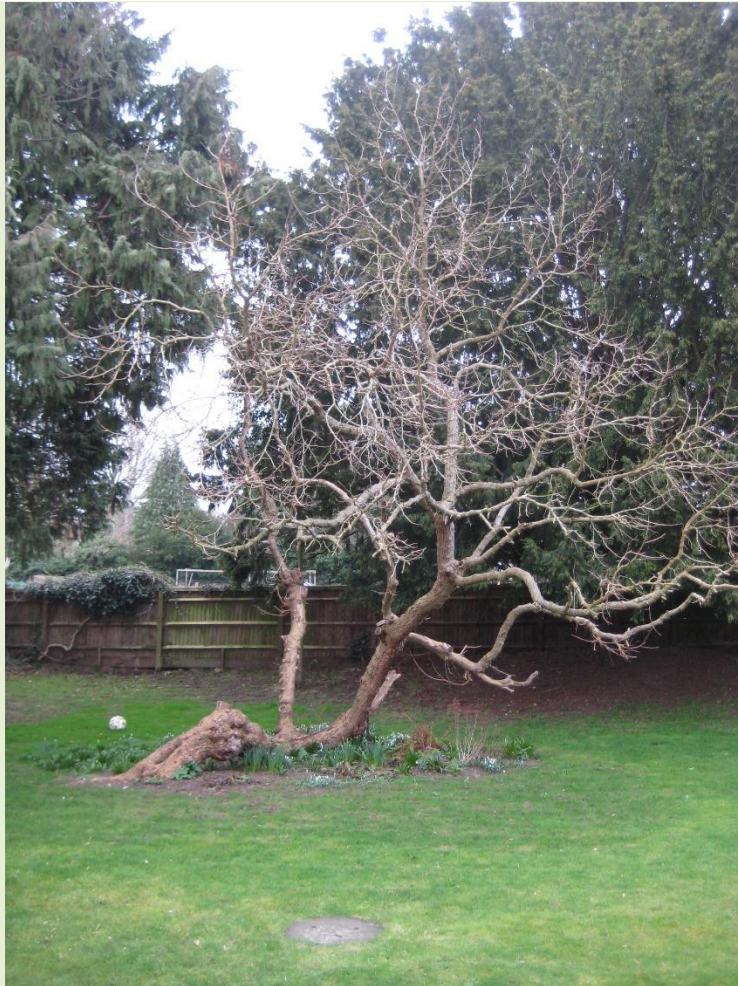
**Image 2 – T7 (Mulberry)**

- 5.7.1 No ground level changes within the RPA areas of retained trees are proposed other than pool/ footing excavations and surface implementation works. Following completion of the project any 'making good' will be with BS3882 compliant topsoil raked out by hand (to no more than 100mm depth within any tree RPA) and then seeded/ planted as appropriate. We encourage the use of composted bark mulch where possible within the RPA of retained trees. On this project particularly below T5 & T7.

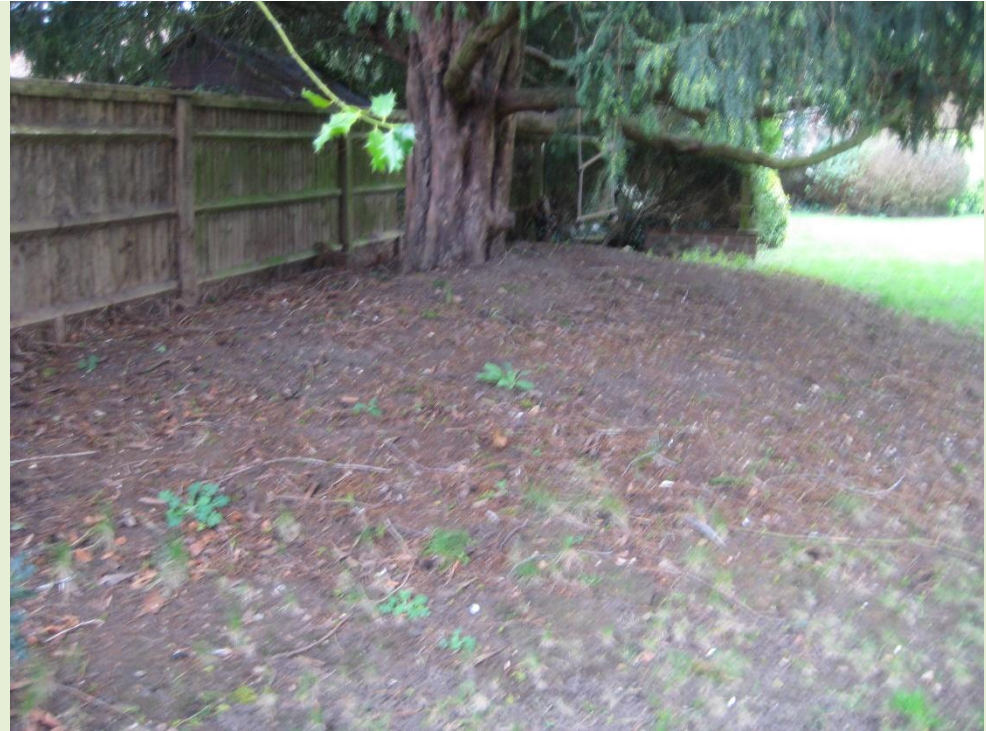
**Image 3 –Mulching below the canopy of T5 would design out the issue of grass not growing and benefit this tree.**

- 5.7.2 We recommend the use of composted bark mulch where possible within the retained tree RPA's. As well as aiding water retention and increasing soil microbial activity it can design out issues associated with leaf and needle drop or lawns not establishing close to mature trees.
