## Preliminary Ecological Appraisal and Roost Assessment

71 London Road, Wokingham, RG40 1YA

26<sup>th</sup> November 2024

*Front and rear extensions with associated internal alterations*

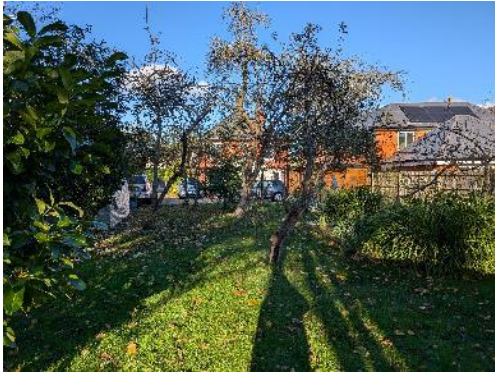
| Invertebrates | | | | |
|---|---|---|---|---|
| Bat foraging and commuting habitat | | The scattered trees and hedgerow on site provide suitable habitat for commuting and foraging bats (Fig 1). The local area is connected via heavily fragmented treelines and hedgerow, which connects to small parcels of woodland. As the local area is densely populated, there are high levels of street lighting which may deter some of the more light averse bat species. Due to | | |

| | <p>the minimal suitable habitat nearby, fragmentation of local connectivity and high levels of light pollution in combination with the suitable on-site habitat, the site has moderate suitability for foraging and commuting bats.</p> <p><b>Fig 1</b></p> |

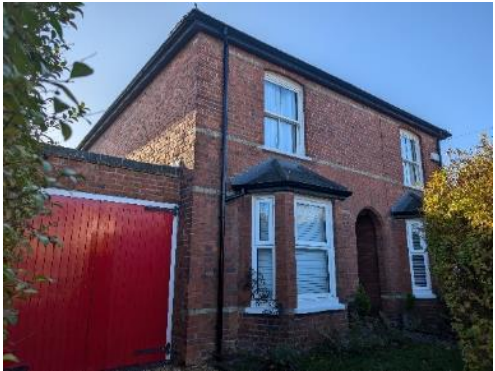
| B1 - overview | <p>B1 is a detached residential dwelling to the north of site constructed of brick and mortar with a hipped roof, clad in slate roof tiles (Fig 2). There is an attached garage to the east also constructed of brick and mortar with a pitched, slate tile roof and a southern, single story, gabled extension with a polished plaster finish and slate tile roof. There are windows and doors on both the northern and southern elevations and a chimney on the western elevation of the roof.</p> <p><b>Fig 2</b></p> |

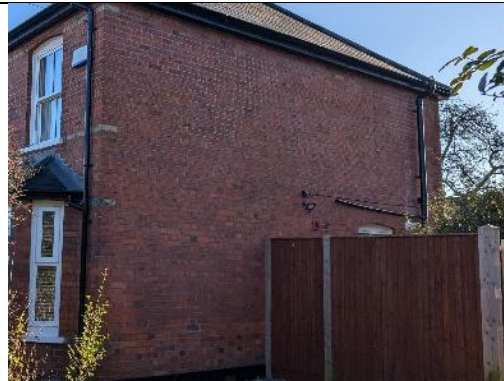
**Fig 3**

| B1 – exterior | <p>The brick and mortar appear to be in good condition (Fig 3), leaving no gaps. The windows and doors appear to be tightly fitted (Fig 4), leaving no gaps. The eaves appear to be tightly fitted (Fig 5), leaving no gaps.</p> |

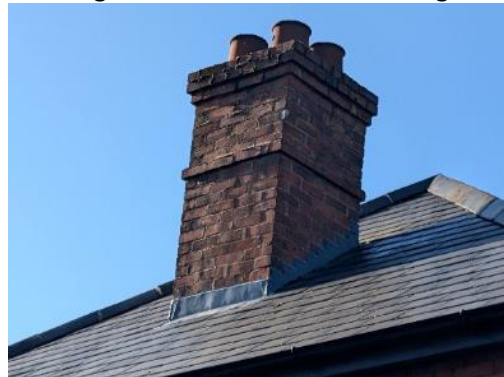
**Fig 6**

The lead flashing around the chimney appears to be tightly fitted (Fig 6), leaving no gaps. There are a small number of lifted roof tiles on the main section of the house (Fig 7), and the hip tiles do not appear to be tightly fitted (Fig 8), providing a suitable roosting location for crevice dwelling bat species.

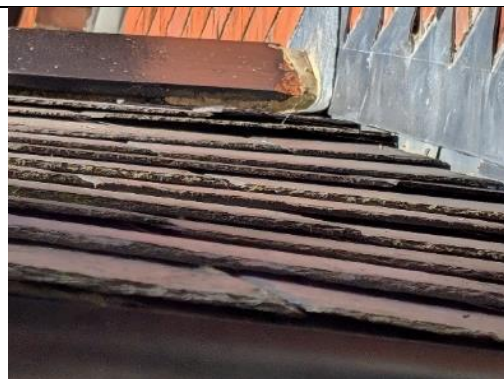
Fig 9

A high volume of the slate tiles on the southern extension are lifted (Fig 9), including gaps between the end tiles (Fig 10) and lifted ridge tiles (Fig 11), providing a suitable roosting location for crevice dwelling bat species.

| <i>Recommendations</i> | <p>Two bat emergence/re-entry surveys are required on B1 during the active bat season to confirm presence/likely-absence of bats roosting in or on the building. These survey visits should be completed during the optimal survey period mid-May to August inclusive. The survey visits should be at least three weeks apart.</p> <p>Three surveyors are required to provide full coverage of the building's elevations to look for emerging/re-entering bats. An infrared camera should also be employed per surveyor as part of the survey to support in identifying where any specific roost access points are located.</p> <p>If any bat roosts are confirmed from this survey schedule, a bat licence would be required to demolish the buildings as it would involve the destruction of roosts. This is applied for with the help of a class 2 licensed bat ecologist after planning permission is granted, but before commencement of works.</p> <p>Enhancements are dependent on the outcome of further surveys</p> |

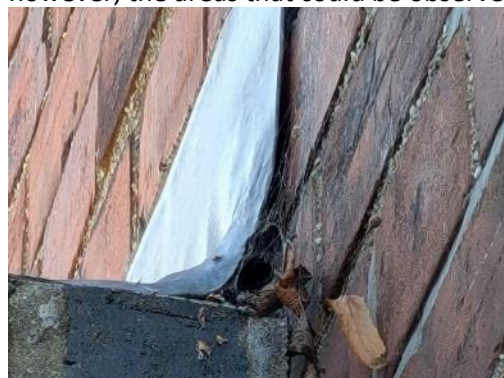
Fig 12

The lead flashing between the main house and the garage is lifted (Fig 12), providing a suitable roosting location for crevice dwelling bat species. It was not possible to fully assess the roof tiles on the garage without accessing the neighbouring property, however, the areas that could be observed appeared to be tightly fitted and in good condition (Fig 13).

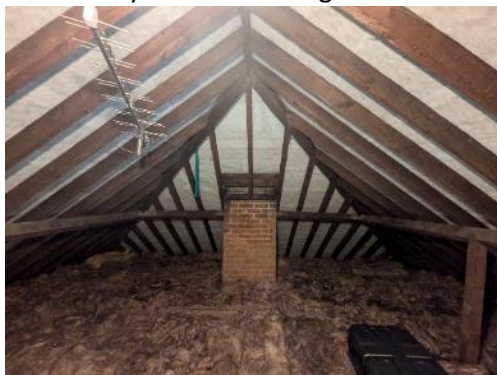
**Fig 14**

**V1:** The loft void within B1 is lined with breathable membrane, insulated with mineral wool insulation, and there are timber beams throughout (Fig 14). The timber beams provide a suitable roosting feature for void dwelling bat species should they gain access to the loft void. There are some small areas of missing mortar on the chimney (Fig 15), however, these do not appear to

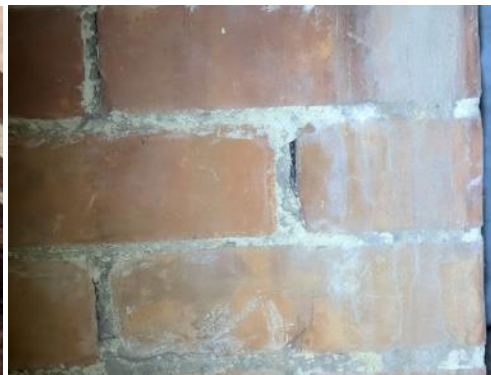
**Fig 15**

continue deep enough to provide a suitable roosting feature for crevice dwelling bat species. The rooving membrane is sagging in places (Fig 16), providing a suitable roosting location for crevice dwelling bat species. No light ingress or direct points of access were identified within V1, however, as there are lifted tiles externally bats may be able to access the loft void via the roof tiles and loosely fitted loft lining.

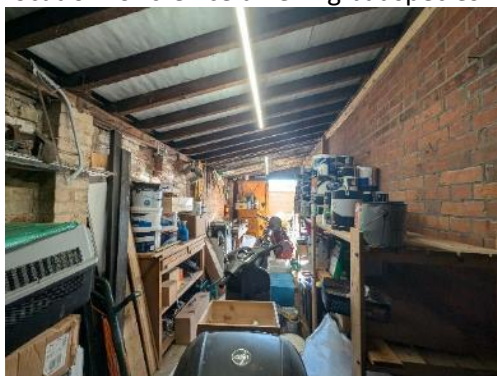
**Fig 17**

**Garage:** The garage is lined with breathable membrane, with timber beams throughout (Fig 17) providing a suitable roosting location for void dwelling bat species. The mortar between bricks is missing in places (Fig 18), providing a suitable roosting location for crevice dwelling bat species.

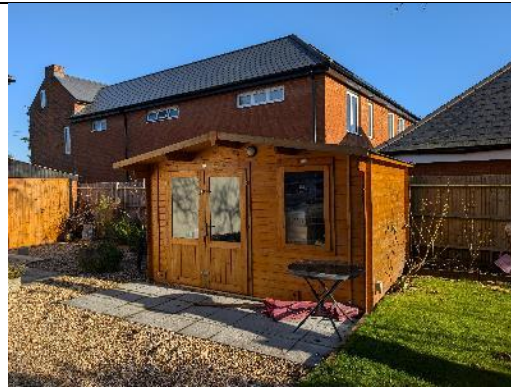
**Fig 21****B2 – exterior**

| B2 - overview | <p>B2 is a cabin to the southeast of B1 constructed of timber with a gabled, bitumen felt roof (Fig 21), predominantly used for storage. There are windows and doors on the western elevation, along with a large area of overhanging eaves.</p> |

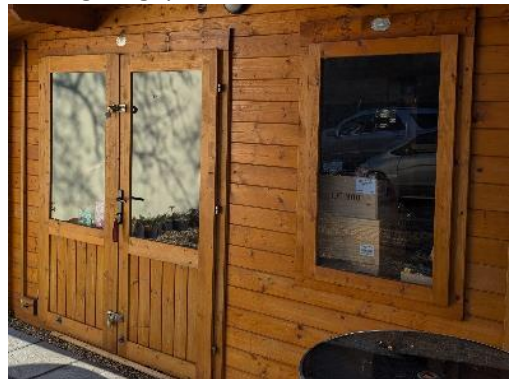
**Fig 22**

The windows and doors appear to be tightly fitted (Fig 22), leaving no gaps. The timber walls appear to be tightly fitted (Fig 23), leaving no gaps.

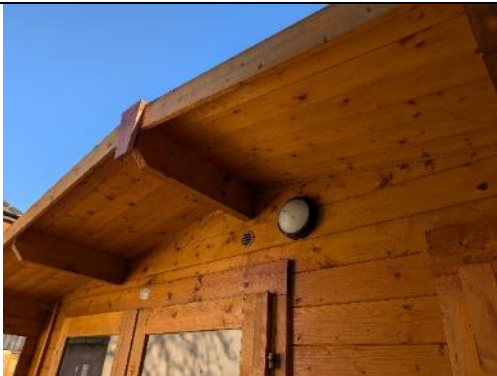
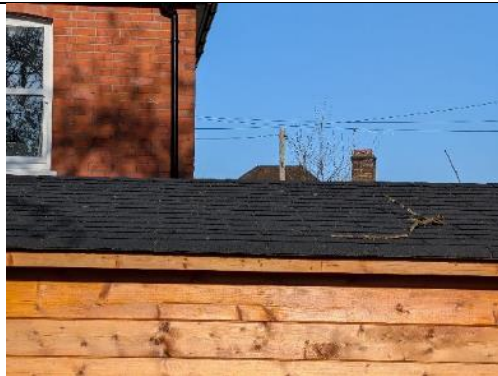
The eaves, including the overhanging eaves to the west, appear to be in good condition (Fig 24), leaving no gaps. The bitumen felt roof appears to be tightly fitted (Fig 25), leaving no gaps.

| | <p><b>Fig 24</b></p> <p><b>Fig 25</b></p> <p>No external roosting features or points of access were identified on B2.</p> | |

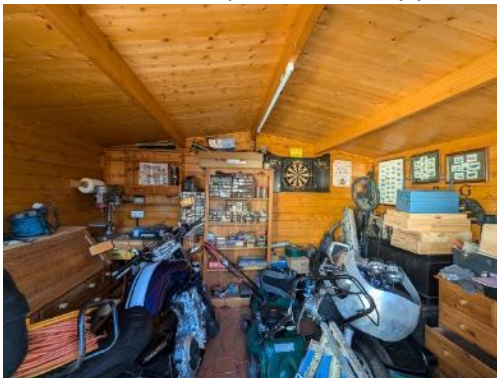
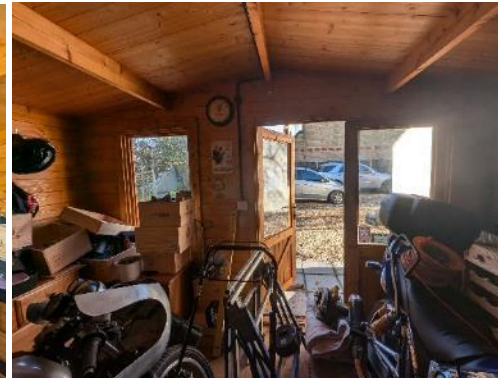
| B2 – interior | <p>While the interior of B2 has timber roof beams (Fig 26) which could provide a suitable roosting feature for void dwelling bat species, the windows on the western elevation result in high levels of light within B2 (Fig 27), resulting in this being an unsuitable roosting location for void dwelling bat species. In addition, no roosting features suitable for crevice dwelling bat species were identified internally, nor were any points of access.</p> <p><b>Fig 26</b></p> <p><b>Fig 27</b></p> <p>No evidence of bats was identified within B2.</p> | |

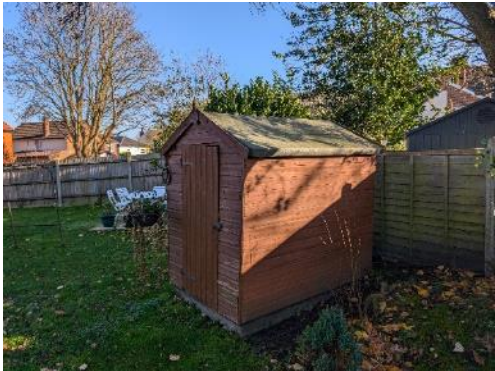
| <p>B3 - overview</p> | <p>B2 is a small shed to the south of site constructed of timber with a gabled roof constructed of chipboard clad with bitumen felt roof (Fig 28), predominantly used for storage. There are no windows on B3, with one door on the northern elevation.</p> <p><i>Fig 28</i></p> |

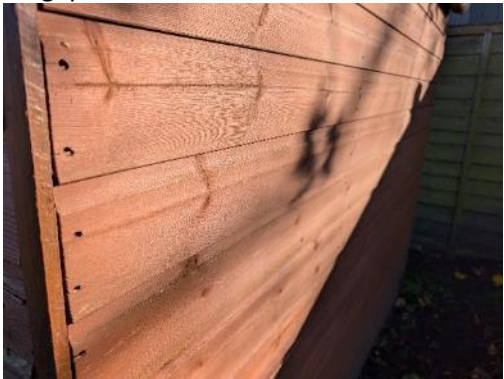
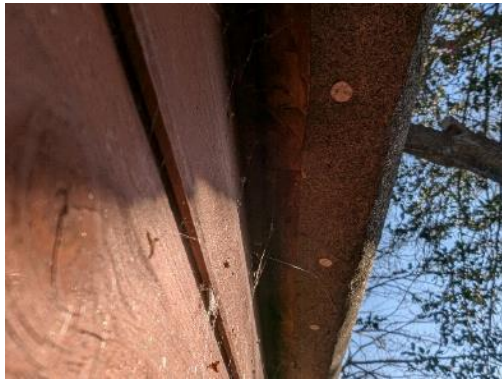
| <p>B3 – exterior</p> | <p>The timber walls appear to be tightly fitted (Fig 29), leaving no gaps. The eaves appear to be in good condition (Fig 30), leaving no gaps.</p> <p><i>Fig 29</i> <i>Fig 30</i></p> <p>The bitumen felt roof appears to be in good condition (Fig 31), leaving no gaps. The door does not close fully, even when locked (Fig 32), providing a potential point of access for void dwelling bat species.</p> |

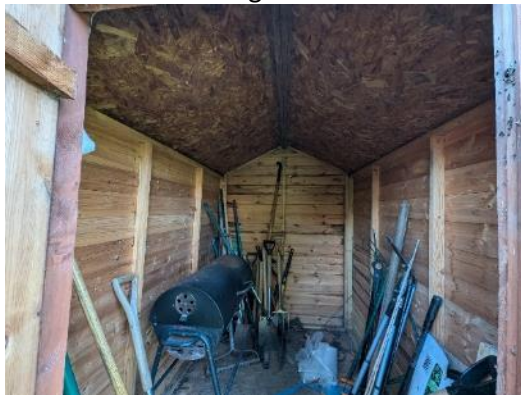
| B3 – interior | <p>There is a chipboard roof with a small ridge beam through the centre (Fig 33), providing a suitable roosting location for void dwelling bat species. No other suitable roosting features were identified. The interior of B3 could be assessed in full, with no crevices or lining for bats to roost beneath, and no bats or evidence of bats were identified. It is therefore considered unlikely that bats are roosting within B3.</p> <p><b>Fig 33</b></p> |
