## Connick Tree Consultants

### TREE DEVELOPMENT REPORT

(BS5837:2012 ARBORICULTURAL IMPACT ASSESSMENT)

| SITE | Waitrose, Rectory Road, Wokingham, Berkshire. RG40 1BB |

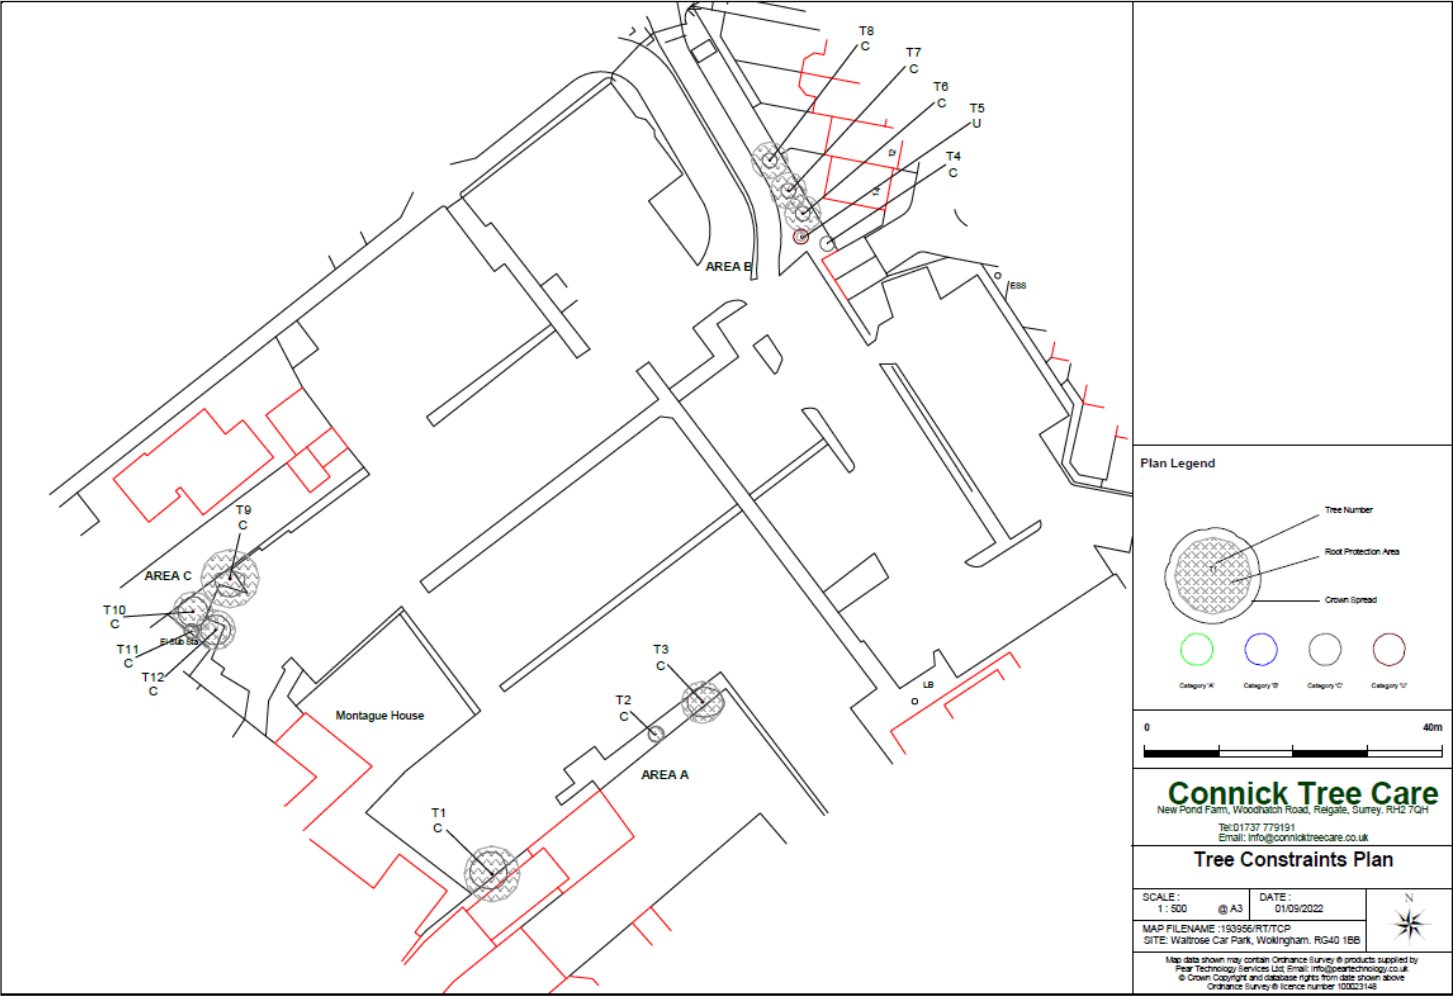
APPENDIX II
TREE CONSTRAINTS PLAN

The root protection area's (RPA's) of the trees recorded within the survey are shown in the Tree Constraints Plan (Appendix II).

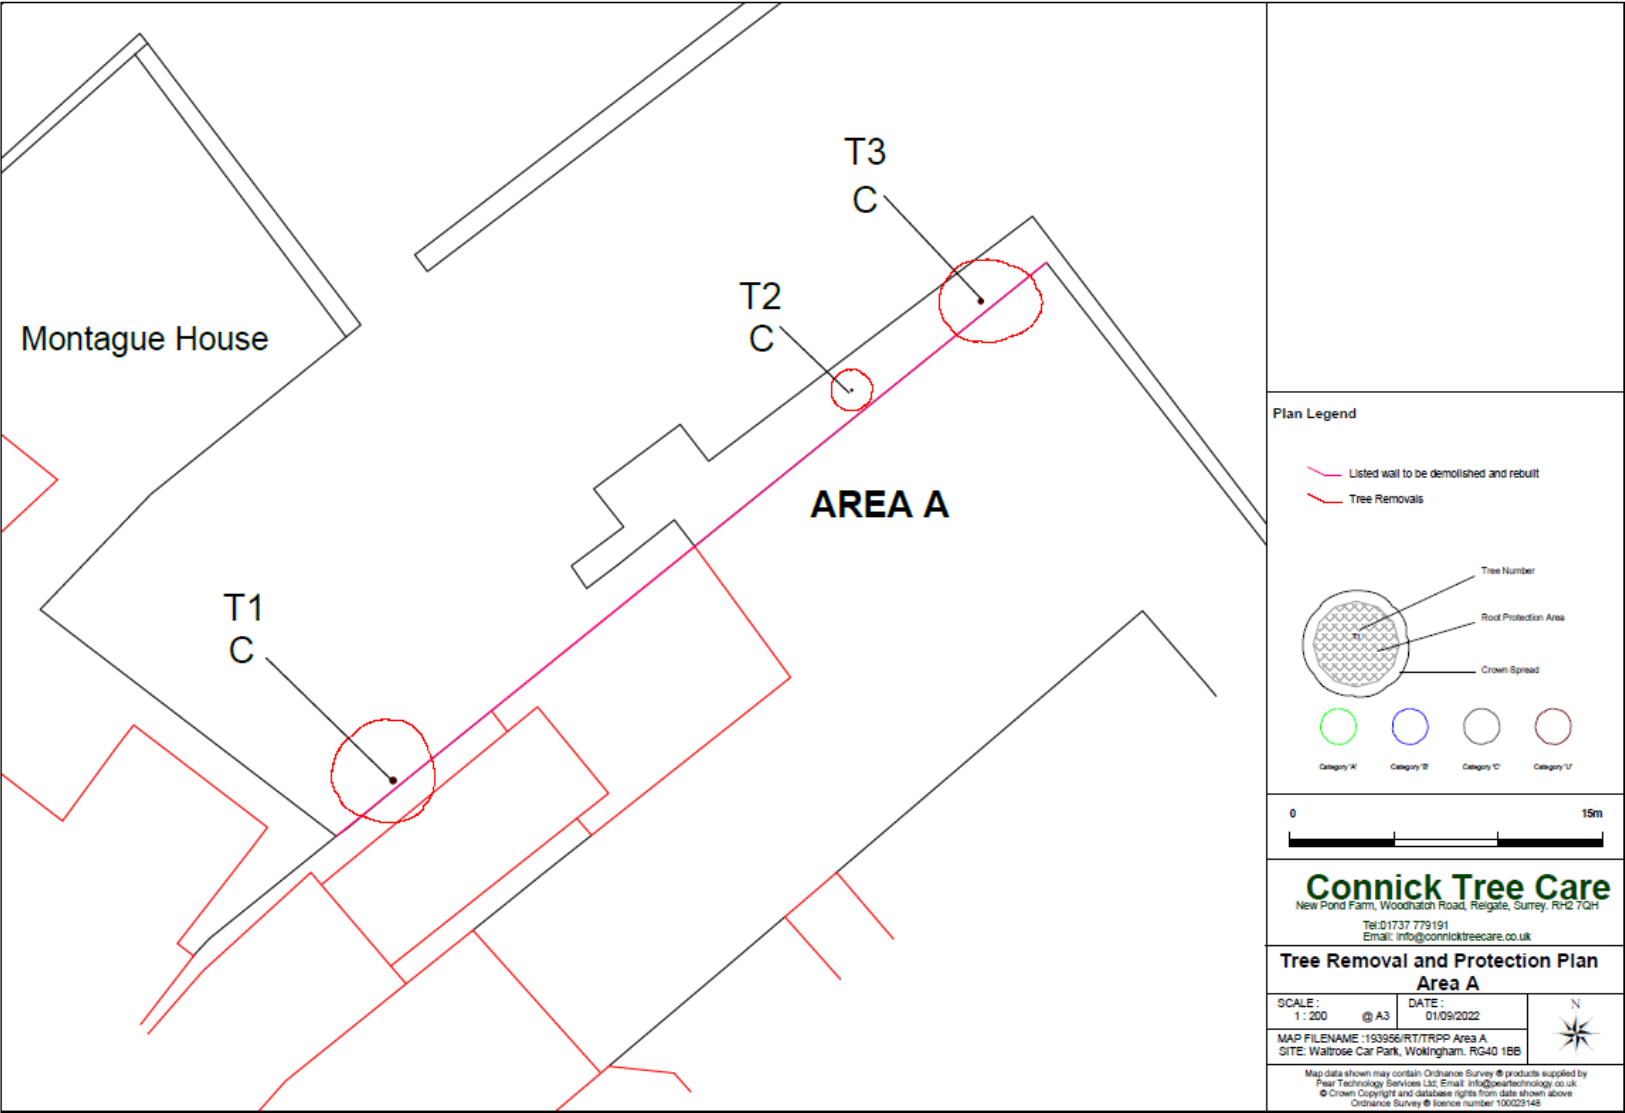
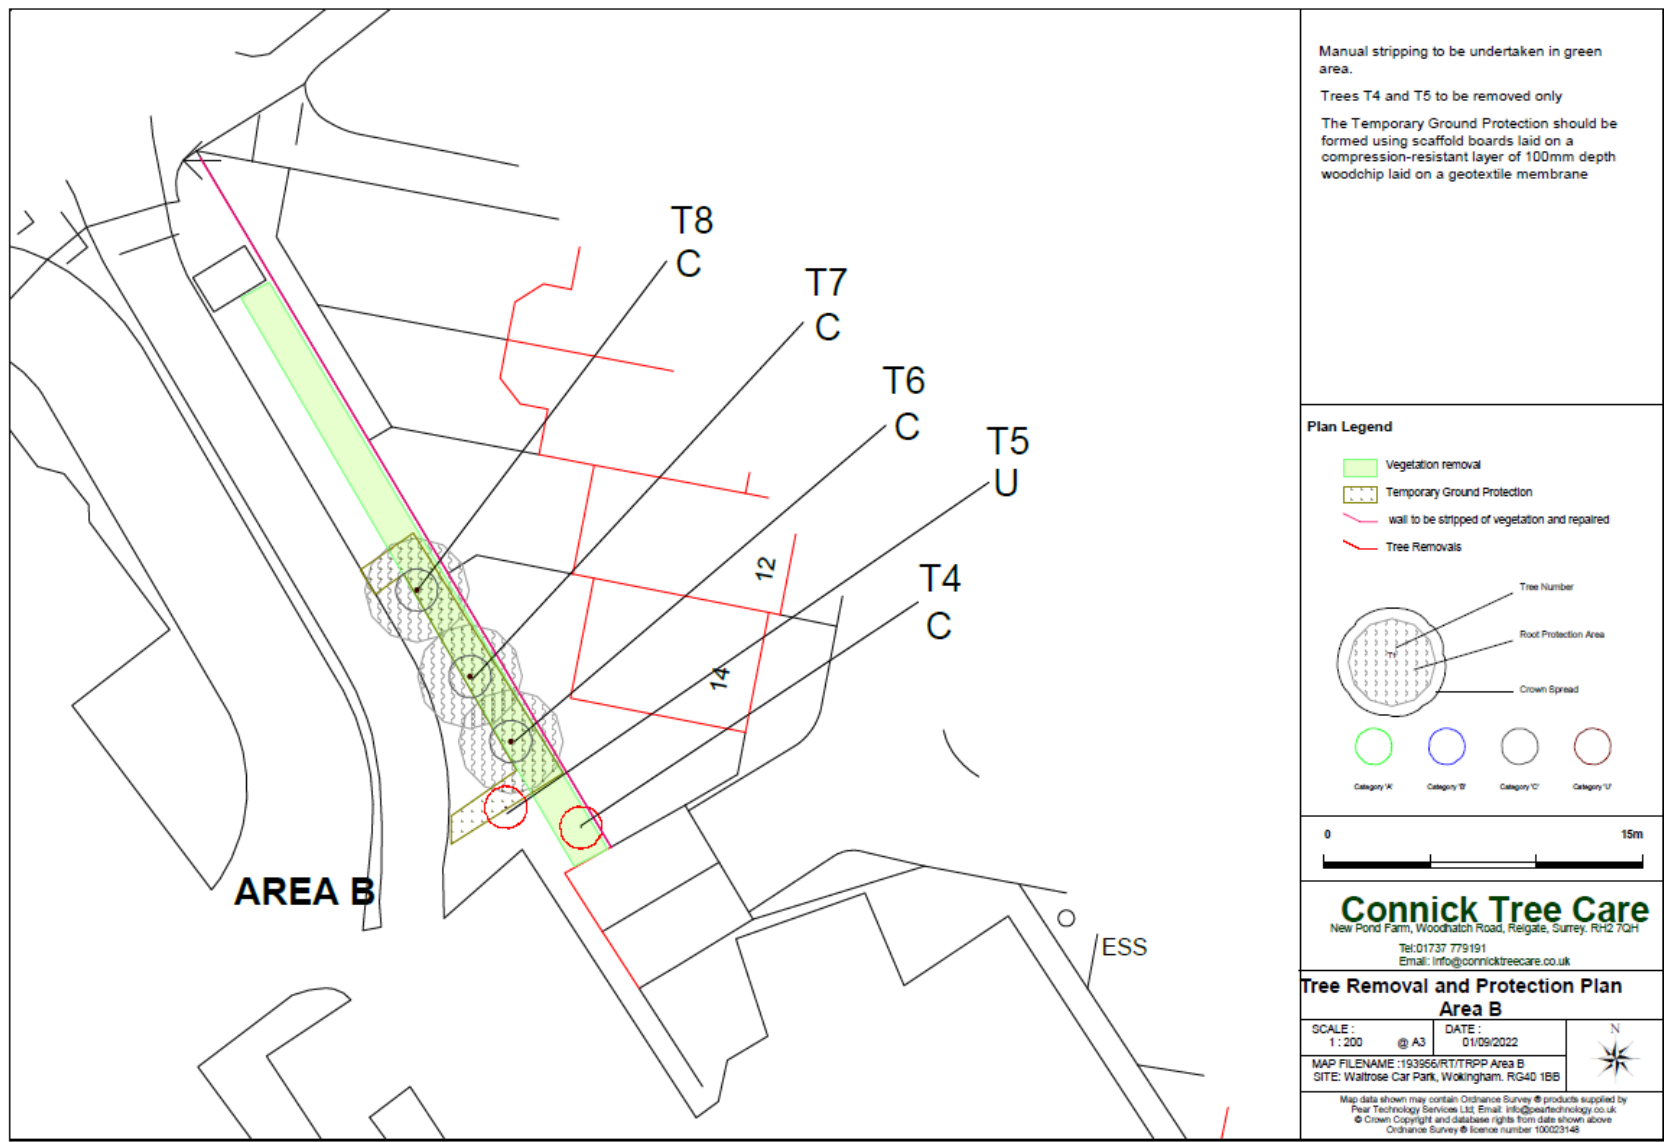
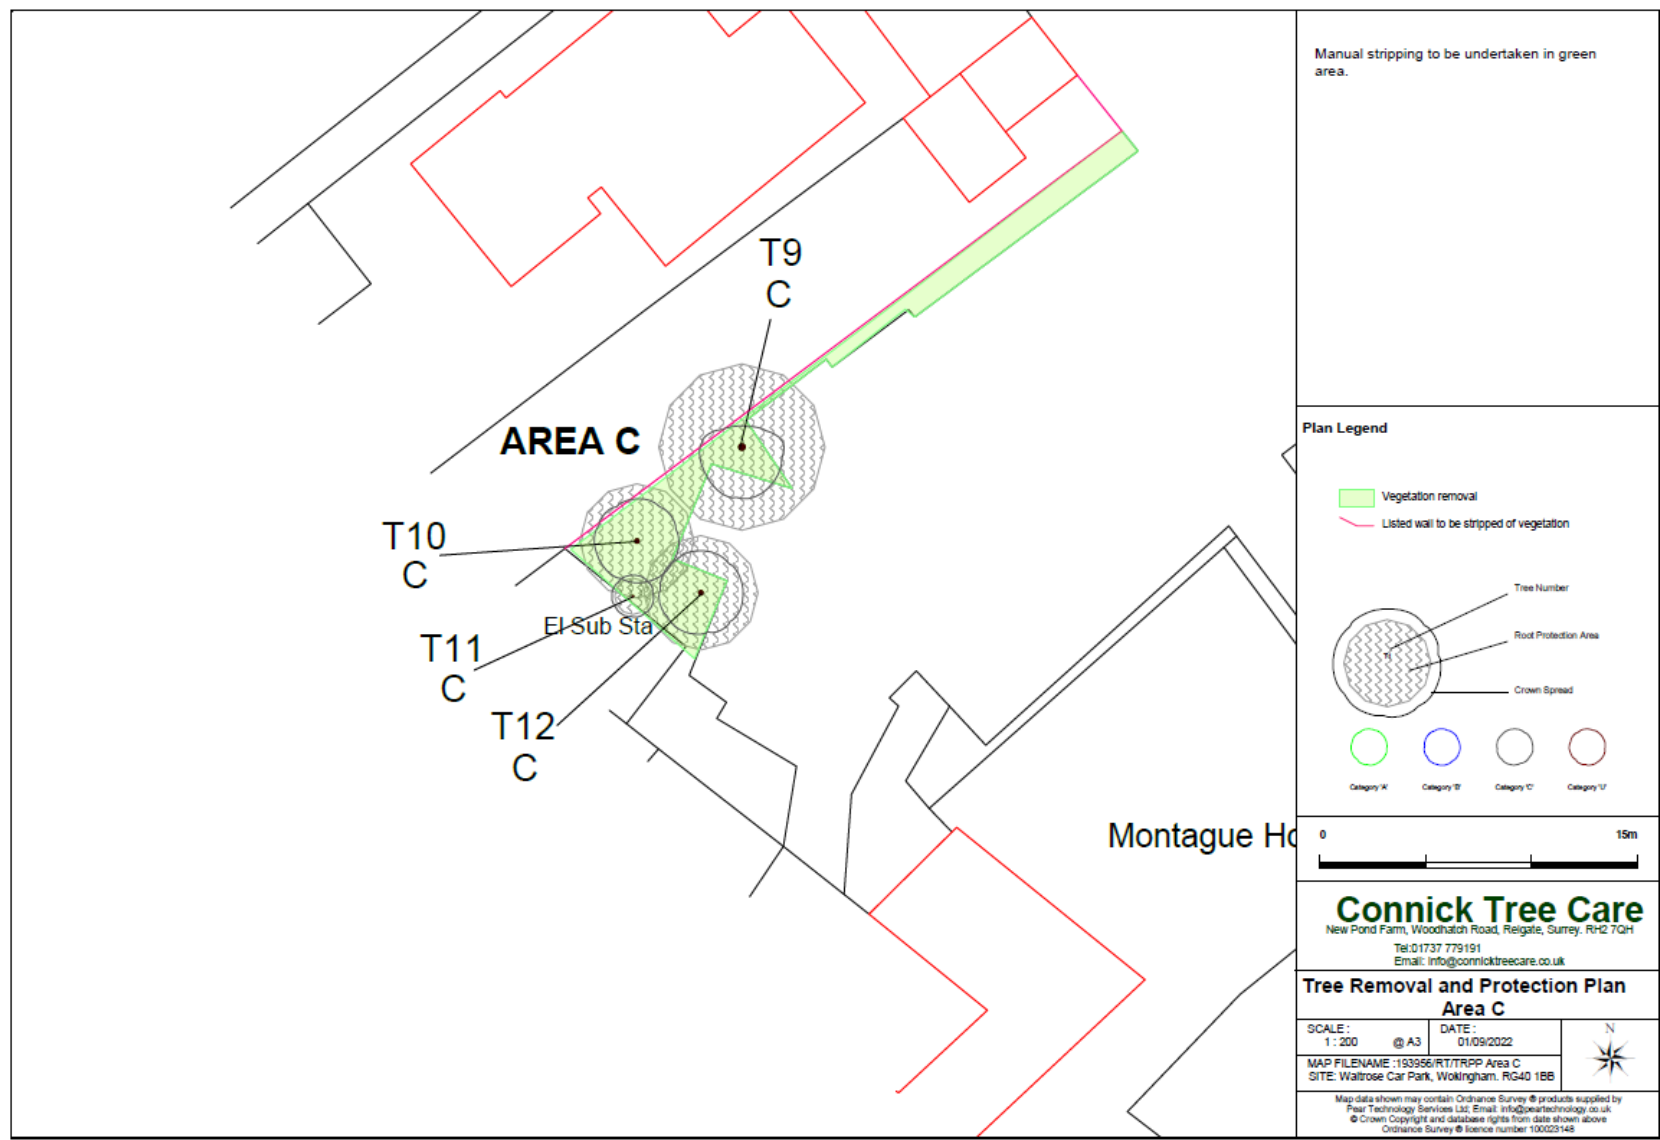
APPENDIX III
TREE REMOVAL AND PROTECTION PLANS

The survey process and the Tree Protection Plan (Appendix III) have indicated the extent of the theoretical Root Protection Areas (RPA) of the surveyed trees and identifies the potential impacts resulting from the proposed development. There will be limited impact to the trees from the necessity to work adjacent to the Root Protection Areas. This proposed work will consist of pedestrian access and materials having to enter the trees RPA's.

Consideration has been given to retaining all the trees. However, ultimately their removal is dependent on their condition and proximity to the development. This survey has identified that 4 trees requires removal to facilitate the development.

- T1 a young Sycamore (*Acer pseudoplatanus*)
- T2 a young flowering Cherry (*Prunus spp.*)
- T3 a semi-mature flowering Cherry (*Prunus spp.*)
- T4 a young Sycamore (*Acer pseudoplatanus*)
