## Arboricultural Impact Assessment

Expansion and updating of facilities  
including demolition of buildings and  
replacement with  
workshop/store/office building,  
improved access, additional  
hardstanding, and associated  
landscaping and boundary fencing

Lister Wilder  
Whitehouse Farm  
Beech Hill Road  
Spencers Wood  
Reading  
RG7 1HR

Survey Date: 3<sup>rd</sup> July 2025  
Report Date: 28<sup>th</sup> November 2025  
Project no: 2478

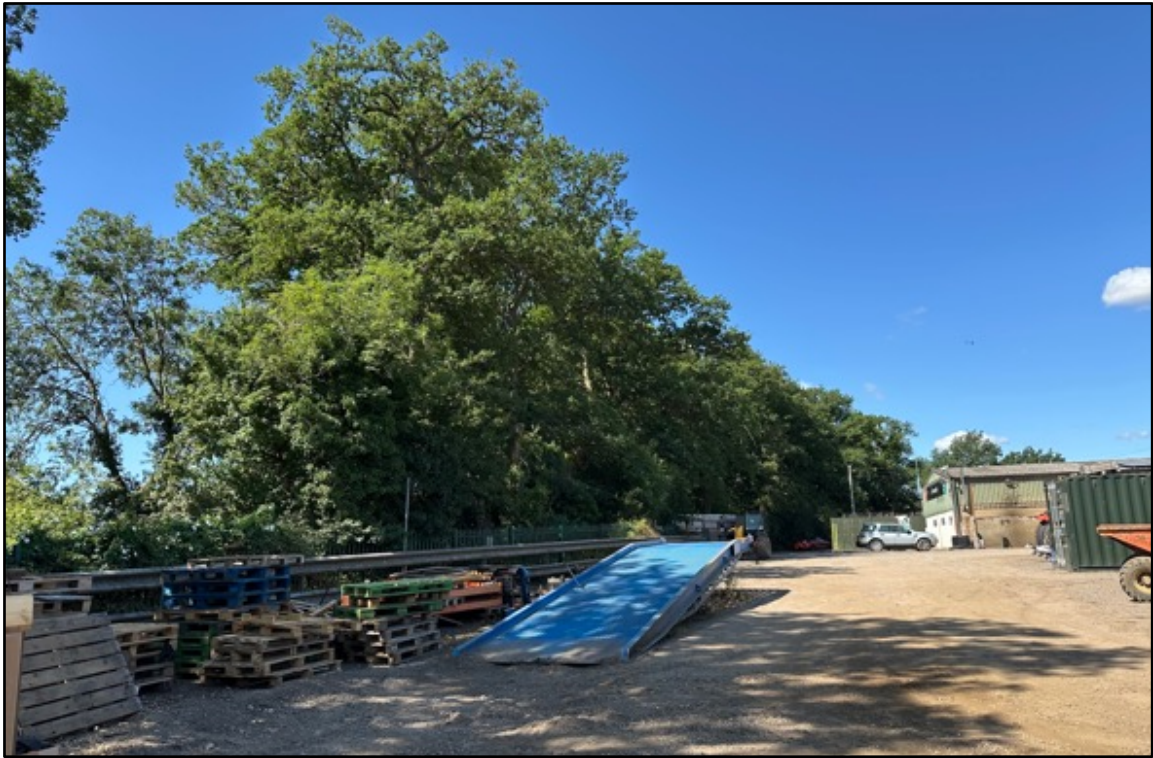
| Tree/<br>Group<br>No. | Species | Height<br>(m) | Stem<br>Diam. at<br>1.5m<br>(mm) | Branch Spread (m) | | | | Canopy<br>Clearance<br>(m) | Age<br>Class | Observations | Management<br>Recommendations | Estimated<br>Remaining<br>Contribution<br>(years) | BS 5837<br>Category<br>Grading | Protect-<br>ion<br>Distance<br>(m) | Root<br>Protect.<br>Area<br>(m2) |
|---|---|---|---|---|---|---|---|---|---|---|---|---|---|---|---|
| G1 | Oak | 14 - 19 | 150 - 650 | | | | | 4 | Semi-mature-<br>Early<br>mature | Just outside palisade fence. No close access - trees only viewed from within site. Oak with ash and occasional field maple. Dieback in ash - likely to ash dieback disease ( <i>Hymenoscyphus fraxineus</i> ). Some dead trees. Hazel, elder, thorn and scrub below. Dead and broken branches in ash and some oak, with deadwood up to 150mm diameter over site. | Remove deadwood over site. Remove ash trees with ash dieback which could fall into site or into the highway. | 20-40 | B2 | 7.8 | 191 |
| T3 | Ash | 19 | est 680 | 8.5 | 9 | 8 | 8 | 4.0 | Mature | Within G1. Stem obscured by ivy and bramble. Base not inspected. Dieback throughout crown - likely ash dieback disease with associated risk of future failure. Dense ivy. | Remove. | <10 | U | 8.2 | 209 |

Above: View to west along southern edge of site. Tree group G1 is located outside the palisade fence.

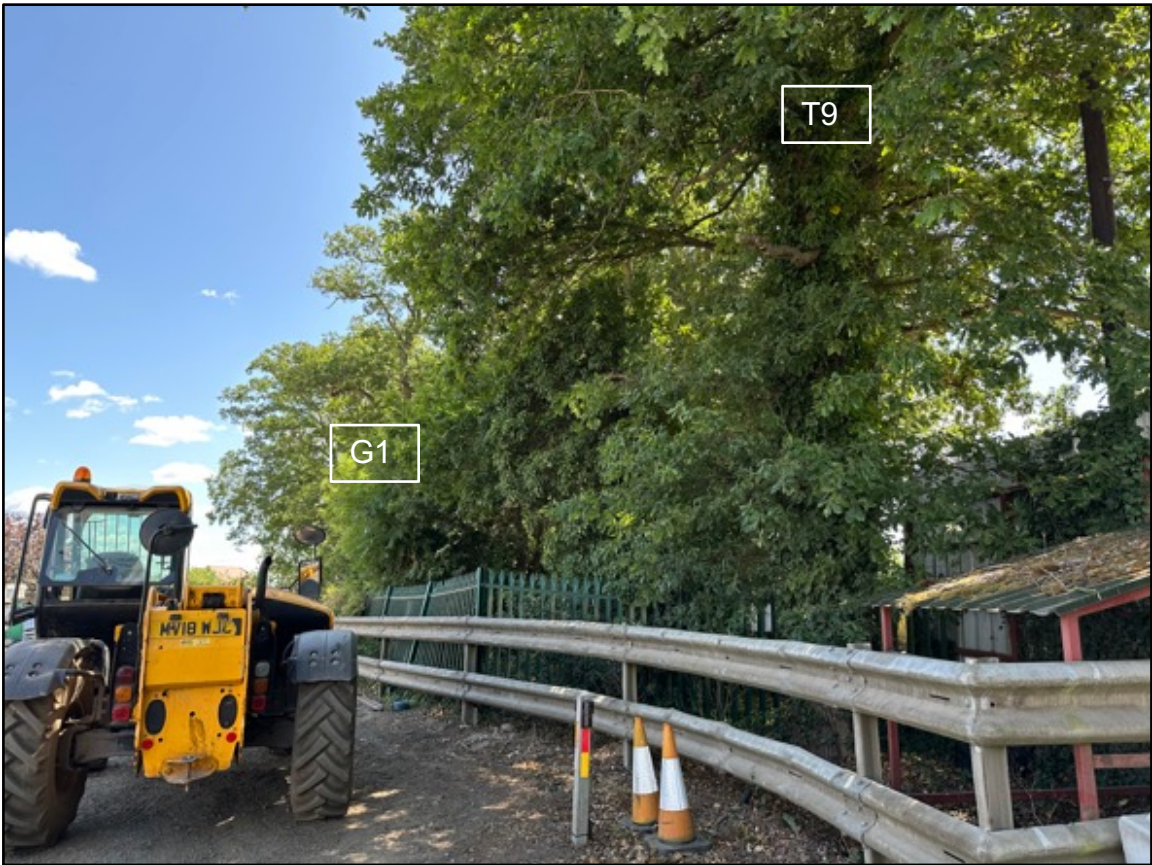
| Tree/<br>Group<br>No. | Species | Height<br>(m) | Stem<br>Diam. at<br>1.5m<br>(mm) | Branch Spread (m) | | | | Canopy<br>Clearance<br>(m) | Age<br>Class | Observations | Management<br>Recommendations | Estimated<br>Remaining<br>Contribution<br>(years) | BS 5837<br>Category<br>Grading | Protect-<br>ion<br>Distance<br>(m) | Root<br>Protect.<br>Area<br>(m2) |
|---|---|---|---|---|---|---|---|---|---|---|---|---|---|---|---|
| T9 | Oak | 11.5 | est 500 | 4.5 | 2.5 | 5.5 | 2 | 3.5 | Early<br>mature | To back of armco fence and to front of palisade fence. Ivy over stem - base not inspected. Low limbs cut back over site. Fresh growth from basal stem. Suppressed by adjacent trees with crown swept to northwest. Basal bark damage to northwest. Minor deadwood. | Remove section of ivy from base. | 20-40 | B2 | 6.0 | 113 |

Above: View to east along southern edge of site. Oak T9 is set to back of Armco and to front of palisade fence. G1 is to back of palisade fence.

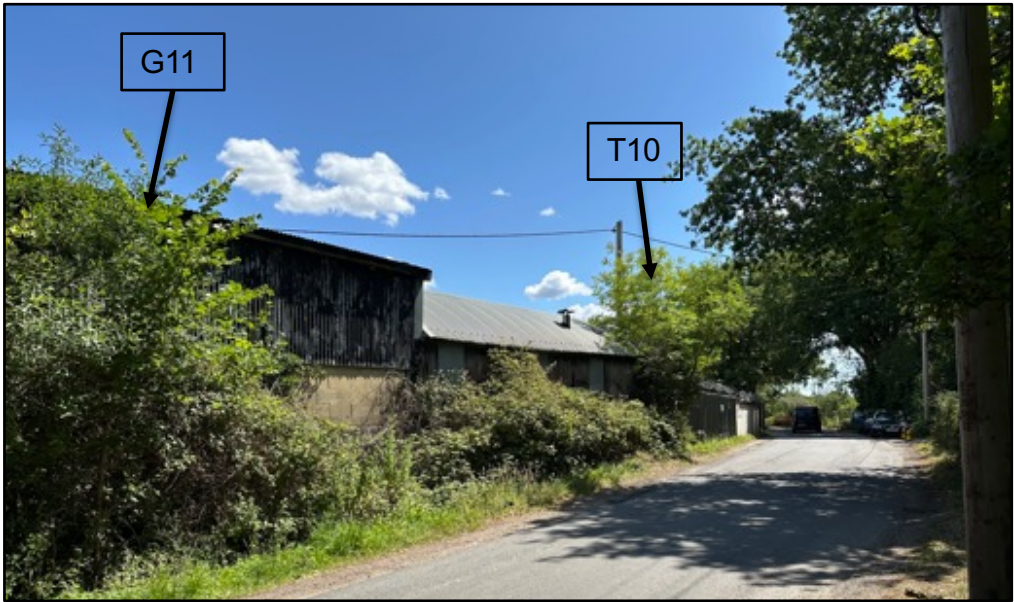
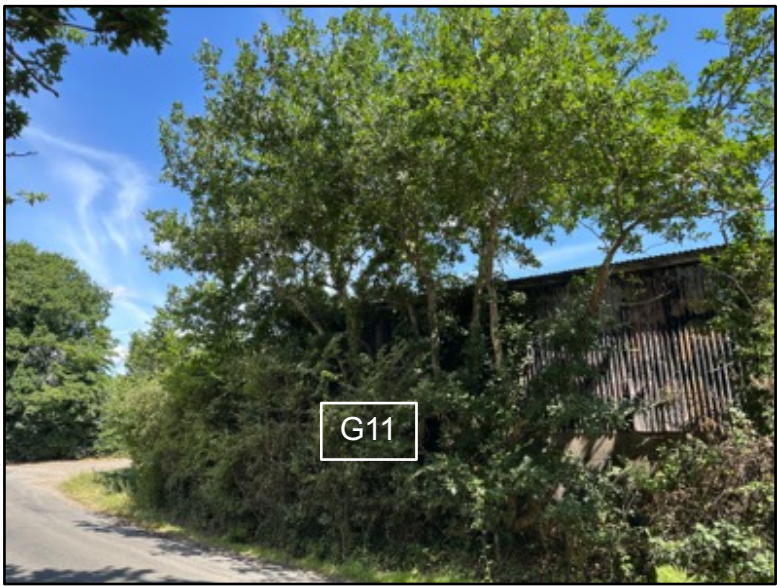
| Tree/<br>Group<br>No. | Species | Height<br>(m) | Stem<br>Diam. at<br>1.5m<br>(mm) | Branch Spread (m) | | | | Canopy<br>Clearance<br>(m) | Age<br>Class | Observations | Management<br>Recommendations | Estimated<br>Remaining<br>Contribution<br>(years) | BS 5837<br>Category<br>Grading | Protect-<br>ion<br>Distance<br>(m) | Root<br>Protect.<br>Area<br>(m2) |
|---|---|---|---|---|---|---|---|---|---|---|---|---|---|---|---|
| T10 | Ash | 5 | 180 | 2 | 2 | 2.5 | 3 | 3 | Semi-<br>mature | Self set tree growing from building base. Poor form and structure. Five stems, average 80mm diameter, some truncated. | Remove. | 5-15 | C2 | 2.2 | 15 |
| G11 | Hedgerow | 3 - 7.5 | 50 - 180 | | | | | 0 | Semi-<br>mature-<br>Early<br>mature | Line of trees between buildings and ditch. Species including oak, elm, thorn, cherry and willow. Some dead and dying elm. Some self set trees growing in gap between buildings. Bramble. | Remove to clear visibility splay and to allow new hedge planting. | 15-30 | B-C2 | 2.2 | 15 |

Hedgerow G11 and ash T10 are proposed for removal to allow clearance to the visibility splay. A new hedgerow is proposed, which will be set slightly further back from the roadside.

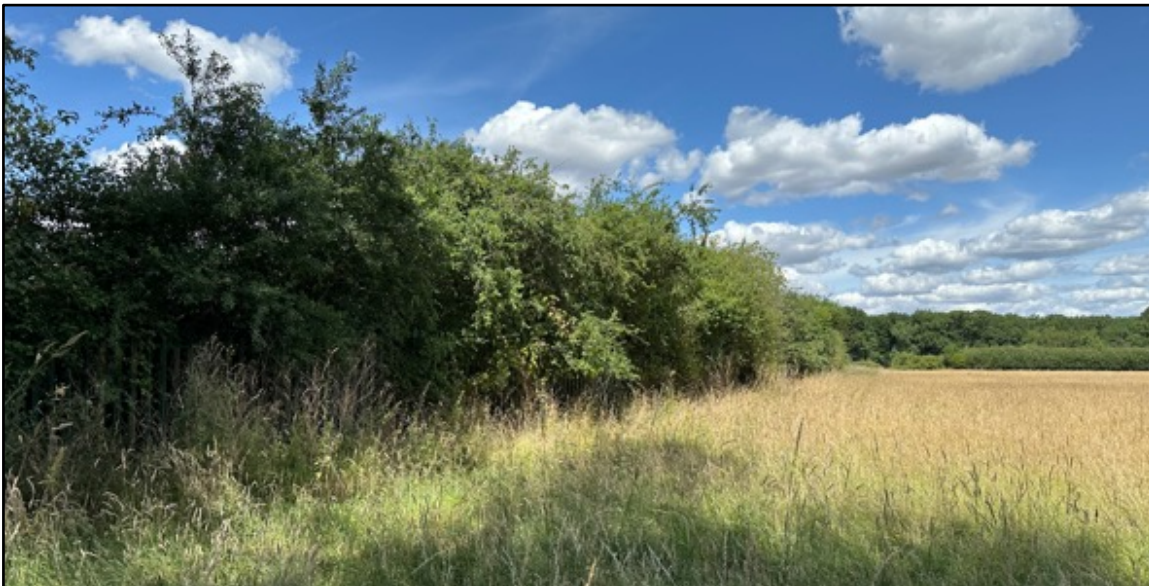
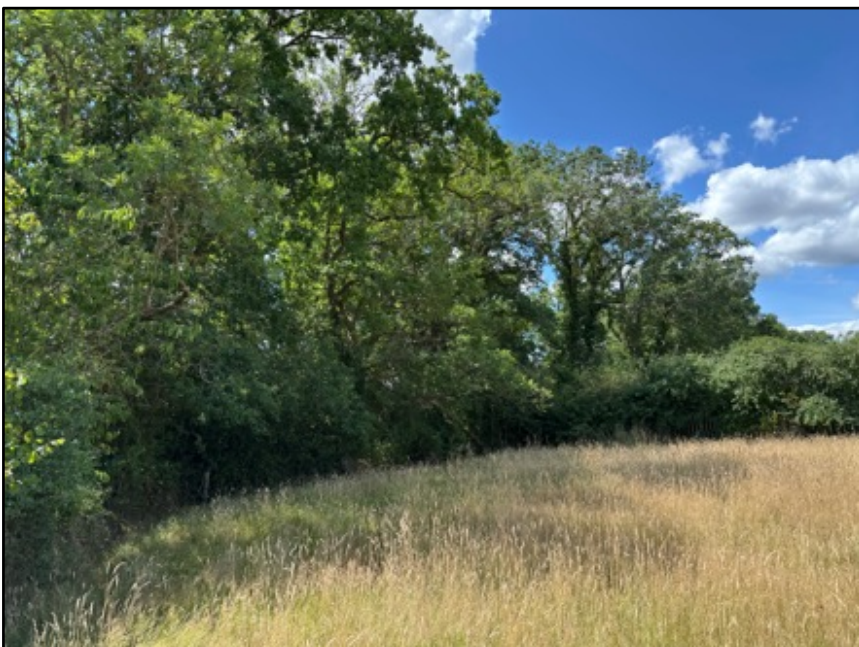
| Tree/<br>Group<br>No. | Species | Height<br>(m) | Stem<br>Diam. at<br>1.5m<br>(mm) | Branch Spread (m) | | | | Canopy<br>Clearance<br>(m) | Age<br>Class | Observations | Management<br>Recommendations | Estimated<br>Remaining<br>Contribution<br>(years) | BS 5837<br>Category<br>Grading | Protect-<br>ion<br>Distance<br>(m) | Root<br>Protect.<br>Area<br>(m2) |
|---|---|---|---|---|---|---|---|---|---|---|---|---|---|---|---|
| T12 | Oak | 10 | 530 | 7 | 3 | 4.5 | 6 | 2.5 | Early<br>mature | Two stems from 0.8m - est 350 & 400mm. Upper stems of western stem dead with eastern stem showing reasonable vitality. Five barbed wire strands embedded in stem. Ivy over stems. Providing habitat. | Cut barbed wire to prevent further embedment, and re-instate fencing further from stem. | 20-40 | B2-3 | 6.4 | 127 |
| T13 | Oak | 15 | 550 | 7.5 | 5 | 7 | 4 | 1.5 | Early<br>mature | Two ascending stems from 1.2m - est 360 & 420mm. Base not inspected. Good vitality. | | >40 | B2 | 6.6 | 137 |

Left: View along southern edge of field, with tree group G1 and oak trees T12 and T13 outside post and wire fence.
