# Development tree report for Hall Hunter Partnership

This report is an arboricultural assessment to cover the requirements under B.S.5837:2012 - Trees in relation to design, demolition, and construction.

Dairy Cottage,  
Heathlands Road,  
Wokingham,  
Berkshire,  
RG40 3AN

Prepared by Steve Wood (O.N.D. Arboriculture M.Arbor.A.) for and behalf of SMW (Tree) Consultancy Ltd on <sup>3rd</sup> May 2024

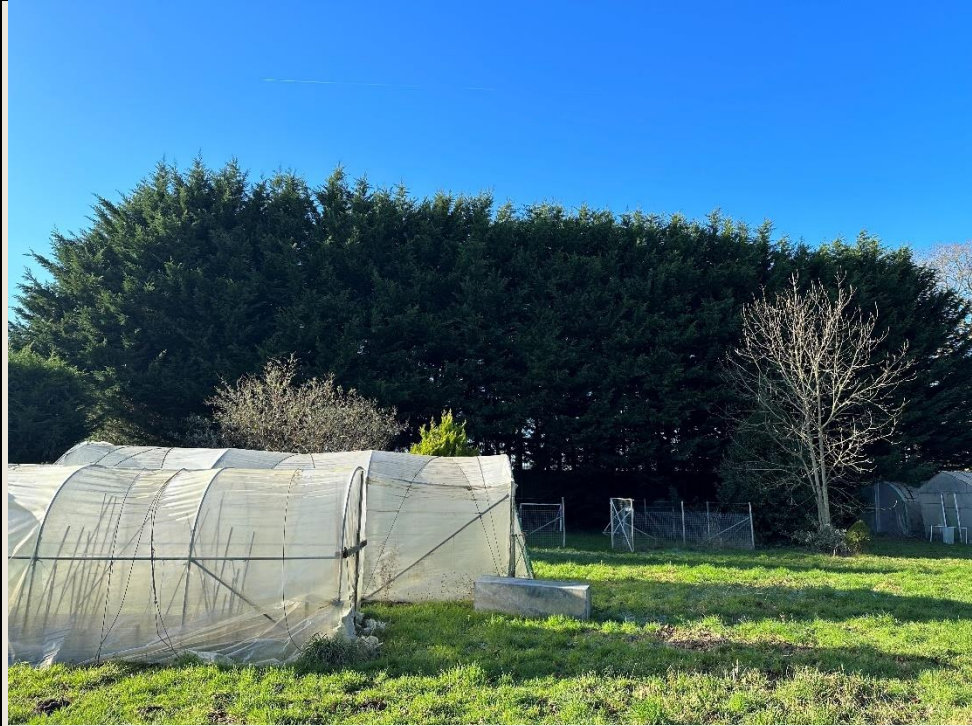
6. H9 and H10 are extremely overbearing, and the shading factor of these hedges would affect the 'reasonable' enjoyment of the proposed dwelling and garden. It would be far more beneficial to remove these hedges and replant with a more suitable hedge/ tree coverage.

| Tree ID | In Conservation Area/TPO | Species & Maturity | Likely Bat Habitat | Measurements estimated | Height (m) | Height and direction of first significant branch (m) | Number of Stems | Stem 1 (mm) or average diameter for trees with more than 5 stems | Stem 2 (mm) | Crown Spread (m) | | | | Crown height (average) | Crown, Stem, Basal Area | B.S. Category | Life Expectancy | Physical Condition | Build Stage | Recommended action | Date | Comment |
|---|---|---|---|---|---|---|---|---|---|---|---|---|---|---|---|---|---|---|---|---|---|---|
| H9 | Yes | Species:<br>Leyland Cypress<br><br>Latin:<br>X Cupressocyparis leylandii<br><br>Maturity:<br>Early Mature | Unknown | No | 15 | 2s | 1 | 220 | | 4 | 9 | 3 | 9 | 2 | Crown-Fair,<br><br>Stem-Fair,<br><br>Basal Area-Fair | C1 | 10 to 20 yrs. | Fair | Pre-construction | Recommended action:<br>Removal and replacement replanting within the site | 16.01.24 | Large Leyland Cyprus hedge boarding property on the western boundary, likely that some sections, or all of this hedge, will need to be removed to create an entrance. |

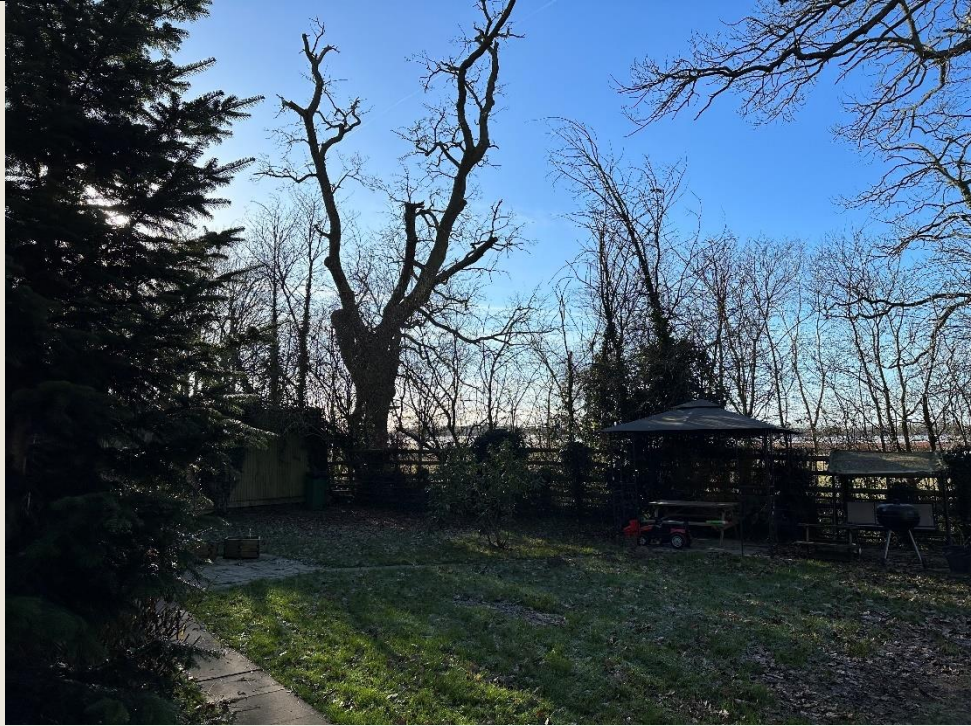
| Tree ID | In Conservation Area/TPO | Species & Maturity | Likely Bat Habitat | Measurements estimated | Height (m) | Height and direction of first significant branch (m) | Number of Stems | Stem 1 (mm) or average diameter for trees with more than 5 stems | Stem 2 (mm) | Crown Spread (m) | | | | Crown height (average) | Crown, Stem, Basal Area | B.S. Category | Life Expectancy | Physical Condition | Build Stage | Recommended action | Date | Comment |
|---|---|---|---|---|---|---|---|---|---|---|---|---|---|---|---|---|---|---|---|---|---|---|
| H10 | Yes | Species:<br>Leyland Cypress<br><br>Latin:<br>X Cupressocyparis leylandii<br><br>Maturity:<br>Early Mature | Unknown | No | 16 | 2.5e | 1 | 225 | | 10 | 4 | 10 | 5 | 2 | Crown-Fair,<br><br>Stem-Fair,<br><br>Basal Area-Fair | C1 | 10 to 20 yrs. | Fair | Pre-construction | Recommended action:<br>Removal and replacement replanting within the site | 16.01.24 | Long boundary hedge to the westernmost property on the site. |

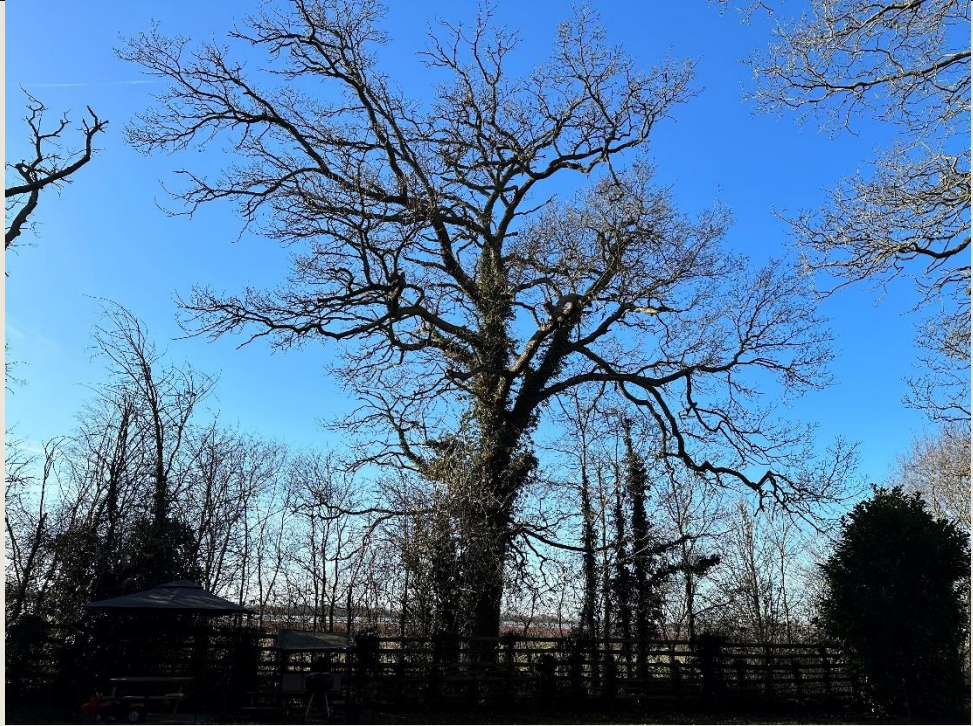
5. T11 has been categorised as a U category tree and thus should not be considered and impact upon the development, even if this tree was a higher classification its level of intrusion is minimal and thus, we do not consider it impact to warrant any mitigation.

| Tree ID | In Conservation Area/TPO | Species & Maturity | Likely Bat Habitat | Measurements estimated | Height (m) | Height and direction of first significant branch (m) | Number of Stems | Stem 1 (mm) or average diameter for trees with more than 5 stems | Stem 2 (mm) | Crown Spread (m) | | | | Crown height (average) | Crown, Stem, Basal Area | B.S. Category | Life Expectancy | Physical Condition | Build Stage | Recommended action | Date | Comment |
|---|---|---|---|---|---|---|---|---|---|---|---|---|---|---|---|---|---|---|---|---|---|---|
| T11 | Yes | Species:<br>Common Oak<br><br>Latin:<br>Quercus robur<br><br>Maturity:<br>Over Mature | Unknown | Yes | 18 | 5w | 1 | 950 | | 9 | 5 | 7 | 9 | 7 | Crown-Declining,<br><br>Stem-Poor,<br><br>Basal Area-Fair | U | <10 yrs. | Declining | Pre-construction | Recommended action:<br>See comment | 16.01.24 | Tree is located to the west of the site approximately 2m from the boundary fence. Tree is it advanced stages of decline with numerous dead limbs and decay fungi at the base. Essential this tree is assessed from a health and safety perspective. |

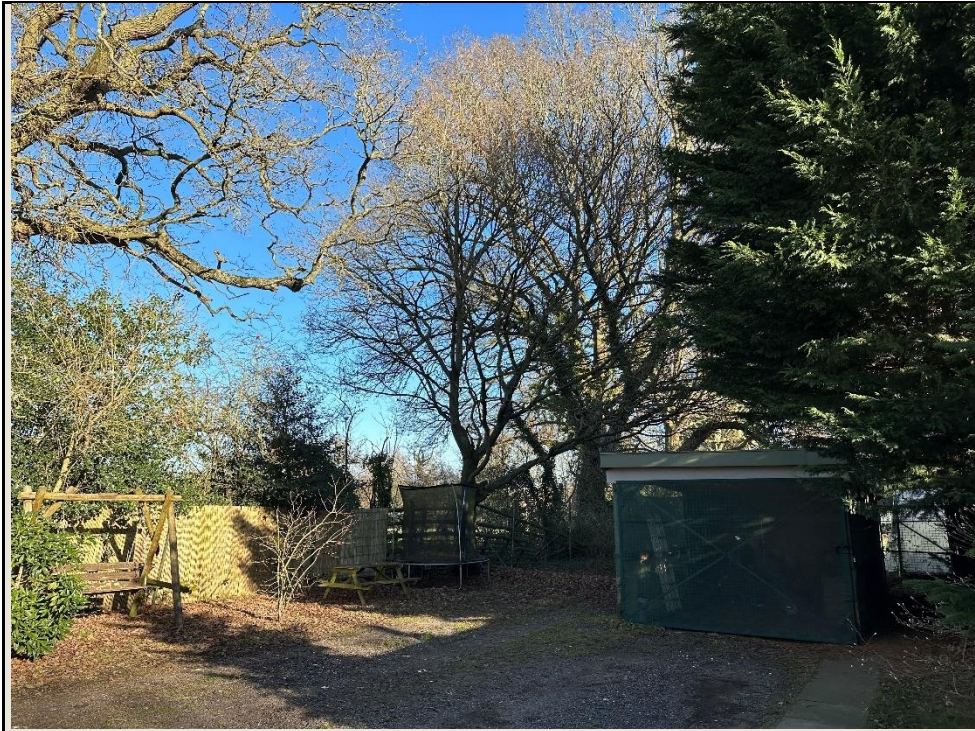
| Tree ID | In Conservation Area/TPO | Species & Maturity | Likely Bat Habitat | Measurements estimated | Height (m) | Height and direction of first significant branch (m) | Number of Stems | Stem 1 (mm) or average diameter for trees with more than 5 stems | Stem 2 (mm) | Crown Spread (m) | | | | Crown height (average) | Crown, Stem, Basal Area | B.S. Category | Life Expectancy | Physical Condition | Build Stage | Recommended action | Date | Comment |
|---|---|---|---|---|---|---|---|---|---|---|---|---|---|---|---|---|---|---|---|---|---|---|
| T12 | Yes | Species:<br>Common Oak<br><br>Latin:<br>Quercus robur<br><br>Maturity:<br>Over Mature | Yes | Yes | 26 | 4w | 1 | 1000 | | 12 | 9 | 12 | 9 | 5 | Crown-Fair,<br><br>Stem-Ivy,<br><br>Basal Area-Fair | A3 | >40 yrs. | Fair | Pre-construction | Recommended action:<br>No action | 16.01.24 | Tree also located 2m to the west of the site boundary. Stem and midsection crown is heavily covered in ivy and a large proportion of deadwood throughout the crown. |

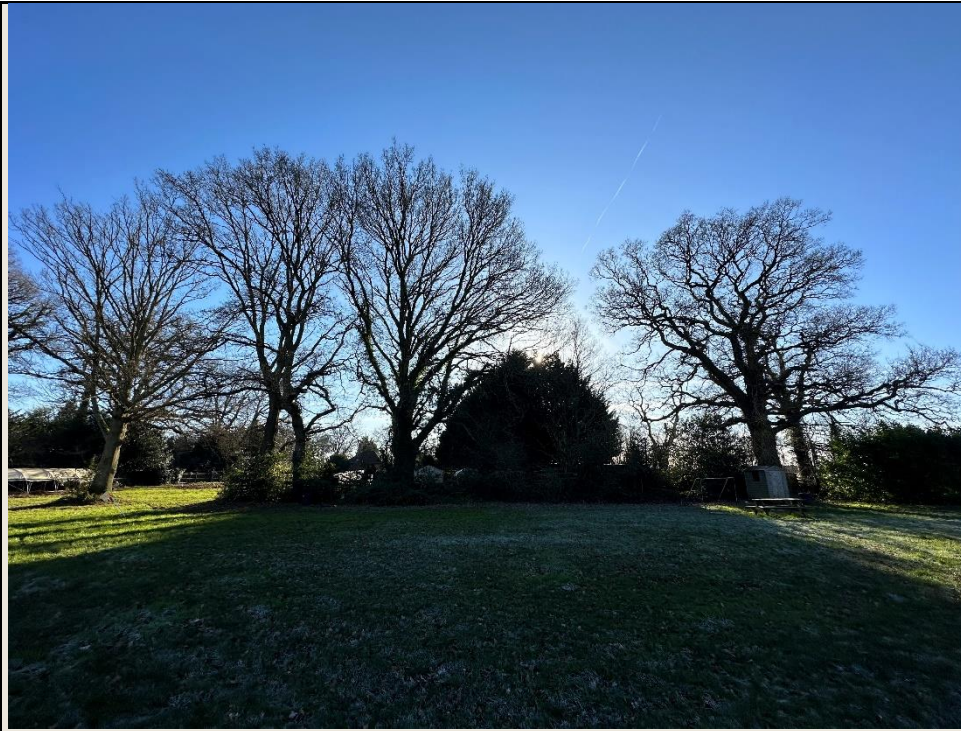
T13 & T14

| Tree ID | In Conservation Area/TPO | Species & Maturity | Likely Bat Habitat | Measurements estimated | Height (m) | Height and direction of first significant branch (m) | Number of Stems | Stem 1 (mm) or average diameter for trees with more than 5 stems | Stem 2 (mm) | Crown Spread (m) | | | | Crown height (average) | Crown, Stem, Basal Area | B.S. Category | Life Expectancy | Physical Condition | Build Stage | Recommended action | Date | Comment |
|---|---|---|---|---|---|---|---|---|---|---|---|---|---|---|---|---|---|---|---|---|---|---|
| T13 | Yes | Species:<br>Common Oak<br><br>Latin:<br>Quercus robur<br><br>Maturity:<br>Mature | No | No | 12 | 2.5e | 1 | 450 | | 7 | 6 | 7 | 6 | 4 | Crown-Fair,<br><br>Stem-Fair,<br><br>Basal Area-Fair | B3 | 20 to 40 yrs. | Fair | Pre-construction | Recommended action:<br>No action | 16.01.24 | Tree located on the northern boundary fence to the site with a reasonably well distributed crown spread with some deadwood in the lower crown. |

| Tree ID | In Conservation Area/TPO | Species & Maturity | Likely Bat Habitat | Measurements estimated | Height (m) | Height and direction of first significant branch (m) | Number of Stems | Stem 1 (mm) or average diameter for trees with more than 5 stems | Stem 2 (mm) | Crown Spread (m) | | | | Crown height (average) | Crown, Stem, Basal Area | B.S. Category | Life Expectancy | Physical Condition | Build Stage | Recommended action | Date | Comment |
|---|---|---|---|---|---|---|---|---|---|---|---|---|---|---|---|---|---|---|---|---|---|---|
| T14 | Yes | Species:<br>Common Oak<br><br>Latin:<br>Quercus robur<br><br>Maturity:<br>Over Mature | Yes | No | 26 | 4w | 1 | 1200 | | 9 | 11 | 9 | 12 | 6 | Crown-Fair,<br><br>Stem-Ivy,<br><br>Basal Area-Fair | A2 | >40 yrs. | Fair | Pre-construction | Recommended action:<br>No action | 16.01.24 | Located approximately 2m from the northern boundary fence of the site with area to the east a sports pitch. Stem is heavily covered in dead ivy thus the DBH has been estimated. |

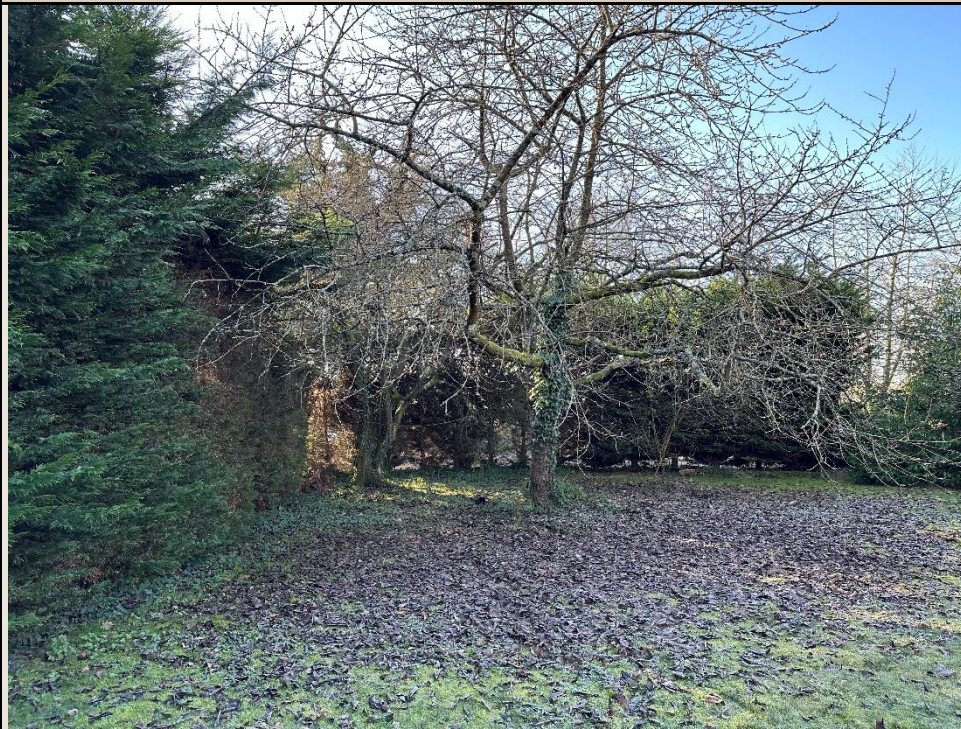
8. G23 requires removal as it is currently too close to the existing property for the building to be demolished.
9. There is no possible influence from the proposed alteration on the remaining surveyed trees.

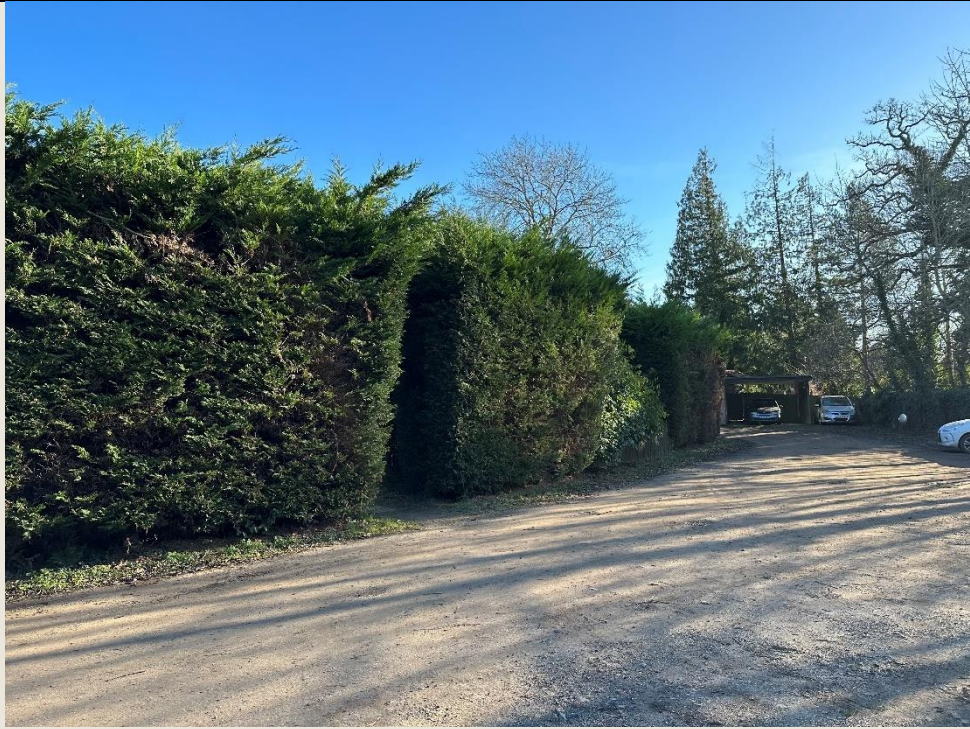
7. H22 borders the garden of the current southernmost dwelling of Dairy Cottage. It requires removal to allow for the construction of the proposed two new dwellings in this vicinity. This is also applicable to G26.

| Tree ID | In Conservation Area/TPO | Species & Maturity | Likely Bat Habitat | Measurements estimated | Height (m) | Height and direction of first significant branch (m) | Number of Stems | Stem 1 (mm) or average diameter for trees with more than 5 stems | Stem 2 (mm) | Crown Spread (m)<br>N E S W | | | | Crown height (average) | Crown, Stem, Basal Area | B.S. Category | Life Expectancy | Physical Condition | Build Stage | Recommended action | Date | Comment |
|---|---|---|---|---|---|---|---|---|---|---|---|---|---|---|---|---|---|---|---|---|---|---|
| H22 | Yes | Species:<br>Leyland Cypress<br><br>Latin:<br>X Cupressocyparis leylandii<br><br>Maturity:<br>Early Mature | No | No | 4 | 0.5w | 1 | 170 | | 10 | 1 | 10 | 1 | 1 | Crown-Fair,<br>Stem-Fair,<br>Basal Area-Fair | C2 | <10 yrs. | Fair | Pre-construction | Recommended action:<br>Removal and replacement replanting within the site | 16.01.24 | Tree of average to poor condition which has been maintained, but excessively cut back on one side, revealing brown foliage. |
