## **ARBORICULTURAL DEVELOPMENT REPORT**

### **Development tree report for Hall Hunter Partnership**

Site Address: Dairy Cottage, Heathlands Road,  
Wokingham, Berkshire, RG40 3AN

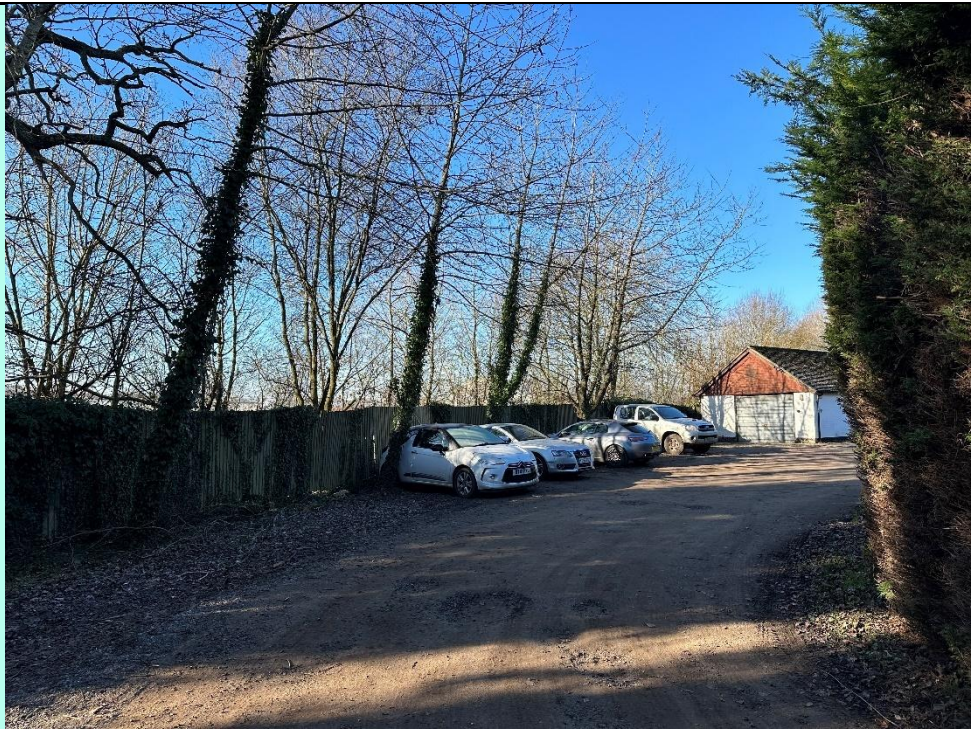
6. H9 and H10 are extremely overbearing, and the shading factor of these hedges would affect the 'reasonable' enjoyment of the proposed dwelling and garden. It would be far more beneficial to remove these hedges and replant with a more suitable hedge/ tree coverage.

| Tree ID | In Conservation Area/TPO | Species & Maturity | Likely Bat Habitat | Measurements estimated | Height (m) | Height and direction of first significant branch (m) | Number of Stems | Stem 1 (mm) or average diameter for trees with more than 5 stems | Stem 2 (mm) | Crown Spread (m)<br>N E S W | | | | | Crown height (average) | Crown, Stem, Basal Area | B.S. Category | Life Expectancy | Physical Condition | Build Stage | Recommended action | Date | Comment |
|---|---|---|---|---|---|---|---|---|---|---|---|---|---|---|---|---|---|---|---|---|---|---|---|
| H9 | Yes | Species:<br>Leyland Cypress<br><br>Latin:<br>X Cupressocyparis leylandii<br><br>Maturity:<br>Early Mature | Unknown | No | 15 | 2s | 1 | 220 | | 4 | 9 | 3 | 9 | 2 | | Crown-Fair,<br>Stem-Fair,<br>Basal Area-Fair | C1 | 10 to 20 yrs. | Fair | Pre-construction | Recommended action:<br>No action | 16.01.24 | Large Leyland Cyprus hedge boarding property on the western boundary, likely that some sections, or all of this hedge, will need to be removed to create an entrance. |

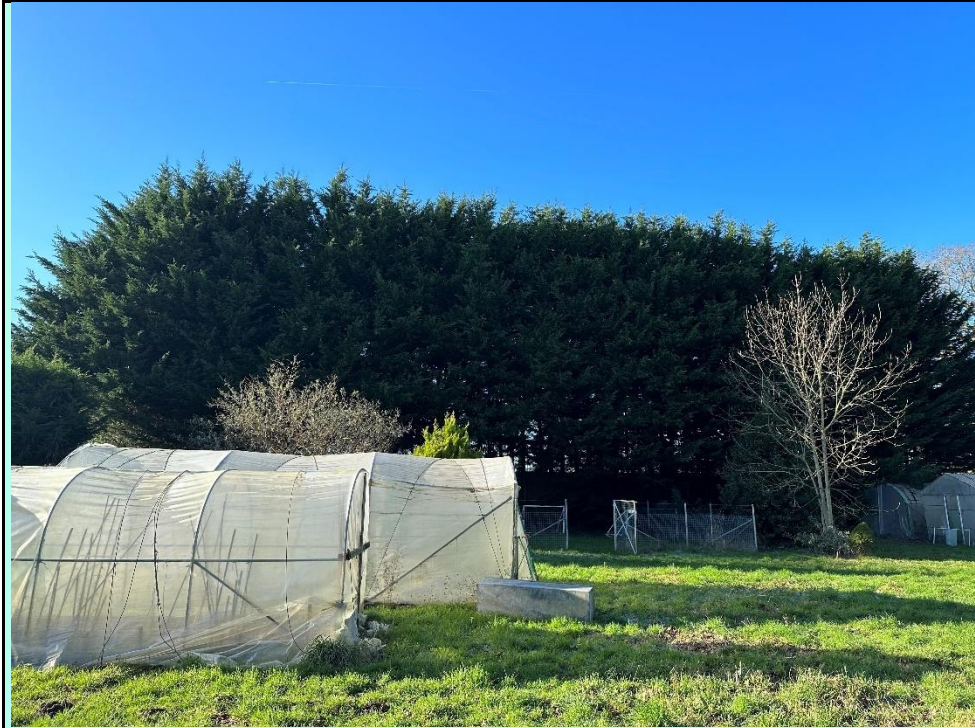
| Tree ID | In Conservation Area/TPO | Species & Maturity | Likely Bat Habitat | Measurements estimated | Height (m) | Height and direction of first significant branch (m) | Number of Stems | Stem 1 (mm) or average diameter for trees with more than 5 stems | Stem 2 (mm) | Crown Spread (m)<br>N E S W | | | | | Crown height (average) | Crown, Stem, Basal Area | B.S. Category | Life Expectancy | Physical Condition | Build Stage | Recommended action | Date | Comment |
|---|---|---|---|---|---|---|---|---|---|---|---|---|---|---|---|---|---|---|---|---|---|---|---|
| H10 | Yes | Species:<br>Leyland Cypress<br><br>Latin:<br>X Cupressocyparis leylandii<br><br>Maturity:<br>Early Mature | Unknown | No | 16 | 2.5e | 1 | 225 | | 10 | 4 | 10 | 5 | 2 | | Crown-Fair,<br>Stem-Fair,<br>Basal Area-Fair | C1 | 10 to 20 yrs. | Fair | Pre-construction | Recommended action:<br>No action | 16.01.24 | Long boundary hedge to the westernmost property on the site. |

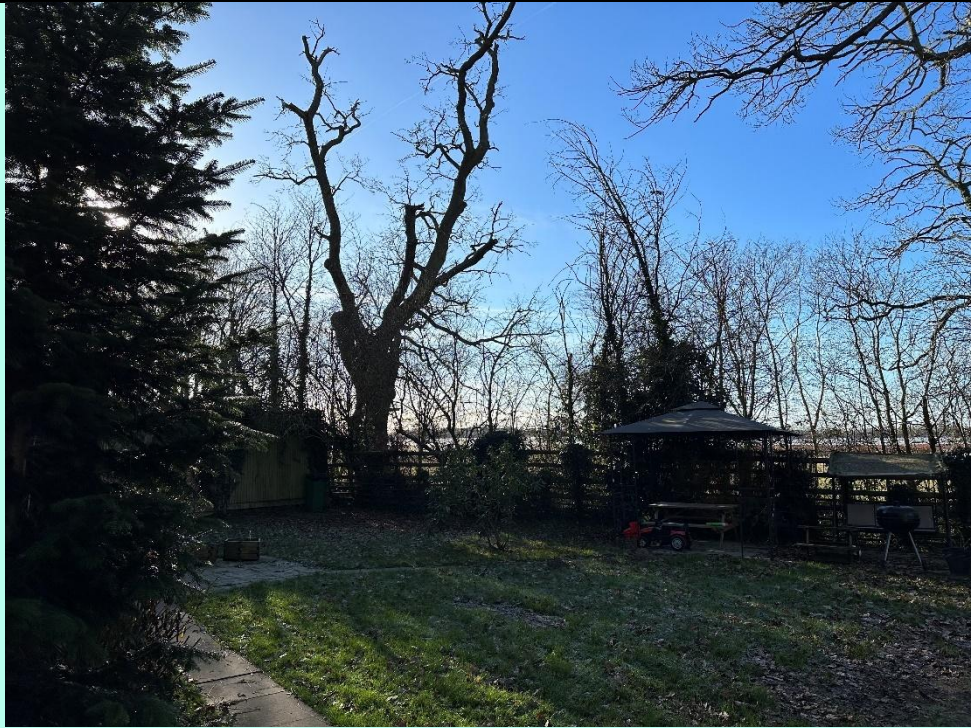
5. T11 has been categorised as a U category tree and thus should not be considered and impact upon the development, even if this tree was a higher classification its level of intrusion is minimal and thus, we do not consider it impact to warrant any mitigation as the only potential impact is from the car parking area which is at the peripheral edge of the RPA.

| Tree ID | In Conservation Area/TPO | Species & Maturity | Likely Bat Habitat | Measurements estimated | Height (m) | Height and direction of first significant branch (m) | Number of Stems | Stem 1 (mm) or average diameter for trees with more than 5 stems | Stem 2 (mm) | Crown Spread (m)<br>N E S W | | | | | Crown height (average) | Crown, Stem, Basal Area | B.S. Category | Life Expectancy | Physical Condition | Build Stage | Recommended action | Date | Comment |
|---|---|---|---|---|---|---|---|---|---|---|---|---|---|---|---|---|---|---|---|---|---|---|---|
| T11 | Yes | Species:<br>Common Oak<br><br>Latin:<br>Quercus robur<br><br>Maturity:<br>Over Mature | Unknown | Yes | 18 | 5w | 1 | 950 | | 9 | 5 | 7 | 9 | 7 | | Crown-Declining,<br>Stem-Poor,<br>Basal Area-Fair | U | <10 yrs. | Declining | Pre-construction | Recommended action:<br>See comment | 16.01.24 | Tree is located to the west of the site approximately 2m from the boundary fence. Tree is it advanced stages of decline with numerous dead limbs and decay fungi at the base. Essential this tree is assessed from a health and safety perspective. |

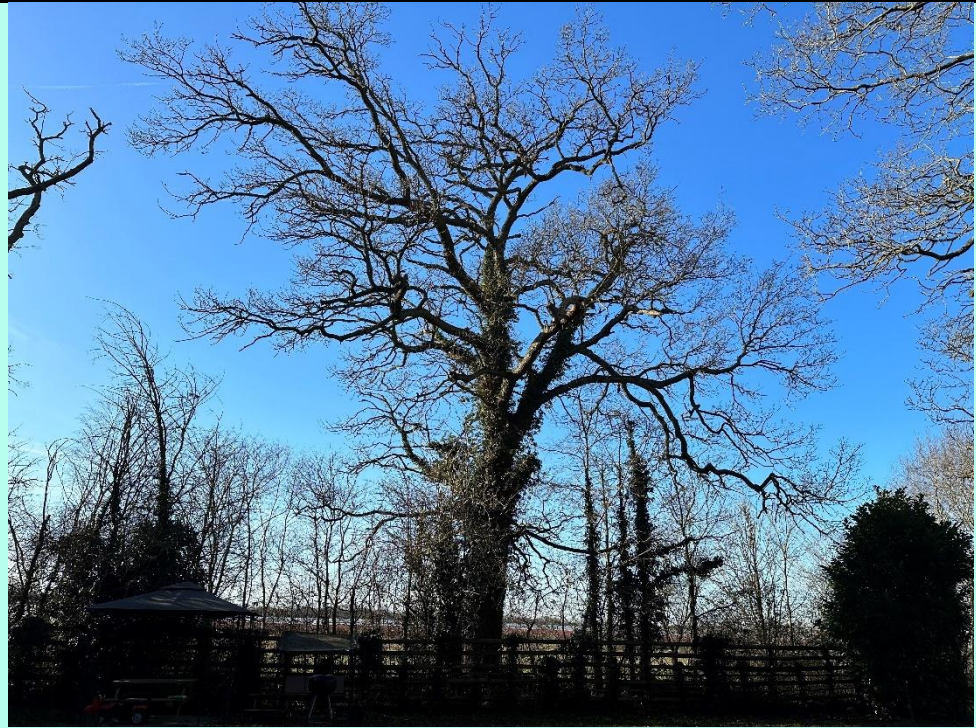
| Tree ID | In Conservation Area/TPO | Species & Maturity | Likely Bat Habitat | Measurements estimated | Height (m) | Height and direction of first significant branch (m) | Number of Stems | Stem 1 (mm) or average diameter for trees with more than 5 stems | Stem 2 (mm) | Crown Spread (m)<br>N E S W | | | | | Crown height (average) | Crown, Stem, Basal Area | B.S. Category | Life Expectancy | Physical Condition | Build Stage | Recommended action | Date | Comment |
|---|---|---|---|---|---|---|---|---|---|---|---|---|---|---|---|---|---|---|---|---|---|---|---|
| T12 | Yes | Species:<br>Common Oak<br><br>Latin:<br>Quercus robur<br><br>Maturity:<br>Over Mature | Yes | Yes | 26 | 4w | 1 | 1000 | | 12 | 9 | 12 | 9 | 5 | | Crown-Fair,<br>Stem-Ivy,<br>Basal Area-Fair | A3 | >40 yrs. | Fair | Pre-construction | Recommended action:<br>No action | 16.01.24 | Tree also located 2m to the west of the site boundary. Stem and midsection crown is heavily covered in ivy and a large proportion of deadwood throughout the crown. |

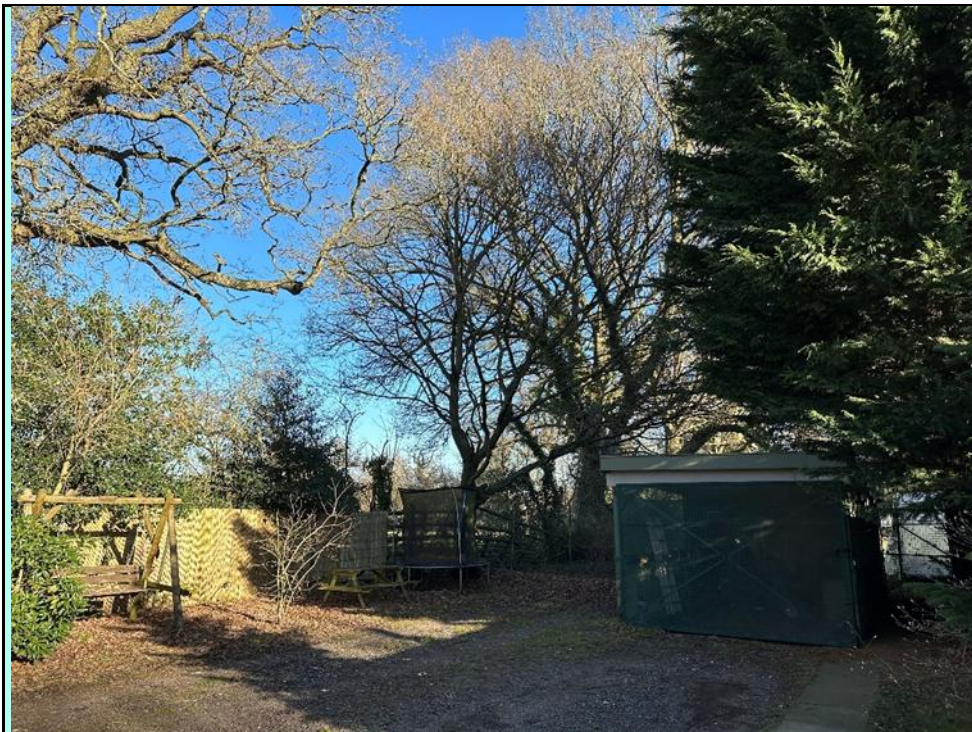
T13 & T14

| Tree ID | In Conservation Area/TPO | Species & Maturity | Likely Bat Habitat | Measurements estimated | Height (m) | Height and direction of first significant branch (m) | Number of Stems | Stem 1 (mm) or average diameter for trees with more than 5 stems | Stem 2 (mm) | Crown Spread (m)<br>N E S W | | | | | Crown height (average) | Crown, Stem, Basal Area | B.S. Category | Life Expectancy | Physical Condition | Build Stage | Recommended action | Date | Comment |
|---|---|---|---|---|---|---|---|---|---|---|---|---|---|---|---|---|---|---|---|---|---|---|---|
| T13 | Yes | Species:<br>Common Oak<br><br>Latin:<br>Quercus robur<br><br>Maturity:<br>Mature | No | No | 12 | 2.5e | 1 | 450 | | 7 | 6 | 7 | 6 | 4 | | Crown-Fair,<br>Stem-Fair,<br>Basal Area-Fair | B3 | 20 to 40 yrs. | Fair | Pre-construction | Recommended action:<br>No action | 16.01.24 | Tree located on the northern boundary fence to the site with a reasonably well distributed crown spread with some deadwood in the lower crown. |

| Tree ID | In Conservation Area/TPO | Species & Maturity | Likely Bat Habitat | Measurements estimated | Height (m) | Height and direction of first significant branch (m) | Number of Stems | Stem 1 (mm) or average diameter for trees with more than 5 stems | Stem 2 (mm) | Crown Spread (m)<br>N E S W | | | | | Crown height (average) | Crown, Stem, Basal Area | B.S. Category | Life Expectancy | Physical Condition | Build Stage | Recommended action | Date | Comment |
|---|---|---|---|---|---|---|---|---|---|---|---|---|---|---|---|---|---|---|---|---|---|---|---|
| T14 | Yes | Species:<br>Common Oak<br><br>Latin:<br>Quercus robur<br><br>Maturity:<br>Over Mature | Yes | No | 26 | 4w | 1 | 1200 | | 9 | 11 | 9 | 12 | 6 | | Crown-Fair,<br>Stem-Ivy,<br>Basal Area-Fair | A2 | >40 yrs. | Fair | Pre-construction | Recommended action:<br>No action | 16.01.24 | Located approximately 2m from the northern boundary fence of the site with area to the east a sports pitch. Stem is heavily covered in dead ivy thus the DBH has been estimated. |

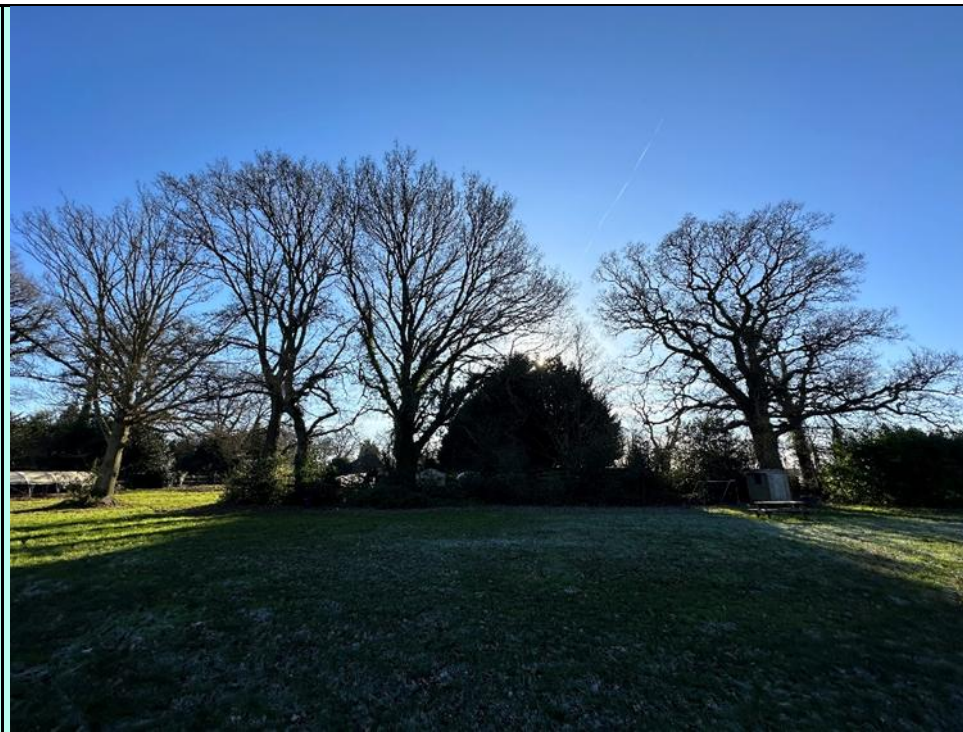
Trees T15 to T18

| Tree ID | In Conservation Area/TPO | Species & Maturity | Likely Bat Habitat | Measurements estimated | Height (m) | Height and direction of first significant branch (m) | Number of Stems | Stem 1 (mm) or average diameter for trees with more than 5 stems | Stem 2 (mm) | Crown Spread (m)<br>N E S W | | | | | Crown height (average) | Crown, Stem, Basal Area | B.S. Category | Life Expectancy | Physical Condition | Build Stage | Recommended action | Date | Comment |
|---|---|---|---|---|---|---|---|---|---|---|---|---|---|---|---|---|---|---|---|---|---|---|---|
| T15 | Yes | Species:<br>Common Oak<br><br>Latin:<br>Quercus robur<br><br>Maturity:<br>Over Mature | Yes | Yes | 28 | 6w | 1 | 1200 | | 10 | 6 | 10 | 12 | 6 | | Crown-Good,<br>Stem-Ivy,<br>Basal Area-Fair | A2 | >40 yrs. | Good | Pre-construction | Recommended action:<br>No action | 16.01.24 | Tree located on the northern boundary of the site. High value tree. Lower stem and mid crown heavily covered in ivy. |
| T16 | Yes | Species:<br>Common Oak<br><br>Latin:<br>Quercus robur<br><br>Maturity:<br>Mature | Unknown | No | 15 | 4s | 1 | 520 | | 9 | 6 | 1 | 4 | 5 | | Crown-Fair,<br>Stem-Fair,<br>Basal Area-Fair | B2 | 20 to 40 yrs. | Fair | Pre-construction | Recommended action:<br>No action | 16.01.24 | Tree located on the northern boundary and is of a heavily suppressed nature, with an excessively biased crown to the east. |
| T17 | Yes | Species:<br>Common Oak<br><br>Latin:<br>Quercus robur<br><br>Maturity:<br>Mature | Unknown | Yes | 25 | 2.5s | 1 | 950 | | 7 | 5 | 10 | 5 | 5 | | Crown-Good,<br>Stem-Fair,<br>Basal Area-Fair | A2 | >40 yrs. | Good | Pre-construction | Recommended action:<br>No action | 16.01.24 | Tree is located on the opposite side of the northern boundary fence with a large amount of major deadwood in the lower crown. |

| Tree ID | In Conservation Area/TPO | Species & Maturity | Likely Bat Habitat | Measurements estimated | Height (m) | Height and direction of first significant branch (m) | Number of Stems | Stem 1 (mm) or average diameter for trees with more than 5 stems | Stem 2 (mm) | Crown Spread (m)<br>N E S W | | | | | Crown height (average) | Crown, Stem, Basal Area | B.S. Category | Life Expectancy | Physical Condition | Build Stage | Recommended action | Date | Comment |
|---|---|---|---|---|---|---|---|---|---|---|---|---|---|---|---|---|---|---|---|---|---|---|---|
| T18 | Yes | Species:<br>Common Oak<br><br>Latin:<br>Quercus robur<br><br>Maturity:<br>Over Mature | | No | 26 | 6s | 1 | 865 | | 9 | 7 | 11 | 6 | 6 | | Crown-Fair,<br>Stem-Fair,<br>Basal Area-Good | A2 | >40 yrs. | Fair | Pre-construction | Recommended action:<br>No action | 16.01.24 | Last tree of this northern boundary section. Main stem bifurcates at 3m into triple stem crown with a large amount of deadwood in the mid and lower section. |

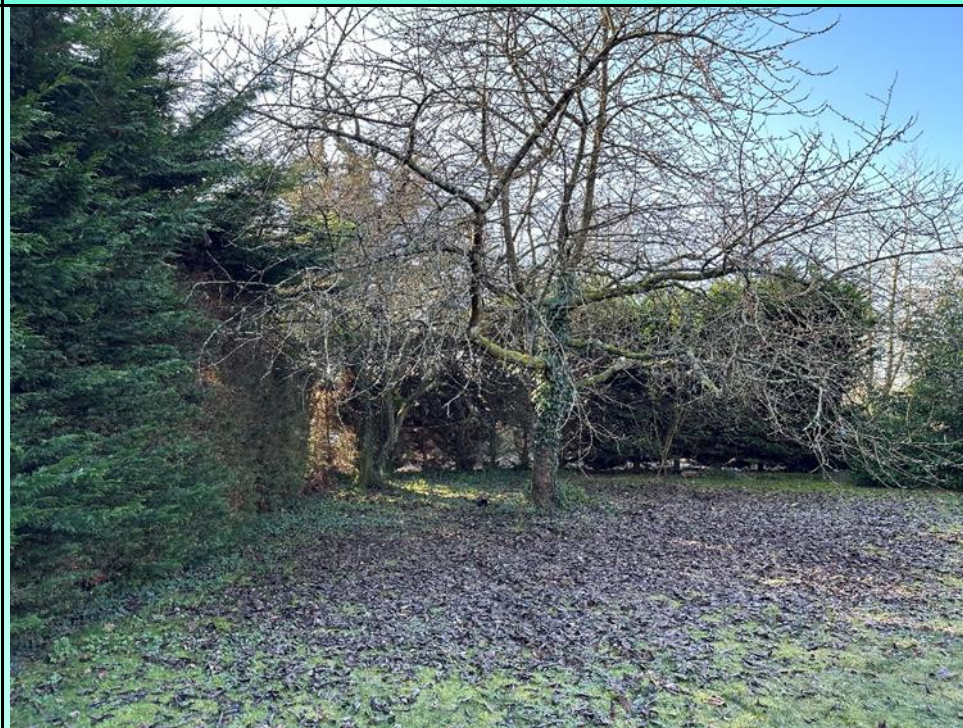
8. Trees T24 & T25 are both of relative low condition with minimal environmental benefits and very close to the building of Plot 1.
9. There is no possible influence from the proposed alteration on the remaining surveyed trees.
