# MEMORANDUM

| <b>Service</b> | Green Infrastructure | <b>App No:</b> | 252533 |
| <b>Address:</b> | Reddam House, Bearwood Road, Sindlesham, RG41 5BG. | | |
| <b>Proposal:</b> | Application for Listed Building consent for the proposed structural remedial works to stairwell. | | |

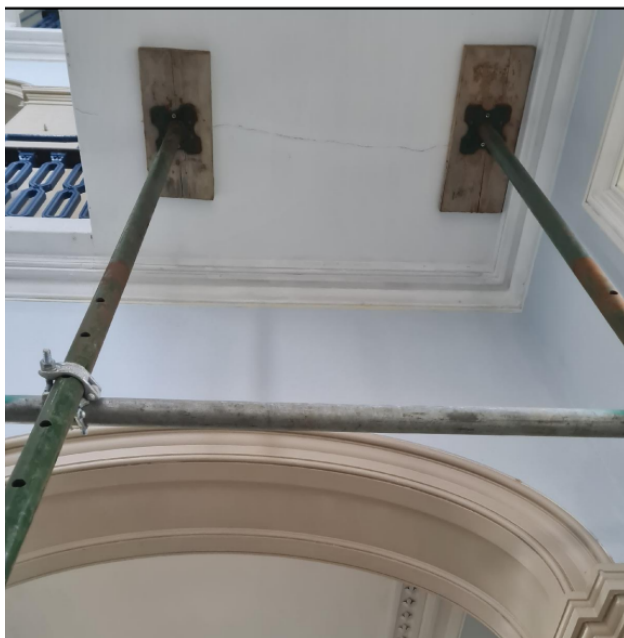
At this point it should be said that at the time the visit for this consultation response aside from the visual evidence issue seen with the need to prop the first-floor landing to the cantilevered staircase it did not seem apparent that this cracking issue was noticeable or evident on the other floor landings, none of which have had to be propped for safety.

Underside of cantilevered landing of stairs at first floor.

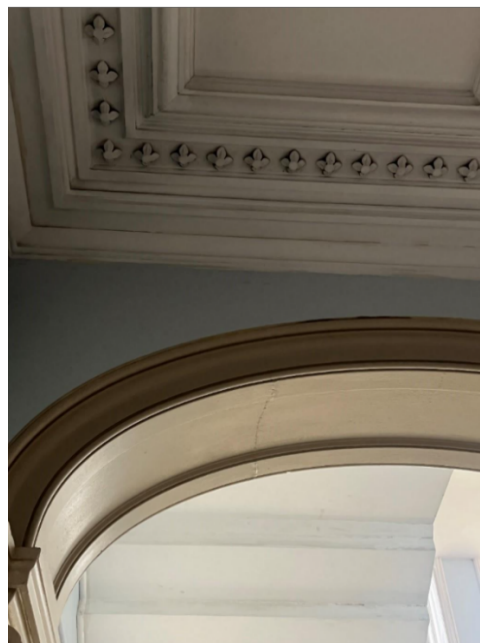
There is historic decorative cornice crown moulding detailing to the ceilings of the formal corridor/landing to each of the floors (other than basement level) of the main building to which the staircase give access to. Whilst an original and plainer cornice moulding detail runs beneath the cast iron balustrades, of each of the floor slabs, on the stairwell side, running across the back of underside of the landing, atop each staircase run and along the outer wall of the back stair enclosure.

As proposed, it would be necessary to remove sections of these historic decorative cornice mouldings, along with the walling plaster, in order to fix the brackets and spread plates into to the masonry walling between around the moulded arched opening to the floor level below and each of the cantilevered staircase landing. It

Crown moulding & decorative arch, main building.

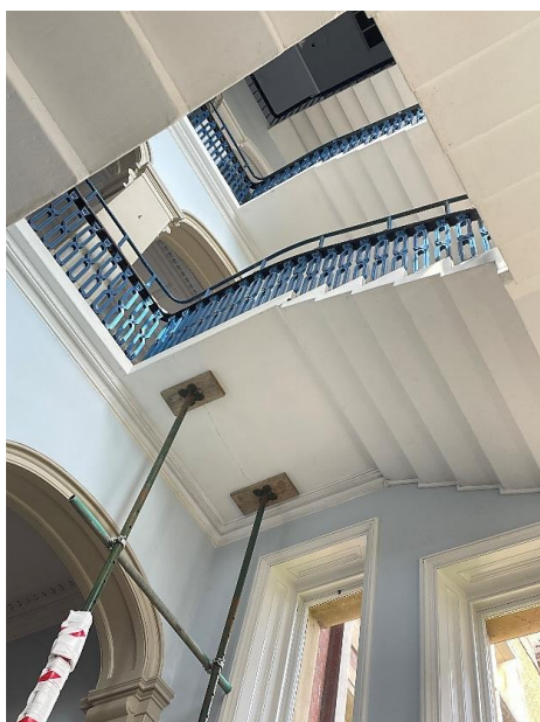
- Also not convinced the sections accurately show the height from the top of the archway opening (it is noted the arch moulding to the arch is not shown) and that of the ceiling/underside of the floor slab of the level above. The photograph attached shows a much smaller apparent gap.

- Whilst it is clear the height of the masonry walling above the decorative floor level archway landing opening to have installed the intended support brackets, albeit with one of the brackets seemingly would extend down to terminate close (best guestimate is less than 100mm) to the decorative arch moulding. In slab of the floor above resulting in a reduced area of masonry walling over the decorative moulded arch opening does suggest that it is questionable there is sufficient space to install at least one of the backing plates, which appear to be 500mm in length (best guestimate). As such there is concern spreader plates may affect the decorative moulding of the archways.

Figure 1. View of underside of feature arch over ground floor landing.

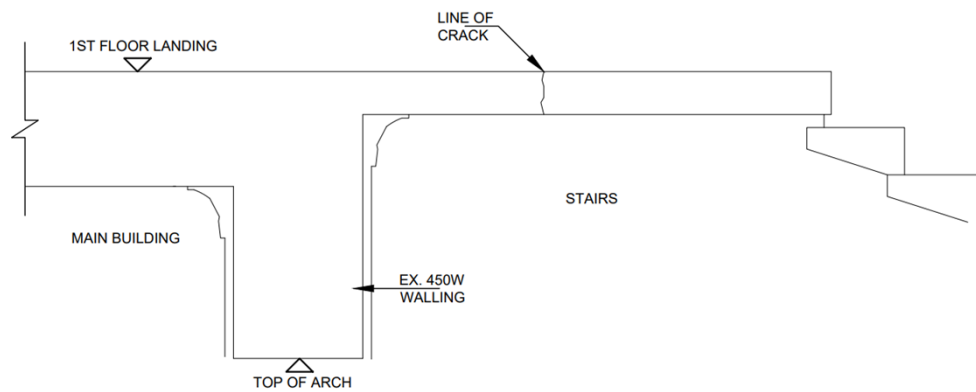
**EX. SECTION AT ARCH OPENING - UNDERSIDE  
OF 1ST FLOOR REAR STAIRCASE (1:20)**

- The sections do not accurately depict the profile of the cornice moulding, especially that of the crown moulding, which does not accord with the form and depth (projection out onto the ceiling).

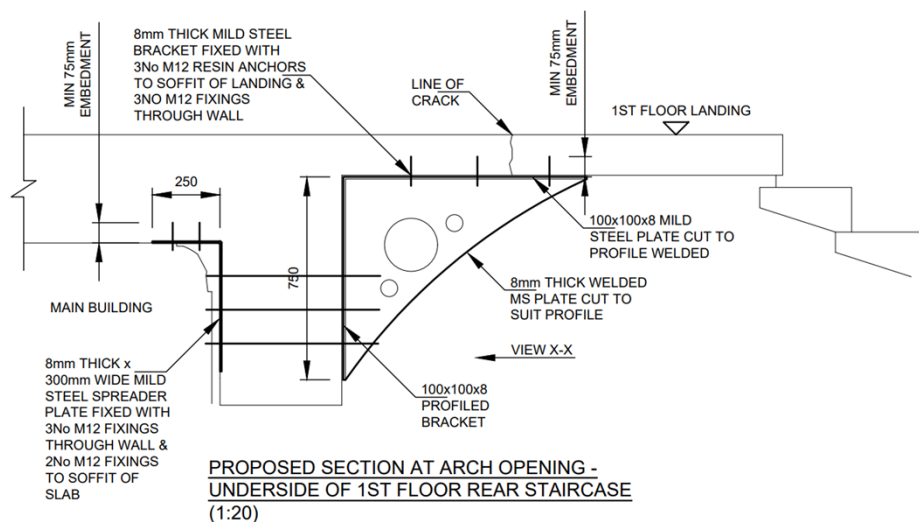
**PROPOSED SECTION AT ARCH OPENING -  
UNDERSIDE OF 1ST FLOOR REAR STAIRCASE  
(1:20)**

In terms of the actual intended structural works the proposal is for the addition of mild steel brackets with a 'L' shaped profile to them that are to be secured in pairs to underside of the staircases floor level landings and also secured in the masonry walling above the archway opening to the floor level below, with a 300mm wide mild steel spreader plate added on the aspect of the walling within the main building, with the upper end 250mm of the spreader plate bent over 90 degrees and fixed into the ceiling/floor slab.

From a heritage stance the concern here then is with the apparent intention remove part of these decorative cornice mouldings in order to both affix brackets and their back plates to the masonry walling, with the submitted proposed section drawings appears to indicate the intention to have removed both the cornice moulding and wall plaster where the brackets are to be situated. Whilst the proposed elevation does not make it clear as to the extent of the cornice and plasterwork would need to be removed. Furthermore, with respect to proposed elevation plan it is not clear given the 'L' shaped profile of the brackets as to whether they are to be a mirrored pair or not. And whether, given the intention to cut back the plasterwork to the face of the masonry wall to be able mount the brackets as to whether the plaster would be re-instated over the back vertical portion of the brackets or not.

Notwithstanding the details submitted, prior to commencement of any works to remove plasterwork and cornice moulding in order to have installed the gallows brackets and spreader plates, details to confirm the position of the gallows brackets and spreader plates have been submitted to and approved in writing by the local planning authority. The details shall confirm installation of the brackets and spreader plates on the masonry walling over the arched opening to the floor level can be carried out without affecting the decorative moulding of the arched opening. Works to install the gallows brackets and spreader plates shall then be undertaken in accordance with the details as approved.

Notwithstanding the details submitted, no works to make repairs to the historic decorative cornice mouldings and the plaster to the walling until details setting out the methodology for the re-instatement of the cornice mouldings and wall plaster have been submitted to and approved in writing by the local planning authority. The reinstatement of the cornice mouldings and wall plaster shall then be undertaken in accordance with those details so approved.
