**Arboricultural Implications  
Assessment  
for a proposed development  
at  
The Old Thatch  
Lower Sandhurst Road  
Finchampstead  
RG40 3TH  
Rev B**

**Client: Robert & Lucy Westell  
The Old Thatch  
Lower Sandhurst Road  
Finchampstead  
RG40 3TH**

**Date**  
14/01/2026

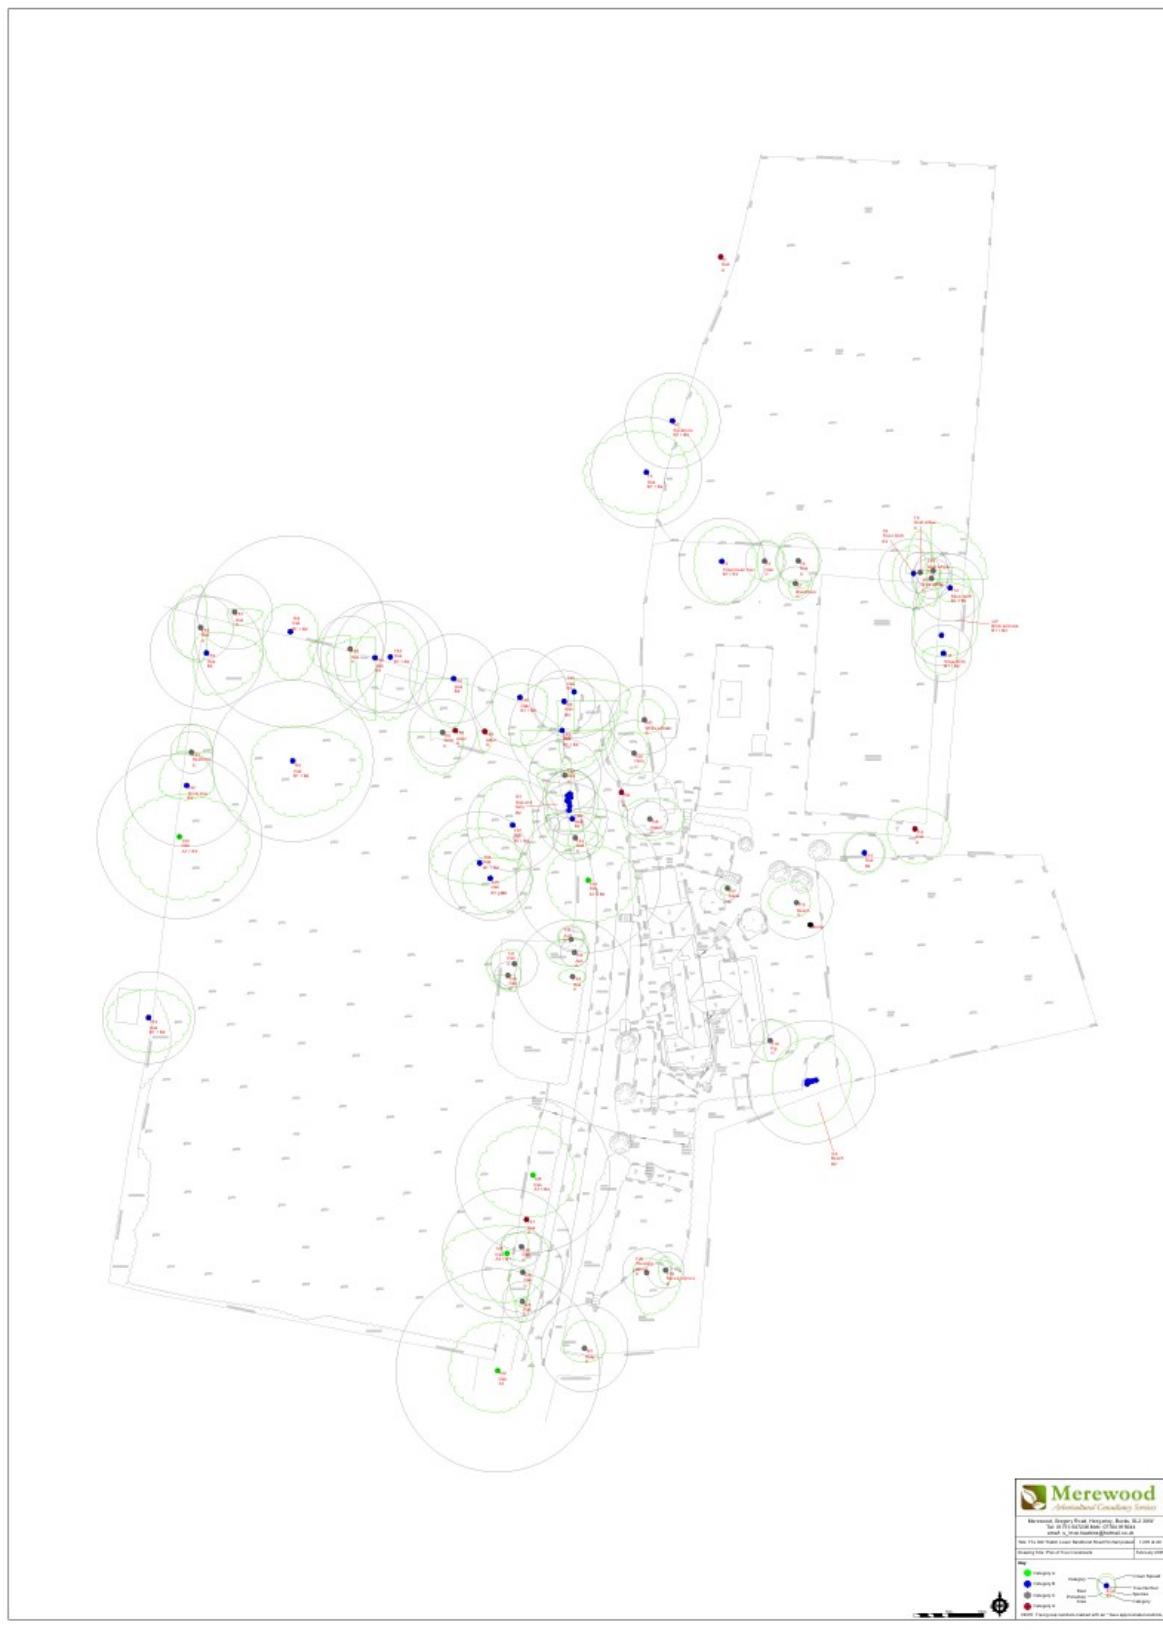
### Plan of Tree Constraints

2.1.2 The survey has revealed that that of the 64 trees and 3 groups of trees surveyed, 5 are category 'A'; 23 are category 'B' plus 3 category 'B' groups; 30 are category 'C' and 6 are category 'U'.

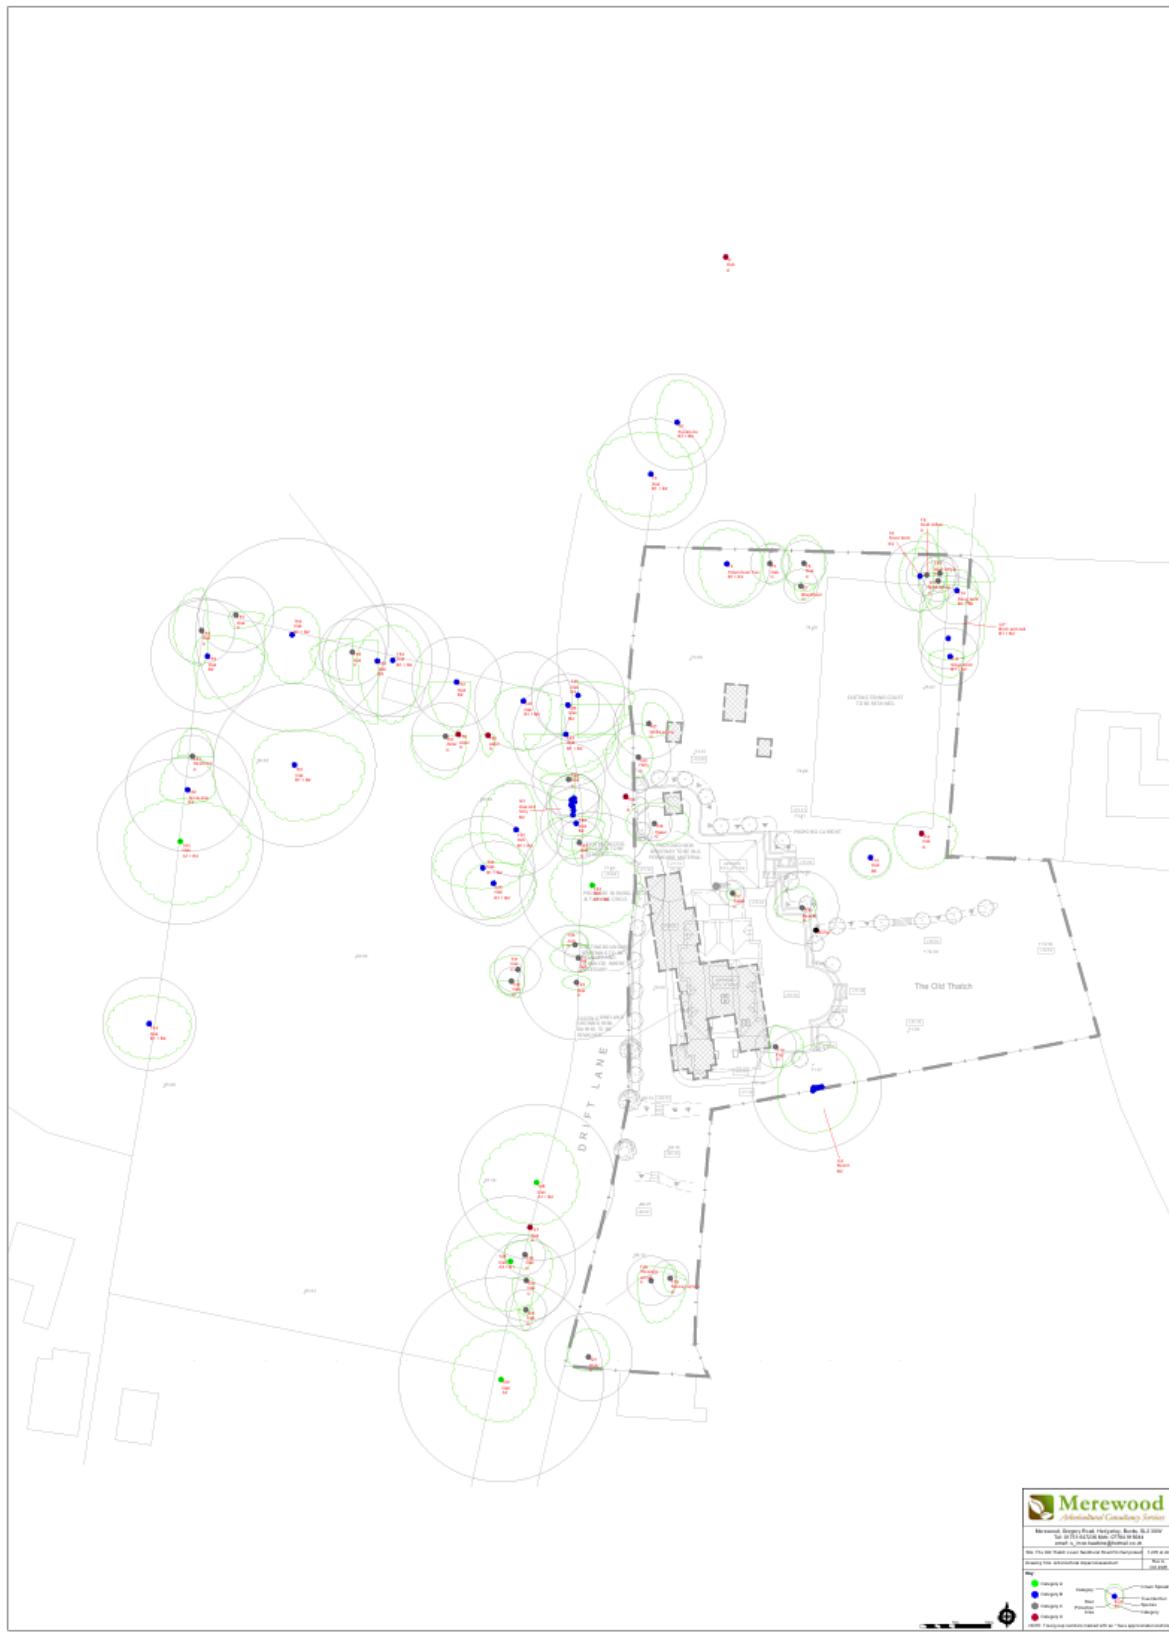
### **Impact Assessment Plan**

3.6.1 The proposed driveway takes a different shape and position to the existing driveway but would create only a very minimal impact on the RPA of the oak (T34). This conclusion is reached taking into account the existing driveway and the existing building, the footprint of which will be partly occupied by the new driveway following demolition.

3.6.3 The proposed building and patio do encroach onto the RPA of the group of beech trees (G2), but it is considered that it will still be possible to retain these trees. In coming to this conclusion the following factors are taken into account.

- a) The total encroachment amounts to 15m<sup>2</sup> out of the total RPA amounting to just 6.5%, well within the tolerance limits of normally growing healthy trees.
- b) The encroachment is largely from the patio element, that requires a shallower foundation than the main house. Deeper roots will remain beneath the patio.
- c) The remaining rooting area available to the trees extends unhindered in all other directions, so a substantially larger than minimum soil volume will still be available to the trees to continue to support normal vitality.

- 3.2.1 The proposals require the removal of a total of 5 category 'C' trees. These are T16, T17, T18, T38 and T40.
- 3.2.2 In addition, dead and diseased trees with a limited life expectancy (category U) are to be removed in the interests of sound arboricultural management.

3.6.2 In order to further protect the roots of the oak (T34), a cellular confinement product is to be used to create a permeable layer onto which the final driveway can be laid, following completion of the construction work to the house.
