**Arboricultural Implications  
Assessment  
for a proposed development  
at  
The Old Thatch  
Lower Sandhurst Road  
Finchampstead  
RG40 3TH**

**Client: Robert & Lucy Westell  
The Old Thatch  
Lower Sandhurst Road  
Finchampstead  
RG40 3TH**

**Date**  
07/05/2025

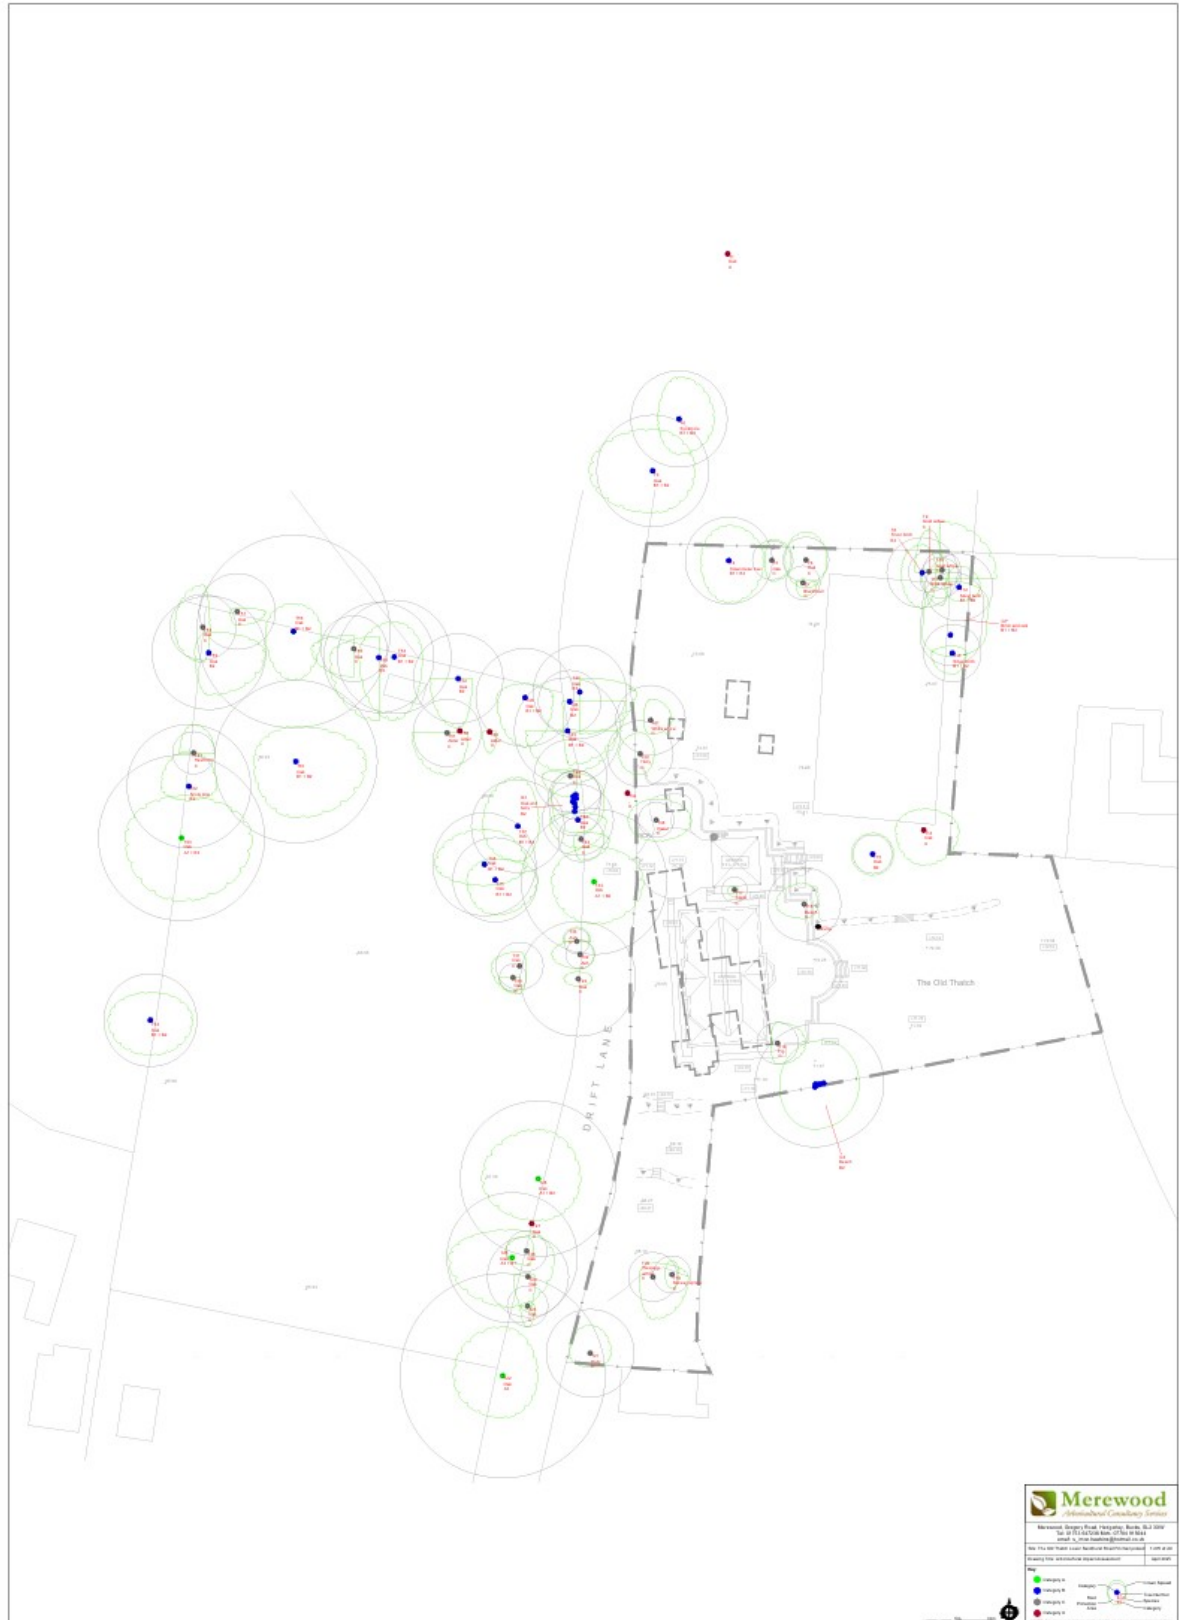
### Impact Assessment Plan

- 3.6.1 The proposed house will encroach slightly onto the RPA of the group of beech trees (G2). This encroachment is caused by the construction of the patio area and amounts to 15m<sup>2</sup> out of a total RPA of 226.5m<sup>2</sup> or 6.5%.

- 3.6.2 It is considered that this encroachment would not be excessively detrimental to the group of trees.
- 3.6.3 The proposed driveway takes a different shape and position to the existing driveway but would create only a very minimal impact on the RPA of the oak (T34). This conclusion is reached taking into account the existing driveway and the existing building, the footprint of which will be partly occupied by the new driveway following demolition.

3.2.1 The proposals require the removal of a total of 5 category 'C' trees. These are T16, T17, T18, T38 and T40.
