Ref: LAS\_463  
Date: 15.12.2023

**Site: The Coopers, Penny Lane, Wargrave**

## **Arboricultural Statement**

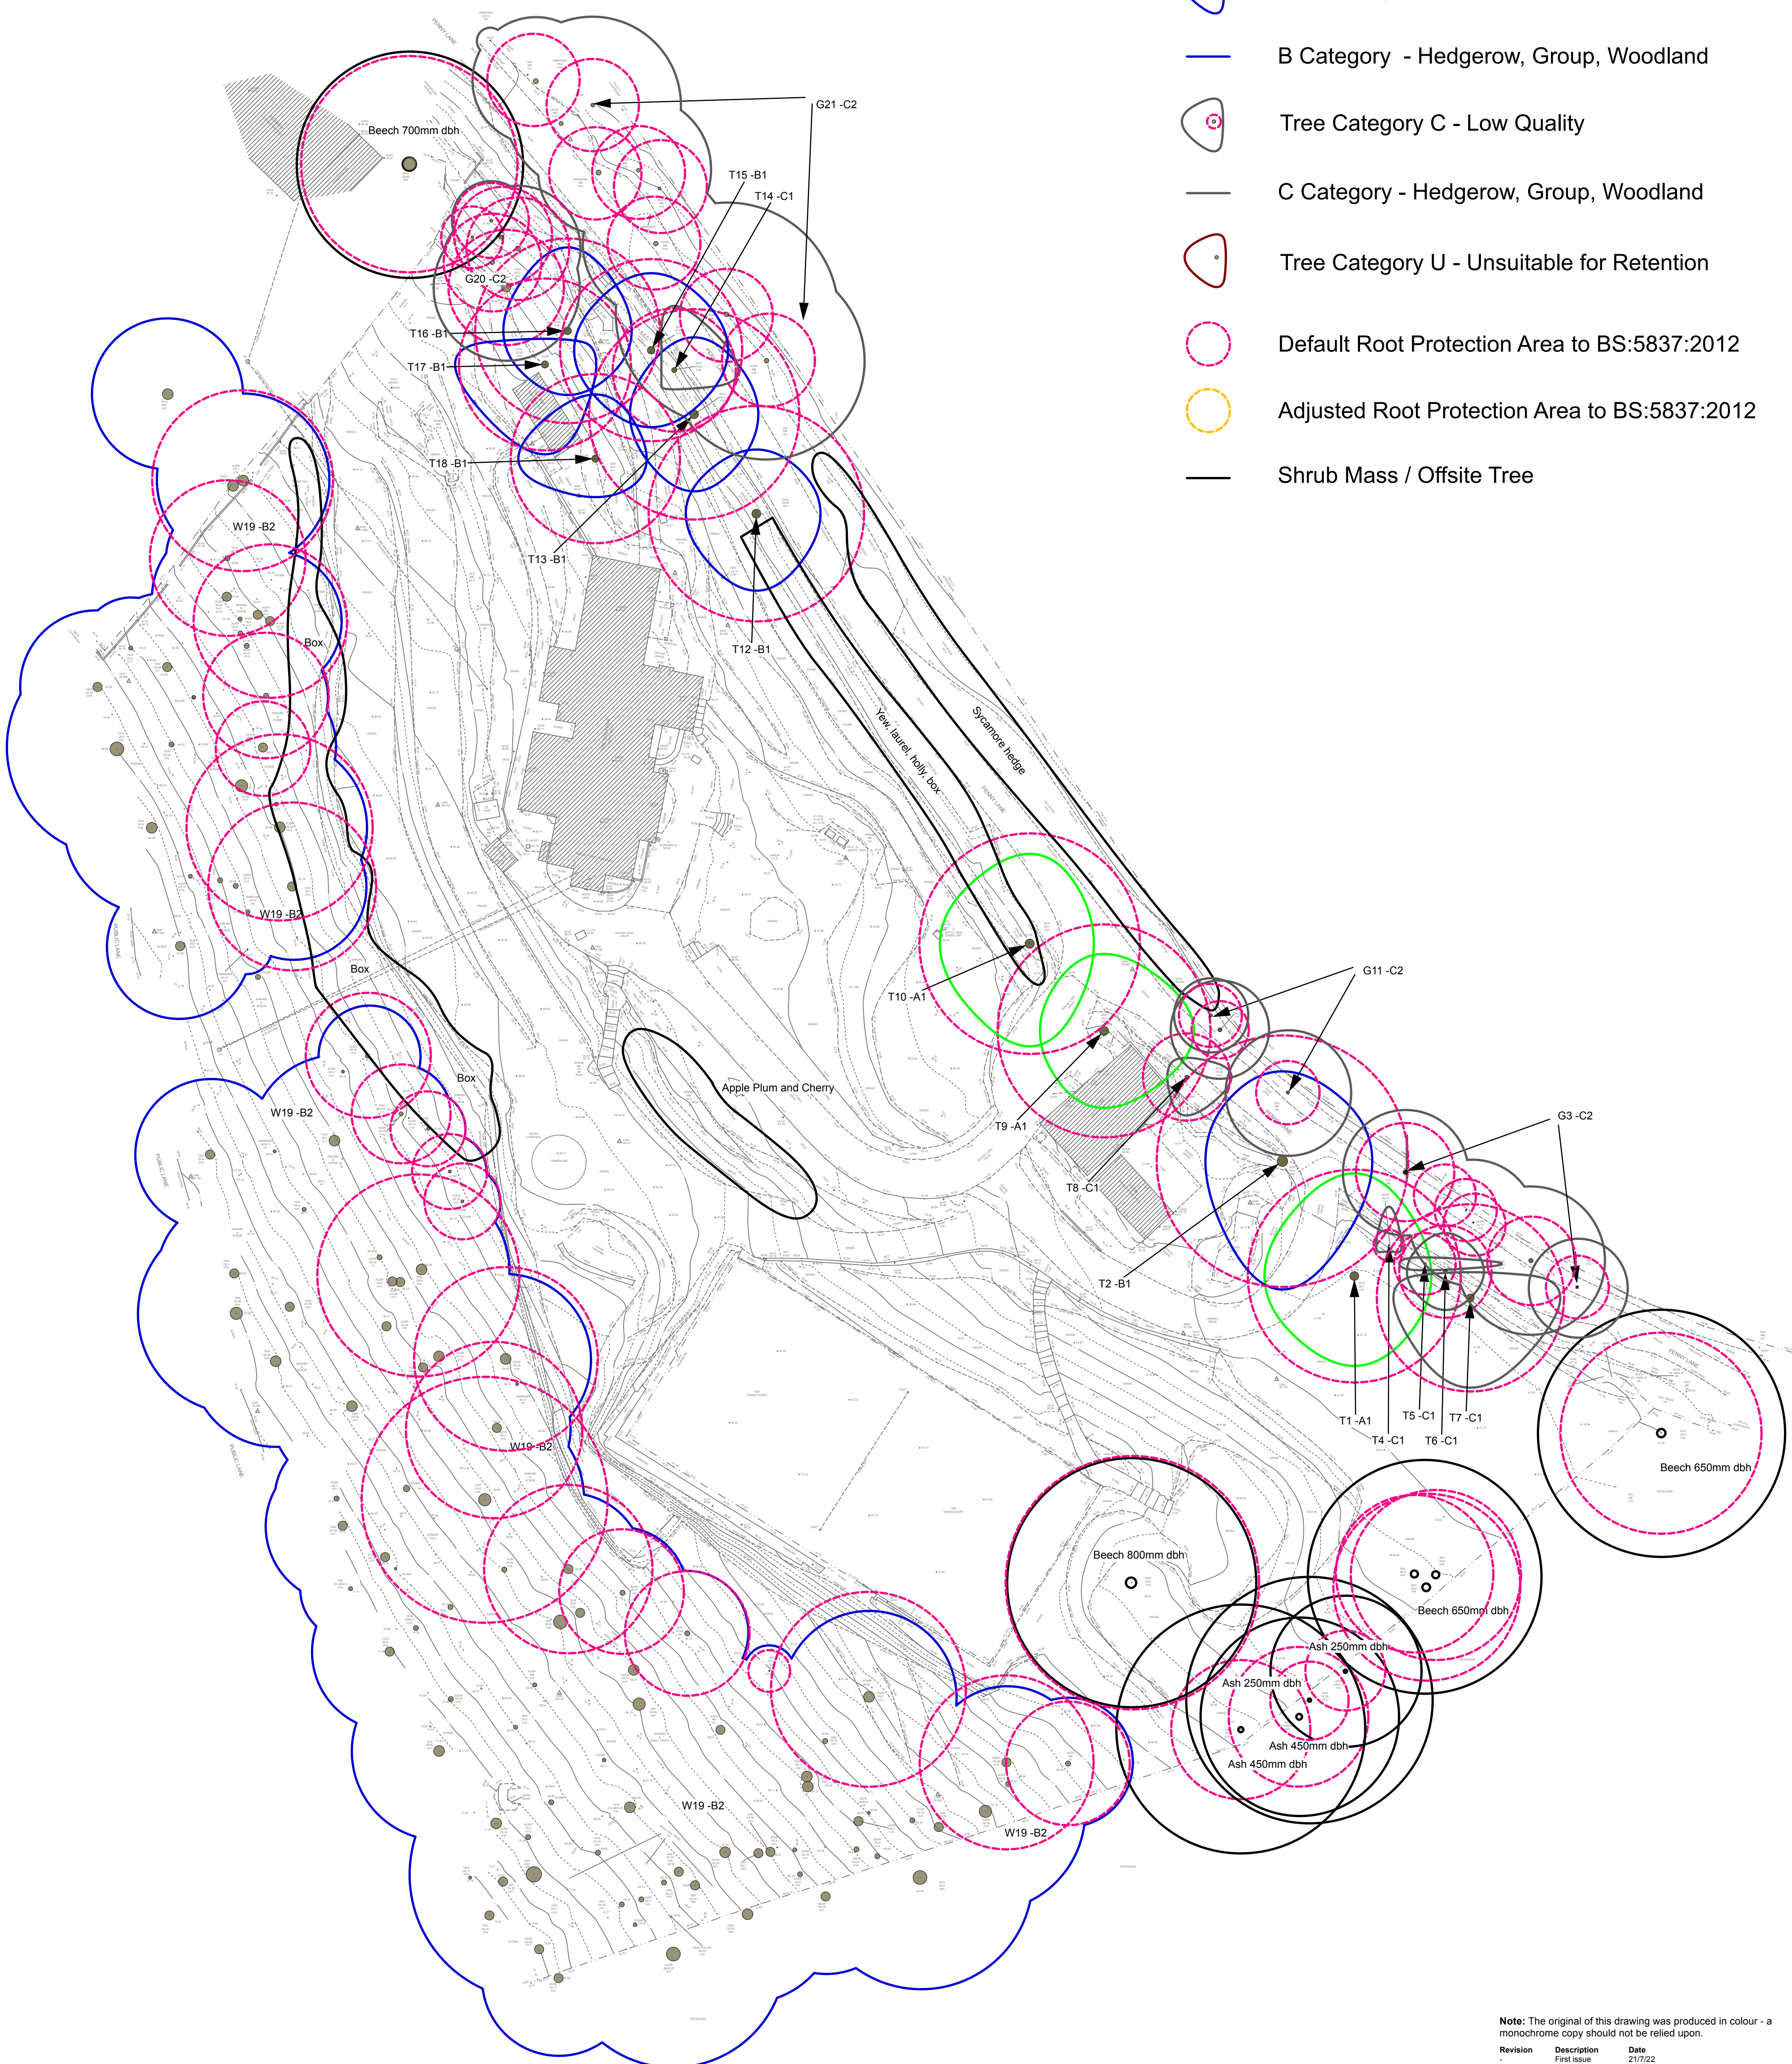
**Appendix 1:  
Tree Survey and Constraints Plan and Schedule**

| Ref no. | Species | Ht. (m) | | | | | Crown Spread (m) | | | | | | | | Life stage | ULE | Physiological Condition | Structural Condition | General observations and Notes |
|---|---|---|---|---|---|---|---|---|---|---|---|---|---|---|---|---|---|---|---|
| T1 | Beech | 12.0 | 690 | 8.3 | 215 | A1 | 8.0 | 6.0 | 7.0 | 7.0 | N/A | - | N/A | 3.5 | M | 20+ | Good | Fair | Large tree, dense canopy. Some interior deadwood, twin stem from 5m with kinked leaders. Past branch loss evident. |
| T2 | Beech | 13.0 | 820 | 9.8 | 304 | B1 | 7.0 | 7.0 | 10.0 | 6.0 | N/A | - | N/A | 3.5 | M | 20+ | Good | Fair | Large tree, dense crown, interior canopy deadwood and past branch loss, stem leans slight to north east, and is set on edge of bridleway embankment. Bark damage appears may be canker. |
| T9 | Beech | 15.0 | 690 | 8.3 | 215 | A1 | 6.0 | 7.0 | 6.0 | 5.0 | N/A | - | N/A | 2.0 | M | 20+ | Good | Fair | Stem leans east, large tree, dense canopy, some interior deadwood, canopy touching outbuilding. |
| T13 | Beech | 19.5 | 680 | 8.2 | 209 | B1 | 6.0 | 5.0 | 6.0 | 5.0 | N/A | - | N/A | 5.5 | M | 20+ | Good | Fair | Large tree on edge of drive and bridleway, pruned in past, some past branch loss. Cavity in old branch loss point west side. |
| T16 | Beech | 19.5 | 600 | 7.2 | 163 | B1 | 6.5 | 5.0 | 5.0 | 5.0 | N/A | - | N/A | 5.0 | M | 20+ | Fair | Fair | High canopy, deadwood in Lower canopy needs removing, appears central leader snapped out in past leading dead branch stub. Needs climbing inspection to determine extent of decay. Small, cavities in old pruning wounds north side. |

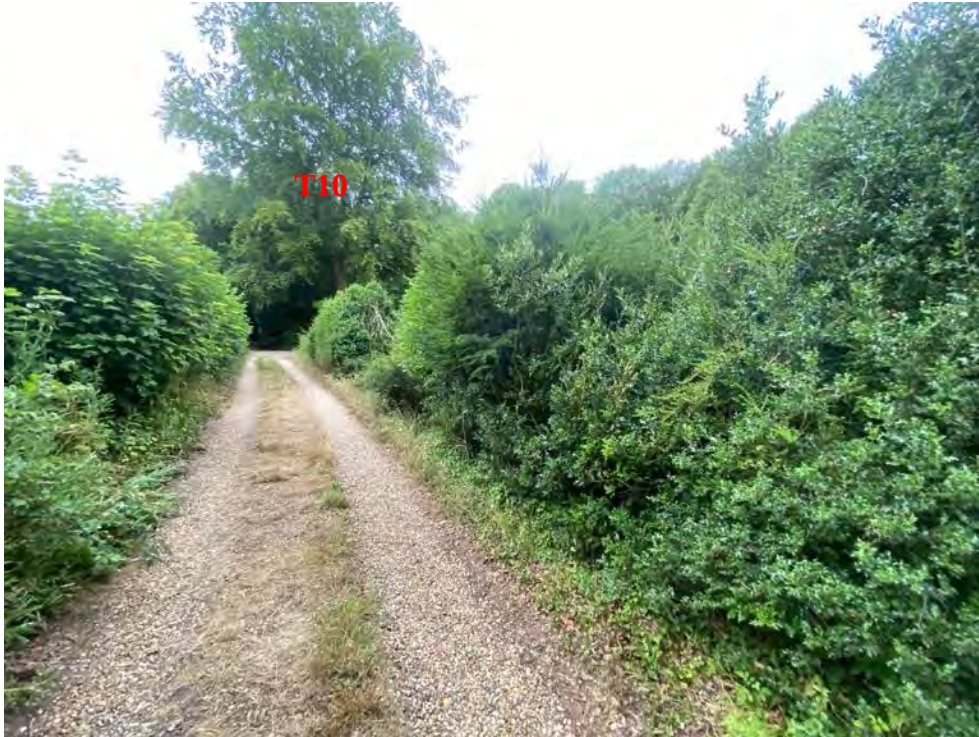
Photoview 1: View south along access drive towards T10.

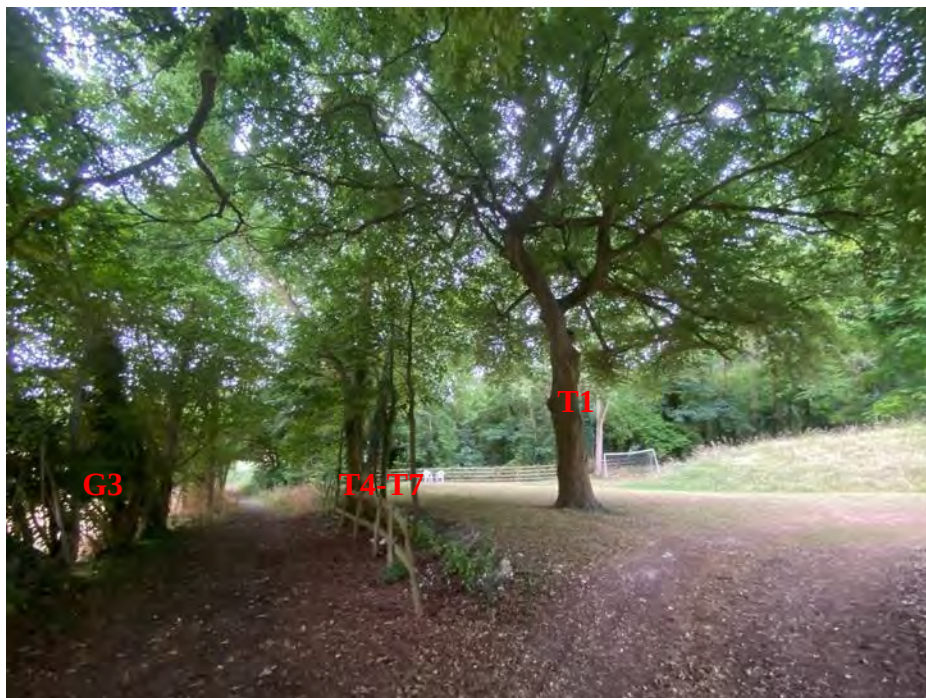
Photoview 2: View south-east towards T1, G3 and T4-T7.

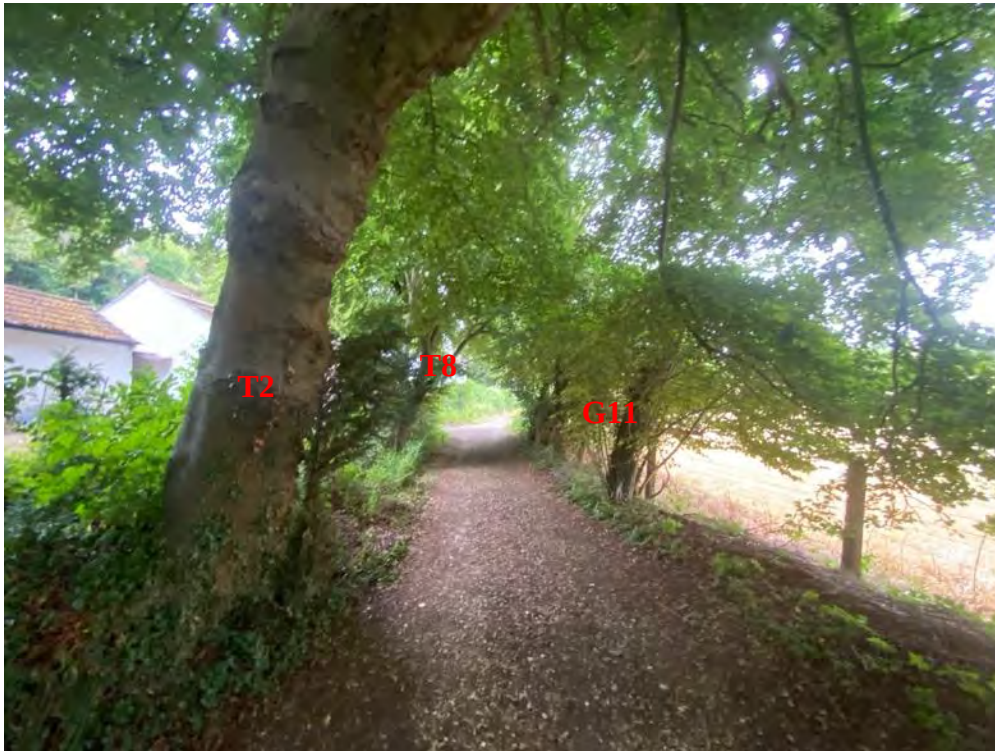
Photoview 3: View north-west towards T2.

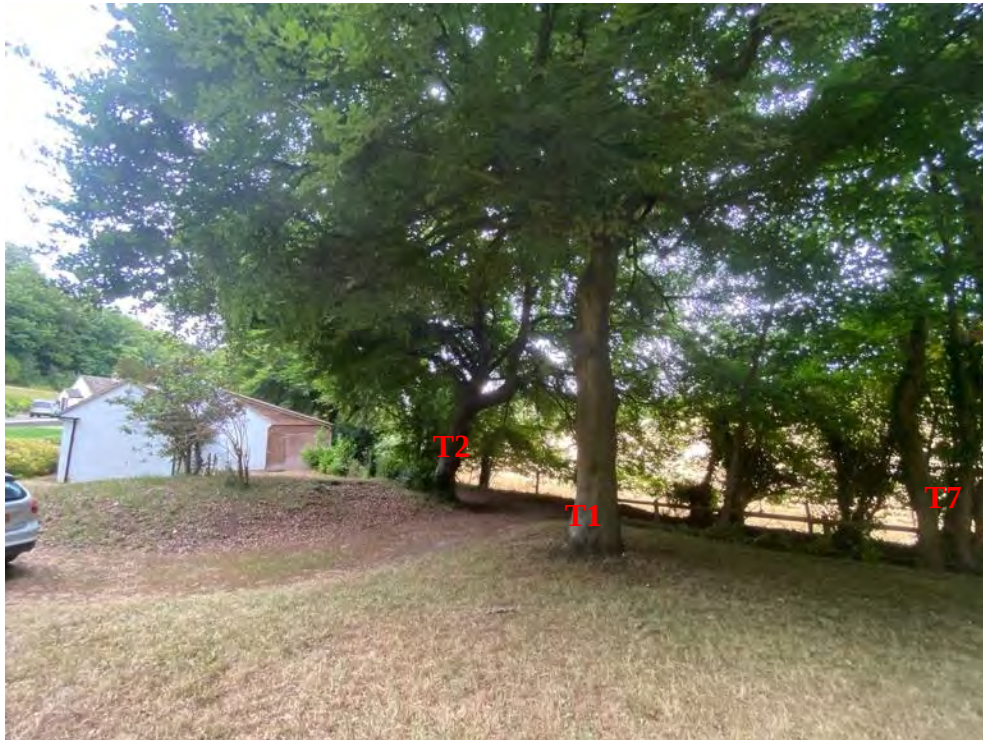
Photoview 5: View north at T1 and T2.

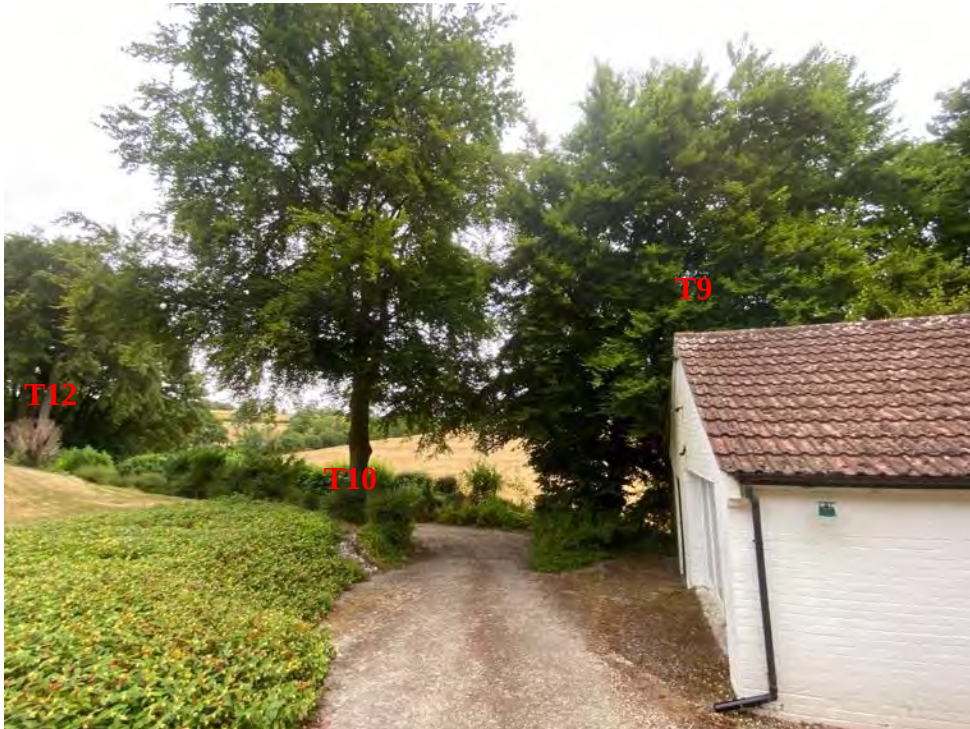
Photoview 11: View north east at T9 and T10.

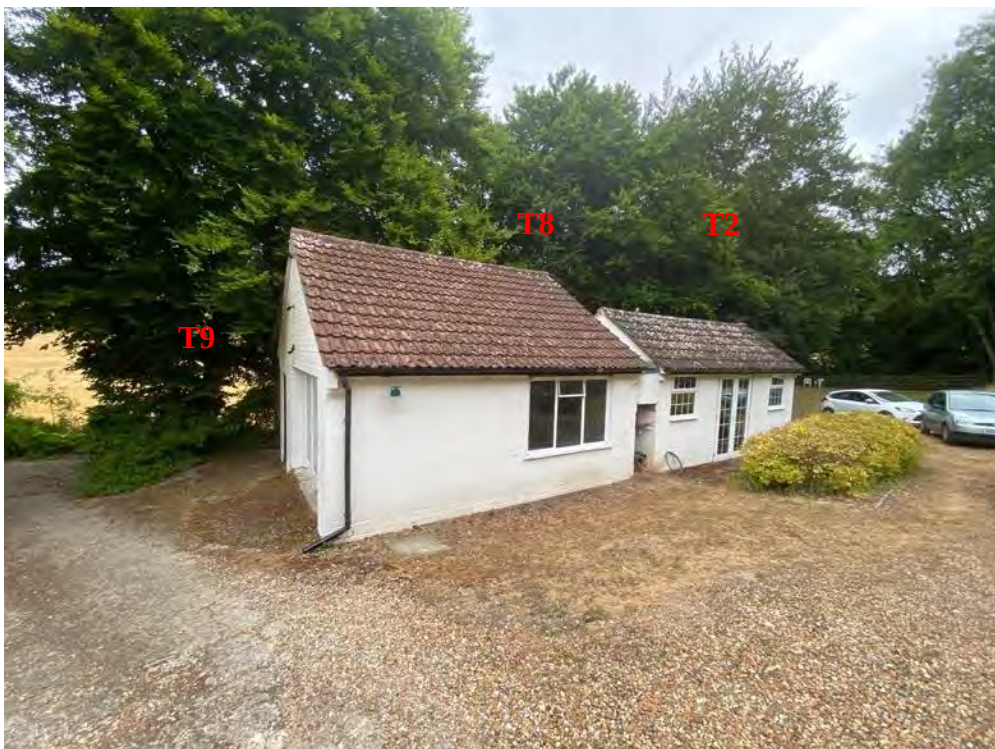
Photoview 12: View east at T9, T8 and T2.

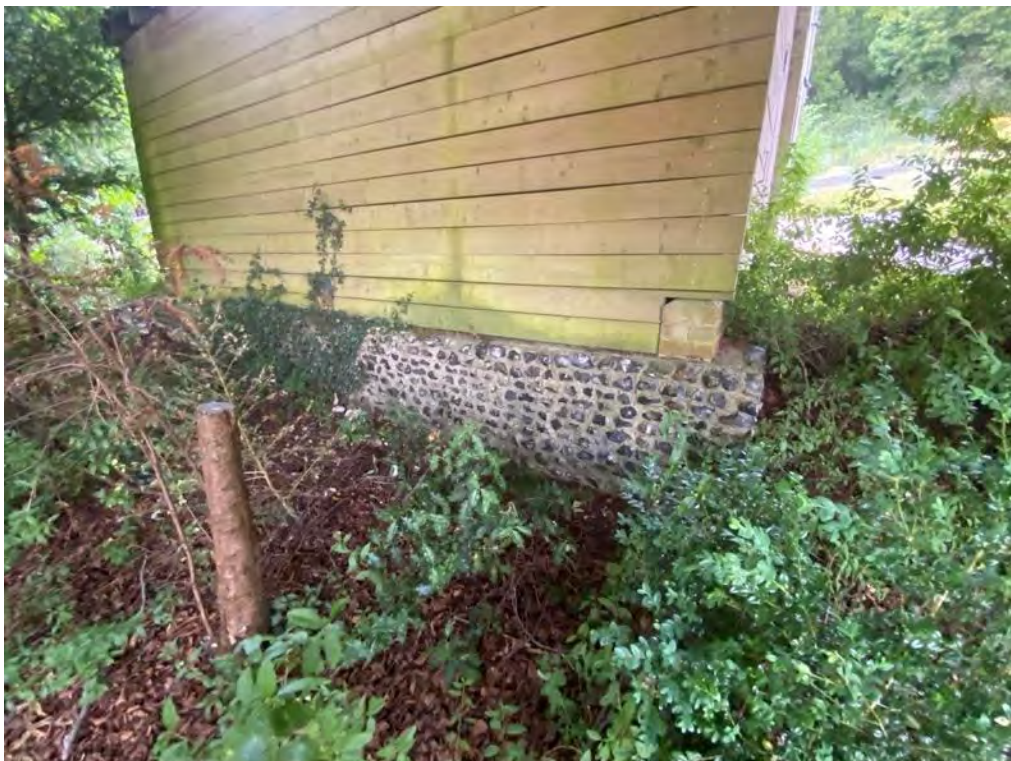
Photoview 14: View west at existing annex structure near T8 and T9.

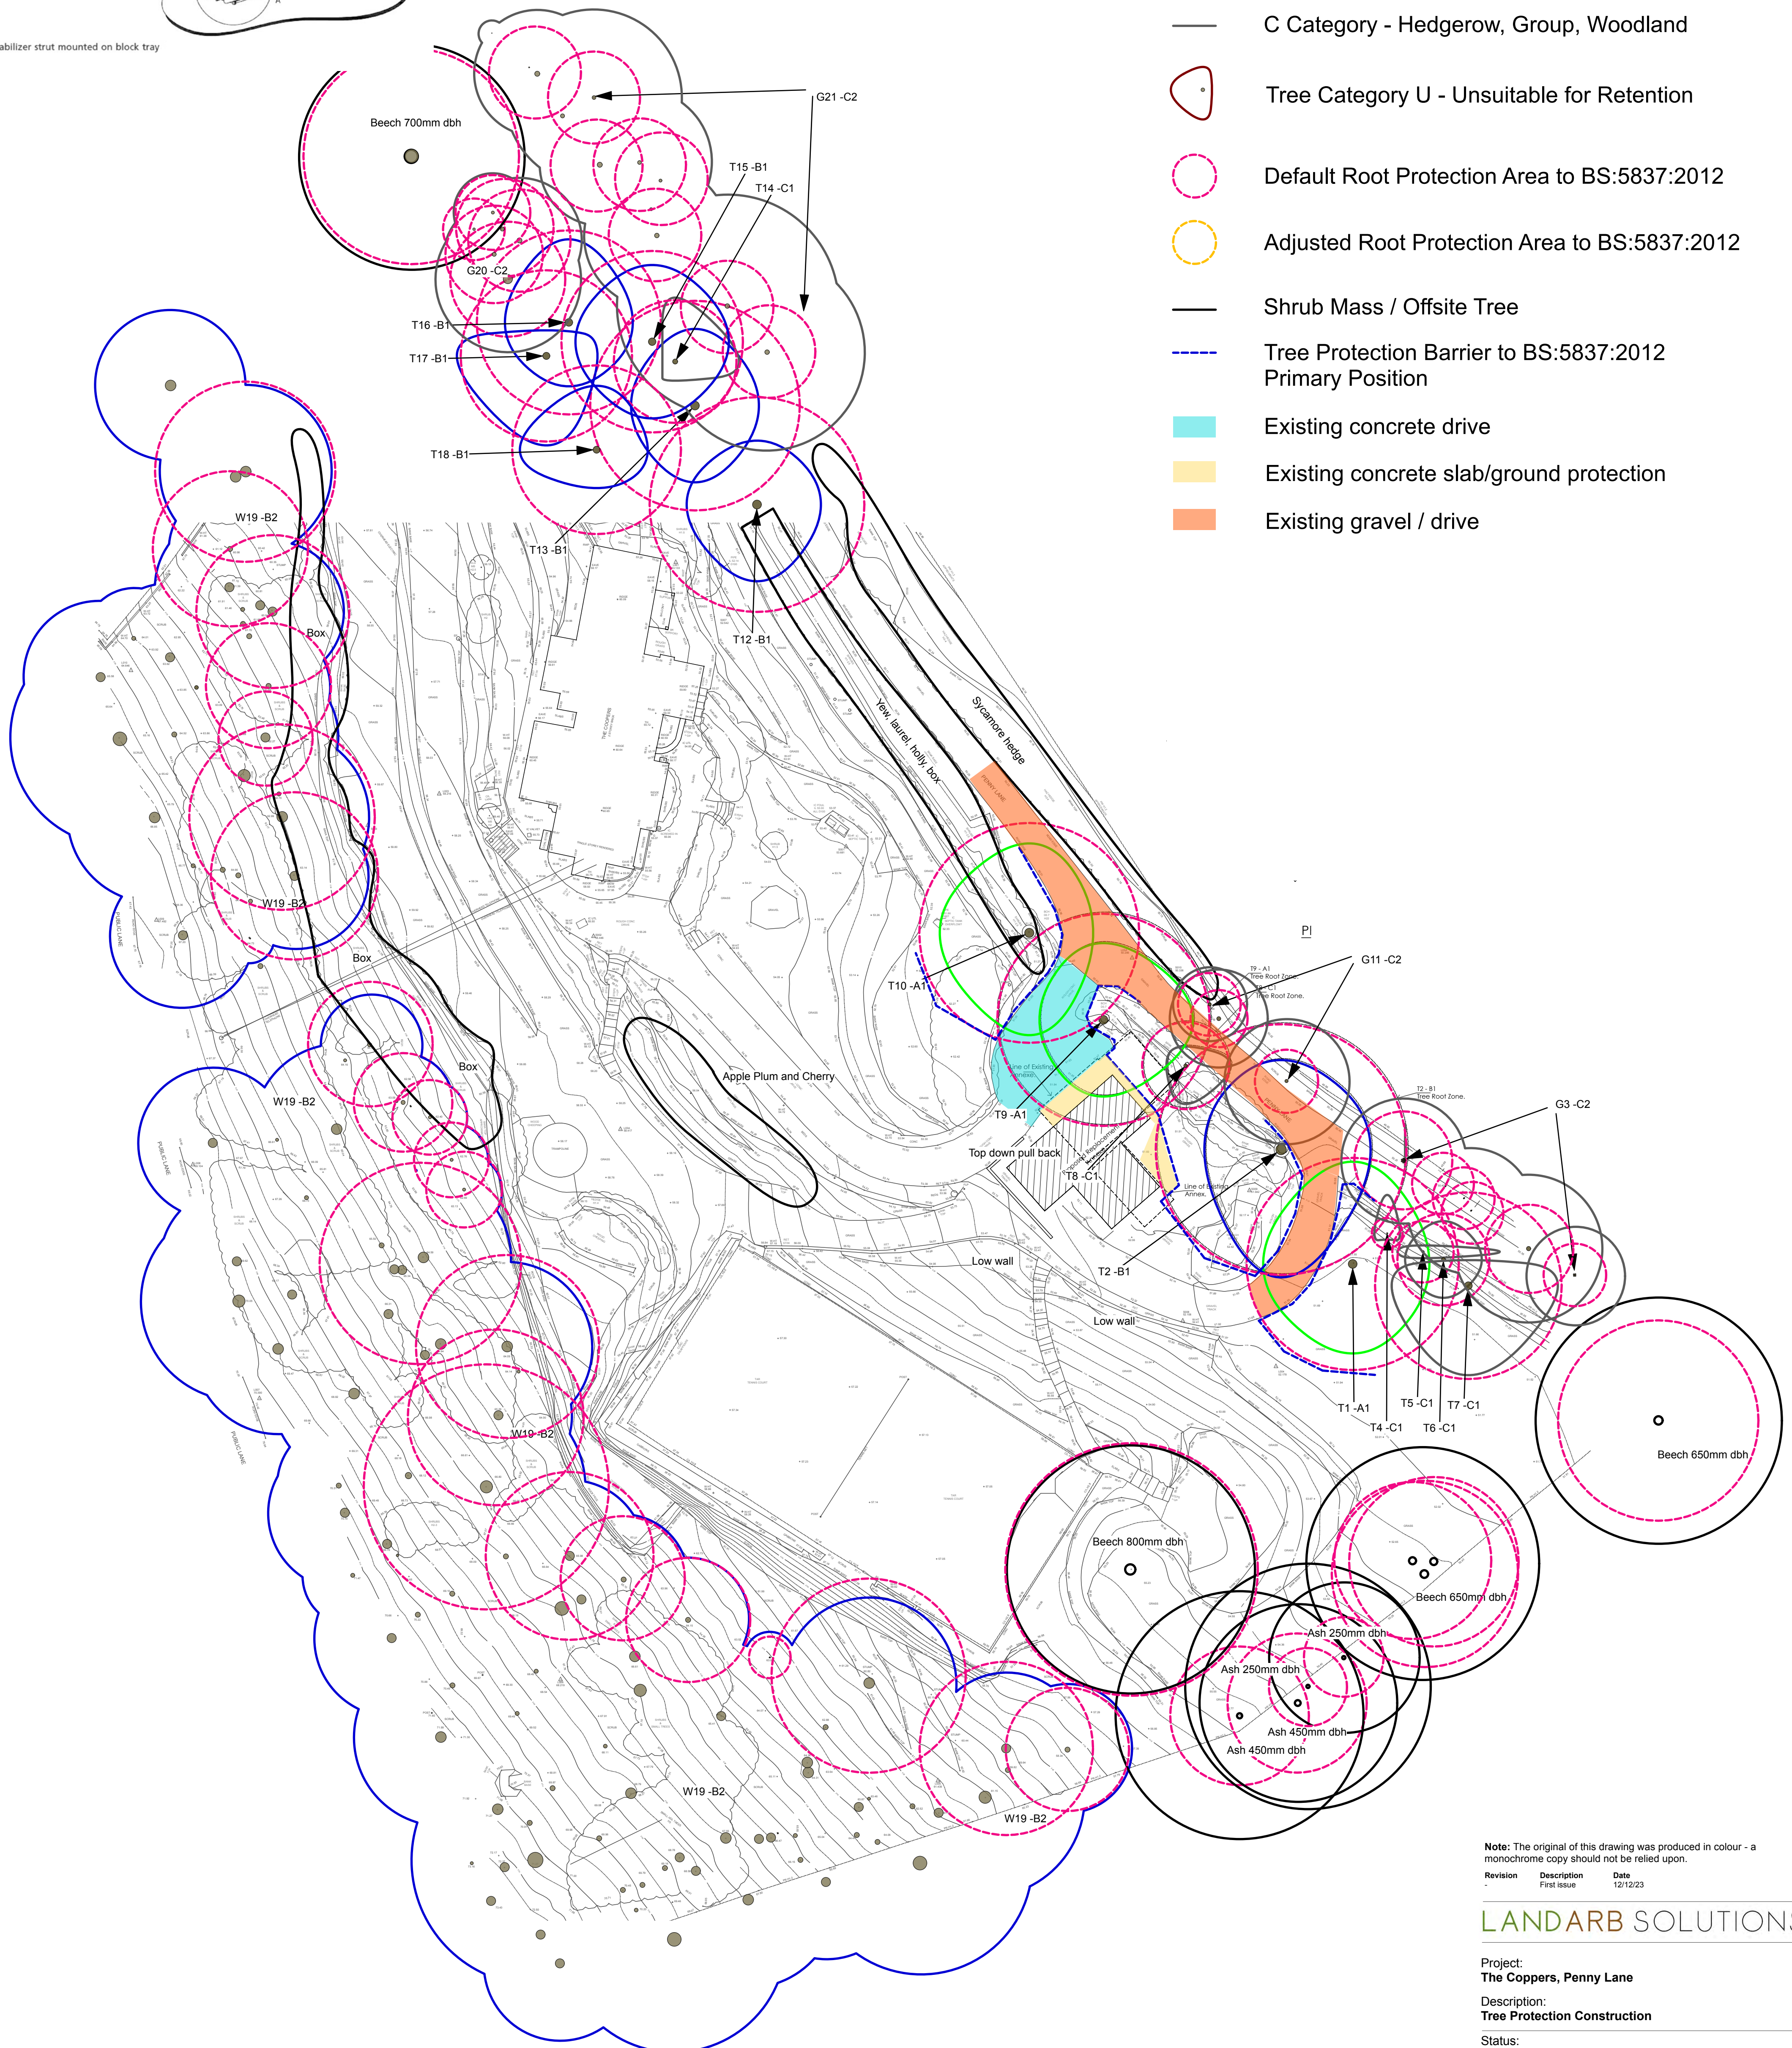
Description:  
**Tree Protection Construction**

- 6.14 Tree protection fencing, although brought forward, would not be able to be installed to fully protect the entire default RPA of T9 and T2 as fencing will need to be set back from the proposed new building edge to allow access for construction. Currently these

areas are covered in concrete hard surfacing. However, following demolition works, these areas (shown in beige in Appendix 6) will become exposed. Areas of RPAs not protected by fencing or covered with hard surfacing will require temporary ground protection.

- 6.12 Following demolition works, fencing is to remain in place around the edge of the existing accesses / drives to protect T10, T9, T2 and T1. However, with the removal of the existing building and concrete base/foundation, fencing will need to be brought forward away from T8 to protect more of the RPA of T9 and exposed ground.
- 6.13 Protection fencing is to be installed as per the TPP Construction (Appendix 6) following demolition works and prior to construction works starting on sit. It is to remain in place for the duration of construction works.

- 6.15 Temporary ground protection in the form of scaffold boards or ground guards set upon a 100-150mm layer of wood chippings set on a geotextile would be appropriate.
- 6.16 An example of ground protection is set out in Appendix 7.
- 6.17 Ground protection for areas around the new building (as shown in beige on the TPP Construction) will need to be installed prior to construction works and remain in place until completed.
