## **Preliminary Roost Assessment**

**2 Grove Cottages, Sandford Lane, Reading, RG10 0SX**

Survey conducted 22<sup>nd</sup> October 2024

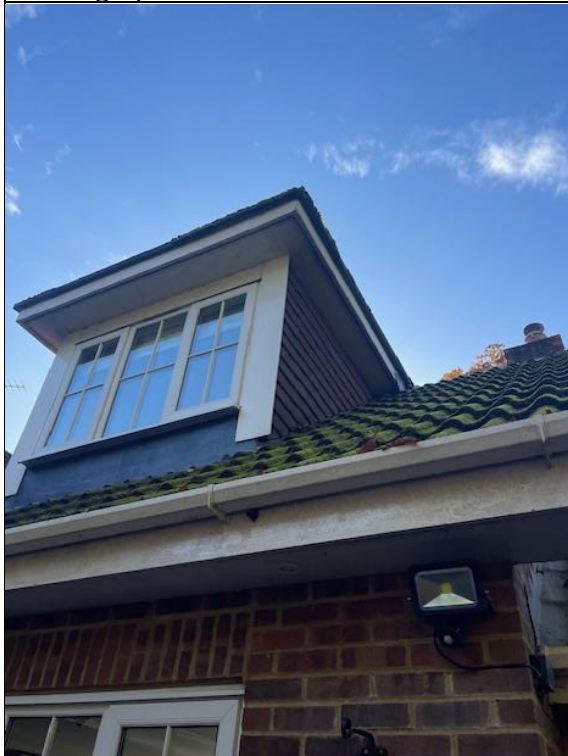
Photograph 3: Dormer window with hanging tiles.

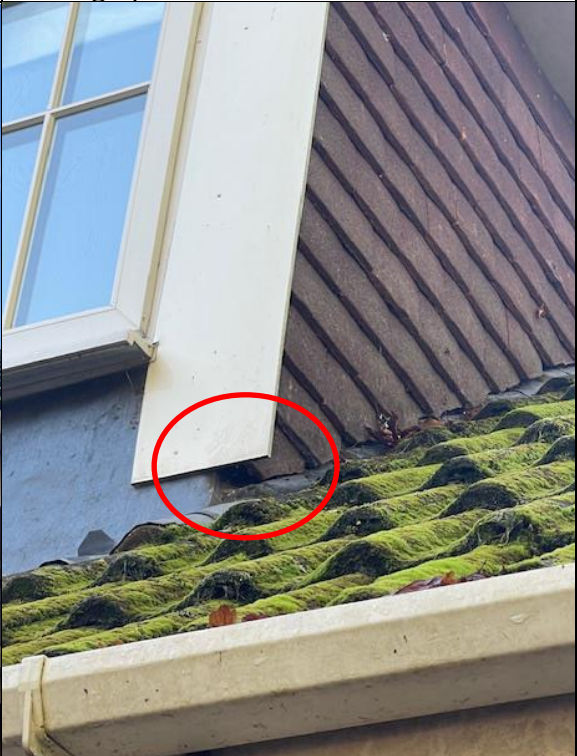
The building could be fully inspected and was assessed as having negligible bat roosting potential. The roof tiles are interlocking and have no gapping and the soffits are in good condition. There were some gaps on the edges of the dormer window which will be replaced. However, these gaps could be fully inspected using a ladder and an endoscope.

Photograph 4: Gaps at the edge of the dormer.

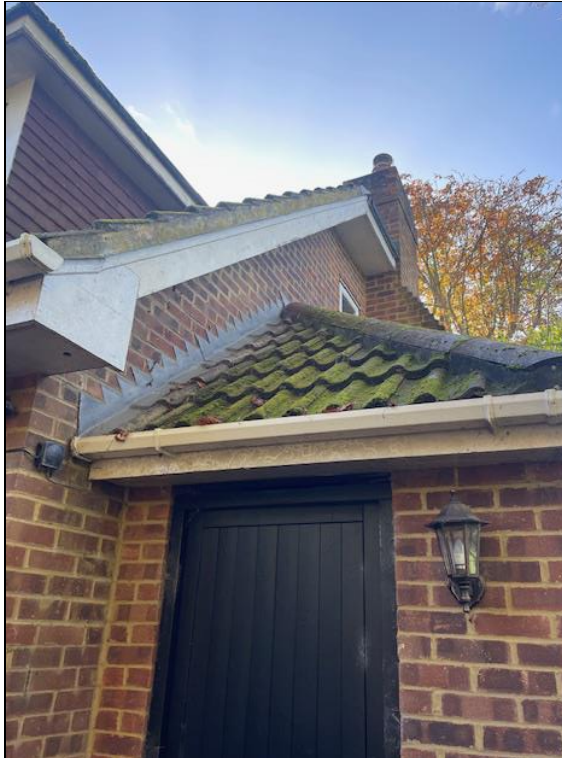
Photograph 5: Wooden soffits.

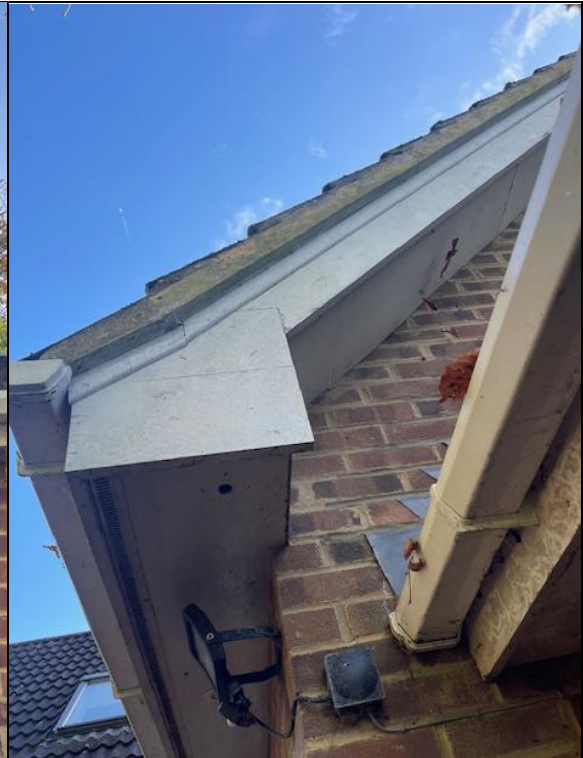
Photograph 6: Wooden soffits.

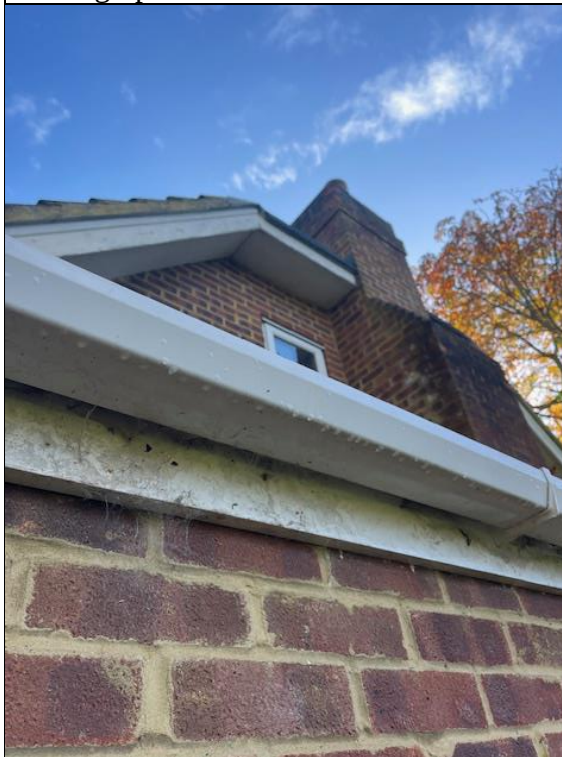
Photograph 7: uPVC guttering.

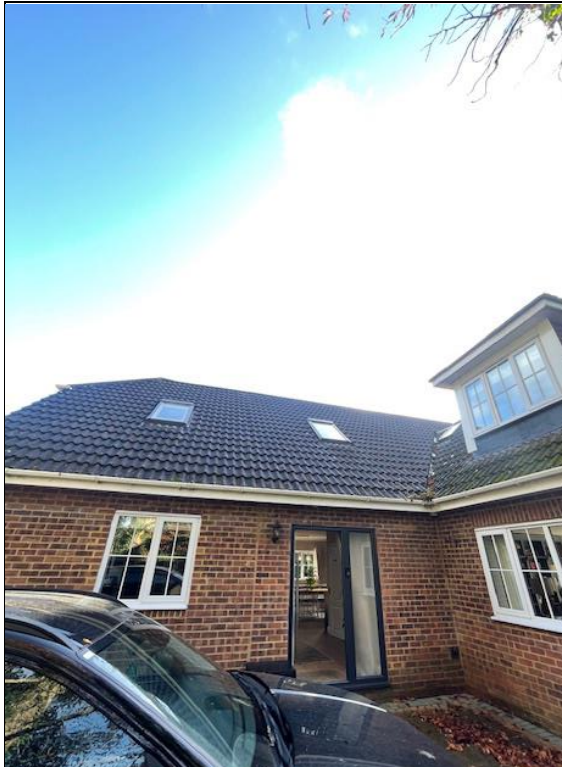
Photograph 9: Interlocking roof tiles.

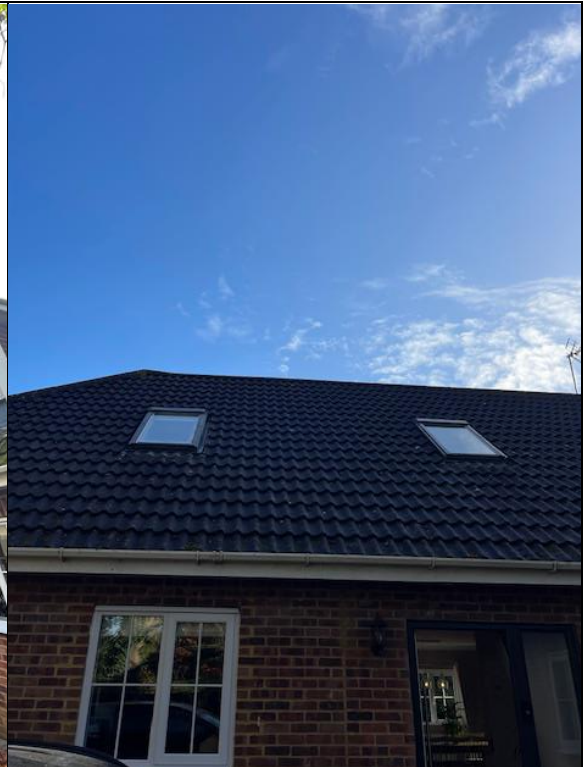
Photograph 10: Interlocking roof tiles.

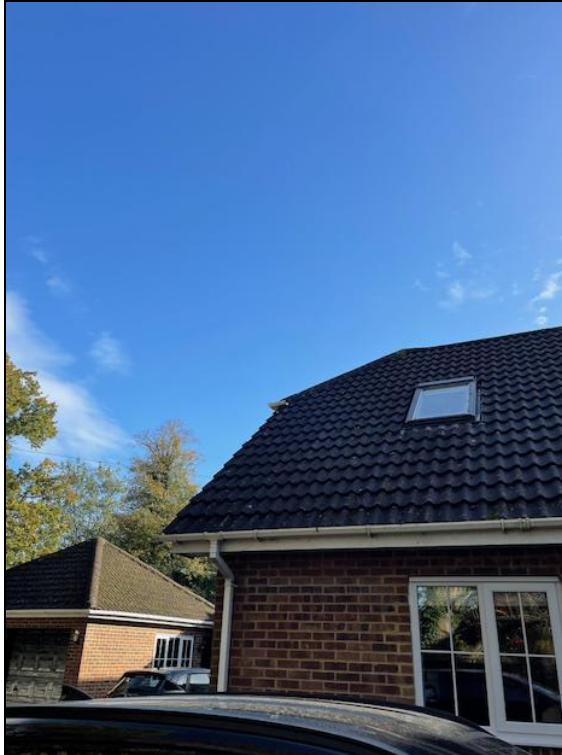
Photograph 11: Interlocking roof tiles.

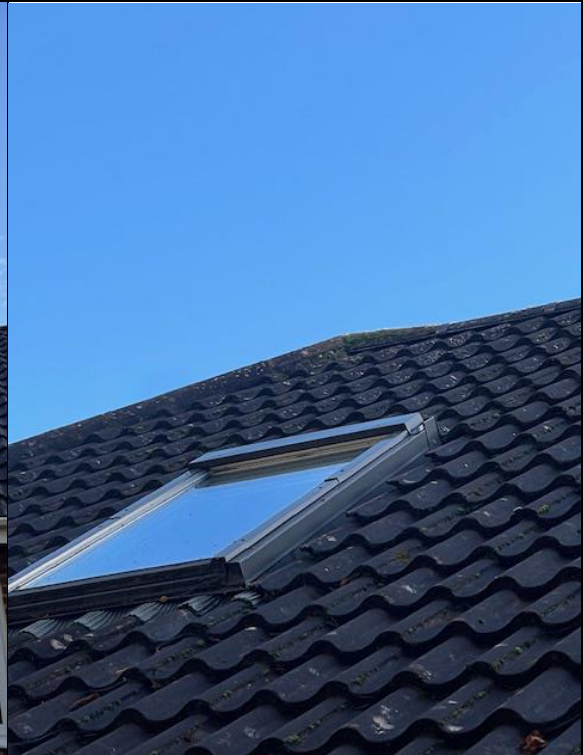
Photograph 12: Interlocking roof tiles.

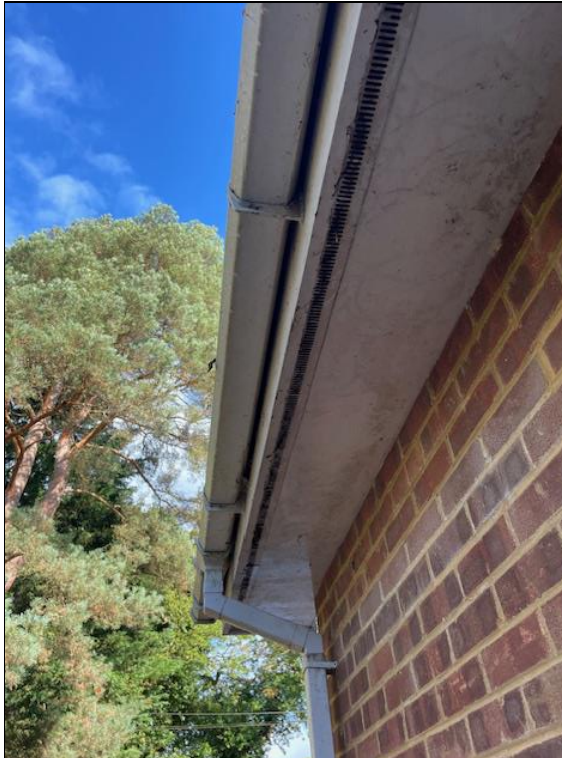
Photograph 13: No visible gaps around the soffits.

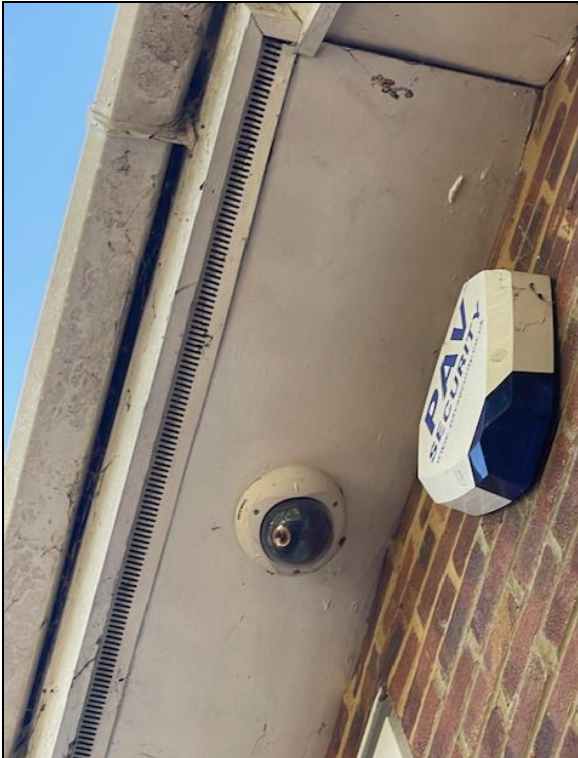
Photograph 17: Wooden soffits.

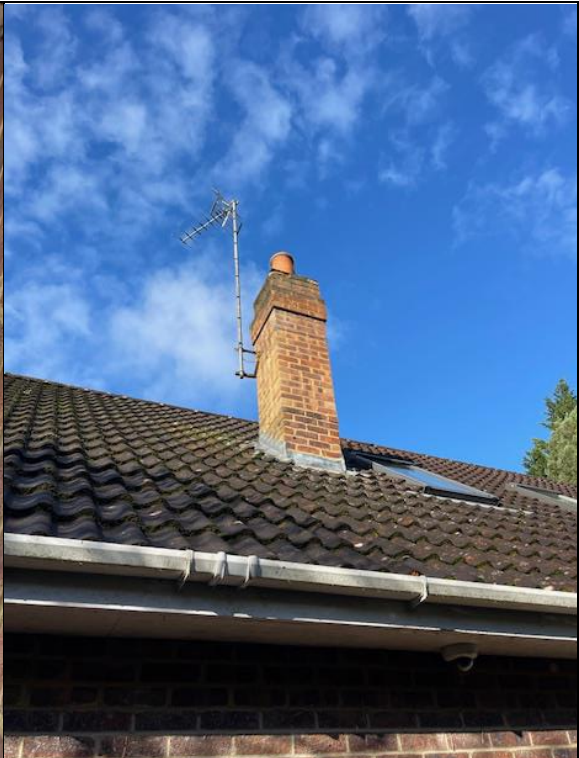
Photograph 18: Side elevation-interlocking roof tiles.

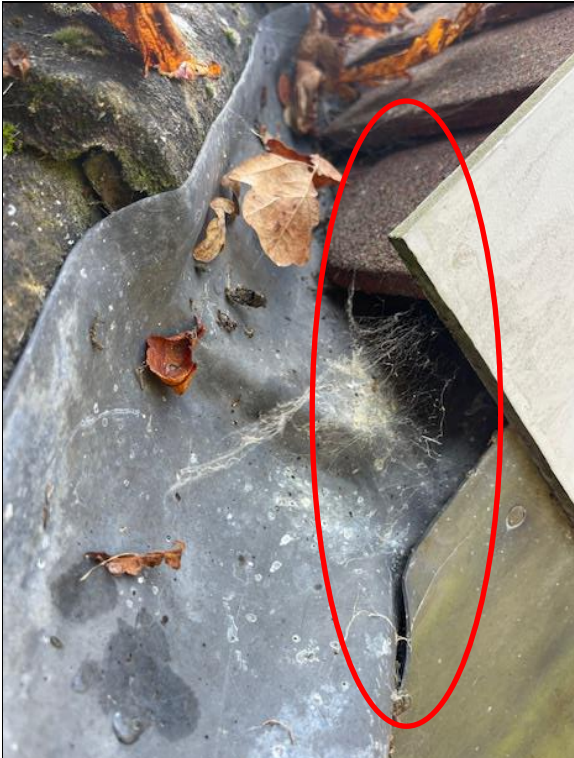
Photograph 21: Gaps between flashing and hanging wall tiles.

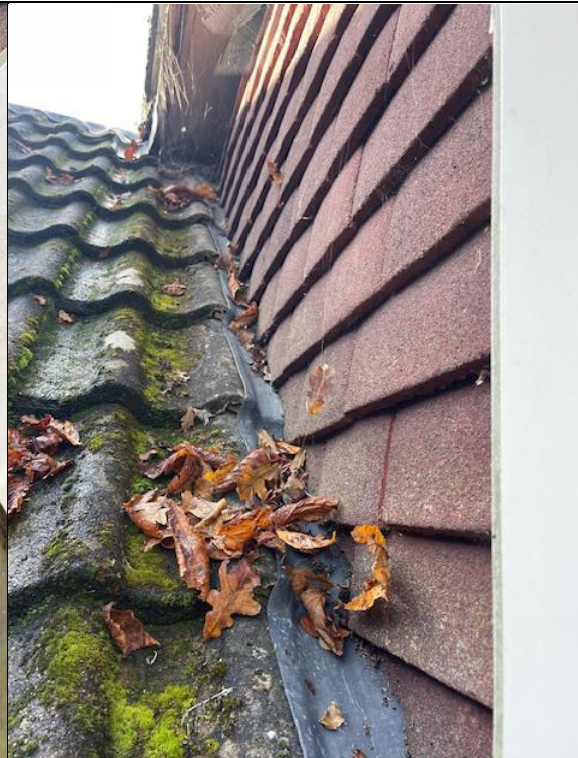
Photograph 22: Gaps between flashing and hanging wall tiles.
