DUCKWORTHS  
ARBORICULTURE LTD.

22<sup>nd</sup> December 2024  
Ref: 06604 / 2024

**APPLICATION FOR WORKS TO LEYLANDII TREES WITHIN THE GARDEN OF 45 FAIRWATER DRIVE, WOODLEY PROTECTED UNDER WOODLAND TREE PRESERVATION ORDER NO. 003 / 1951.**

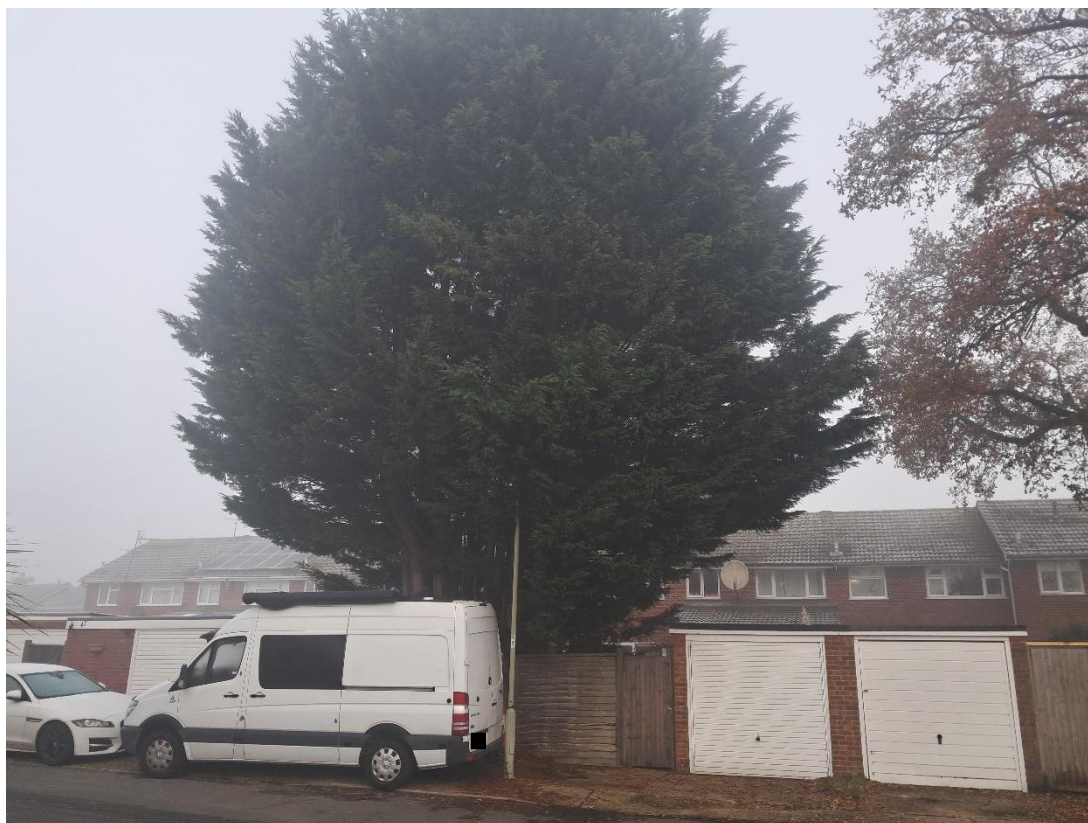
The poor structural form of the group and their proximity to property means that these trees cannot reasonably be retained in this location without future damage to the garage as a direct impact from the growth of the trunks and roots. These trees cause particular nuisance to residents in terms of shade and blocking of daylight..

**Photo 1 – Combined canopy of G001. Streetlight obscured. Trees are overbearing in relation to the adjacent residential gardens.**

These are low-quality trees with poor structural form. The trees provide no aesthetic enhancement in the local area. Reducing the canopy of the group such as would be required to clear the garage / streetlight and reduce shade to a satisfactory degree would expose the woody centres of the crowns further diminishing their amenity. My recommendation is that these trees be felled and the stumps removed.

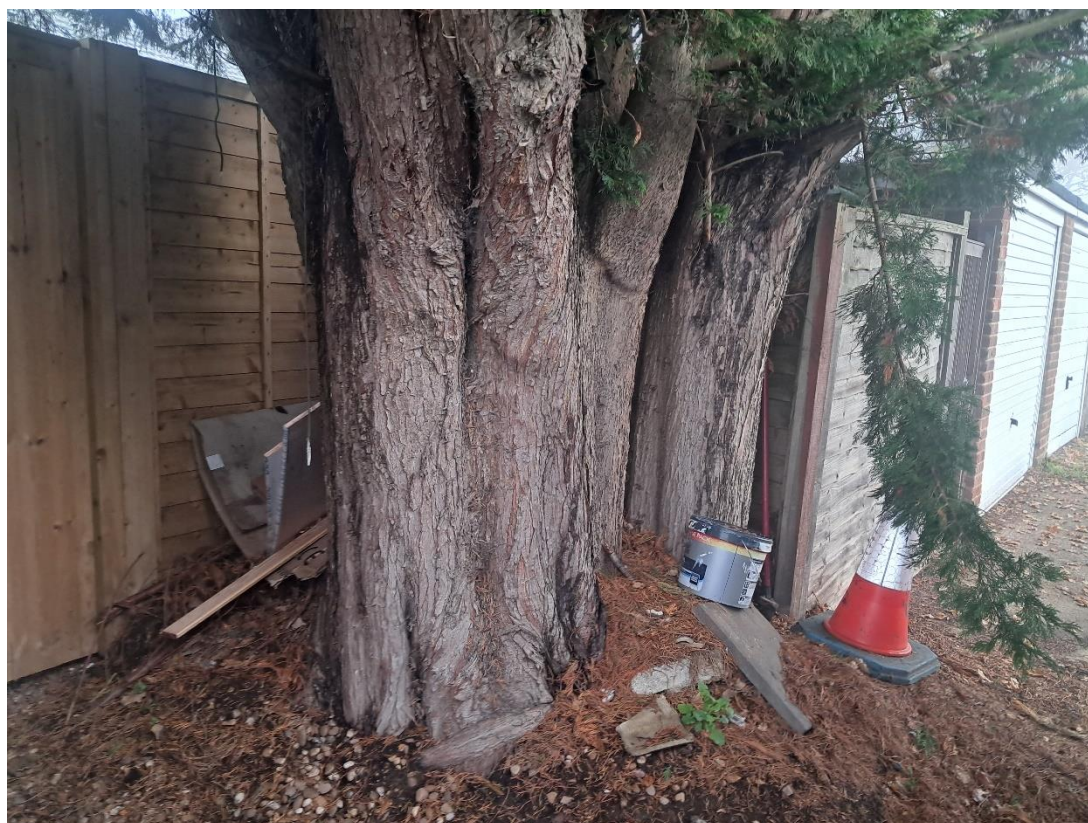
| Ref. | Species | Measurements | Survey Notes | Condition | Inspect Period | Recommendations |
|---|---|---|---|---|---|---|
| G001 | Leyland cypress<br>( <i>X Cuprocyparis leylandii</i> ) | Trunk diameters (mm):<br>610, 460, 440<br>Height (m): 15.5<br>Crown Radius (m): 4.5N,<br>7.5E, 4.5S, 6W<br>Stems: 3 | Three stems planted very close together such that the mature stems are now touching. The tree group is less than 1.5m from the adjacent garages. Girdling roots around the base. All three trees have previously been topped around 2m above ground level and again at 4m. This has created a dense branching structure with poor form and areas of bark inclusion. The broad low crown extends low over the garden of 45 Fairwater Drive. The broad, collective canopy is also in direct contact with the garage roof and obscures the streetlight to the southeast. All three trees have a poor structural form from past management and the group frequently drops small to medium sized branches over the garden and road. Foliage dense, good vitality. | Poor | - | Fell to ground level |

**Photo 2 – G001 – densely planted stems now touching. Future stem growth unsustainable.**

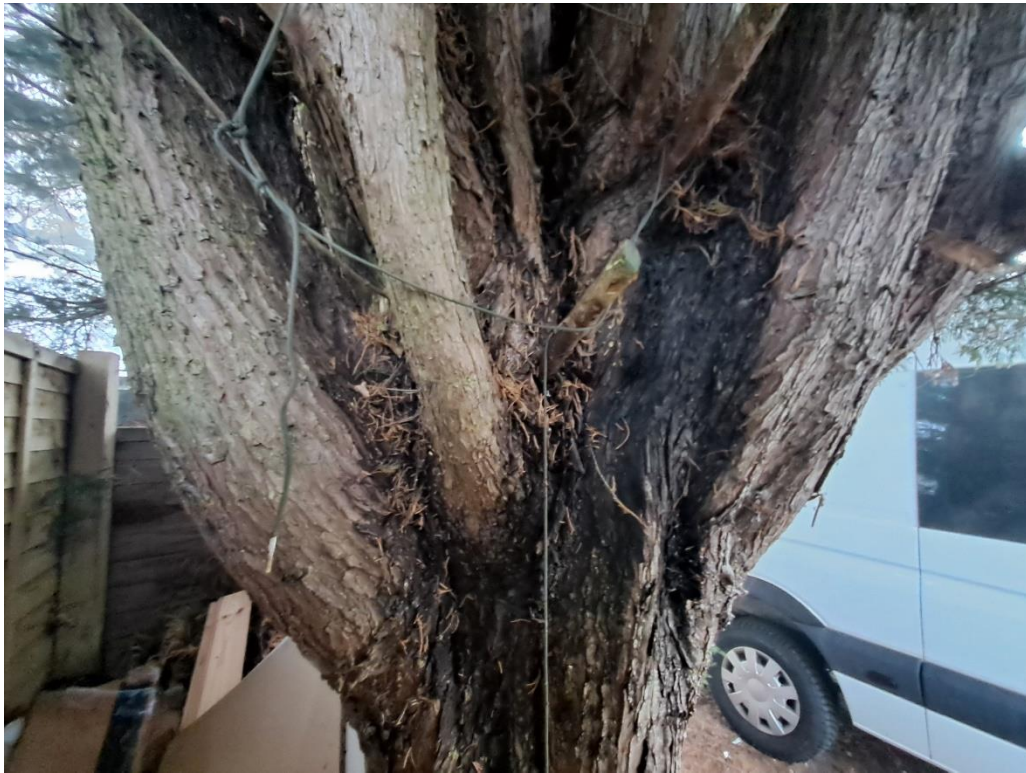
Photo 3 – G001 – poor form with multiple points of growth above previous topping points 2m above ground level.

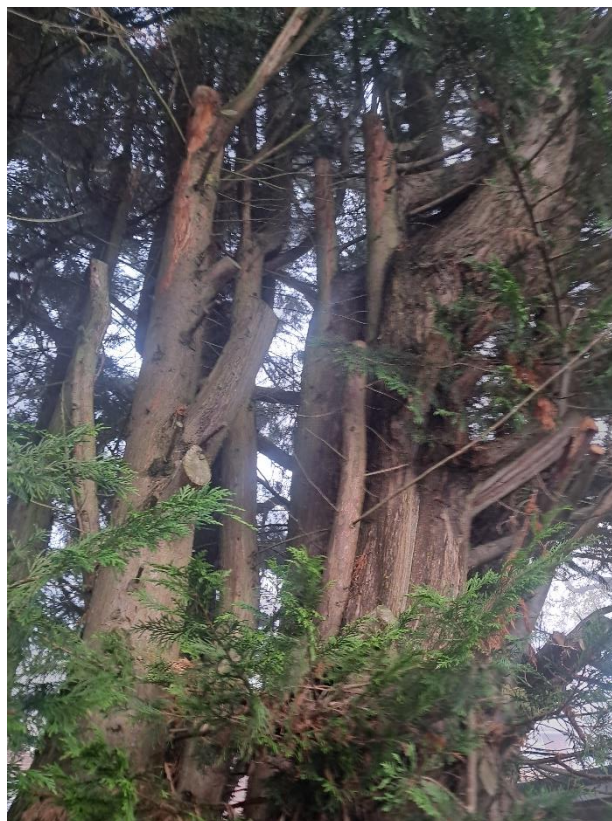
Photo 4 – Dead branch stubs associated with previous topping points. Stumps of side branches from previous branch failure.

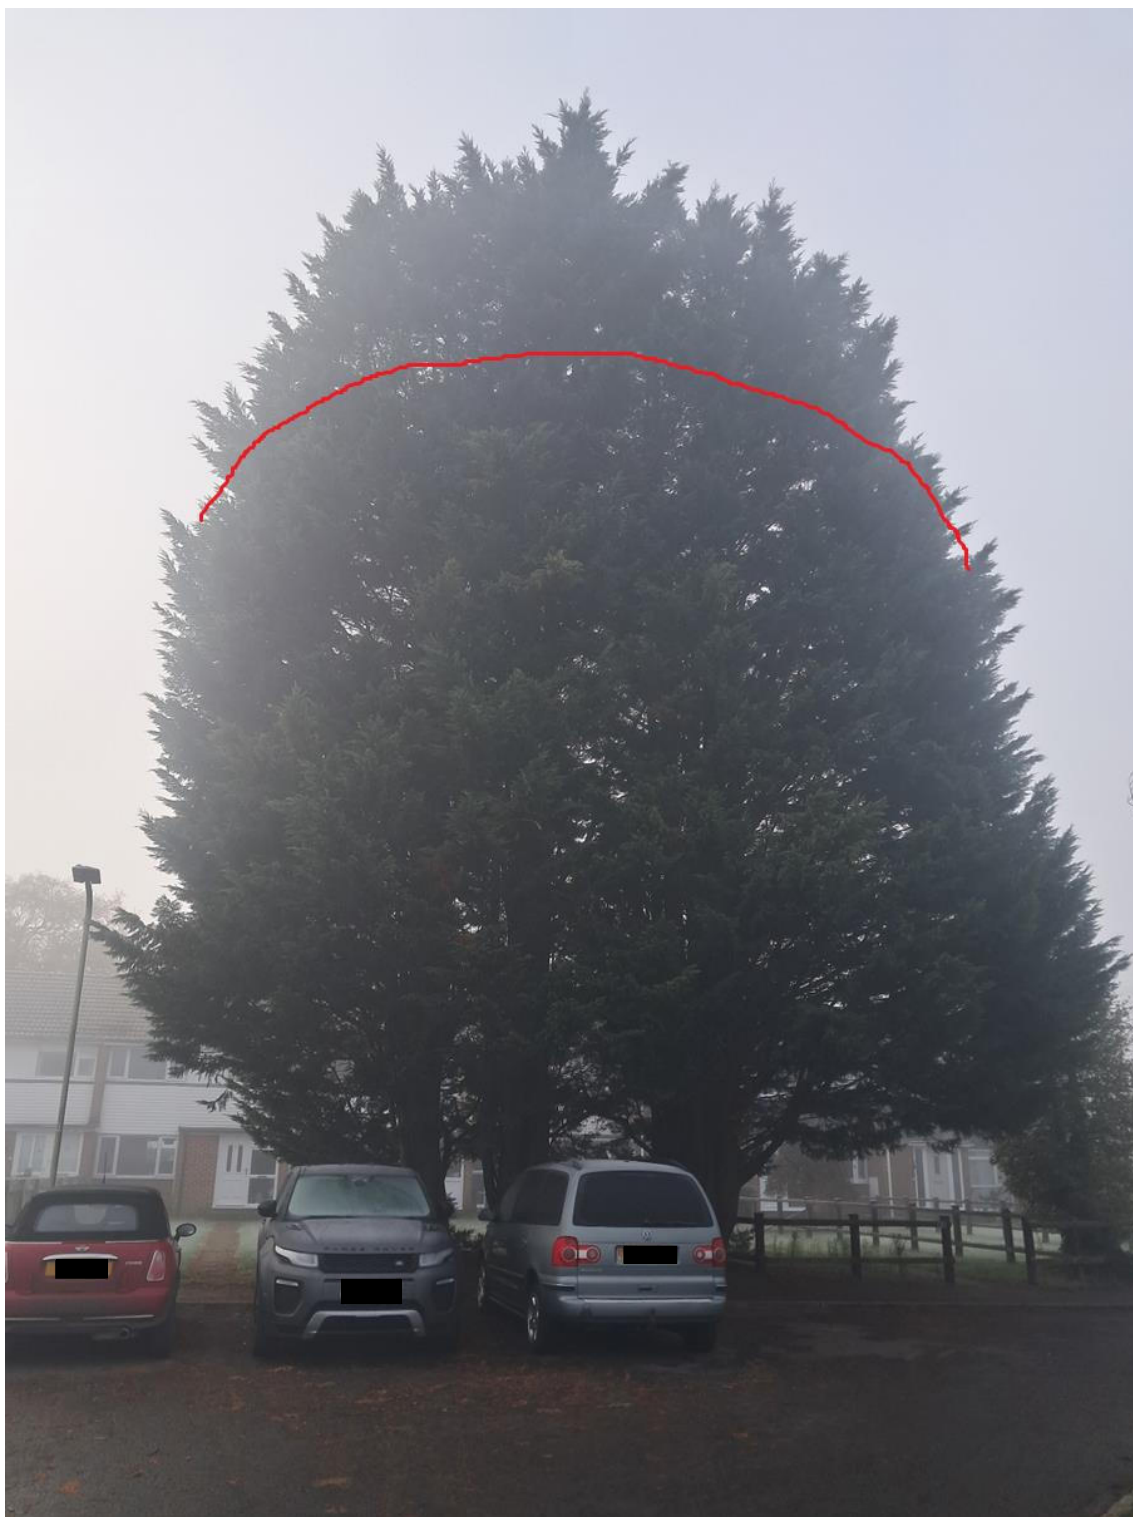
Photo 5 – G002 - North side of group canopy and indicative line of proposed reduction

I have therefore recommended a reduction of the height of trees in G002 for maintenance only. This is to ensure their stability (preventing branch failure) due to the weight of new growth beyond the previous reduction points.

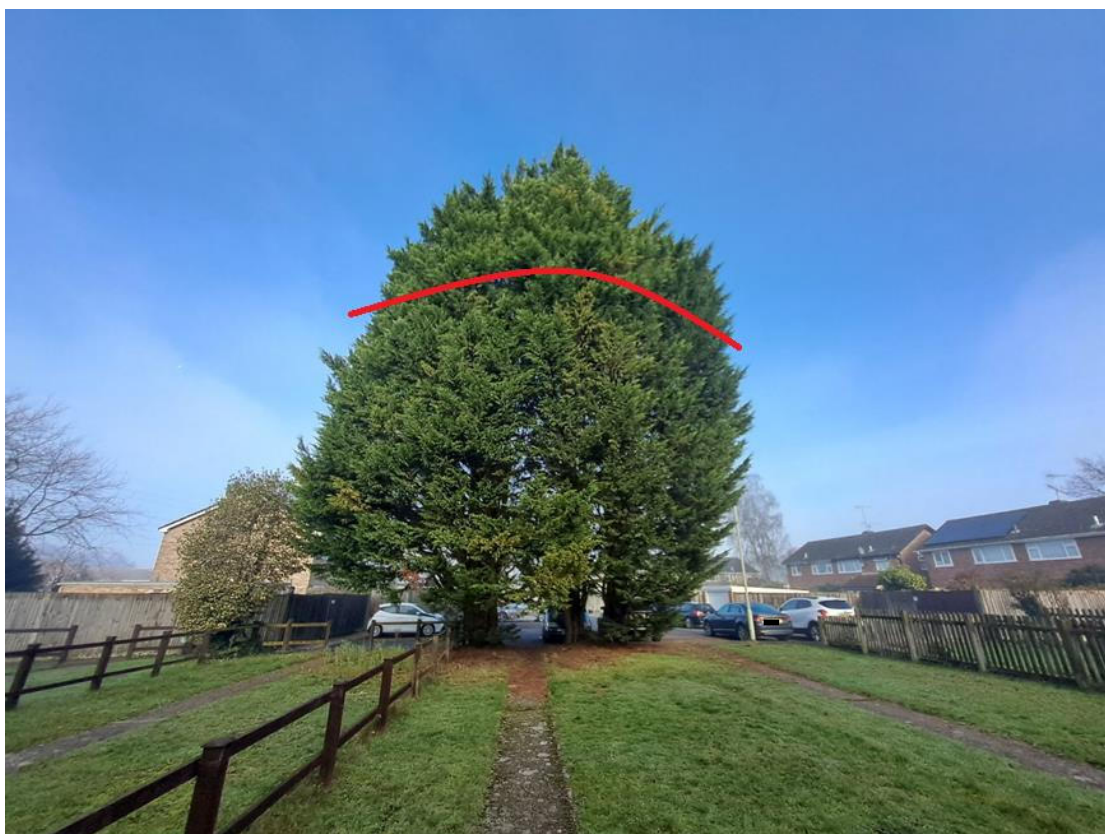
Photo 6 – G002 - South side of group canopy with indicative line of proposed canopy reduction. Note low branches over access path.

Additional works are also required to raise the lower canopy removing selective individual branches where they are obstructing pedestrian and vehicular access.

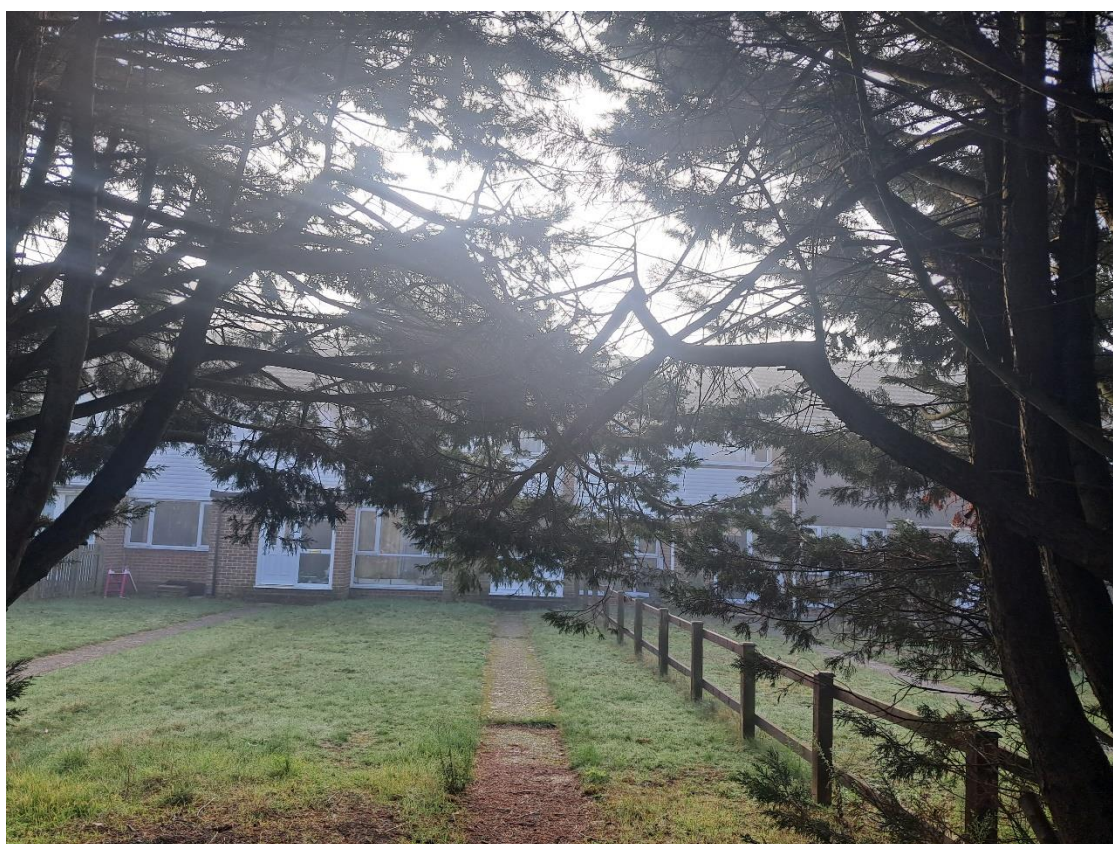
Photo 7 – G002 – Low branches block access to property

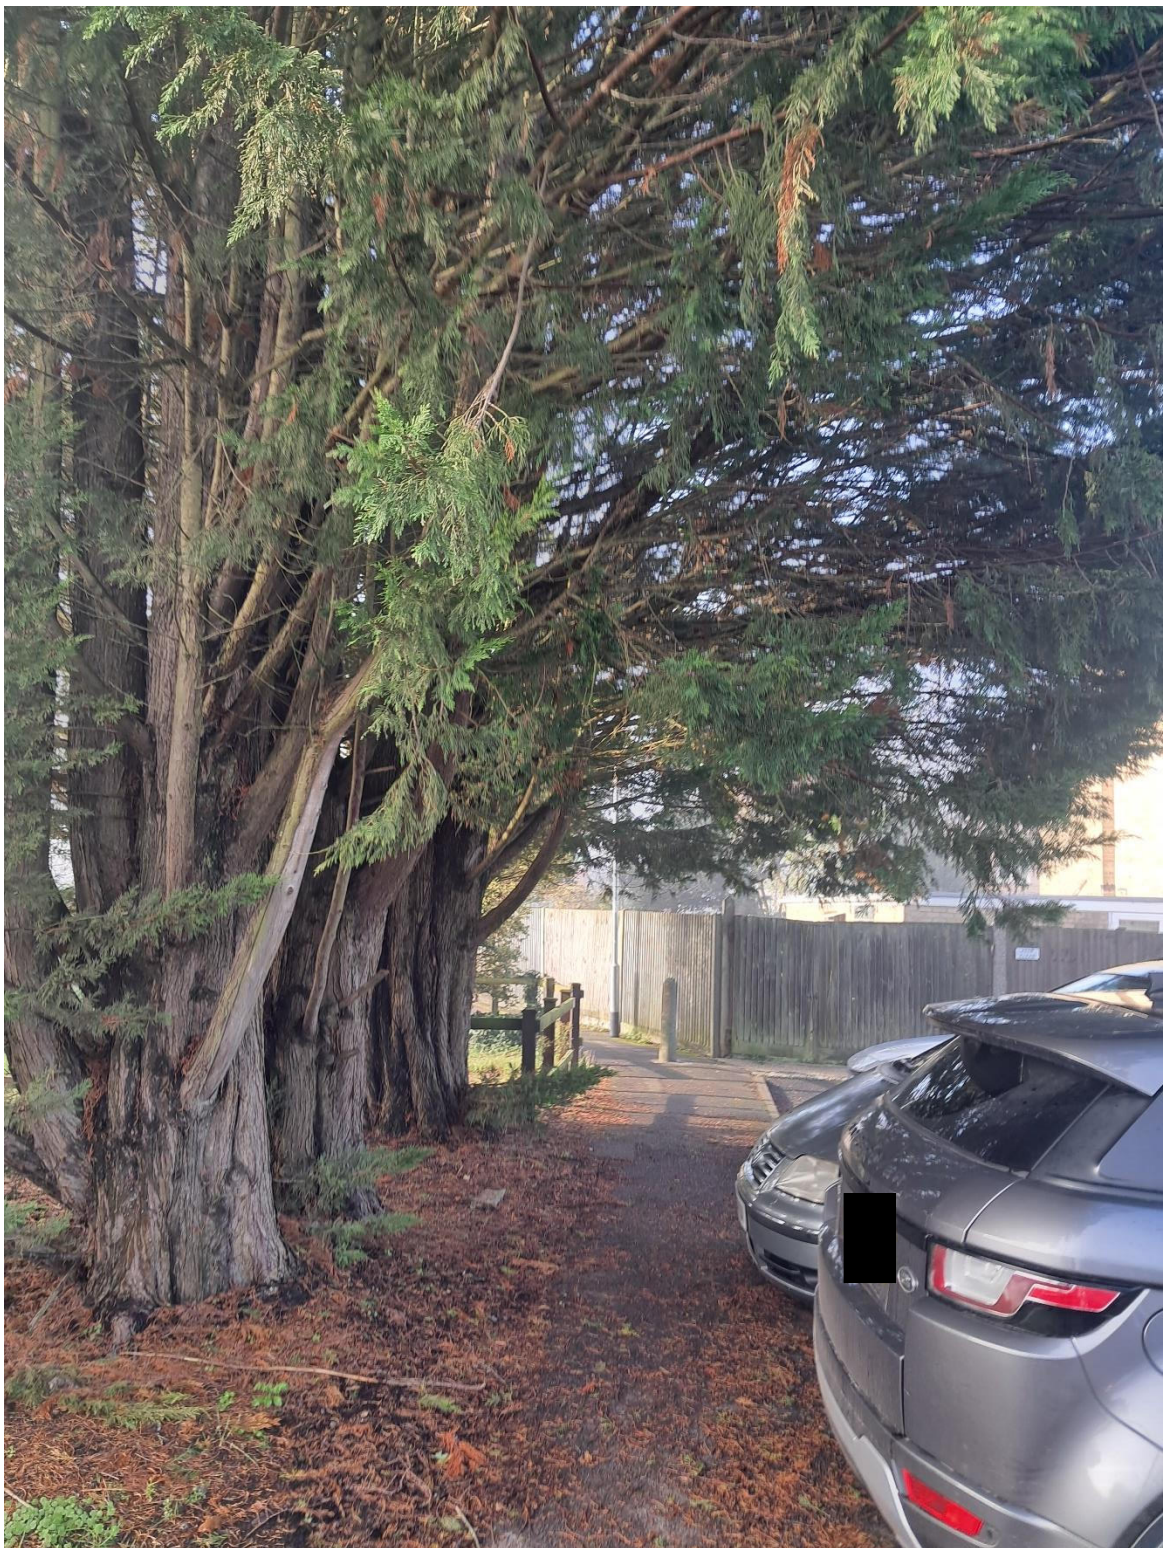
Photo 8 – G002 – Low canopy over footpath and parking
