## **ARBORICULTURAL IMPACT ASSESSMENT FOR 63 HIGH STREET WARGRAVE**

**Prepared on behalf of:  
Mr N Towers  
63 High Street  
Wargrave  
Berkshire  
RG10 8BU**

**Ref: PB/AIA-22/11.02**

**14 November 2022**

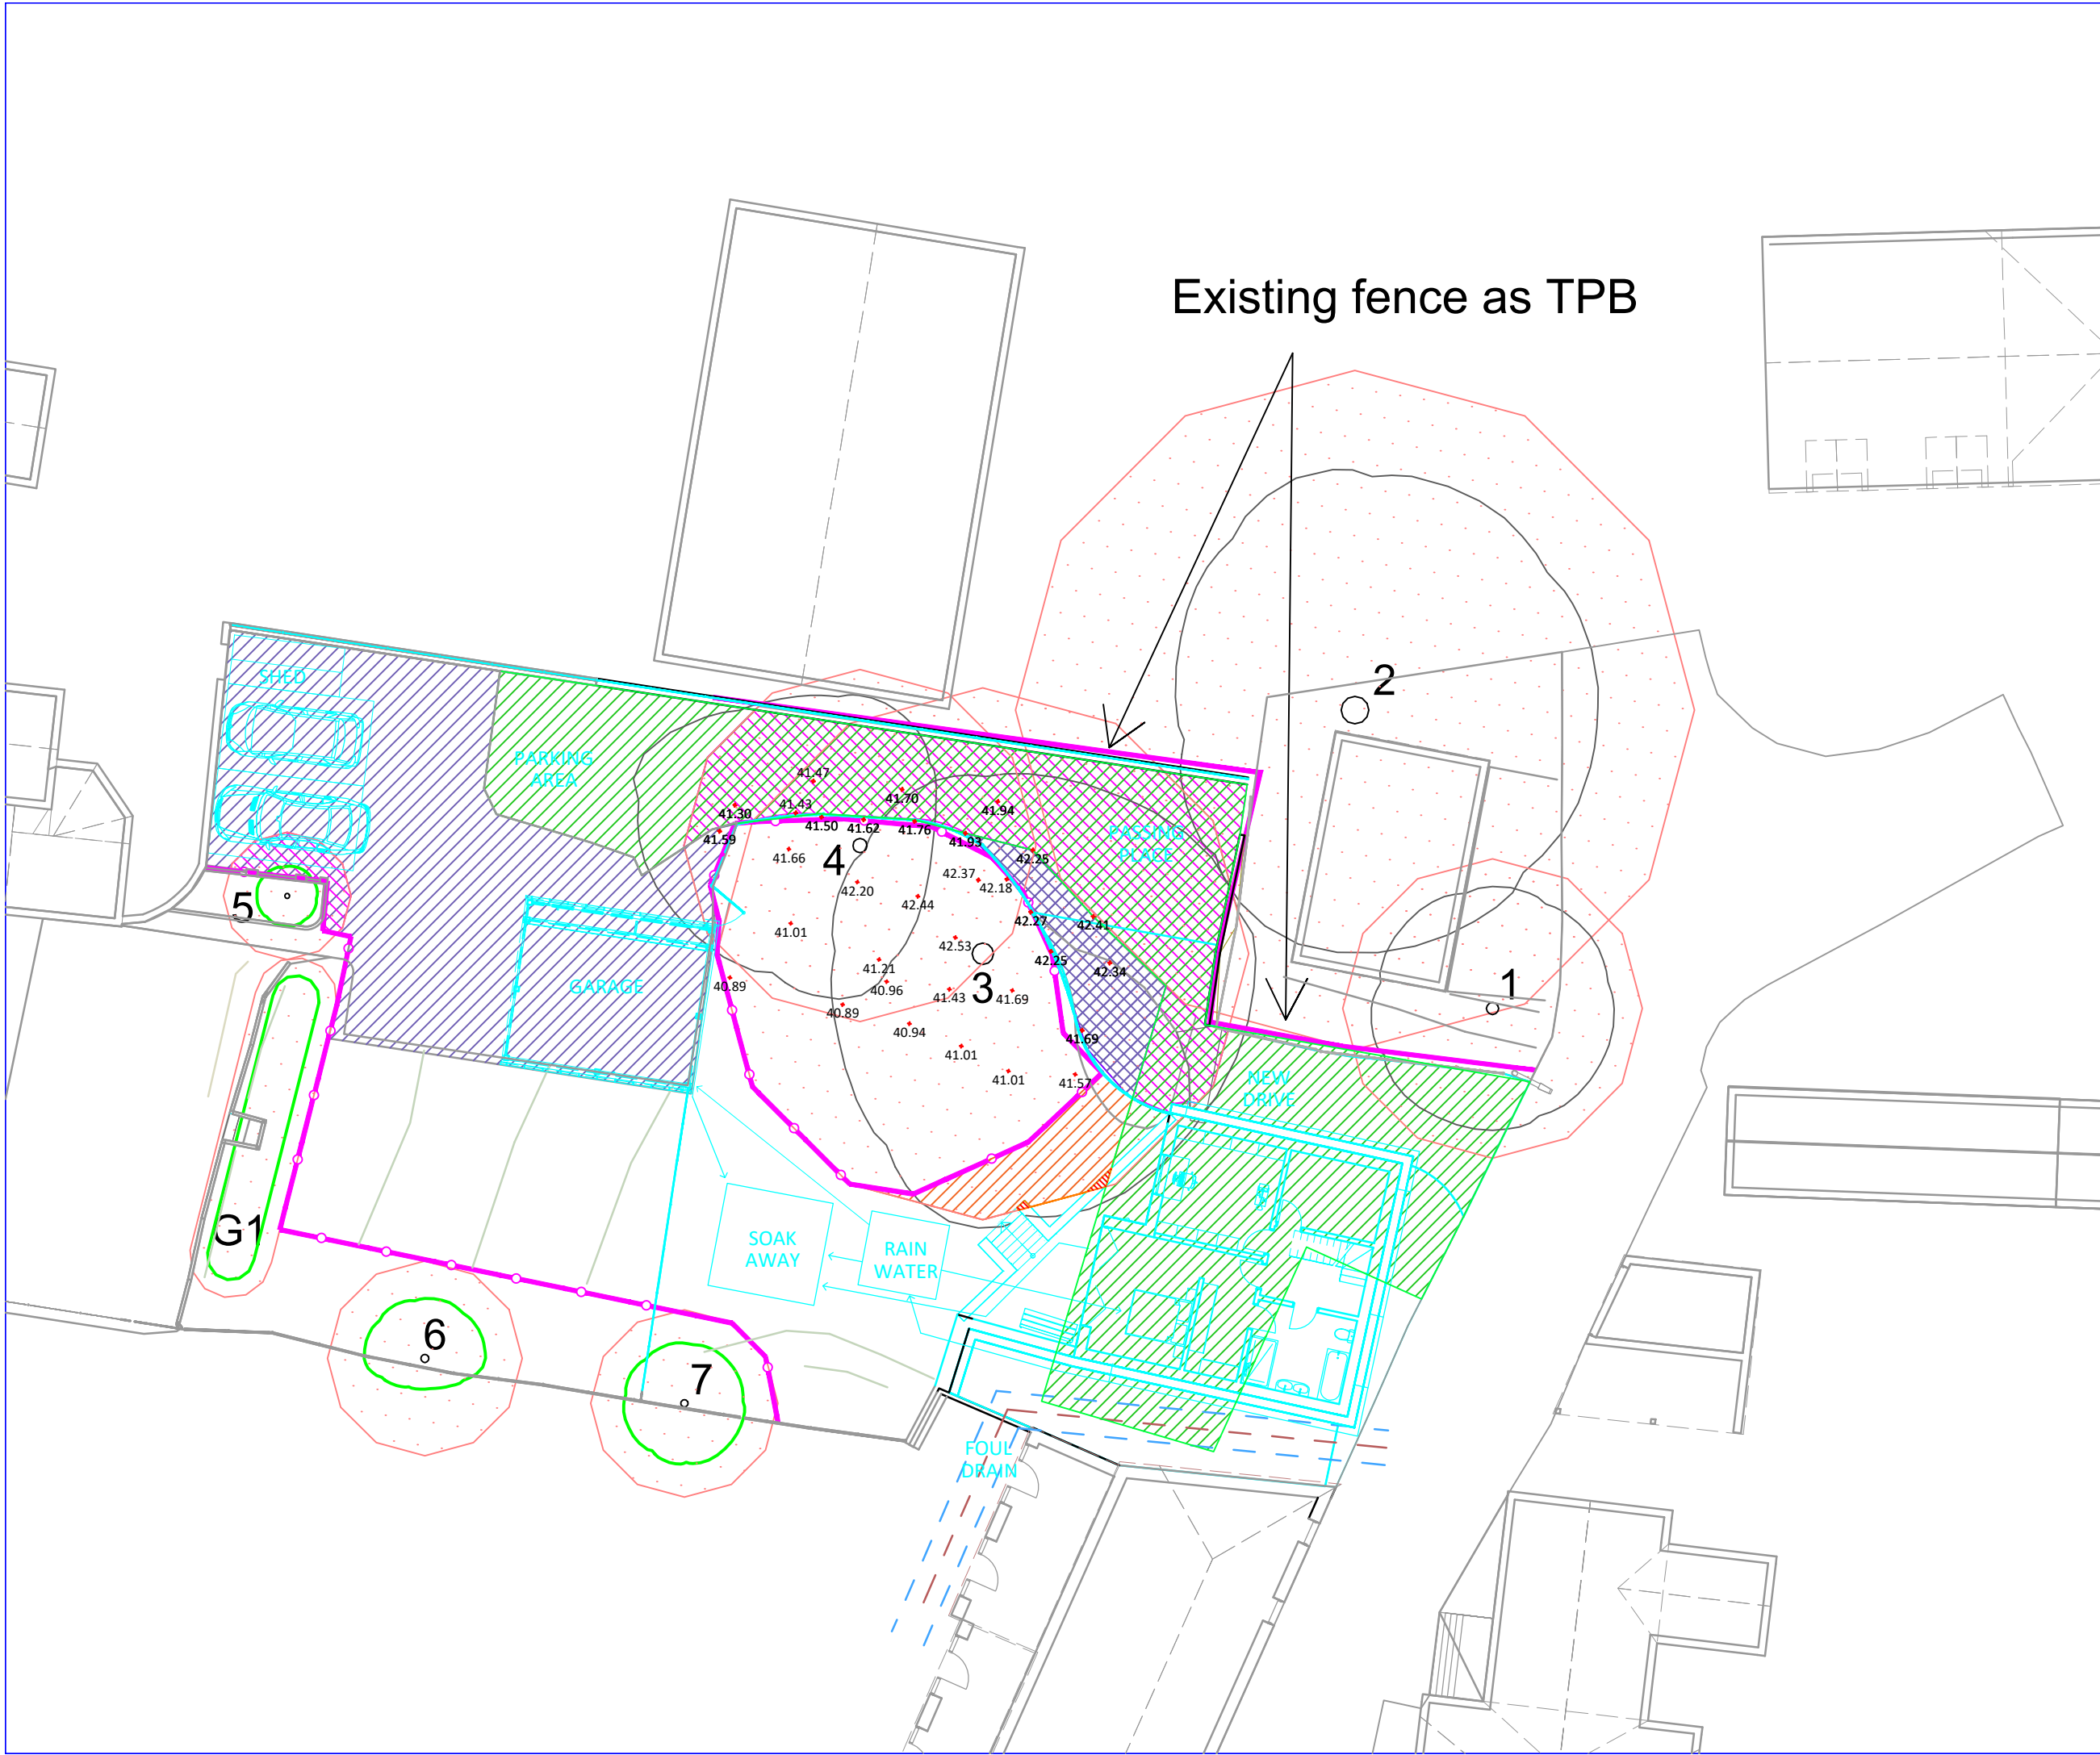
| Drg. No. | PB/MIT-22/11.02 | Rev. | |

- 5.2.1 A very minor RPA incursion is anticipated by the excavation of the foundations for the new dwelling into the RPA of T3; being 1m<sup>2</sup>, or less than 1% of the total RPA 228m<sup>2</sup>. Following the guidelines within Section 5.3 of BS5837:2012, this small area lost by the incursion will be more than compensated by the fact that the tree rooting zone will in reality spread out further around its circumference, which will be contiguous with its theoretical, circular RPA area. The loss of less than 1% of the RPA by the incursion will not in our opinion significantly affect the future viability of these trees.

5.2.5 RPA incursions are anticipated for the construction of new areas of hard-surfaced driveway over part of the RPAs of retained trees T3, T4 and T5. Disturbance to tree roots can be significantly reduced by appropriate mitigation work; in this case by considering:

- There is an area of new driveway over part of the RPA of T3 where there is a drop in level from 42.41 metres at the existing hard surface path down to 41.57 metres on the lawn. The proposed new driveway here will need to be constructed with a reinforced concrete slab, cast on-site, set above ground level, supported on piles, to an engineer's design. This is shown on the mitigation plan ref PB/MIT-22/11.02 as "Ground protection – new hard surface", showing the minimum area.

- 5.2.3 The incursion is so small as not to warrant any specific foundation related mitigation and standard construction methods can be adopted. However, in order to protect roots in the RPA the following generic mitigation should be considered;

- tree protection barriers must be installed prior to any site activity as shown on the mitigation drawing and remain in situ for the duration of the scheme;

- the RPAs of retained trees must be protected with temporary ground protection;
  - any surface vegetation requiring removal within the RPA of T3 must be agreed with the AC prior to removal and must only be removed with hand tools; all excavations within the RPA must be undertaken by hand prior to mechanical operations;

- within the RPAs of retained trees there must be no disturbance of the existing base layer or additional compaction during the construction works.
- all construction of driveways and car parking areas in the RPAs of T3, T4 and T5 must be undertaken using a "no dig" cellular confinement system such as Cellweb, or similar product; 100 millimetre depth for domestic traffic such as cars and vans up to a 6 ton (t) gross vehicle weight (GVW); over a permeable, non-woven geotextile membrane infilled with granular, 20-40 millimetre washed, angular stone infill; shown on PB/MIT-22/11.02 as "Ground protection - Cellweb", showing the minimum area. The finished surface must be a permeable surface or wearing course.

- This foundation will maintain a void beneath the slab to allow movement of air and moisture beneath the slab.
- The piles are to be either;
  - steel helical screw piles, using the smallest practical pile diameter as this reduces the possibility of striking major tree roots, or;

- bored piles formed with a continuous flight auger; lined with a plastic coated cardboard sleeve inserted to debond the pile shaft from volumetric ground movement and to avoid root damage caused by leaching of cementitious materials into the ground.

- The existing hard driveway over the RPA of retained tree T1 adjacent to Backsidean Lane is to be retained, and the surfaced top-dressed with gravel.

- 5.4.2 The accompanying mitigation plan ref PB/MIT-22/11.02 shows the specific tree protection locations required prior to and during the construction works.

- 5.4.3 The default tree protection barrier as specified and detailed in BS 5837:2012 (section 6.2, Fig 2), and included in Appendix 5 of the tree survey report ref SN/5837-22/18.01v2, is designed to provide construction exclusion zones around the RPAs of all trees to be retained.

- 5.4.4 The temporary ground protection must be installed prior to any site or construction activity as shown on mitigation plan ref PB/MIT-22/11.02, referenced as “Temporary ground protection”, and must remain in situ for the duration of the works. The existing hard surfaced drive will not require any further protection.

- 10.1 We recommend that tree protection measures as set out on the mitigation plan ref PB/MIT-22/11.02, and described above in sections 5.2 and 5.4, are installed and remain in situ until all works activity is completed.
