LAND NORTH OF ARBORFIELD ROAD, SHINFIELD  
DESIGNER'S RESPONSE

BELLWAY HOMES LTD (THAMES VALLEY)  
05 February 2026

| <b>Document Reference:</b> | HD008-R005/A |

# Road Safety Audit – Land North of Arborfield Road

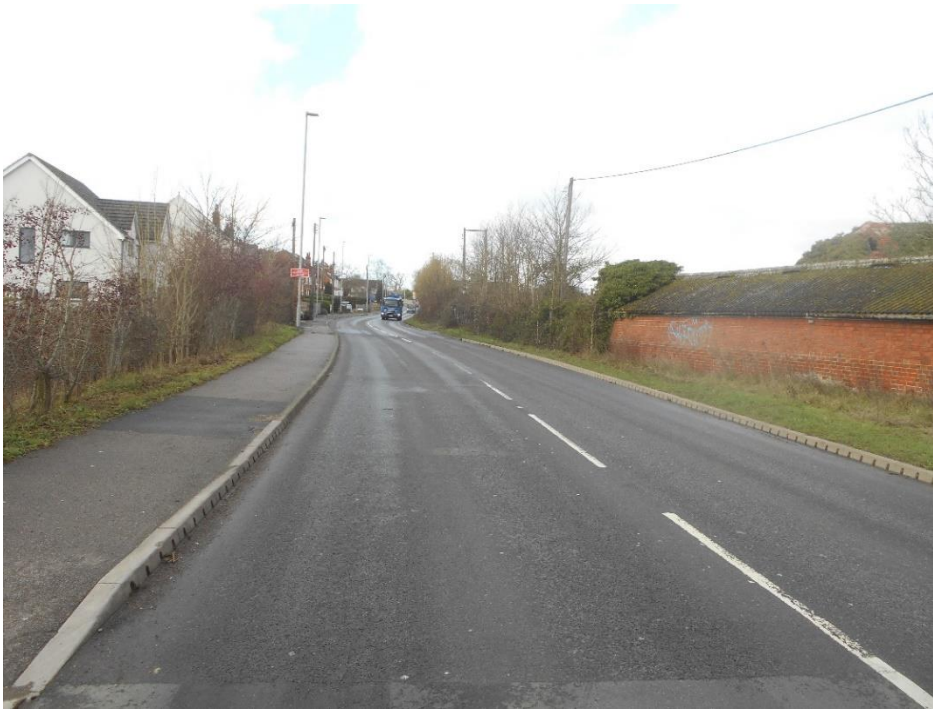
*Arborfield Road looking west. The road will be widened on the right side, to provide a central right-turn lane. A shared-use path is to be constructed on the right to link with existing shared-use network to the east, and a central refuge is proposed at the far end of the building on the right*

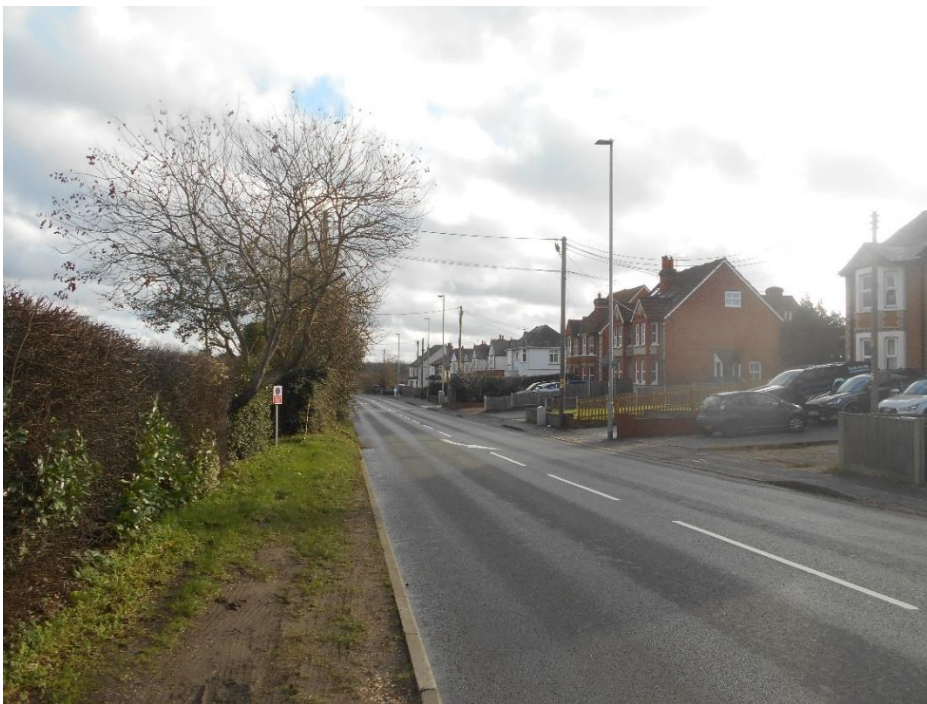
*Arborfield Road looking east. The road will be widened on the left side, with a new pedestrian refuge island just past the white arrow on the carriageway. The new vehicle access will be on the left, further down the road*

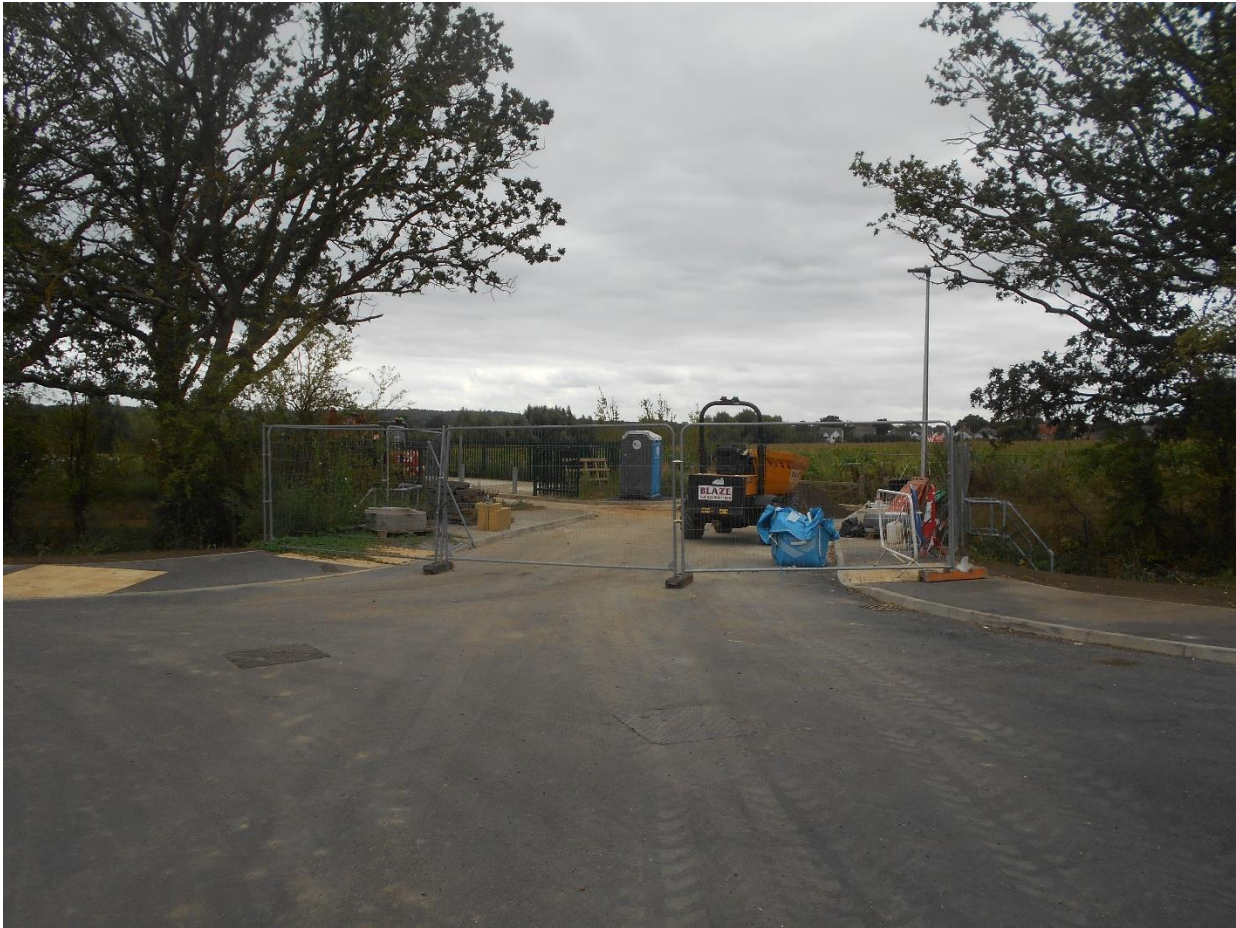
*View looking south from the stub end of Shepherd Road on the existing development to the north of the audit site. This road will continue southward through the proposed new development, reaching Arborfield Road at the new access. The houses on Arborfield Road can just be made out in the distance*

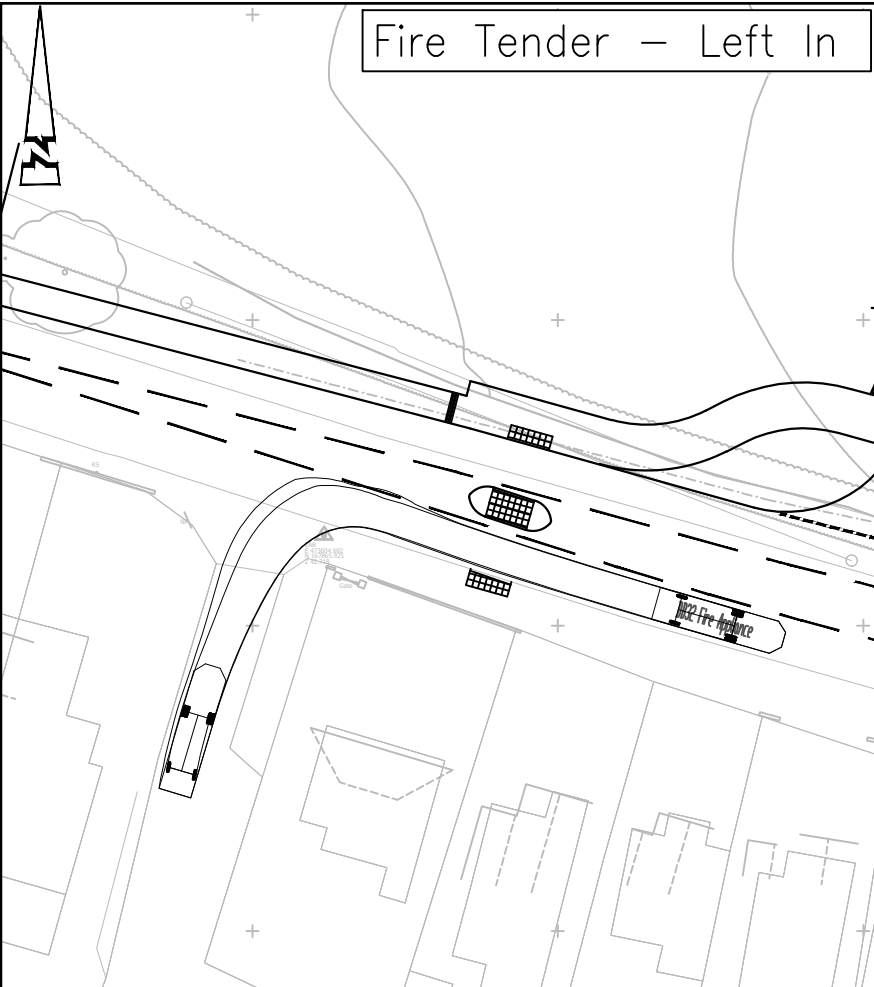
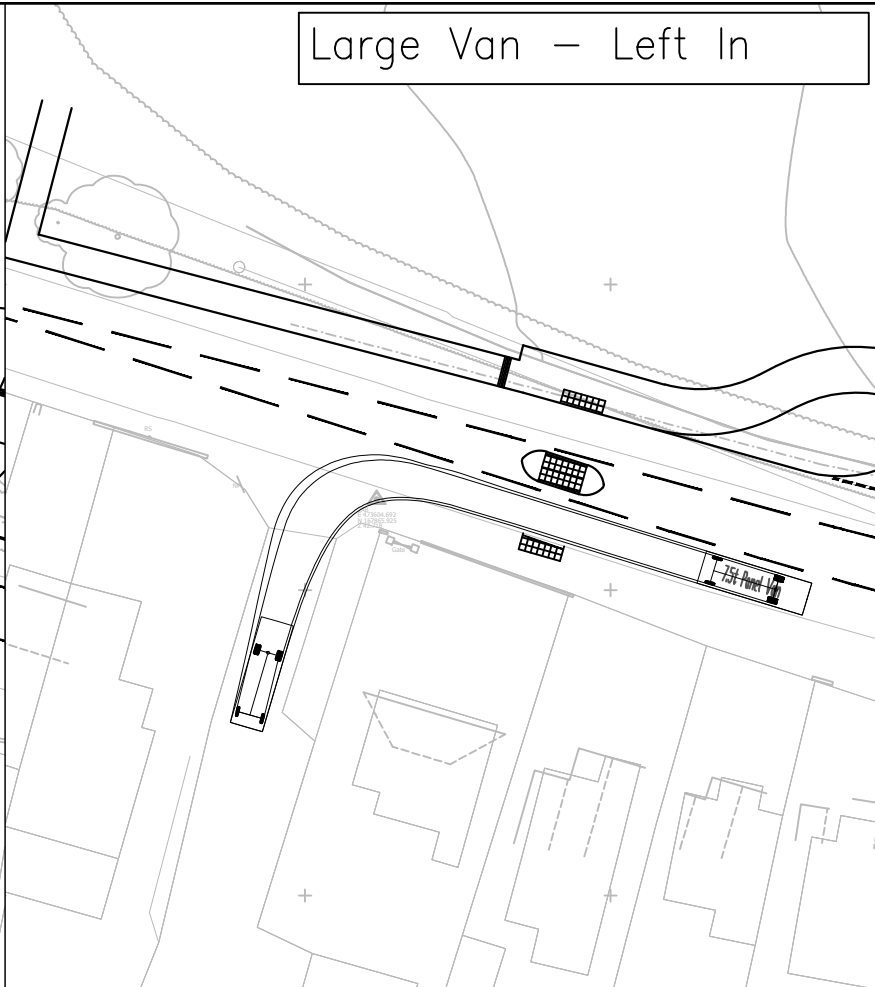
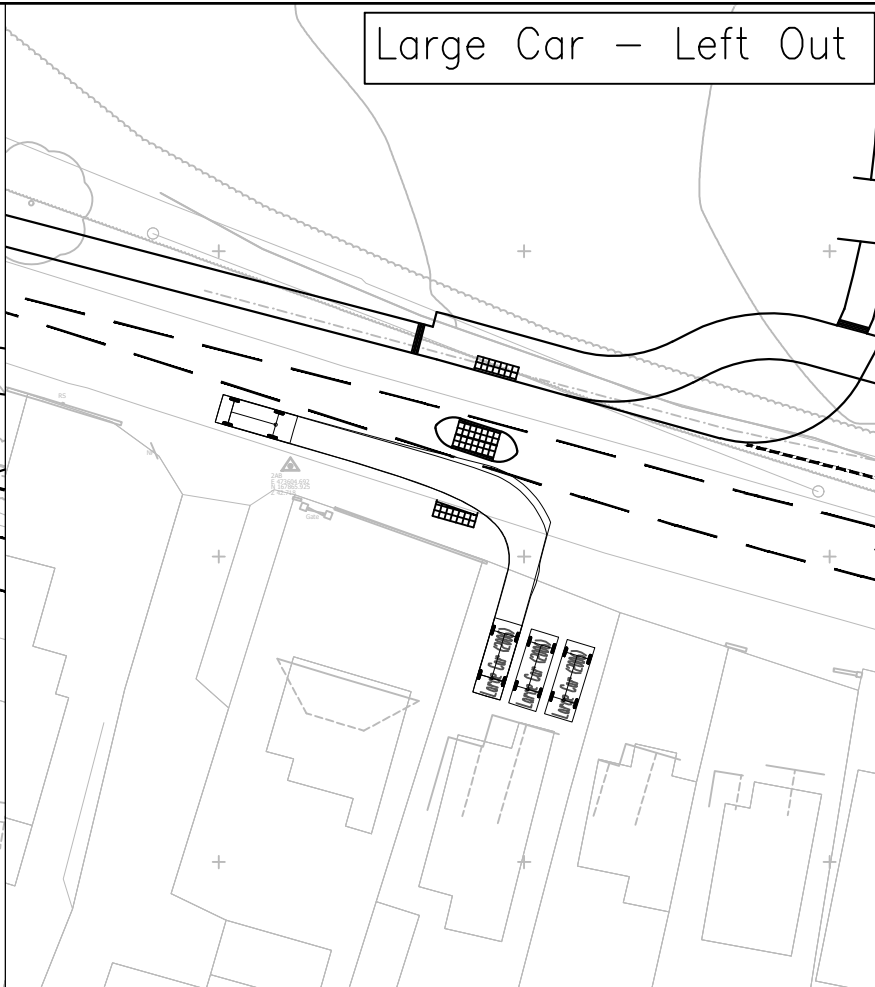
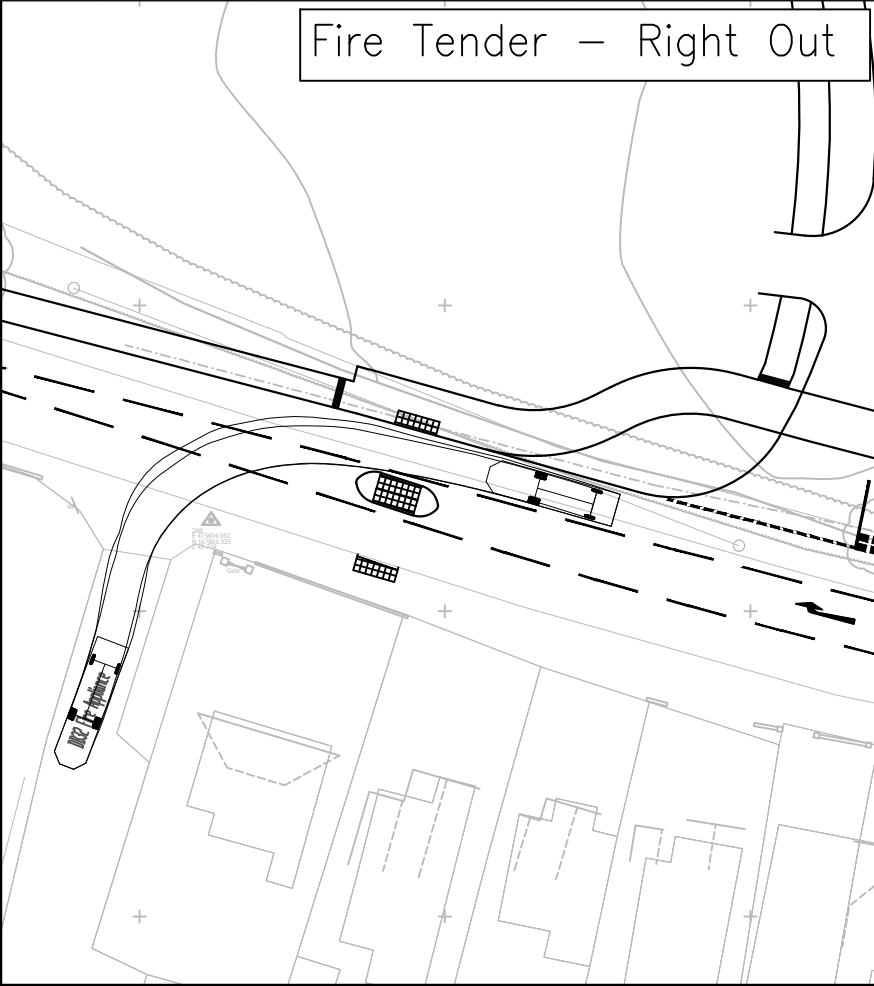
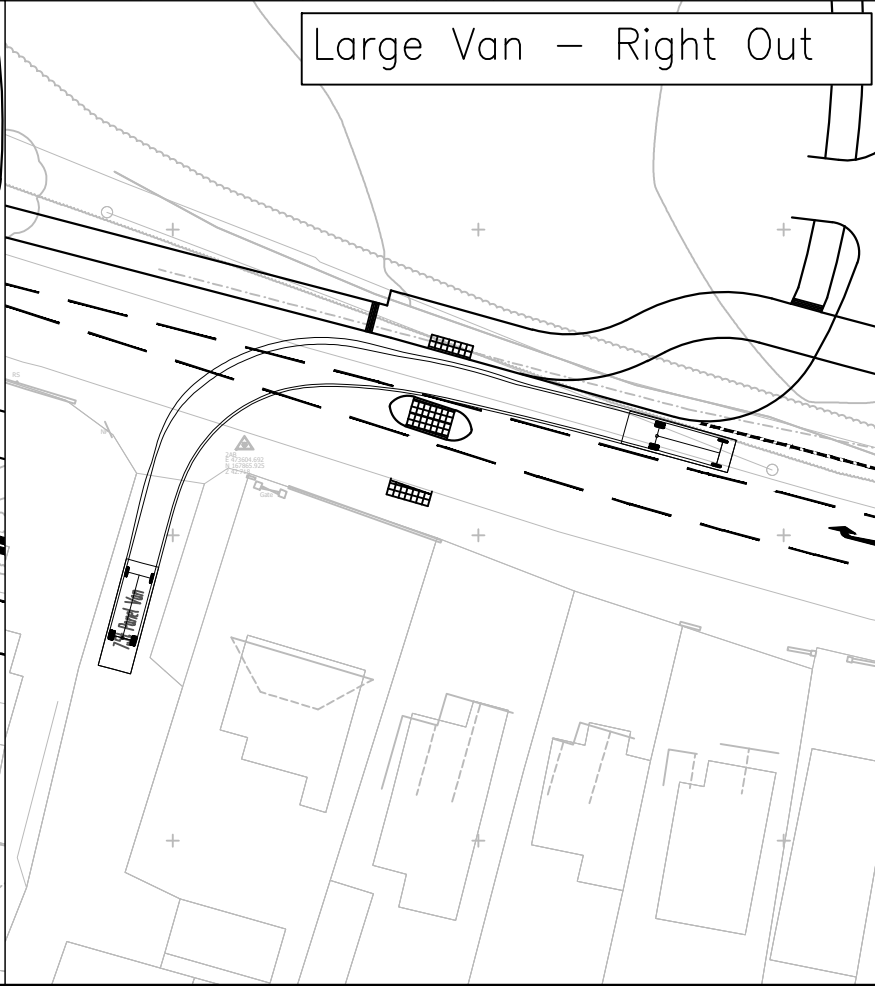
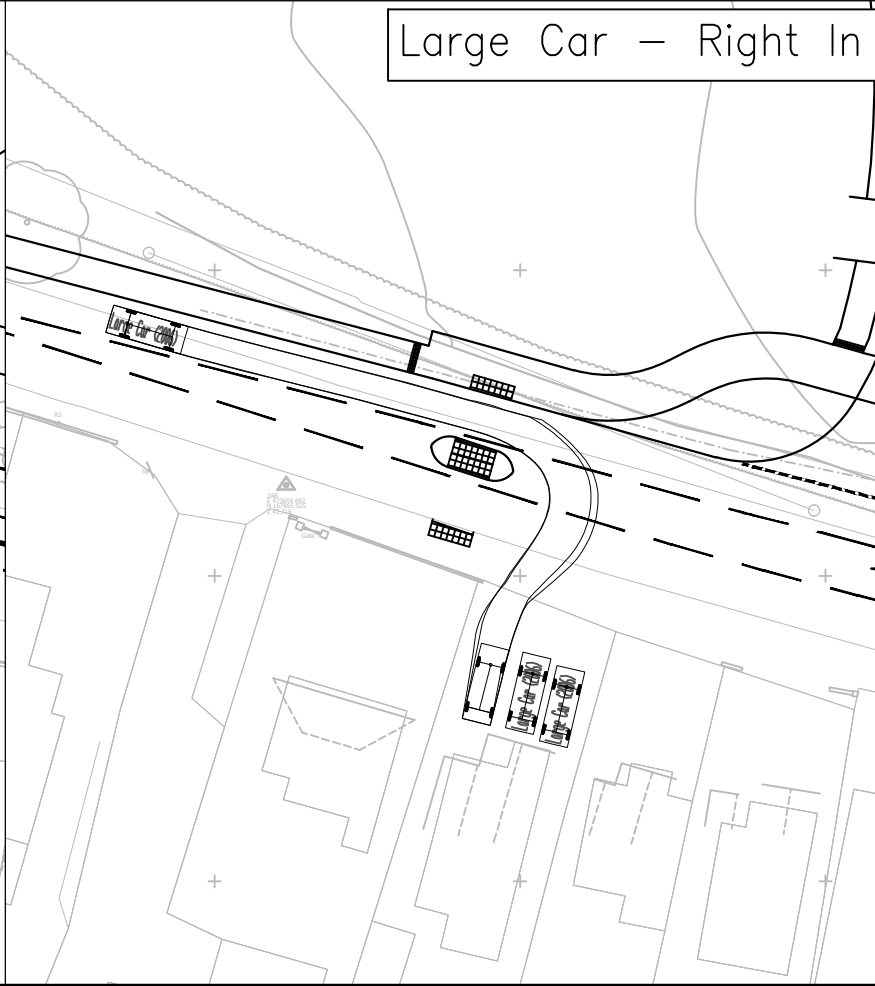
| Drawing No | Revision |

The island is located between private driveways to the east, and an access road leading to several properties, to the west. No swept path analysis drawings have been supplied for vehicles accessing/exiting the driveways or access road. Access for larger vehicles such as a refuse collection vehicle or removals vehicles may be required for the access road, therefore provision for these vehicles to turn should be maintained (note the island appears to have been relocated slightly to the east as part of the redesign, however it still requires checking).

- 2.6.4 Agree - Swept path analysis has been undertaken for each of the adjacent private drives, as provided at drawing HD008-021-P1 provided at **Appendix B** to confirm that the required turning movements can be undertaken by arriving or departing vehicles. The road markings will be considered and amended as part of the S278 works process.

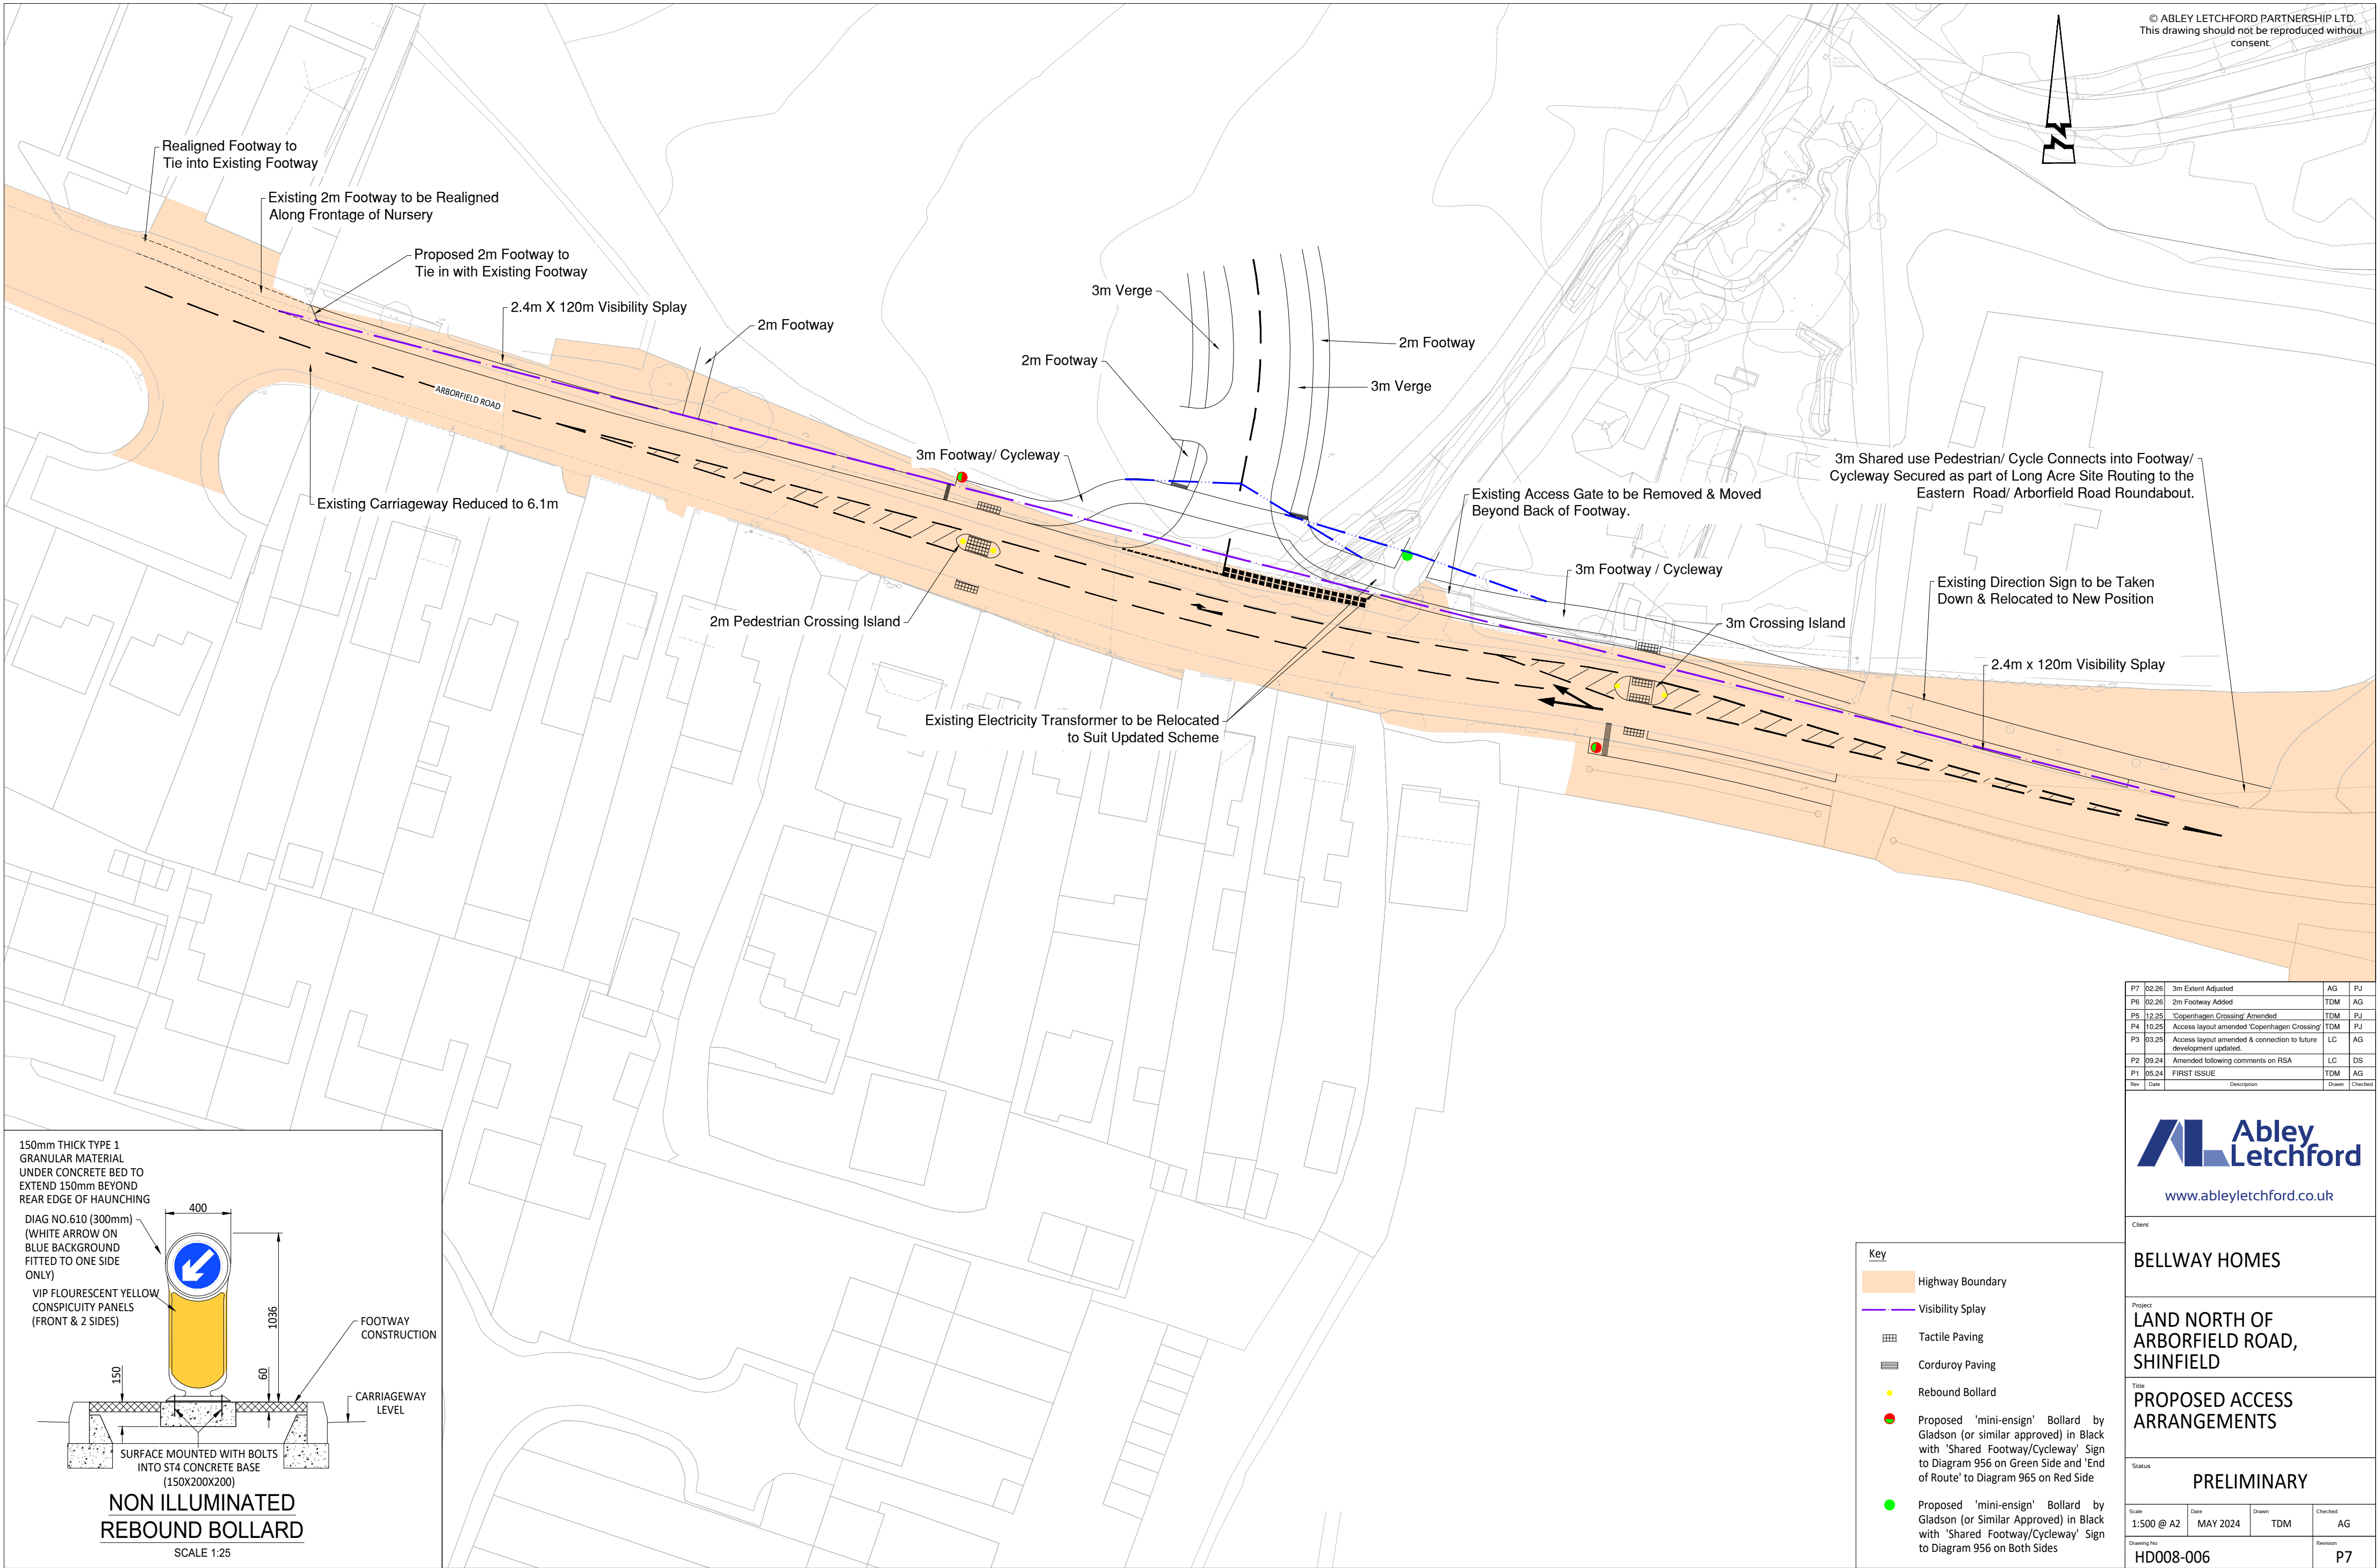
| Drawing No | | | | Revision |

- 2.7.3 The new footway on the north side of Arborfield Road appears to terminate approximately 45 metres short of the existing footway further to the west on this side. Pedestrians will be tempted to walk in the carriageway between the two footways, where they will be at risk of being struck by passing vehicles

- 2.7.5 Agreed - A new 2m footway is proposed on the northern side of Arborfield Road to connect with the existing footway provision to the west as depicted on the revised Access Drawing HD008-006-P7 at **Appendix C**.
