**BS5837 Arboricultural Report and  
Arboricultural Impact Assessment**

| SITE | 45 Frog Hall Drive, Wokingham, Berkshire, RG40 2LE |
| DATE | 22 <sup>nd</sup> September 2024 |

**Construct a two storey extension to the existing detached dwelling.**

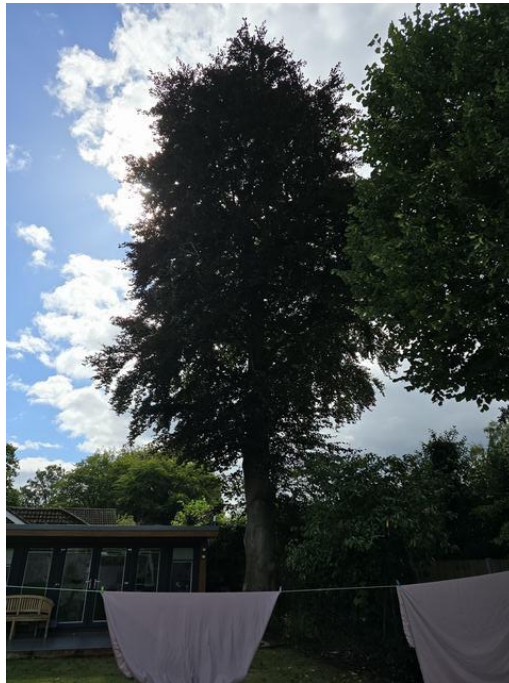
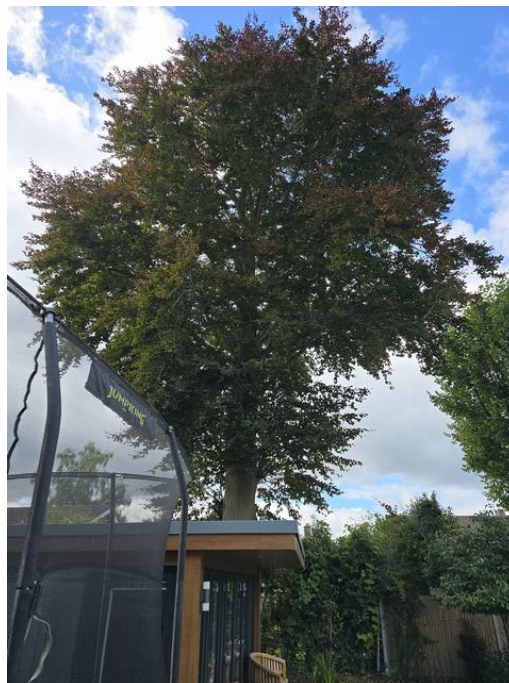
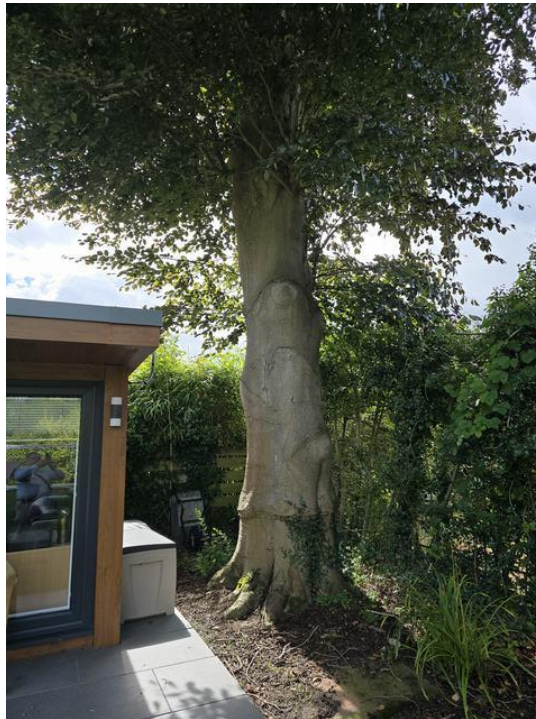
**Image 1** Large copper beech tree T01 in the back garden.

**Image 2** Large copper beech tree T01 in the back garden.

**Image 3** Trunk of large copper beech tree T01 in the back garden.

| Ref | Species | Measurements | Spread | General Observations | Retention Category | RPA | Recommendations | Condition | Reinspect |
|---|---|---|---|---|---|---|---|---|---|
| T01 | Copper beech<br>( <i>Fagus sylvatica purpurea</i> ) | Height (m): 16<br>Stem Diam(mm): 960<br>Spread (m): 7.5N, 8E, 7#S, 7#W<br>Crown Clearance (m): 5<br>Life Stage: Early Mature<br>Rem. Contrib.: 20+ Years | N:7.5<br>E:8<br>S:7#<br>W:7# | No significant observations | B1,2 | Radius: 11.5m.<br>Area: 415 sq. m. | No Action Recommended at this time, (NAR).<br>Install temporary tree protection measures during construction. | Physiological Cond: Good<br>Structural Cond: Good<br>Bat Habitat: Low | <b>3 Yrs.</b> |

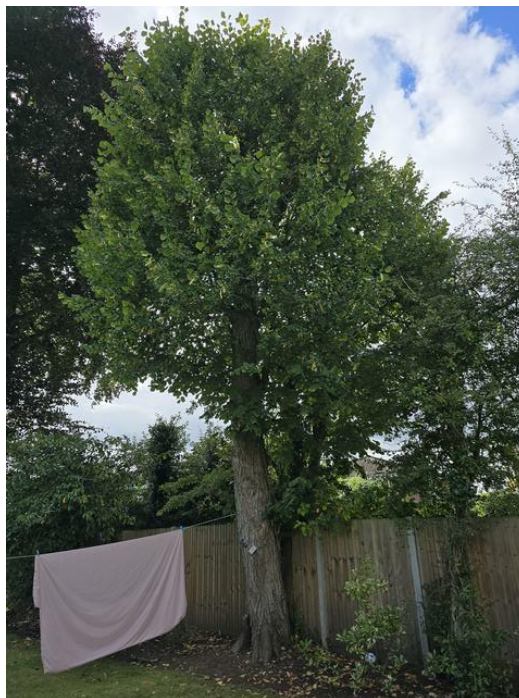
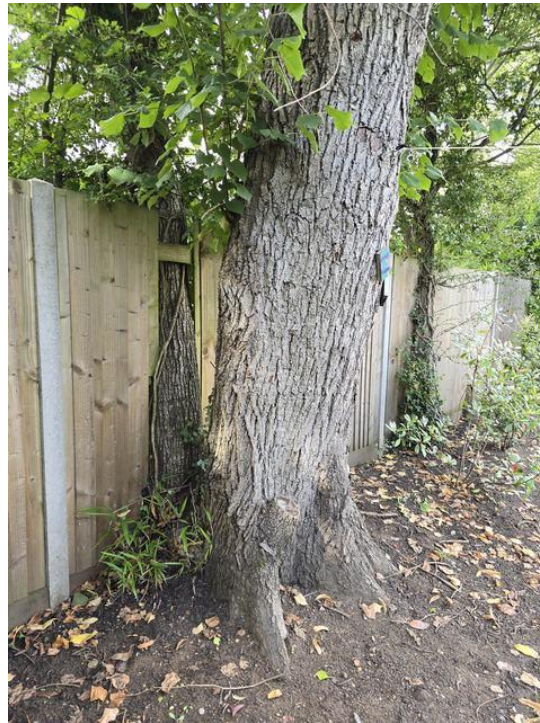
**Image 4** Pollarded lime tree T02 in the back garden.

**Image 5** Trunk of T02 a pollarded lime tree in the back garden.

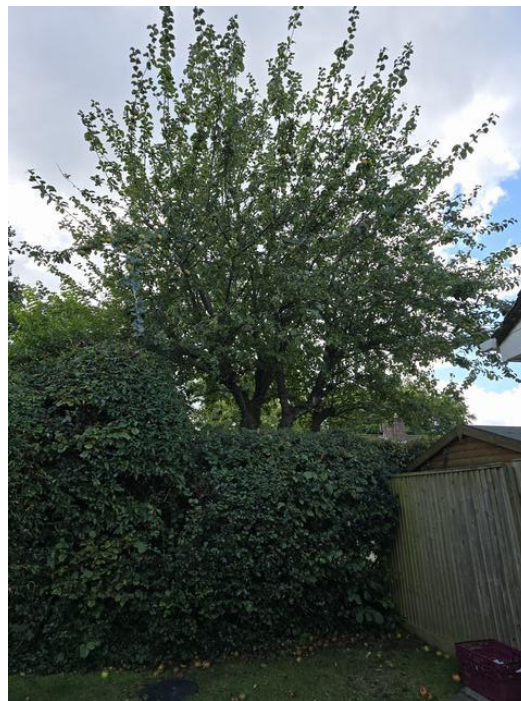
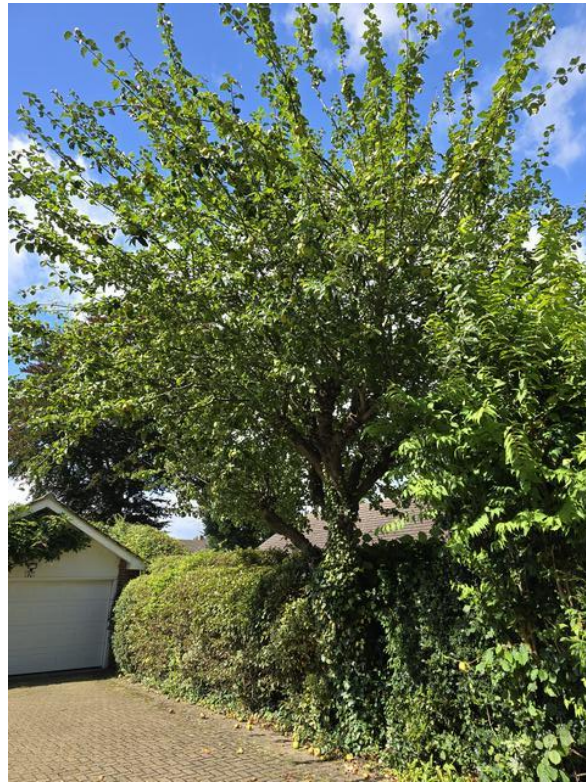
**Image 6** T03 an apple tree in the adjacent front garden.

**Image 7** T03 an apple tree in the adjacent front garden.

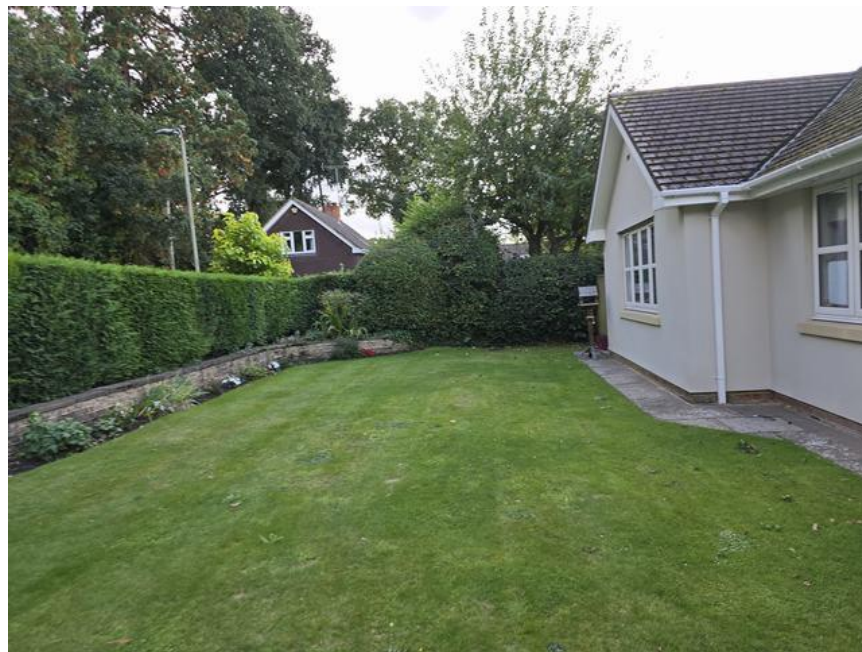
**Image 8** Are of front garden for access to the work area, storage, and facilities.
