18 Primrose Lane,  
Wokingham  
Retrospective Notes

Meadow Cottage, 18 Primrose Lane  
Winnersh, Wokingham, Berkshire, RG41 5UR

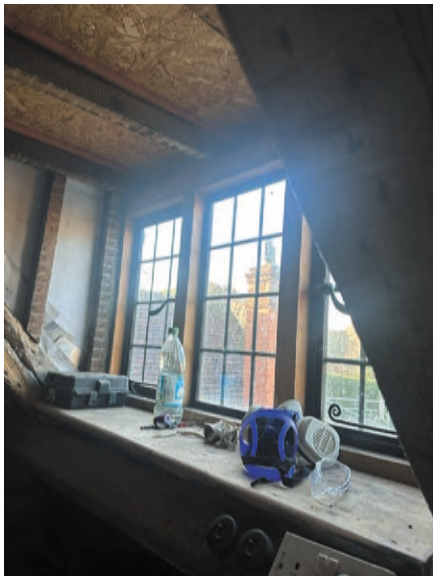
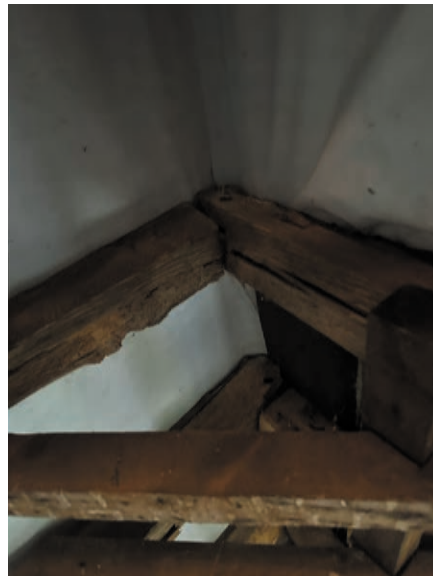
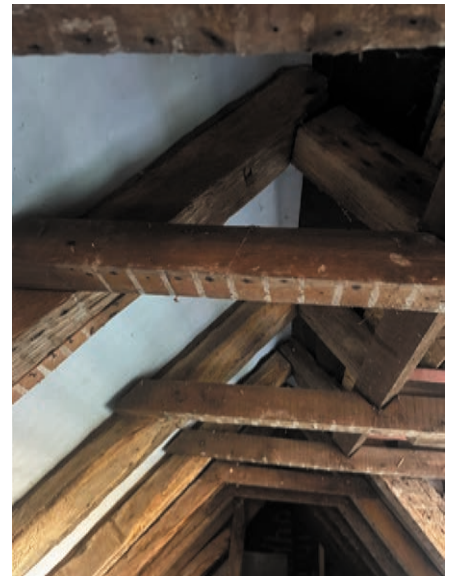
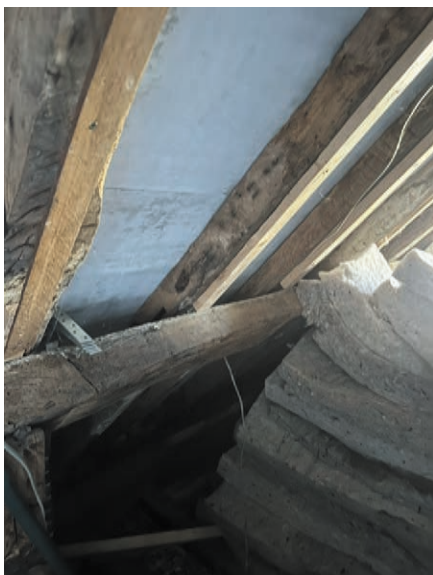
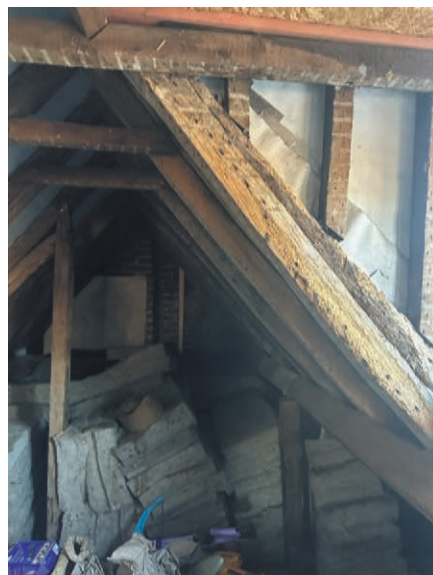
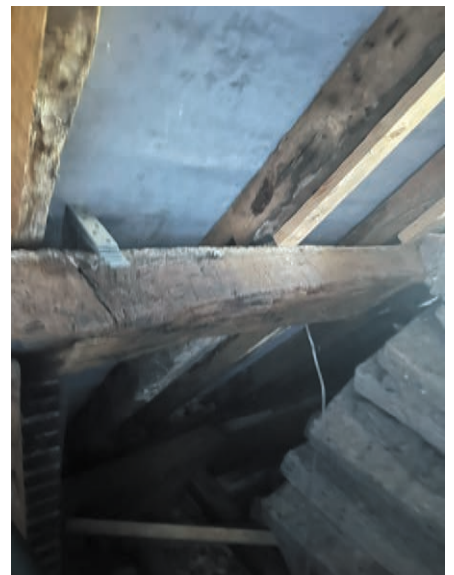
The Conservation officer highlights that the cottage has been re-roofed and has a membrane in place. The Conservation officer also highlights that the lath and plaster in the attic has been removed, along with the wood-chip wall paper finish. The conservation officer also notes that a number of timber repairs have been undertaken to the main roof structure, using softwood.

The client has confirmed that the cottage was re-roofed in 2017, however the existing roof tiles were largely re-used, based on the advise from Giles Stephens when he visited site to review 18 Primrose Cottage. A breather membrane was added to the roof during the re-roofing project. The wood-chip wall paper and lath and plaster were removed at this time to enable the roof structure to be fully reviewed. The hardwood historic timbers were defrassed to confirm there structural integrity. No historic timbers were replaced, however softwood firings were added above some of the hardwood rafters and softwood timbers around the dormer to improve the fall of the lead roof to the dormer.

I attach some images below of the current attic timbers and some images over page during the re-roofing works.

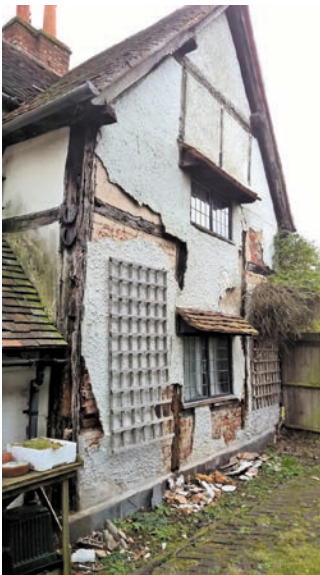
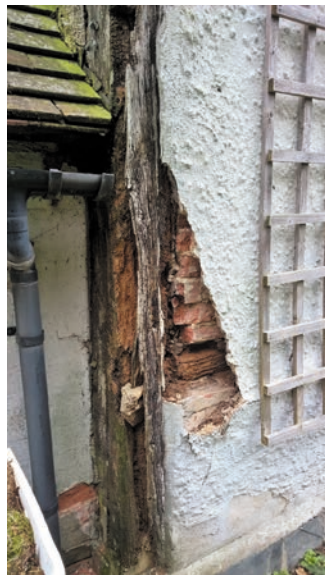
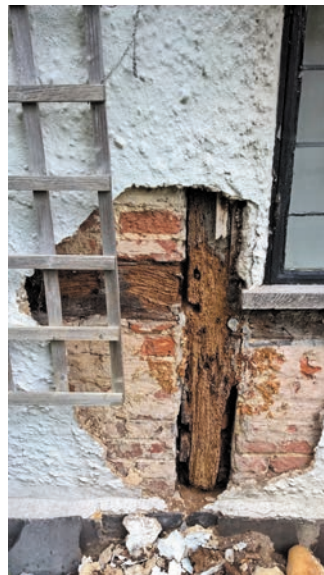
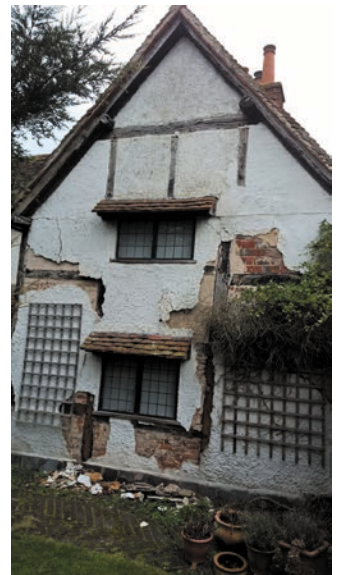
The client has confirmed that repair works to the west gable were undertaken in 2017, with Dunne and Co. undertaking these works. The gable was in a poor condition due to being finished with inappropriate masonry paint and a cementious skim, furthermore the rainwater goods in this area were leaking and concentrating water onto some of the timber frame, causing decay. The timber frame had repairs undertaken, retaining as much of the historic fabric possible. The repairs to the timber frame were largely face place repairs and scarf repairs, retaining as much of the historic timber possible.

I attach some images below of the condition of the west gable prior to the works being undertaken and over page of the west gable end both internally and externally today.

The infill panels were a combination of brick infill panels, block work panels and lime panels. These were repaired and replaced. The panels were finished with lime render and then lime washed with an ochre lime wash. The lime infill and brick infill panels were retained and repaired, with new lime render put over the panels. The block work infill panels were removed and replaced with lime infill panels, rendered over.

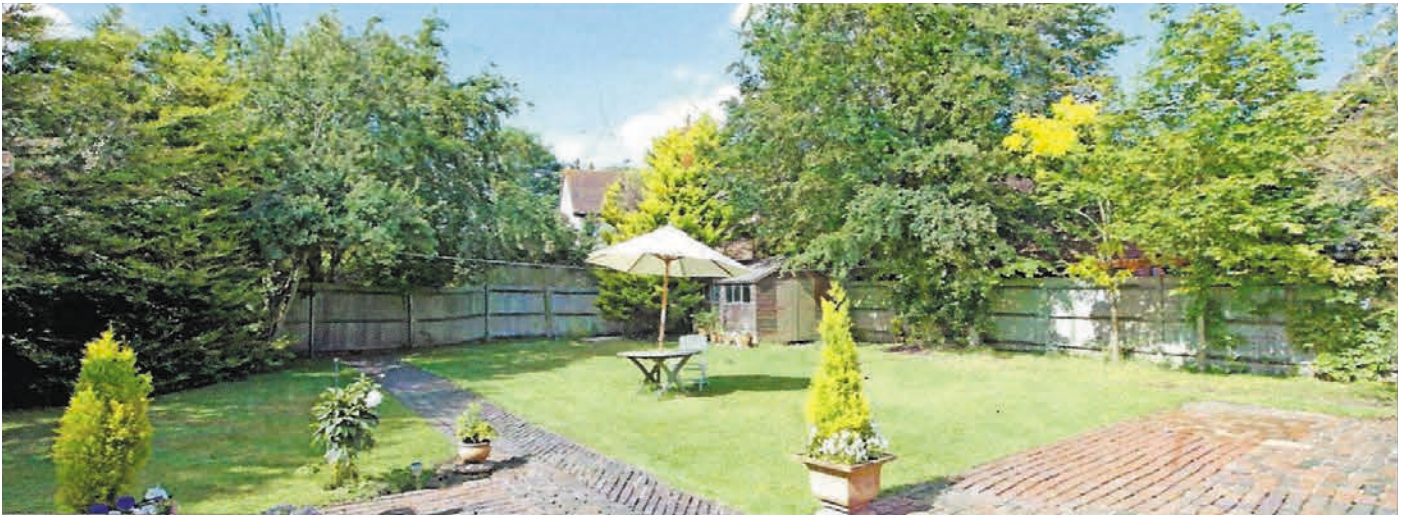
IMAGES FROM 2015 PARTICULARS

The client purchased the property in 2015 and the shed was in place at this point in time and appears to have been at the property for a considerable amount of time before this. I attach an image from the 2015 particulars below. This is a small scale shed and is not affecting the significance of the Listed Building or its context. It provides a space for garden tools and equipment which is needed to maintain the garden at 18 Primrose Cottage.

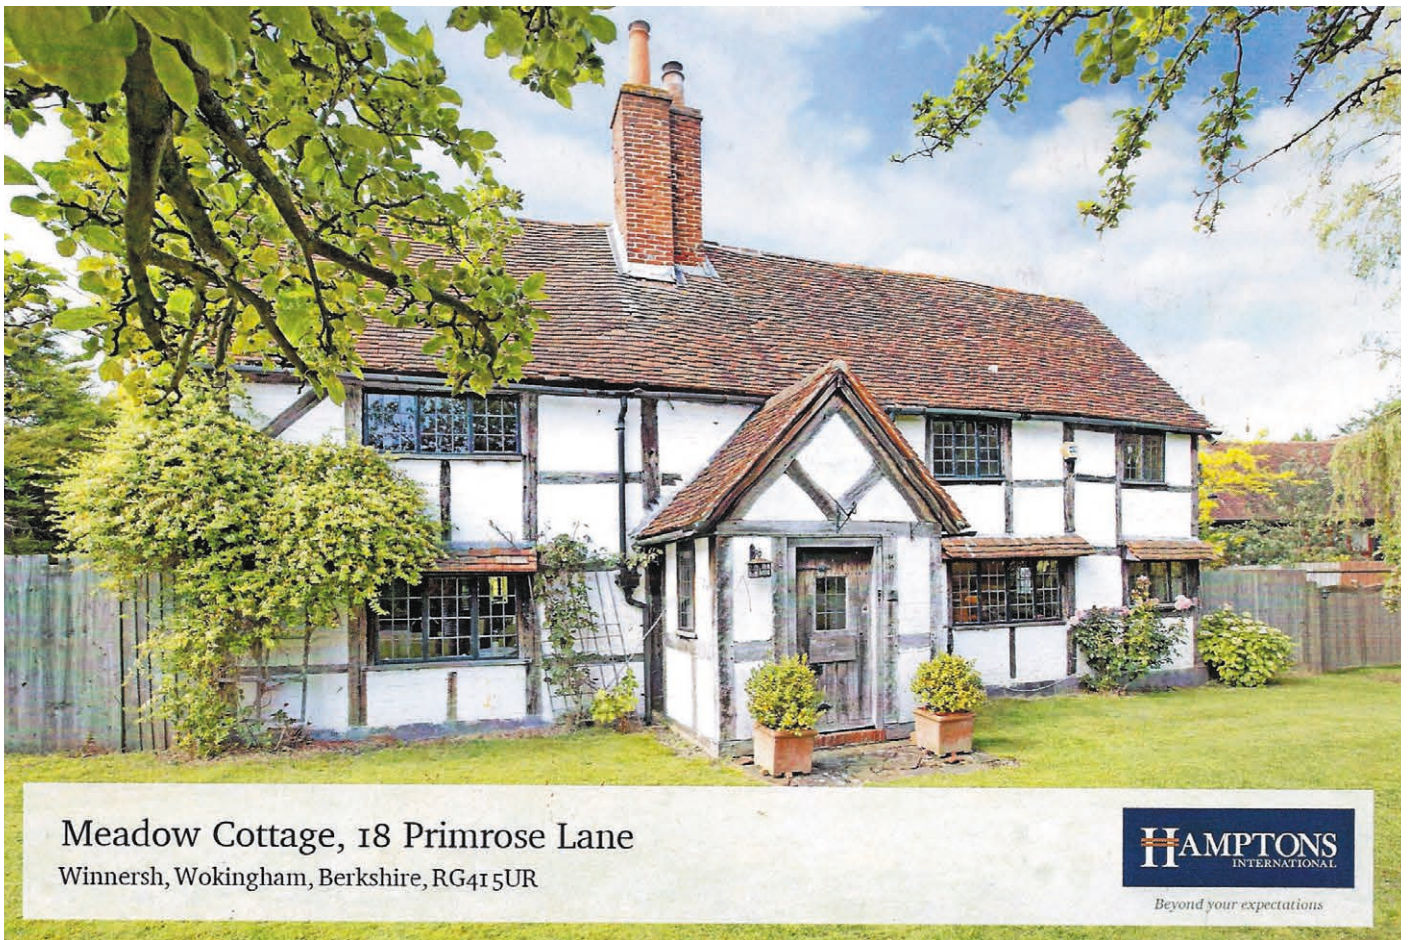
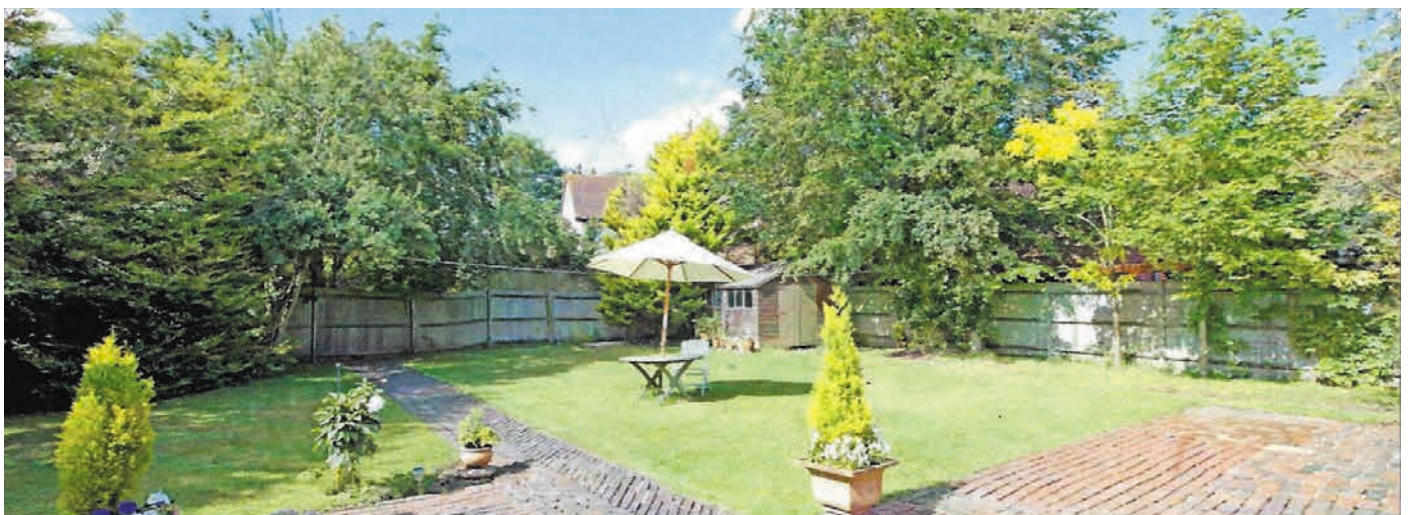
IMAGES FROM 2015 PARTICULARS

The client purchased the property in 2015 and the fences and gates were in place at this point in time and had been providing boundaries for the property for a considerable amount of time before this, however the date that the fences and gates were erected is not known. I attach the particulars from 2015 which show the fencing on-site.

The fencing does not negatively impact the listed building and has been in place for a considerable amount of time and it is unknown what the boundaries were previously to this fencing, although it is likely that this fencing or a similar style of fencing was in place before the cottage garden was split and no. 19 Primrose Cottage was erected.
