# ARBORICULTURAL IMPACT ASSESSMENT

(INC. TREE SURVEY TO BS 5837:2012)

PROJECT - Land off Church Lane, Shinfield

DOC. REF - P4225-AIA01 V1

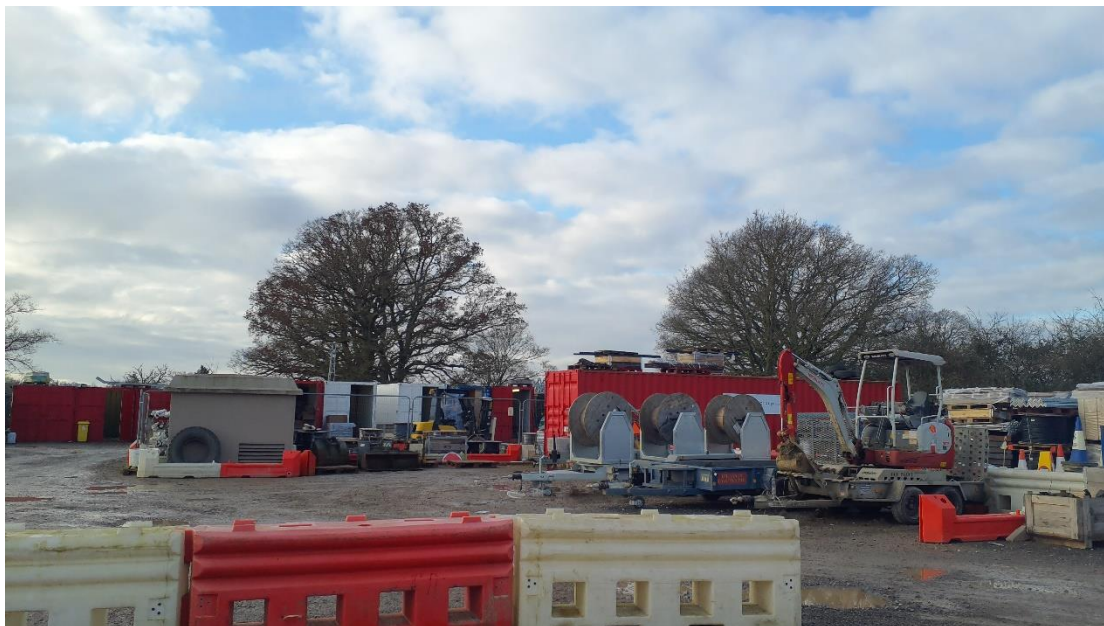
Figure 11 – The north-western corner of the site, pictured from the south-east. T12 can just be seen in the far left of frame, with T11, T10 and T9 visible (from left to right).

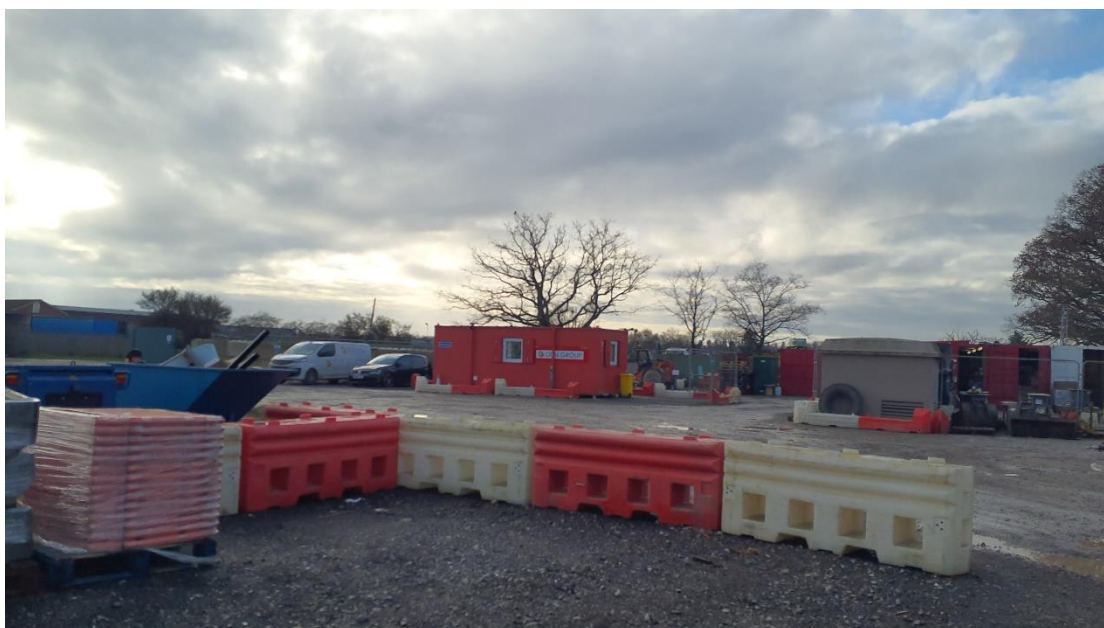
Figure 12 – The western boundary of the site, pictured from the north-east. T14 is visible centre frame, with T13 and T12 to its right, and T11 just visible on the far right.

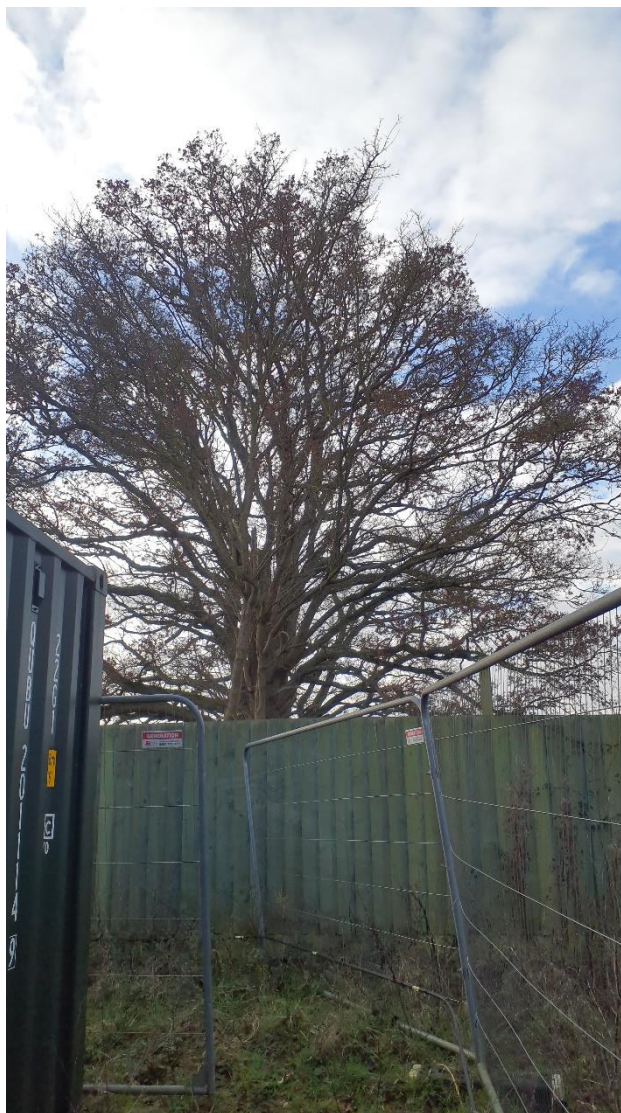
However, compaction within the RPAs of T10, T11, and T14 exceeds tolerable limits, affecting 28%, 46%, and 32% of their RPAs, respectively. This has significantly contributed to their declining vitality. Remedial actions to improve soil structure and quality are necessary if the compound is to remain for the proposed duration.

| Ref. | Tag | Species | Height (m) | Crown (N/E/S/W) | Crown Clearance (m) | DBH (mm) | Life Stage | Structural | Vitality | Additional Notes | General Management Recommendations | Priority | Development Related Tree Works | Tolerance | RPA Radius (m) | RPA Area (m <sup>2</sup> ) | Cat. |
|---|---|---|---|---|---|---|---|---|---|---|---|---|---|---|---|---|---|
| T10 | | Acer campestre (Field maple) | 7 | 4.5 / 2.5 / 2 / 4 | 2 | 200 | Mature | Fair | Fair | Stem and crown measurements estimated due to lack of access to stem. Central leader wounded and decaying, with laterals taking over as leaders. Moderate size deadwood in crown (<150mm diameter). over adjacent site. | | | | Good | 2.4 | 18.1 | C1 |

*Figure 14 – T10, pictured from the east. Its crown is obscured somewhat by the larger oak tree behind it, but its stems can be seen left of centre.*

Soil amelioration via 'vertical mulching' is to be undertaken within the RPAs of T10, T11, and T14. The following specification should be implemented:

Following the vertical mulching, no-dig surfacing (such as Cellweb TRP) should be installed within the RPAs of T10, T11 and T14.

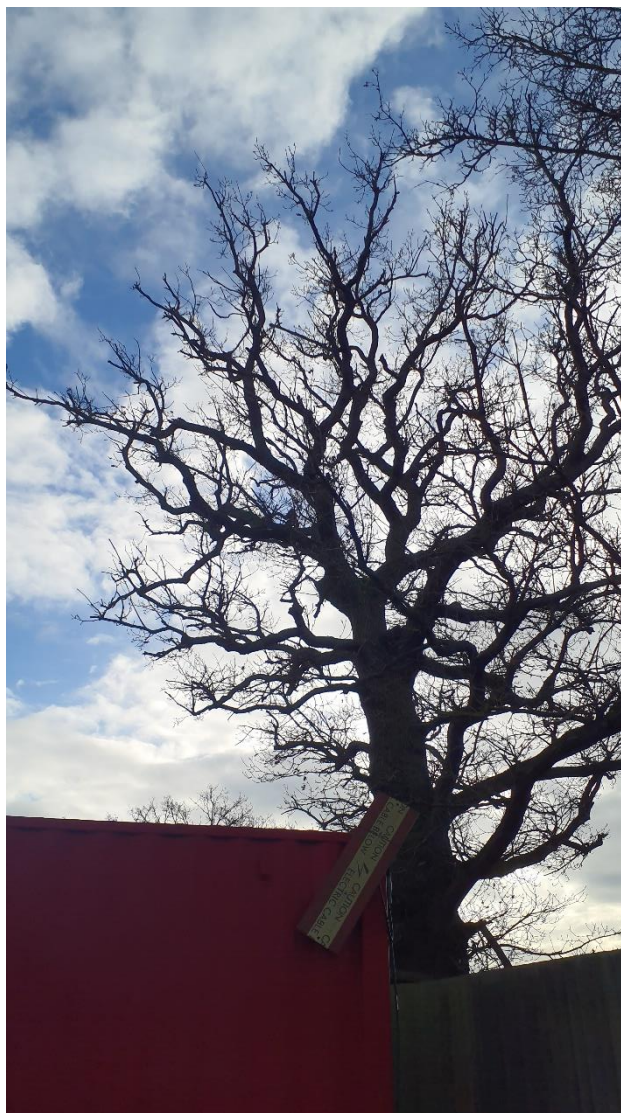
| Ref. | Tag | Species | Height (m) | Crown (N/E/S/W) | Crown Clearance (m) | DBH (mm) | Life Stage | Structural | Vitality | Additional Notes | General Management Recommendations | Priority | Development Related Tree Works | Tolerance | RPA Radius (m) | RPA Area (m <sup>2</sup> ) | Cat. |
|---|---|---|---|---|---|---|---|---|---|---|---|---|---|---|---|---|---|
| T11 | | Quercus robur (English oak) | 13 | 6.5 / 4.5 / 5 / 6.5 | 3 | 850 | Late-Mature | Good | Fair | Tree health in early stage of decline. Upper crown is stag headed. Decline either caused or exacerbated by installation of compound between 2018 and 2020 and heavy compaction within RPA. Moderate size deadwood in crown (<150mm diameter). over containers within site, harm considered unlikely in event of falling deadwood. | Existing surfacing should be removed, and vertical mulching should be carried out within the tree's RPA (see section 3 of Arb Impact Assessment). | 12 Months | | Moderate - Good | 10.2 | 326.9 | B1 |

*Figure 15 – T11, pictured from the north-east. Its declining vitality can be seen clearly, which is likely caused or exacerbated by the compaction of ground within its RPA.*

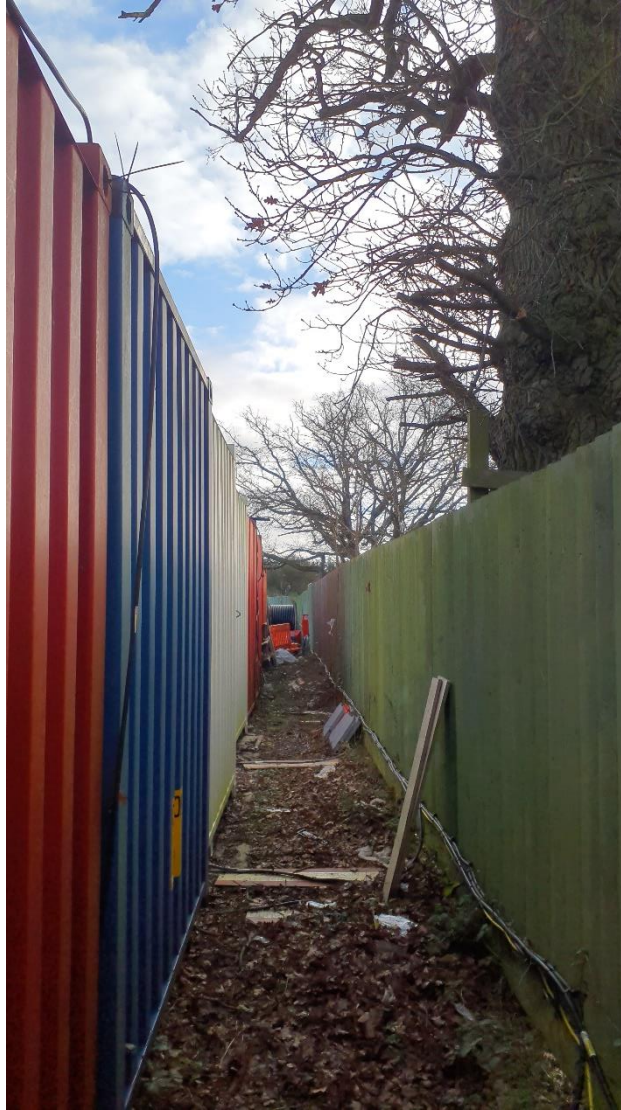
*Figure 16 – The western boundary of the site, pictured from the north. From front to back, T11, T12, T13 and T14 can be seen.*

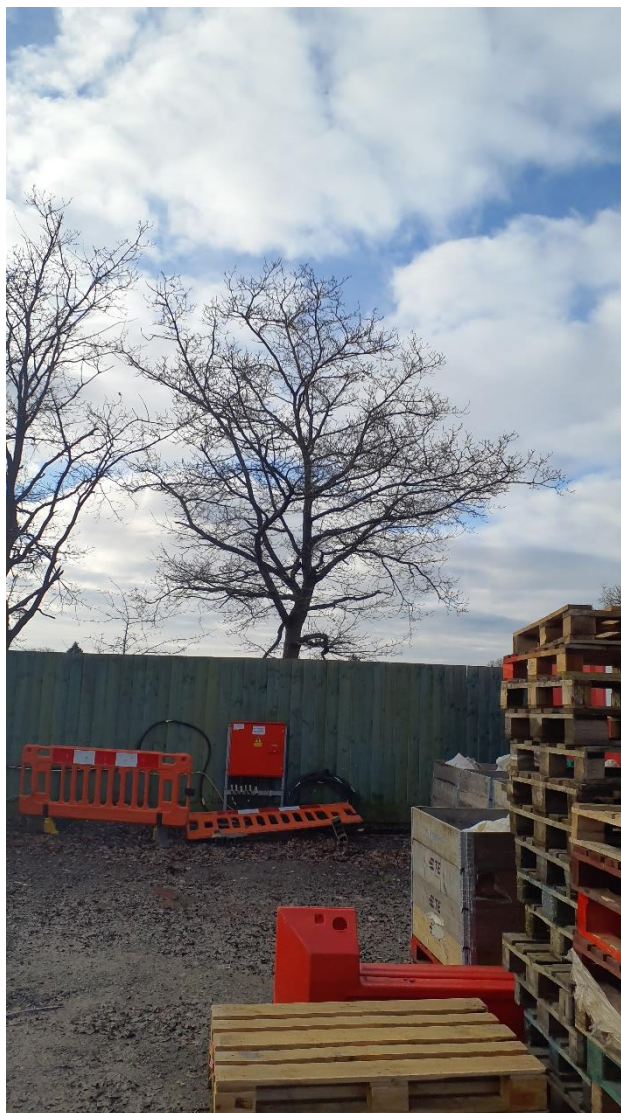
For T4, T12, T13, and G1, the extent of compaction within RPAs is within acceptable limits, covering 11% of T4's RPA, 6% of T12's RPA, 10% of T13's RPA, and <1% of G1's RPA. No mitigation is required for these trees.

*Figure 17 – T12, pictured from the east. The ground within the site has been compacted within its RPA.*

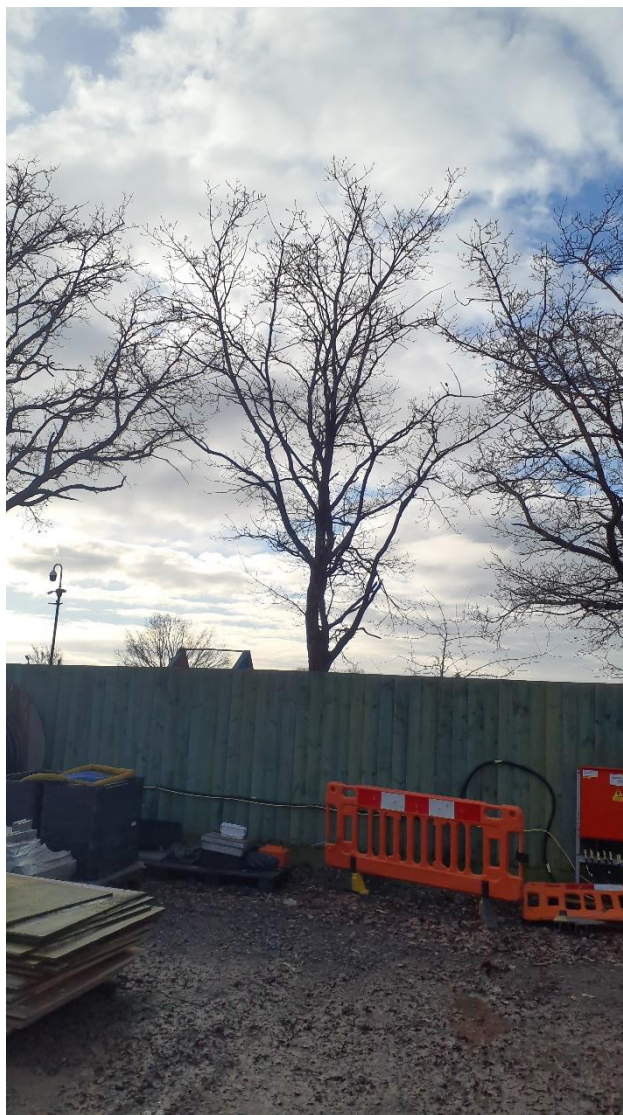
*Figure 18 – T13, pictured from the east. The ground within the site has been compacted within its RPA.*

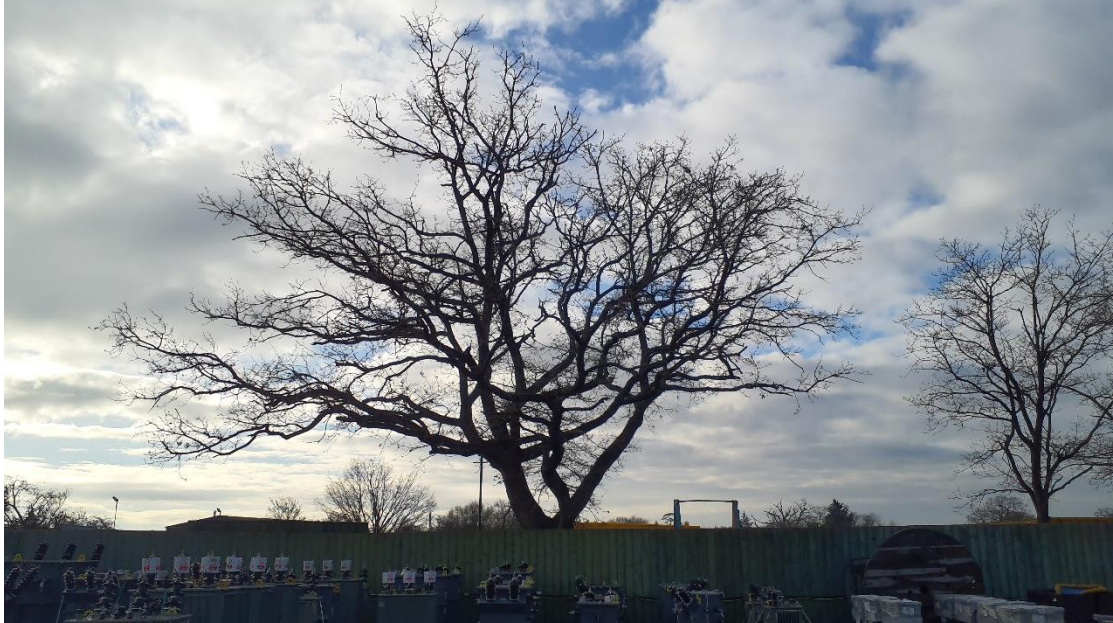
| Ref. | Tag | Species | Height (m) | Crown (N/E/S/W) | Crown Clearance (m) | DBH (mm) | Life Stage | Structural | Vitality | Additional Notes | General Management Recommendations | Priority | Development Related Tree Works | Tolerance | RPA Radius (m) | RPA Area (m²) | Cat. |
|---|---|---|---|---|---|---|---|---|---|---|---|---|---|---|---|---|---|
| T14 | | Quercus robur (English oak) | 14 | 9.5 / 11 / 9.5 / 11 | 4 | 1300 | Late-Mature | Fair | Fair | Stem and crown measurements estimated due to lack of access to stem. Tree health in early stage of decline. Decline either caused or exacerbated by installation of compound between 2018 and 2020 and heavy compaction within RPA. Upper crown becoming stag headed. Moderate size deadwood in crown (<150mm diameter) over both surveyed site and site to west. Harm considered unlikely in event of falling deadwood, but deadwooding may still be prudent in interest of avoiding damage to equipment. | Remove significant deadwood (>30mm diameter and 1m in length). Existing surfacing should be removed, and vertical mulching should be carried out within the tree's RPA (see section 3 of Arb Impact Assessment). | 12 Months | | Moderate - Good | 15.6 | 764.5 | B1 |

*Figure 19 – T14, pictured from the east. The ground within the site has been compacted within its RPA. Decline is visible in its canopy, although not to the same extent as in T11's. The compaction and storage of heavy equipment within its RPA is likely causing or exacerbating the tree's decline.*
