**TREE PRESERVATION ORDER NUMBER: 789/1996**

**APPLICATION NUMBER: 242894**

**SITE ADDRESS: 1 BADGERS SETT, CROWTHORNE, WOKINGHAM, BERKS, RG45 6EY**

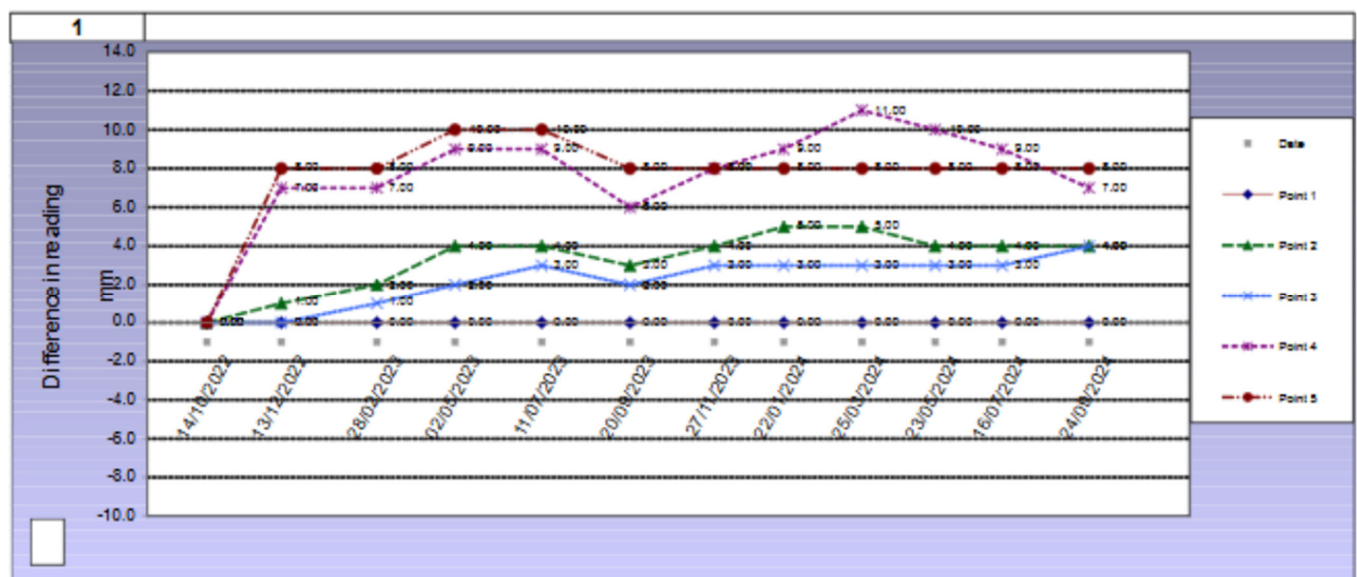
The control (datum) point 'TBM1' used in the level monitoring data is shown to be located on the property itself, adjacent to the trees which the Arboriculture report states are implicated in causing subsidence. Level monitoring points are referenced to a static datum point, therefore the datum point chosen should have been a stable point in an unaffected area of the building you are monitoring. For example, a sewer drain of a good depth, or a purpose installed deep datum at a minimum of 6-8m below any root network. Failure to choose a stable datum will bias the data. The level monitoring data in this case, is therefore considered to be compromised.

The statements above are incorrect, Fig 1. below from this report does not show any level monitoring during summer 2022 as it starts in October 2022 and shows an apparent 7 or 8mm initial rise in ground levels in late 2022 with further rising in the summer months leading up to July 2023. The pattern then follows what could be described as consistent with seasonal movement but from an elevated position with another rise in levels again leading up to March 2024, which shows all level readings remaining above the initial reading. This irregularity has not been explained.

**Fig. 1:** Level monitoring data points 1-5.
