**Planning reference 243228; initial bat survey results to inform proposed new boarding house.**

This letter is written to outline the findings from the phase 2 bat surveys undertaken on trees and Maintenance Building at Reddam House, where their removal and demolition is required to build a new boarding house.

Table 1: Results summary of tree climbing survey

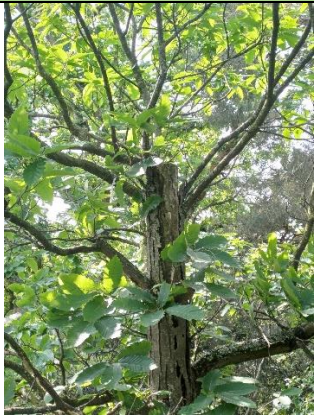
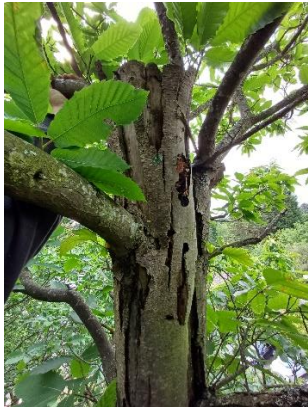
| Tree reference | Results | Recommendation | Photo |
|---|---|---|---|
| G5 (double trunked sweet chestnut) | Both trunks missing the top section of trunk with minor rotting and damage to tip. Damage did not form cavities in the trunk to offer any suitable features for bats. | Downgrade tree to negligible suitability. | <p>Southern trunk</p> <p>Northern trunk</p> |

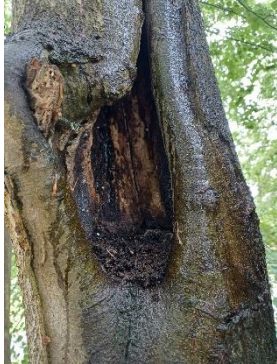
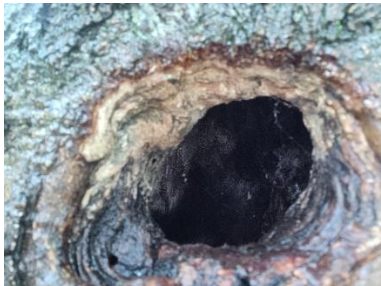
| Tree reference | Results | Recommendation | Photo |
|---|---|---|---|
| T13 | <p>Tree offered 3x PRF-m features after climbing investigation.</p> <ul style="list-style-type: none"> <li>-Tear out extending 30cm into trunk at 15m</li> <li>-Woodpecker holes at 8m high. Two features linked internally extending up 5cm into a wedge features. Old bird nest also found at 5cm down.</li> <li>-Decaying tear out extended up into tree, extending at least 1.2m into trunk.</li> <li>-Remaining features investigated and downgraded to PRF-i or negligible.</li> </ul> | Single further survey on suitable features. | <p>Tear out at 15m</p> <p>Internally linked woodpecker holes</p> |

A single further ariel inspection of T13 and T18 is recommended to be conditioned in the first instance as the bat activity around the trees was recorded low, and suitable mitigation and compensation can be adequately secured through condition for the provision of a derogation bat licence and bat boxes should the trees be found to be bat roosts.

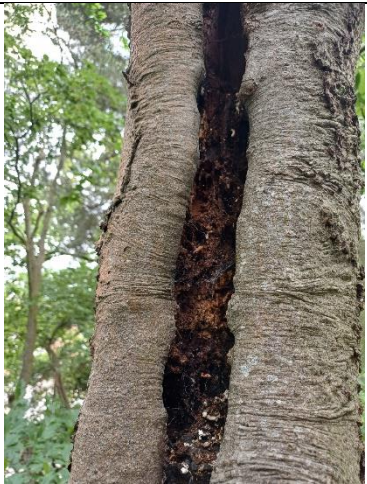
| | | | <p>Tear out with internal cavity</p> |

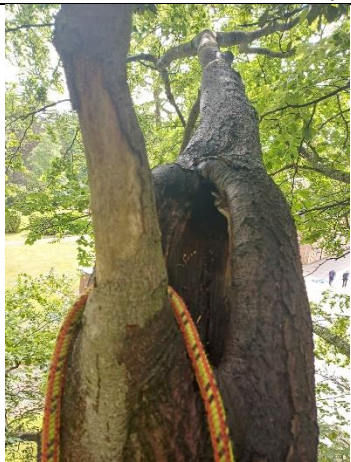
| T18 | <p>Tree offered a single PRF-m feature on southern trunk at 10m. A good feature that extended in 30cm which was clean and dry with minor webbing. Other features on this tree previously identified were downgraded to negligible on further inspection.</p> | <p>A further survey on single suitable feature</p> | <p>Tear out with cavity</p> |

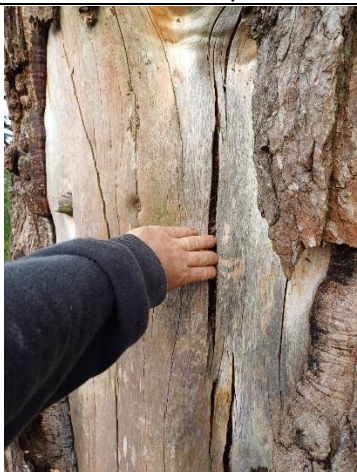
| T21 | <p>Tree fully climbed and inspected. No woodpecker holes found on close inspection. Desiccation cracks not wide/deep enough to support multiple bats. Lifted bark across the trees was quite exposed and insecure. Multiple bird nests found.</p> | <p>Reduce feature suitability from PRF-m to multiple PRF-I and no further surveys required.</p> | <p>Largest desiccation crack</p> |

All PRF-I features identified within the surveys, ground level assessment and climbing surveys, should be compensated on a 1:1 ratio as recommended by best practice. These compensation boxes should be secured by condition once the final surveys are completed onsite.

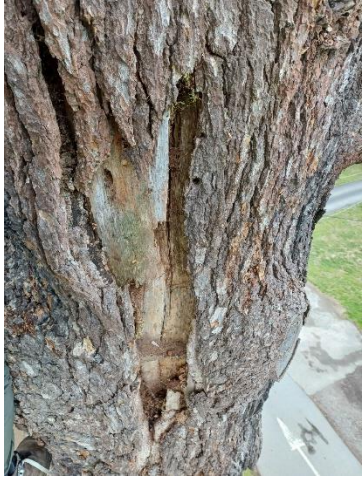
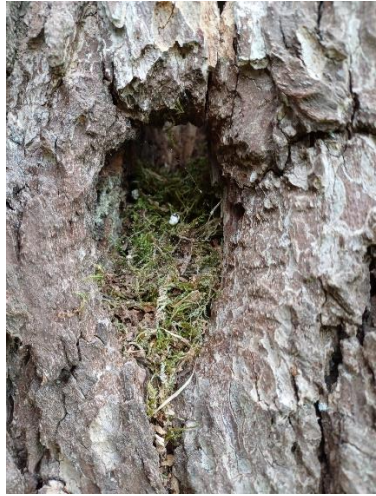
| | | | <p>Example lifted bark</p> <p>Example birds nest</p> |
