Inspired Education Group  
24<sup>th</sup> June 2025.

**Planning reference 243228; Final bat survey results to inform proposed new boarding house.**

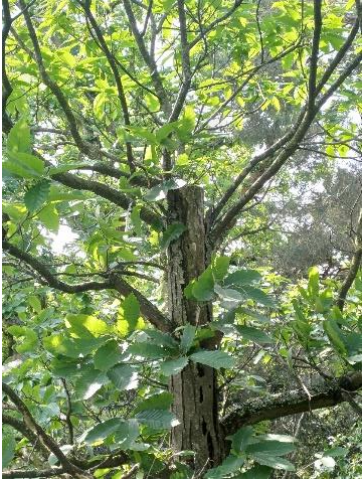
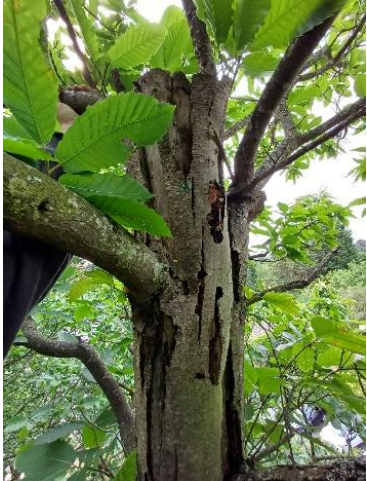
| Tree reference | Results |
|---|---|
| G5 (double trunked sweet chestnut) | Only potential features are the missing tips of both trunks of the tree. On inspection features were some flaking bark but no recess. decay patches are superficial and do not recess. downgrade tree to negligible. |

| Tree reference | Recommendation | Photo | |
|---|---|---|---|
| G5<br>(double trunked sweet chestnut) | Downgrade tree to negligible suitability. | <p data-bbox="603 342 788 371">Southern trunk</p> | <p data-bbox="1007 342 1192 371">Northern trunk</p> |

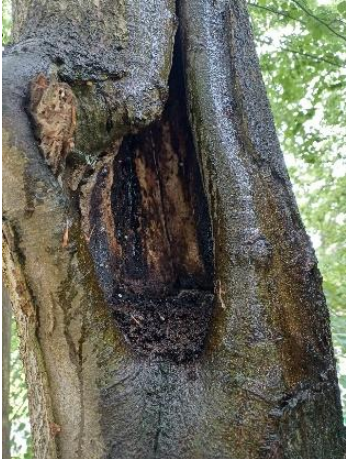
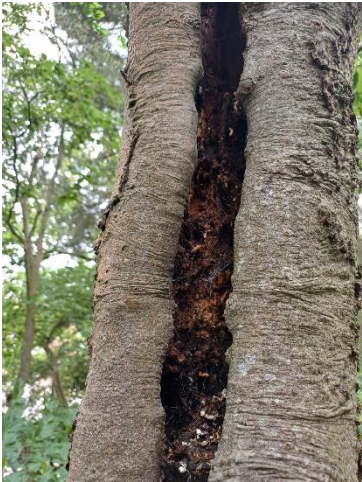
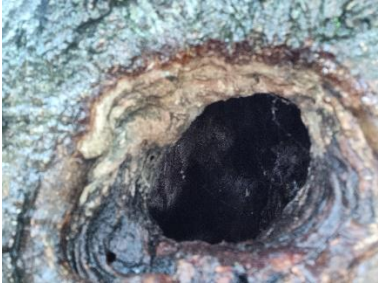
Trees T13 and T18 had the subsequent second climb to assess the PRF-m features. T13 had one notable tear out/rot hole feature that extended 2m up the trunk but had a sludgy internal substance with the cavity and no signs of bats. Two other PRF-m features remained in the same condition and no signs of bats were recorded.

| Tree reference | Results |
|---|---|
| T13 | PRF 1 15m high on N limb. decaying tear out facing SE. tear out entrance is 40cm high x 5cm wide. recesses upwards 29cm with a depth of 8cm. does not recess down. inside cavity dry and clean with no evidence of bats. used endoscope to fully inspect and UV light. apex is domed. PRF 2 small decaying knot hole on S limb (dead at top). feature facing N. entrance is 10cm high x 5cm wide and recess upwards 5cm with a depth of 3cm. densely cobwebbed with no evidence of bats. PRF3 woodpecker hole with decaying knot hole on SE limb approximately 8m high. two features are linked facing SE and SW respectively. recess down 5cm to old bird nest and 5cm up to wedge apex. woodpecker hole densely cobwebbed at entrance. entrance height of WPH 5cm and width 5cm. entrance height and width of knot hole 8cm x 8cm. the depth of the feature is 8cm. PRF 4 is a decaying tear out. entrance is 10cm wide x 15cm high facing N on C stem. no down recess, with high accumulation of debris. recess up at least 1.2m. |

| Tree reference | Results |
|---|---|
| T13 | 2x additional potential PRFs identified at 16m prf 5 and 17m prf 6 high, facing SW. same stem as PRF 1. both PRFs are decaying knot holes but neither recess into a suitable feature. DBH at both PRFs 20cm. prf 5 entrance height is 2cm, width 5cm and recess of 5cm. densely cobwebbed internally. prf 5 entrance height is 15cm and width 6cm with recess of 2cm. PRF 1 as before no evidence of bats. fully inspected. DBH at prf is 20cm. PRF 7 small decaying knot hole below PRF 1 likely dismissed last survey. entrance height 6cm, width 4cm and recess upwards 2cm DBH 20cm. no evidence of bats. PRF 2 same as previous, DBH 20cm. no evidence of bats. PRF4 fully inspected. recess 2m up stem. high sludge throughout + woodlice and slugs. feature PRF-M but due to sludge less suitable than first assessed. DBH 30cm. PRF 3. same as before. DBH 20cm. no evidence of bats |

| Tree reference | Recommendation | Photo | |
|---|---|---|---|
| T13 | Compensate for loss of features | <p data-bbox="603 929 796 958">Tear out at 15m</p> <br> <p data-bbox="603 1939 943 1968">Tear out with internal cavity</p> | <p data-bbox="1007 929 1358 994">Internally linked woodpecker holes</p> |

All PRF-I features identified within the surveys, ground level assessment and climbing surveys, should be compensated on a 1:1 ratio as recommended by best practice. These compensation boxes should be secured by condition once the final surveys are completed onsite. Table 3 below outlines the number of boxes to be supplied as compensation.

Compensation boxes should replicate the loss of potential roosting features on a like for like basis, as such 2 boxes suitable for multiple bats (maternity boxes), as well as 12 standard boxes more suited for small numbers of bats must be installed in suitable locations around the school.

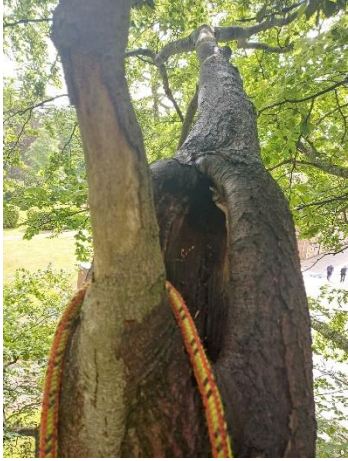
T18 offers a single PRF-m feature on a trunk that was fully investigated. The feature was in the same condition as survey 1 and no field signs of bats were recorded.

| Tree reference | Results |
|---|---|
| T18 | dead limb is not a feature does not recess. all apparent features blind. PRF2 tear out on top of S limb approximately 10m high. feature faces upwards. smells of dirt. 28cm high entrance and 11cm wide. spire apex full of sludge. dry closer to entrance. recesses 60cm up limb with entrance facing NE. DBH at feature 18cm. |

| Tree reference | Results |
|---|---|
| T18 | No new features found on trees and existing feature at 10m on S limb was fully inspected with no evidence of bats found. |

| T18 | Compensate for loss of features | <p>Tear out with cavity</p> | |

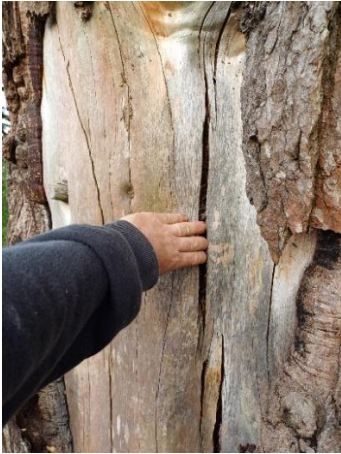
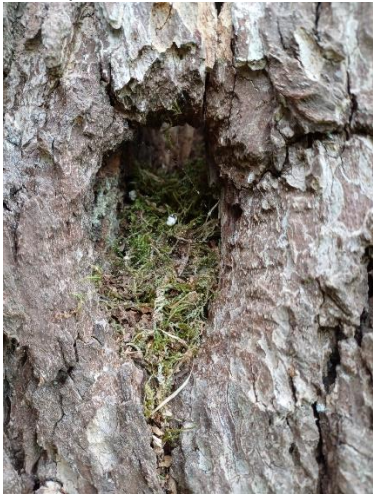
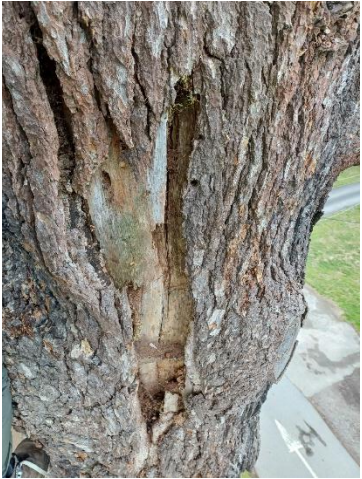
| Tree reference | Results |
|---|---|
| T21 | lifted bark is generally superficial will limited cavities. the small cavities under the lifted bark is dry but exposed to the elements and does not offer a stable environment. fissure identified on E elevation is blind and does not recess. Woodpecker holes are not features. dead limb (PRF4) 15m high facing NW has tear out on end of limb approximately 3m from stem. feature facing slightly up and recesses 10cm. feature is open. |

| T21 | Reduce feature suitability from PRF-m to multiple PRF-I and compensate for impact to features | <p>Largest desiccation crack</p> <p>Example birds nest</p> | <p>Example lifted bark</p> |
