## ARBORICULTURAL REPORT

Addendum to the Tree Condition Survey & Mitigation Strategy by  
Duckworth's Arboriculture 06408/2024 (July 2024): An Arboricultural  
Impact Assessment of Driveway Improvement Works on Adjacent  
Trees

LAND ADJ. WATERLOO COTTAGE & WOODLANDS HOUSE  
BATH ROAD  
KNOWL HILL  
WOKINGHAM  
RG10 9UP

WBC PLANNING APPLICATION REF: 241683

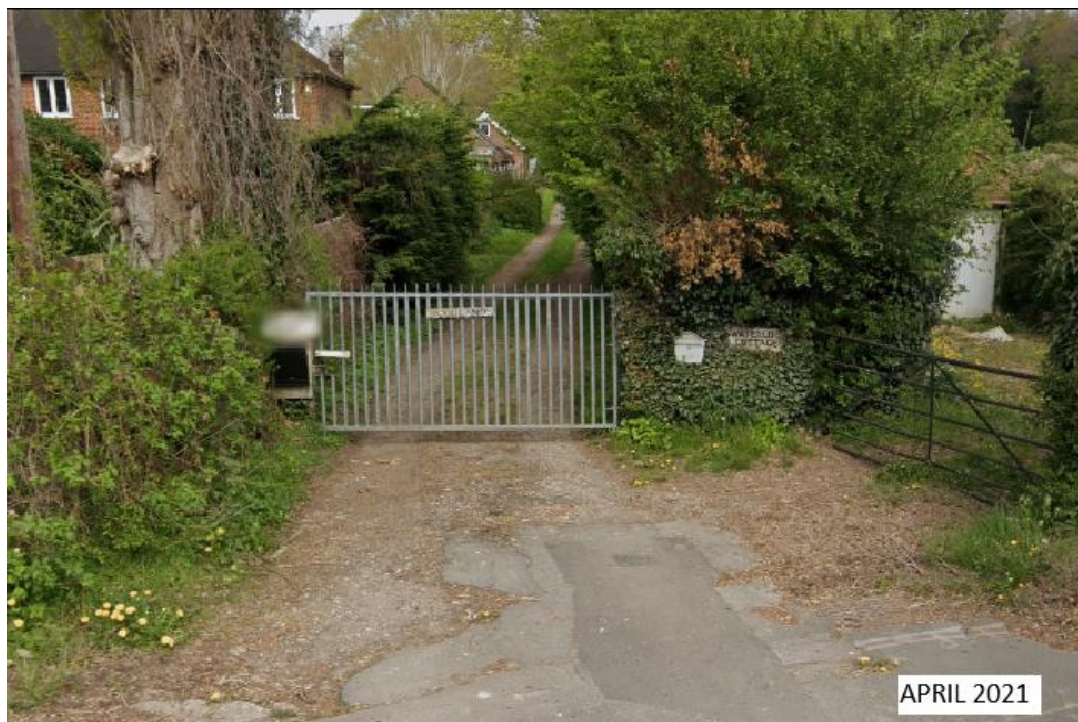
Figure 1 – Google Street View image of the access driveway from April 2021 – prior to resurfacing works

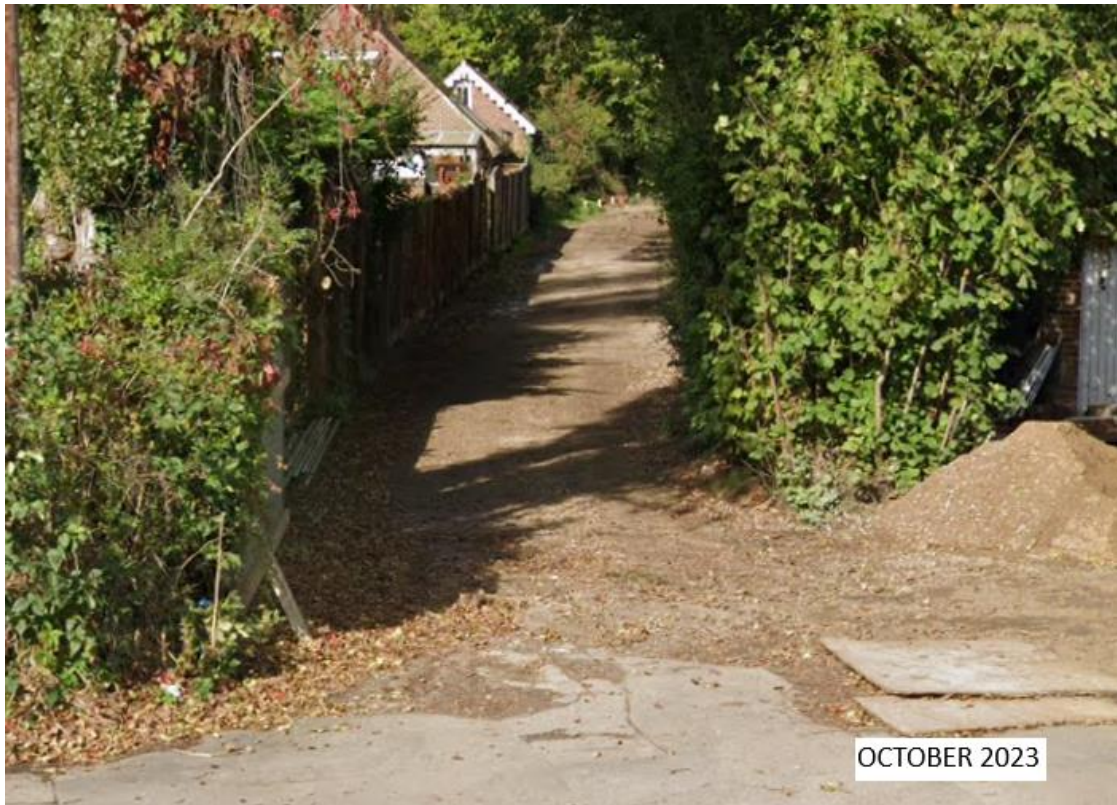
Figure 2 – Google Street View image of the access driveway from October 2023 after new scalplings had been laid.

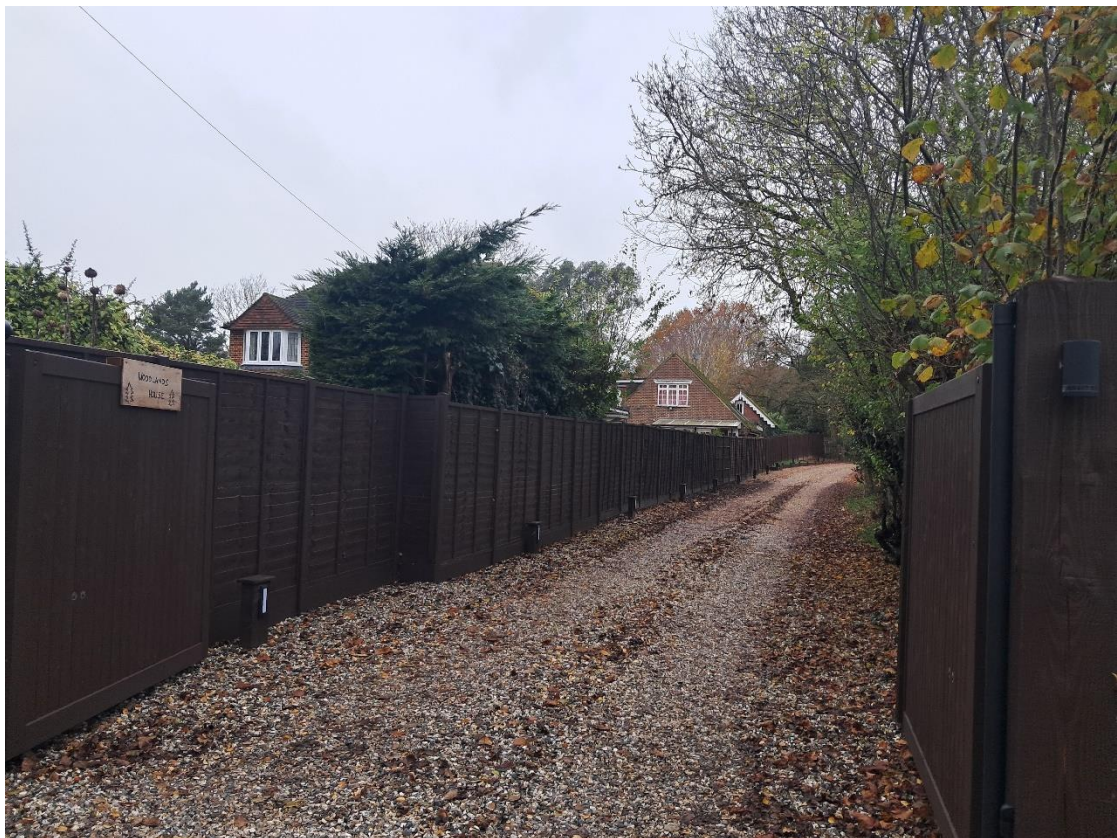
The new gravel driveway is raised above the previous driveway level. The aesthetic gravel surface is retained by an existing boundary fence and the new kickboard border which runs adjacent to the ditch.

The gravel surface and compacted aggregate / scalpings will be semi-porous and will have no greater impact on tree(s) than the original compacted aggregate of the original drive. For the few roots likely to grow under the driveway I am satisfied that the driveway resurfacing will not impoverish or create significantly worse growing conditions for tree roots than would be present under the original driveway surface.

Figure 3 – Photo of the access driveway from November 2024 with new aesthetic stone / gravel surface.

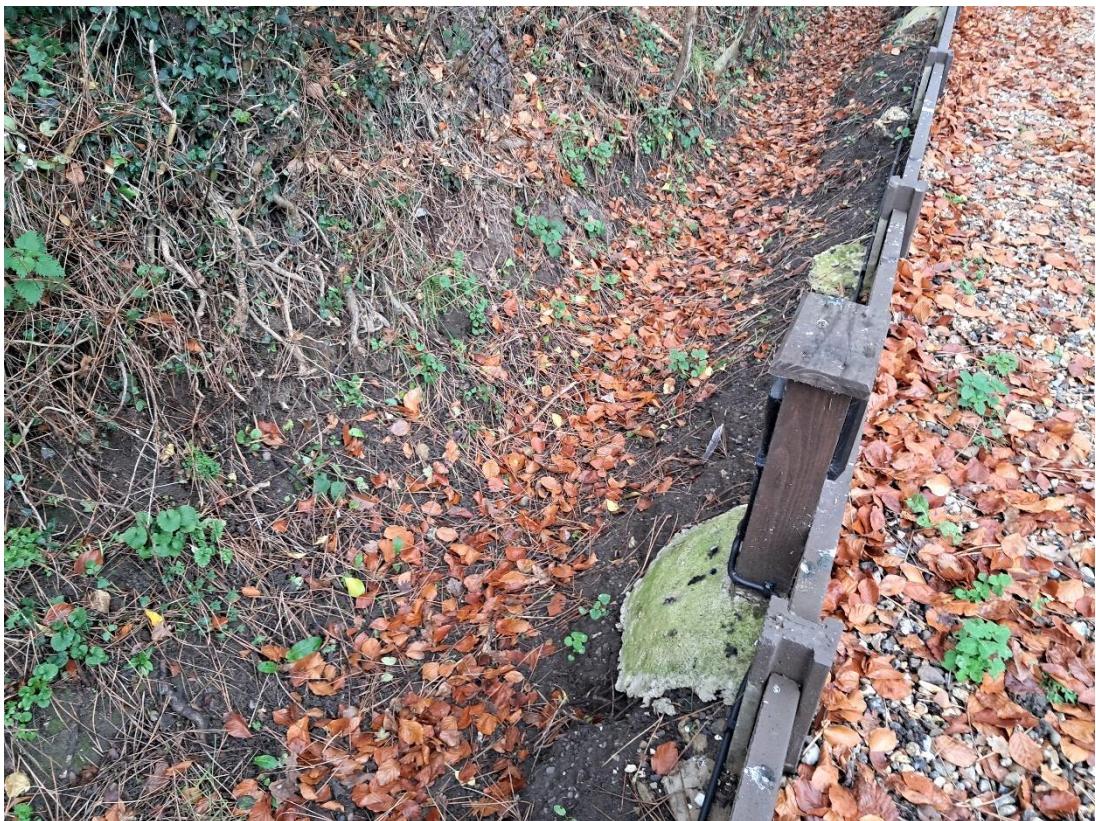
The kickboard sits on existing ground levels and is supported by concrete posts. The concrete posts have mostly been pushed into the ground but where the bank was unstable in some areas, the posts have been shored up with concrete.

It has been confirmed that the post holes for the individual low bollards along the driveway were excavated by hand and posts have been set in concrete.

The leachate from poured wet concrete is toxic to plants. However, the concrete around the postholes was trowelled in place in a semi-set state and this will have reduced leachate from the mix. The concrete, being placed in localised post holes on the far side of the ditch, cover a very small area of each tree's overall rooting area and in an area where few woody roots are likely to be present. The impact on trees on the far side of the ditch will therefore be negligible.

Figure 4 – New Bollard and kickboard.

I am also of the opinion that removing the kickboard, wooden bollards and associated areas of concrete would cause more ground disturbance and potential harm for tree roots and is not advised at this time.

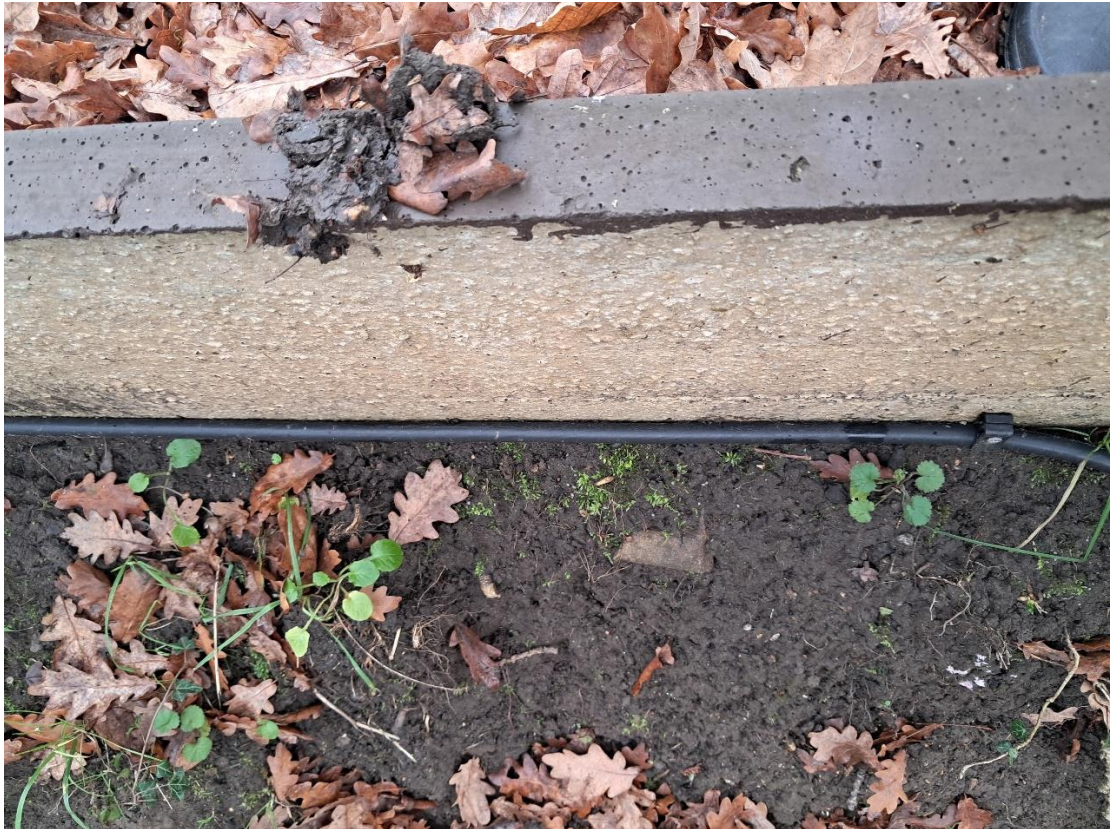
There is a new low-level kickboard adjacent to the ditch line and low wooden lit bollards along the drive. The client has confirmed that the electrical conduit is at ground level and indeed it can be seen where it has been attached to the low kickboard without any trenching on site.

Figure 5 – Kickboard rests on pre-driveway construction ground levels – note the electric cable at base.

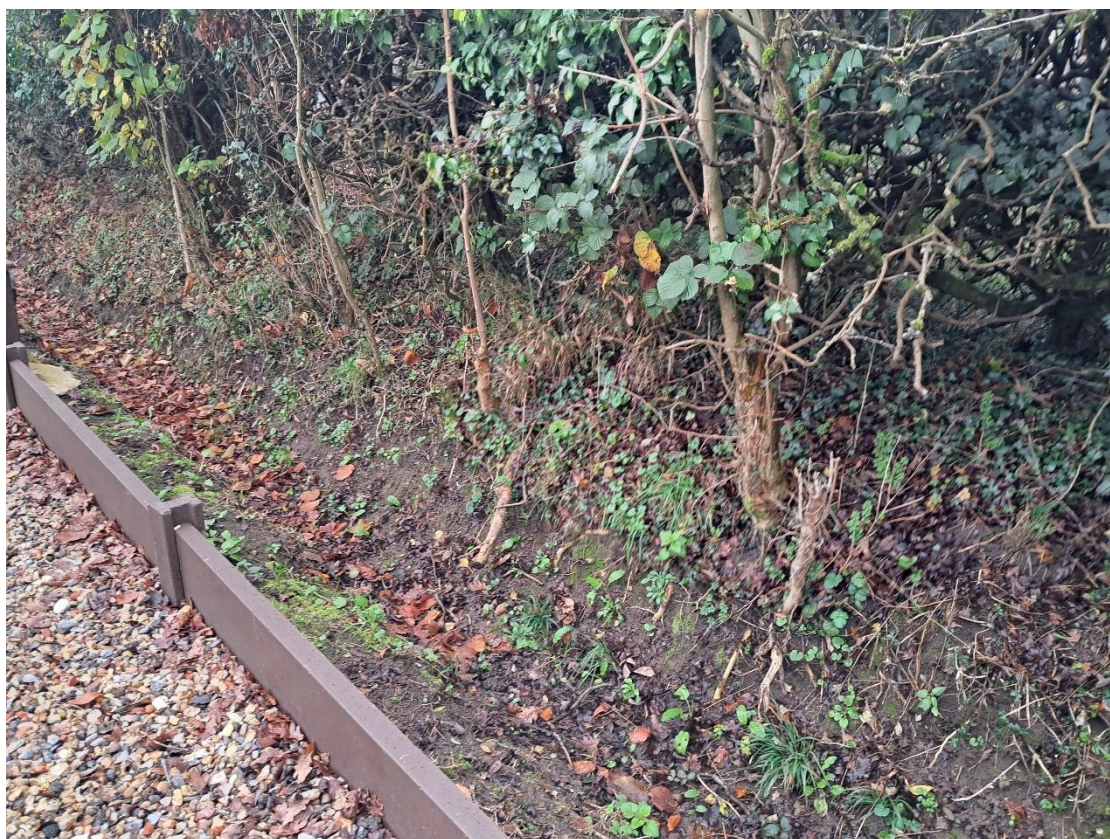
General detritus has been removed from the ditch. I have been advised that aside from this, the ditch has not been widened or deepened in any way. Vegetation along the ditch edge is undisturbed which supports this assertion, and I have noted that there are no exposed or cut roots along the banks of the ditch which may indicate scraping of the sides of the ditch.

Figure 6 – Vegetation along the ditch edge is undisturbed.

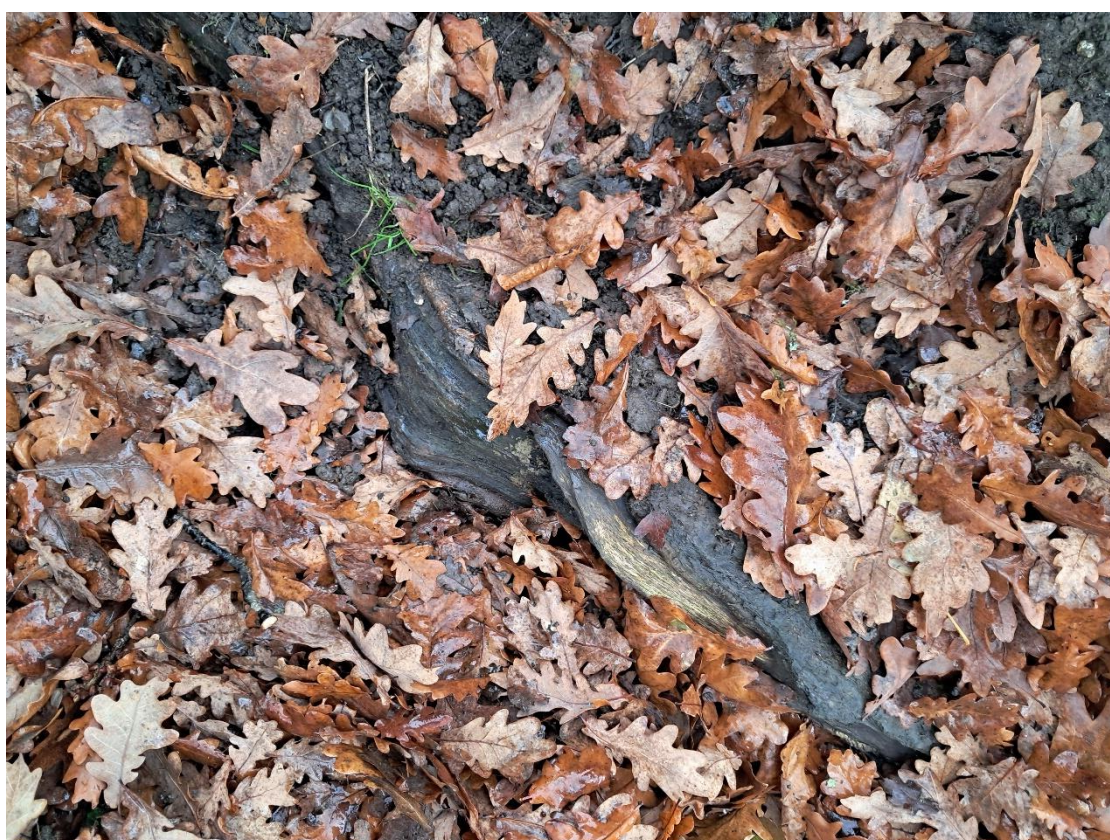
Under the current season's leaf litter in the ditch, there is one damaged root at the base of the ditch adjacent to an Oak tree. New wood and adaptive growth around the wounded area confirms that this is not recent damage and that the wound predates the recent ditch improvement works by many growing seasons.

Figure 7 – Historic Damage to root at base of ditch (predates recent ditch clearance)

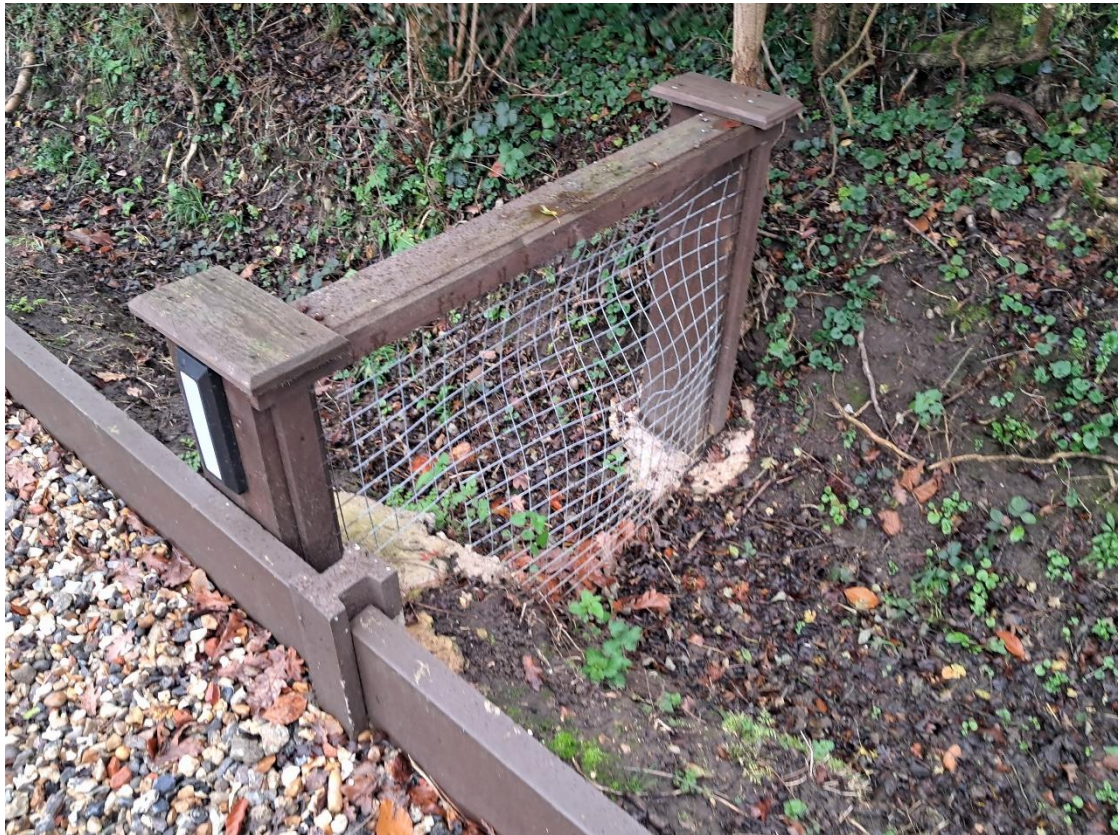
Four wooden framed debris screens have been installed within the ditch to hold back twigs and larger debris to avoid matter building up and blocking the culverts further downstream.

Figure 8 – Historic Damage to root at base of ditch (predates recent ditch clearance)

The leachate from poured wet concrete is toxic to plants. However, the concrete around the postholes was trowelled in place in a semi-set state to prevent it running down the bank and this will have reduced leachate from the mix. The concrete, being placed in localised post holes, covers a very small area of ground. None of the screens are directly adjacent to any significant mature trees. Only smaller shrubby trees which form the hedgerow group will have been affected.

Removing these debris screens and the associated posts and concrete which support them would cause ground disturbance and potential harm for tree roots and is not recommended at this time.

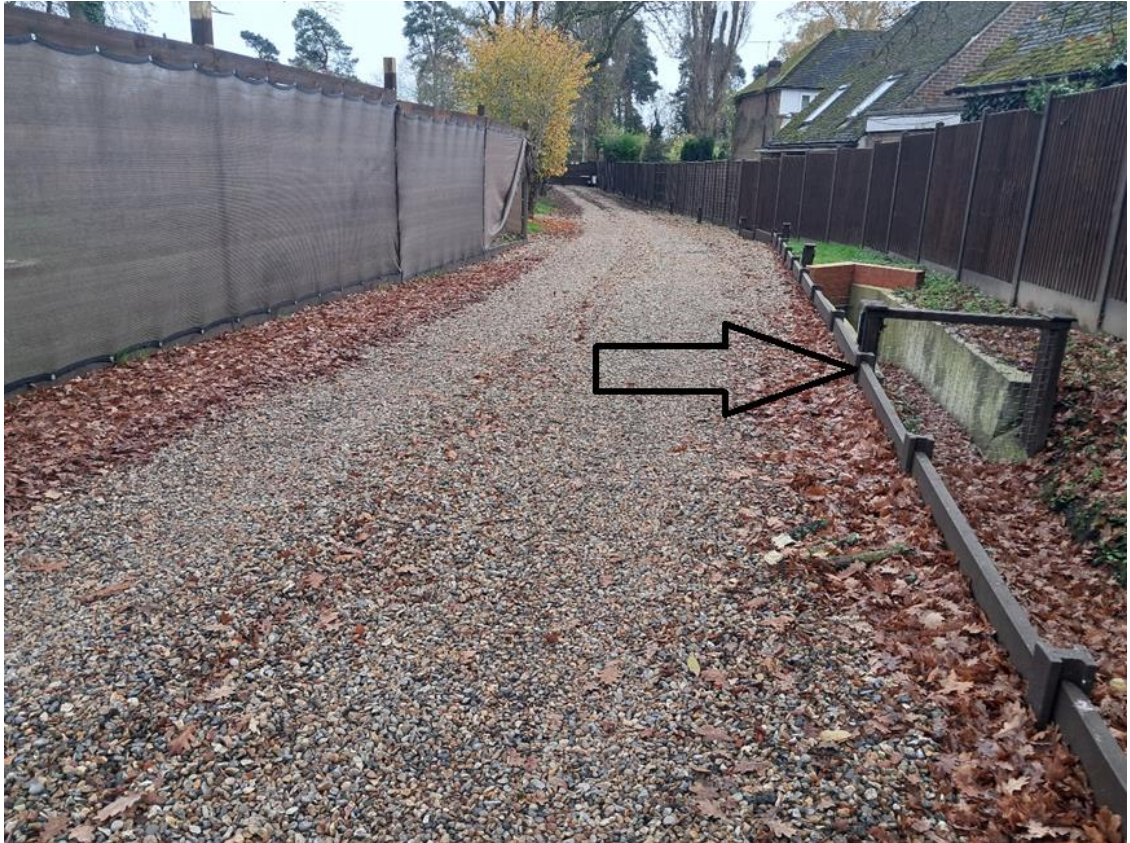
A retaining wall has been constructed to prevent the erosion of the ditch where it heads into the culvert at the southern end of the ditch. The retaining wall is partially within the BS:5837 Root Protection Area (RPA) of T039 (Oak) and 5.6m from the tree's base.

Figure 9 – Retaining wall & culvert at the southern end of the ditch.

Whilst there is no visible evidence of tree root damage it is possible that the excavation of foundations for the retaining wall within the RPA may have caused some smaller fine tree roots to be cut. However, the orientation of the retaining wall which runs radially to the tree's base and its location on the very periphery of the RPA means the impact of its construction on the tree will be small.

T039 (Oak) is otherwise in good health and at the time of both site visits (April 2024 & November 2024) the canopy and bud density show no indication of stress or decline which can occur when tree roots are damaged. I have therefore concluded that there is no permanent harm to the tree as a result of this work.

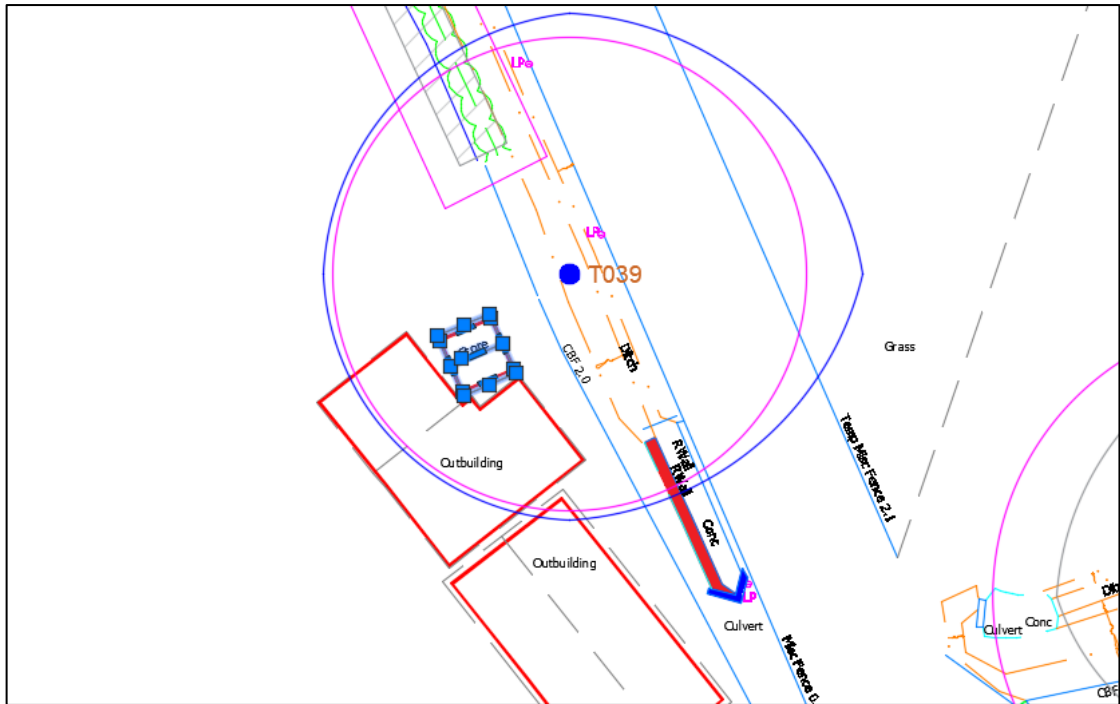
Figure 10 – Culvert (shown in red) in relation to the Root Protection Area of T039 (Oak)

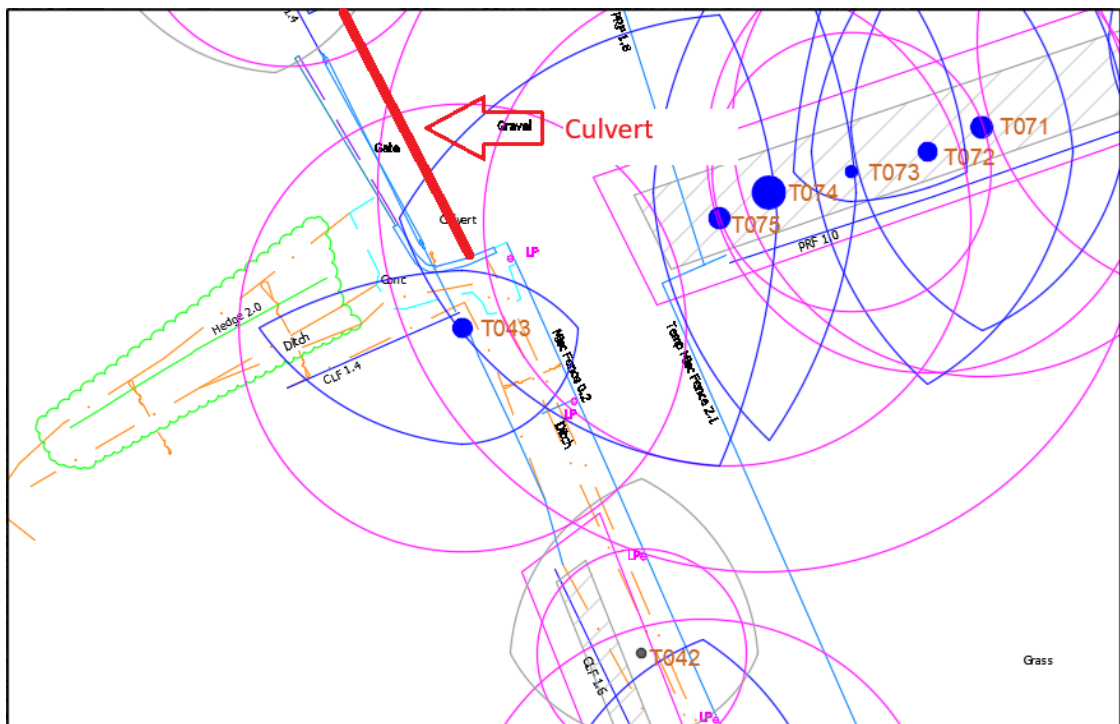
Figure 11 – Culvert (shown in red) in relation to the Root Protection Area of T043 (Oak)

The existing culvert is within the root protection area of T043 (Oak) and the culvert is also partially within the outer root protection areas of T074 (Beech) which is growing on the far side of the access drive.

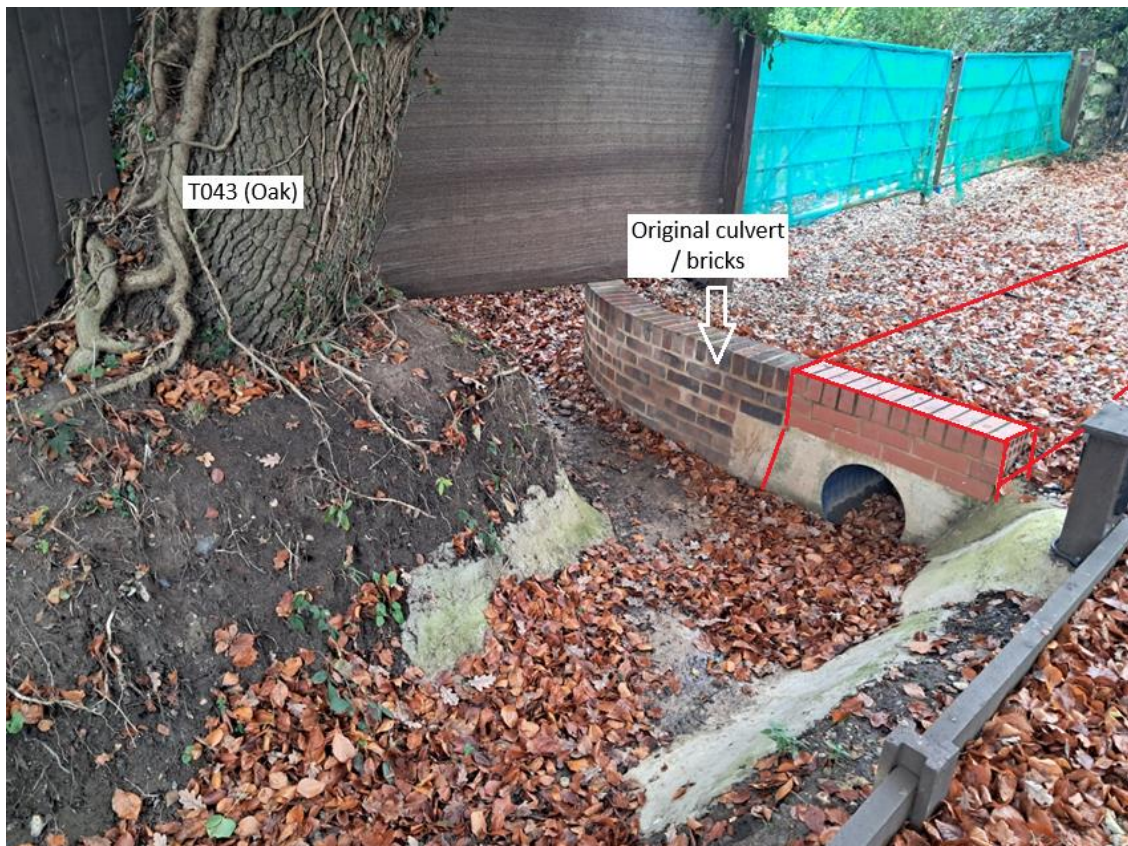
An existing culvert has been replaced at the northern end of the ditch where it crosses the field entrance. The original culvert consisted of a smaller pipe which was blocked by debris. The pipe was removed and replaced with a larger diameter pipe set in concrete

Figure 12 – New culvert (shown in red) at the northern end of the ditch.

The ditch has been lined with concrete. I have been advised that this concrete was laid directly onto the soil without any excavation. The concrete is intended to prevent erosion of the bank where the water negotiates a bend in the ditch.

As advised previously, because the concrete was trowelled in place in a semi-set state, it will have reduced potentially toxic reaching the soil. The concrete appears very shallow and is unlikely to result in significant capping of the tree's overall rooting area. The new culvert is in the position of an existing culvert although some roots may have been impacted with the installation of the wider pipe.

As with T039, T043 (Oak) is in good health and at the time of both site visits (April 2024 & November 2024) the canopy / bud density is normal and the tree is exhibiting no signs of stress or decline which can occur when tree roots are damaged. I have therefore concluded that there is no permanent harm to the tree as a result of this work.
