# The Horns Public House

## HERITAGE IMPACT ADDENDUM

Document No: 1320-HR-A-TP-XX-0002

Date: 14.02.2025

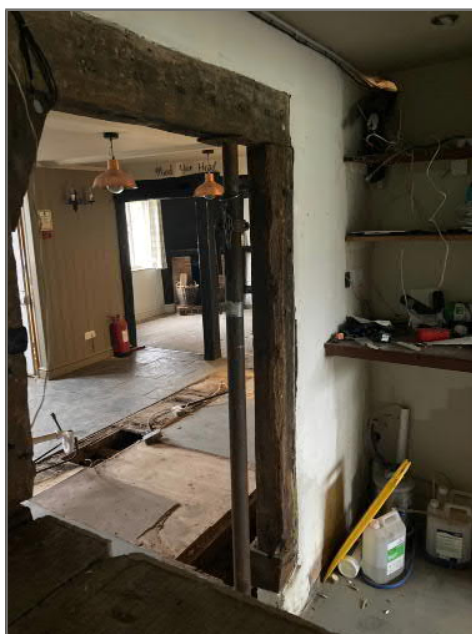
View of return wall at RHS of bar

It can be seen there is no wall in-fill remaining. The proposed location for the steel column with concrete pad foundation is proposed at the corner of the existing timber frame only, and not along the return wall.

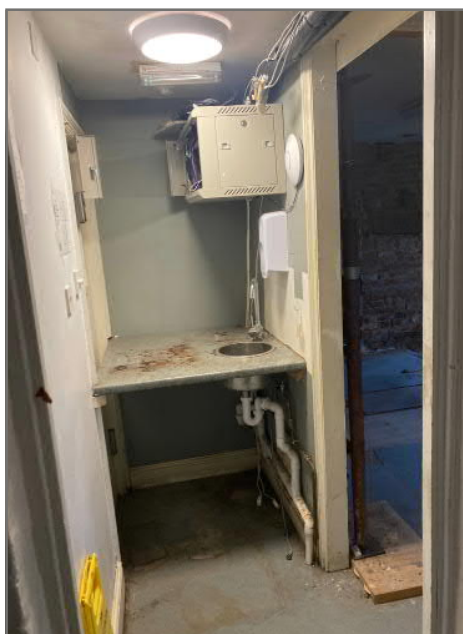
View of return wall at LHS of bar

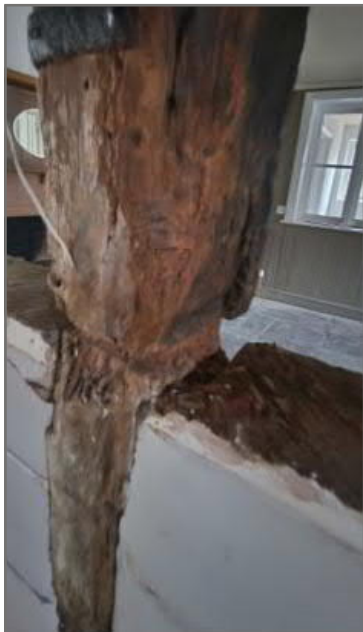
To summarise: the existing timber frame is excessively loaded from both the first floor and from poorly executed past alterations, and has distorted in two directions: left-to-right and back-to-front. This condition is exacerbated by the cut-away timber post - that visible in Image 36 of the Heritage Statement abutted by cement blocks, and the detail, below, whose strength has been judged by the Structural Engineer to be much reduced.

View of cut away timber post

The structural integrity of the building at this critical point - that of the oldest part of the property - is unsustainable in its current condition. Investment is required to adequately support the building and make it safe, which is currently temporarily supported with props. The use of props in the long term is impractical and would always create a 'building site' atmosphere to a portion of the building that would become impassable by building users - essentially sterilising the central space of practical use and being unsatisfactory for the customer experience.

The proposed steel design - as per drawing 1886-21 P in the application - has been revised from partially relieving the load, to entirely relieving the loading upon the historic timber frame - refer to drawing 1886-21 P1 - by the introduction of a second cantilever which reduces the masonry proposed to be cut away.

As explained in the accompanying Structural Engineer's Advice Letter enclosed (refer to the Appendix) the notch in the existing timber is required to stabilise the existing frame, to avoid the need to remove more of the timber frame that would become more unstable, or remove the timber entirely to avoid collapse. The proposed design seeks to do as little as possible to the existing historic structure, whilst achieving a safe solution for the building and securing its viable longterm retention, without which the building may remain propped and unusable.

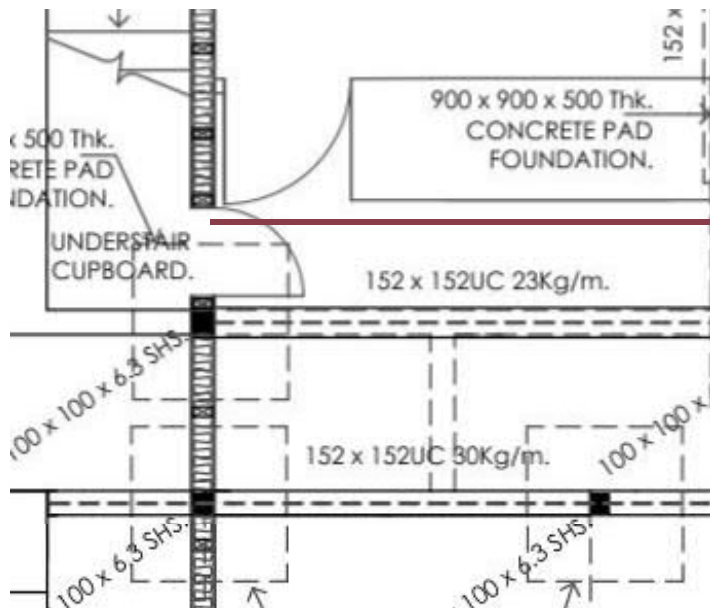
Extract from drawing 1886-20P

"With respect to drawing 1886-05 P and that for the Ground Floor Structural Plan (drawing 1886-20 P). The latter drawings shows a post to the edge of the bar top in line with that of the end of the intended partition wall (with calculated 650mm wide access doorway to the bar). Whilst the position of this post on the other drawing is shown off-set from the end of the partition wall."

Post drawn in error - now removed in updated drawing

The post referred to in drawing 1886-20 P was drawn in error, this has been removed in the revised drawing '1886-20 P1'.

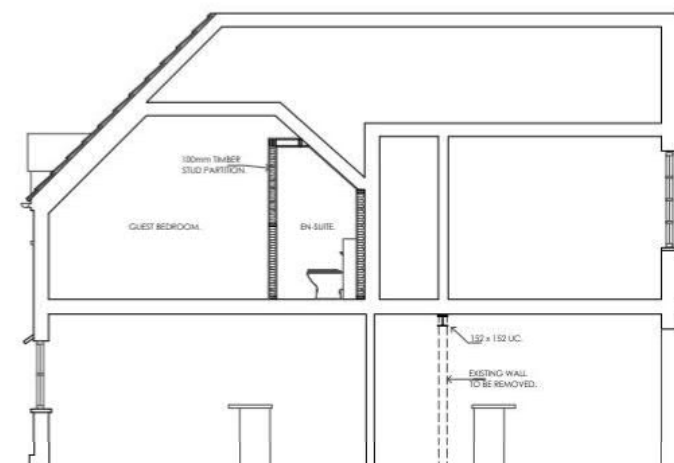
Extract from drawing 1886-10P

"Cross sectional views as proposed shown on drawing 1886-10 P, appears to depict a wall still remaining where walling is to be removed."

The wall referred to in drawing 1886-10 P was drawn in error, this has been removed in the revised drawing '1886-10 P1'.

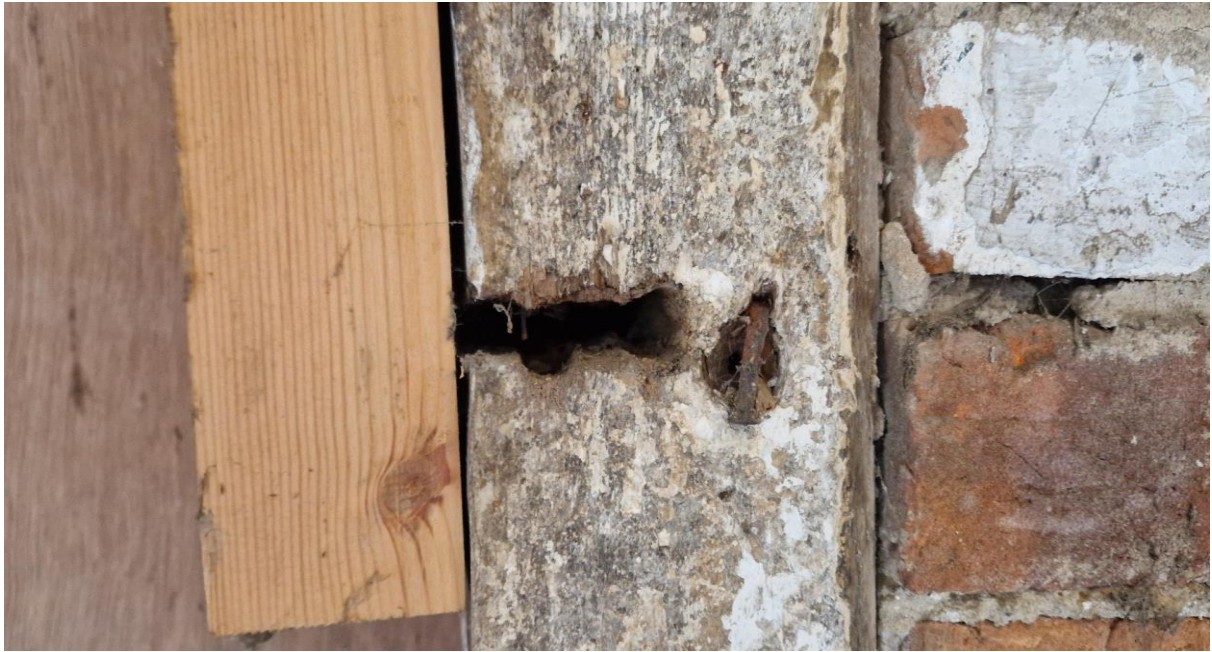
PHOTOGRAPH 1.

To the left-hand side sections of the original beams have been removed in the past, which is now partially supported by a modern-day timber post (built only off the existing timber floor) and a section of timber coach screwed to the original post. The cross-sectional area of this original post has been greatly reduced by two thirds by stitch drilling in the past which we believe may have been for cabling. (Refer to photographs 1 & 2.)

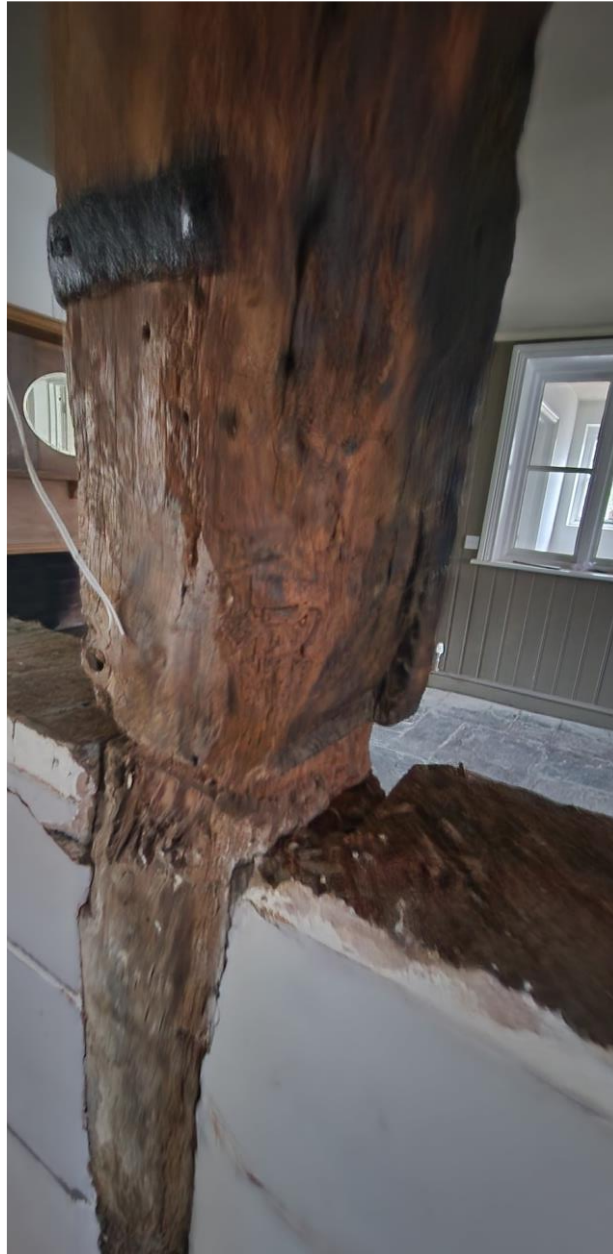
PHOTOGRAPH 3.

To the right-hand side there is the main original corner support post. This has been drastically reduced in section over the years (refer to photographs 3&4.) Having undertaken a load analysis a total load of 72KN is being applied to the wall (more than 7 Tonne.) There is also no acceptable foundation to this wall, and as such the wall / timber framing is not structurally acceptable to support the loadings. To relieve the loading on the wall / frame to prevent the likelihood of failure, a scheme was devised to insert a steel beam over the top of the original wall / frame providing two new small posts. The original wall would then become a non-loadbearing element and could be retained in its current location, thus preserving the historic elements of the building.

To enable this system to be installed it does require that the original top timber beam is notched to allow the steel post to connect to the steel beam. The only possible alternative to this would be to remove the entire wall / frame and rebuild it like for like in new oak timbers, or alternatively to use the steel beam as specified but remove the end post and replace this with a new steel column.

We feel however that the original wall / frame should be retained and that with careful notching to the original timber beam to enable the steel post to be inserted, would be a less intrusive solution to the historic fabric of the building.
