## BS:5837 ARBORICULTURAL REPORT

ARBORICULTURAL SURVEY, IMPACT ASSESSMENT &  
METHOD STATEMENT

37 COMMONS ROAD  
WOKINGHAM  
BERKSHIRE  
RG41 1JJ

Ref: AIA/AMS 06414/ 2024

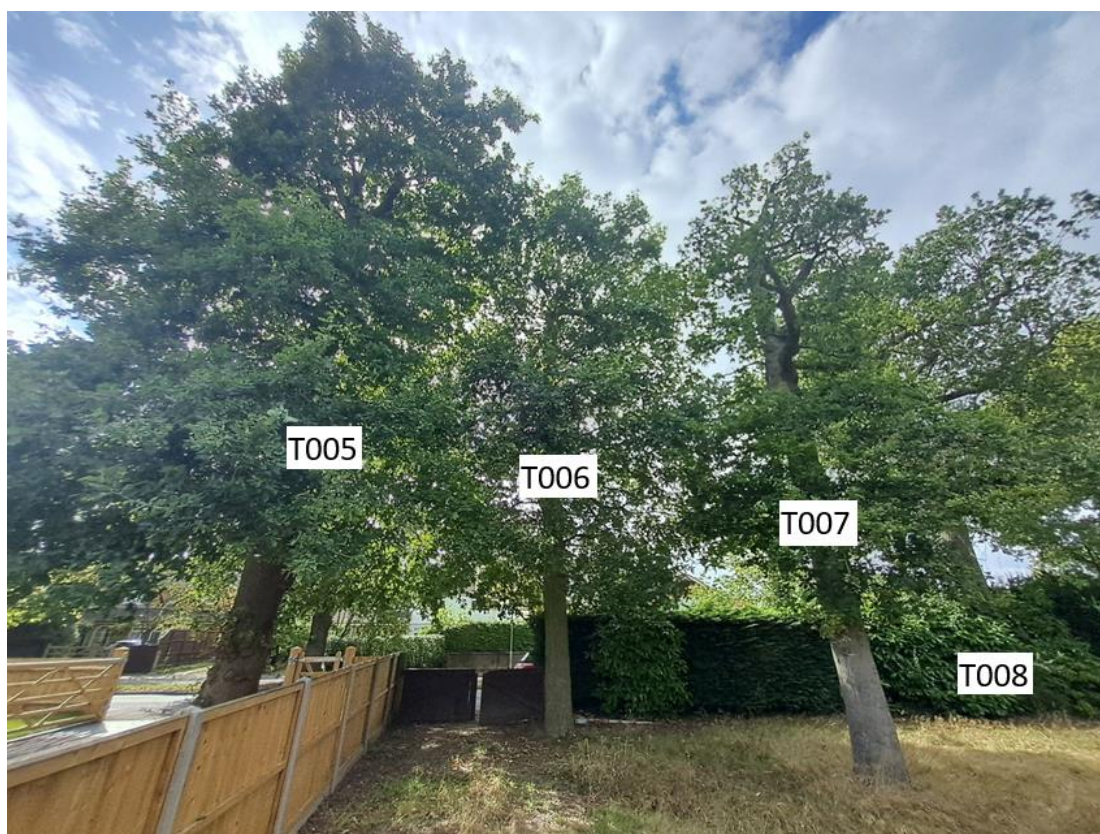
Photo 1 – Trees to the front of 37 Commons Road

T006 & T007 (Oak) have been identified for removal to facilitate the build.

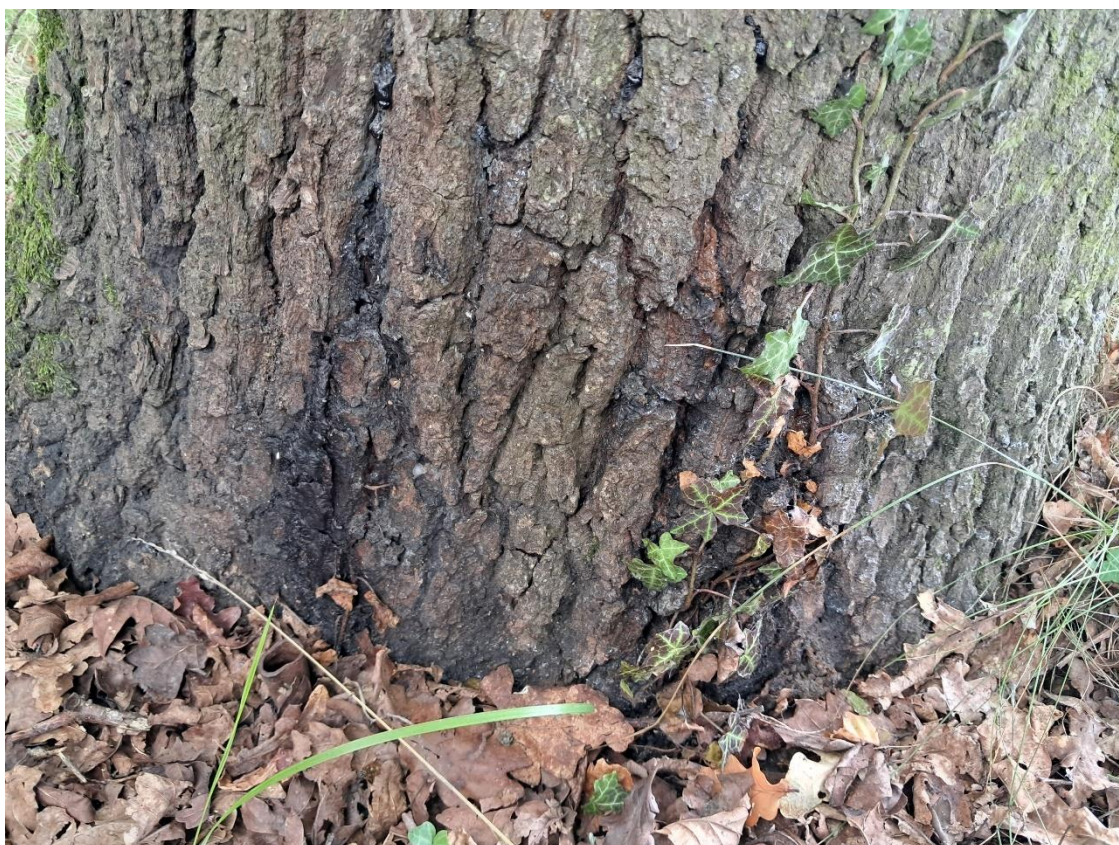
| Ref: | Species | Description | Cat. |
|---|---|---|---|
| T006 | Oak<br>(Quercus robur) | <p>The existing narrow drive for 37 Commons Road has historically kinked around the base of T006.</p> <p>Bleeding canker on lower trunk. Vehicle strike damage on trunk. Slender crown previously heavily reduced but recovering. Foliage density normal.</p> <p>Although the removal of this tree is not essential to facilitate the proposed build, it will enable widening of the existing access and improved parking layout for future occupants.</p> | B1 |

Photo 2 – Bleeding canker at the base of T006 (Oak)

Two trees (T006 & T007) are identified for removal, however their removal is not essential for the replacement dwelling. The current driveway is narrow and has been kinked around the trunk of one tree (T006). T006 has wounding on the trunk where it has been struck by vehicles in the past. The second Oak (T007) is a lower grade tree with a heavily reduced crown undermined by past poor management. The removal of these two trees will enable essential improvements and a more sustainable parking / driveway layout at the front of the property.

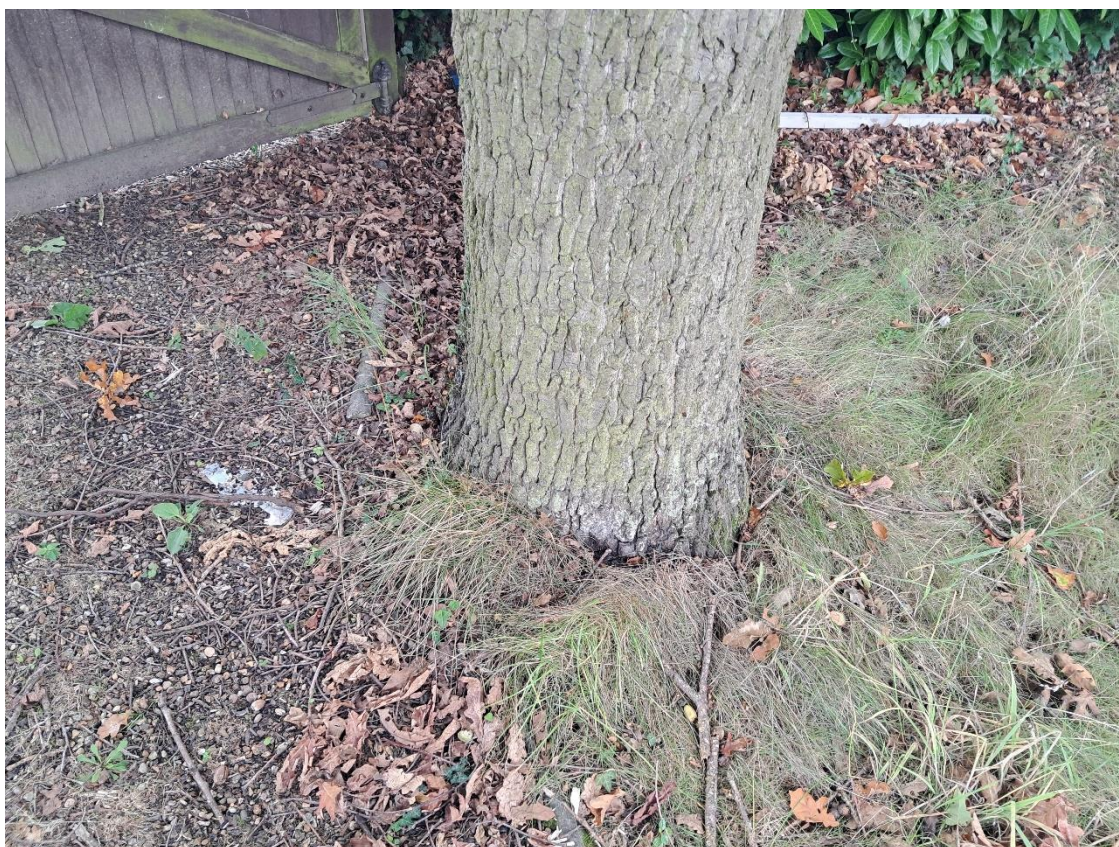
Photo 3 – Driveway kinks around the base of T006 (Oak)

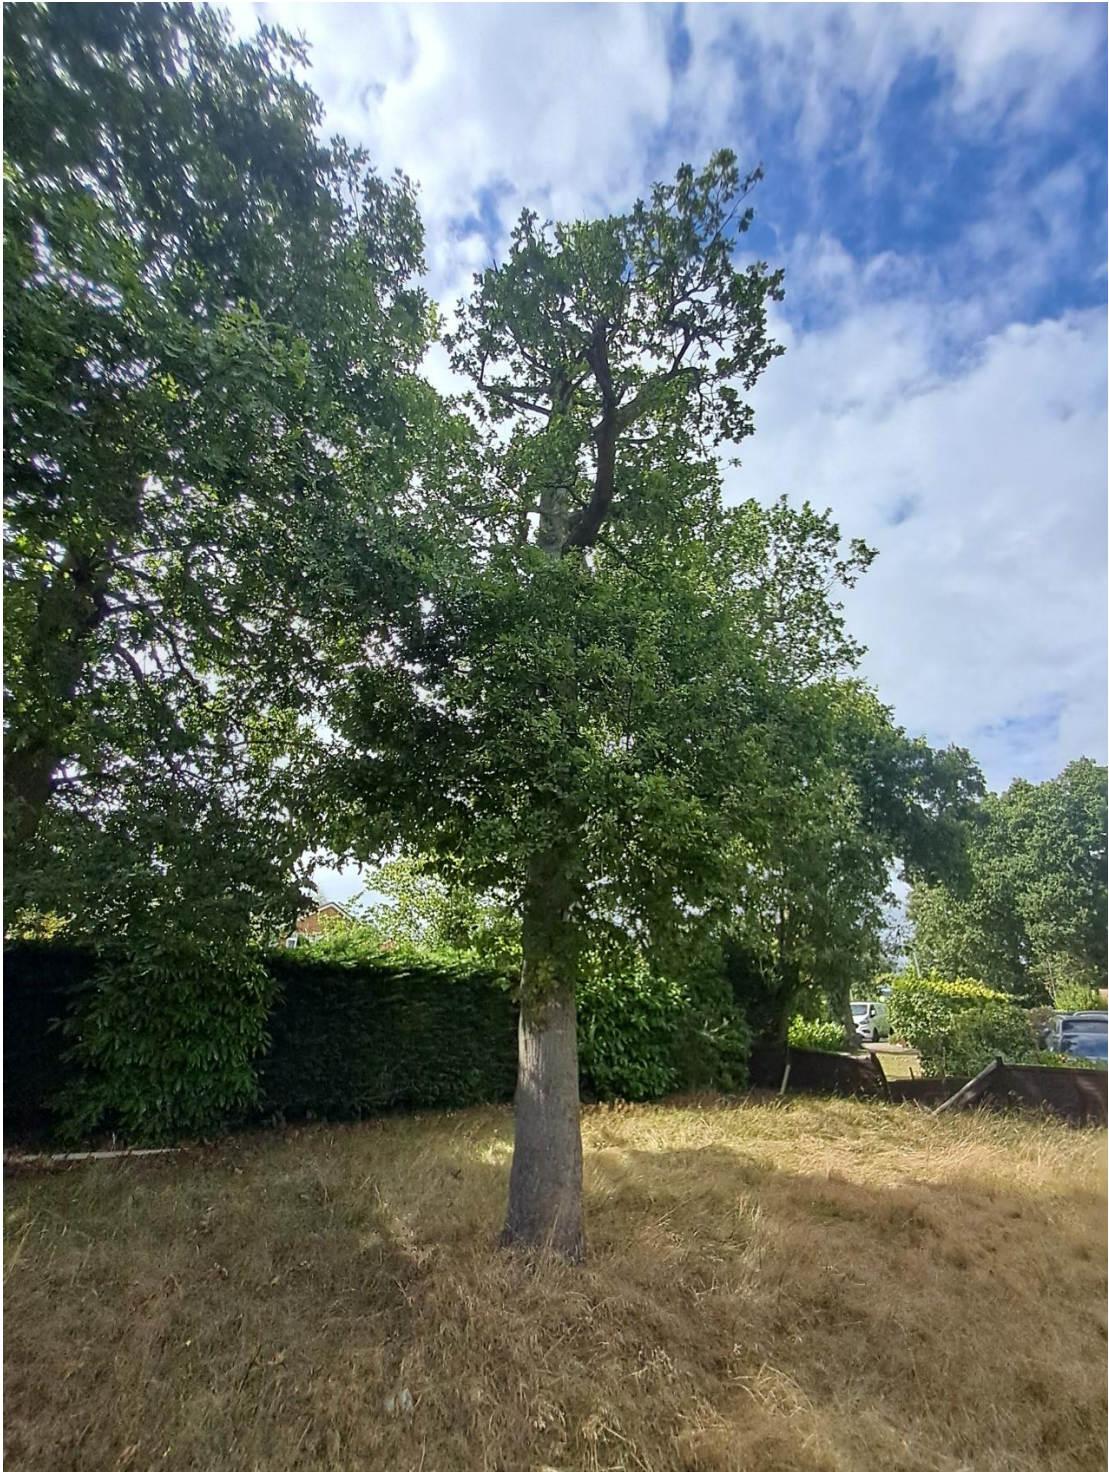
| Ref: | Species | Description | Cat. |
|---|---|---|---|
| T007 | Oak<br>(Quercus robur) | <p>T007 is a low-grade Oak that has been heavily reduced in the past. The tree has a small, lopped crown. The lower canopy shows some indication of recovery, but the upper crown is in decline.</p> <p>The tree is not expected to make a full recovery due to evident lack of vitality – there is no wound wood growth around cutting points.</p> <p>The tree has limited amenity value being largely obscured by Oaks to the front of the site.</p> <p>Although the removal of this tree is not essential to facilitate the proposed build, it will enable improved parking layout for future occupants.</p> | C1 |

Photo 4 – Heavily reduced crown of T007 (Oak)

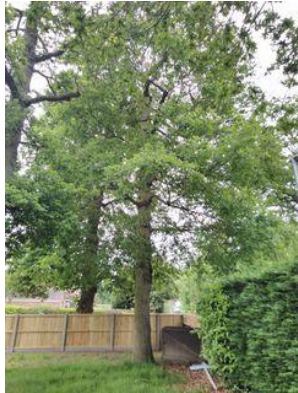
| Ref. | Species | Structure | Measurements | Spread | General Observations | Retention Category | RPA | Summary | Photo |
|---|---|---|---|---|---|---|---|---|---|
| T006 | Pedunculate oak (Quercus robur) | Tree | Height (m): 10<br>Stem Diam(mm): 490<br>Crown Clearance (m): 2<br>Rem. Contrib.: 20+ Years | N:4.5<br>E:3<br>S:4.5<br>W:5 | Vehicle strike damage on trunk. Slender crown previously heavily reduced but recovering. Foliage density normal. | B1 | Radius: 5.9m.<br>Area: 109 sq m. | Physiological Condition: Good<br>Structural Condition: Good<br>Public Amenity Value: Good | |

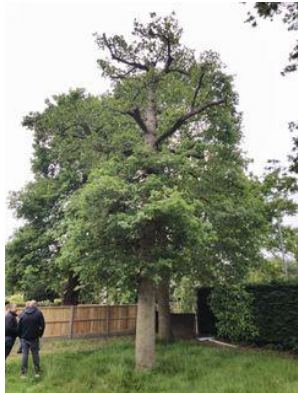
| Ref. | Species | Structure | Measurements | Spread | General Observations | Retention Category | RPA | Summary | Photo |
|---|---|---|---|---|---|---|---|---|---|
| T007 | Pedunculate oak (Quercus robur) | Tree | Height (m): 9<br>Stem Diam(mm): 490<br>Crown Clearance (m): 2<br>Rem. Contrib.: 20+ Years | N:2.5<br>E:2.5<br>S:2.5<br>W:2.5 | Heavily lopped crown, lower canopy recovering but tree unlikely to fully recover due to lack of vitality. No wound wood growth around cutting points. | C1 | Radius: 5.9m.<br>Area: 109 sq m. | Physiological Condition: Fair<br>Structural Condition: Fair<br>Public Amenity Value: Moderate | |
