# Arboricultural Impact Assessment & Arboricultural Method statement

Conway Park

A321 Tunnel

June 2026

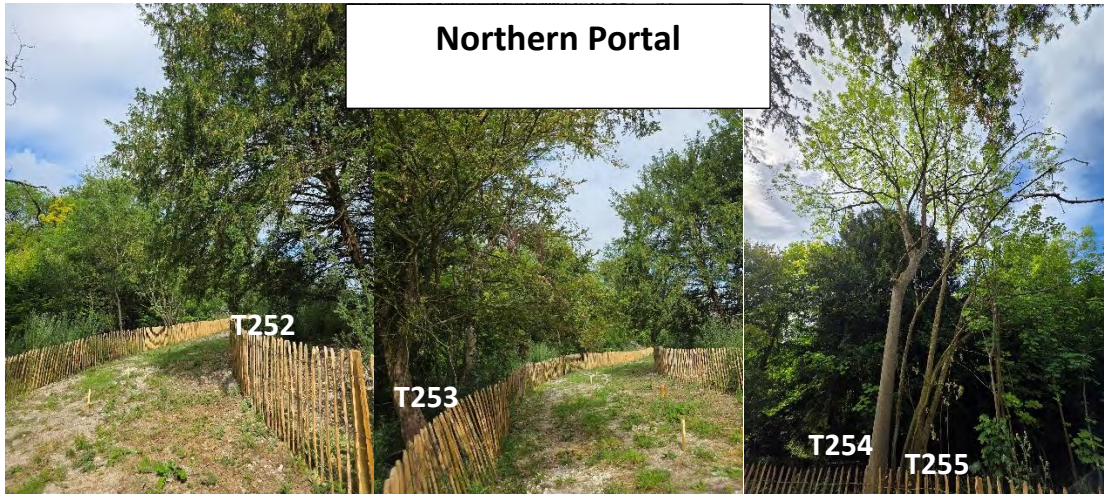
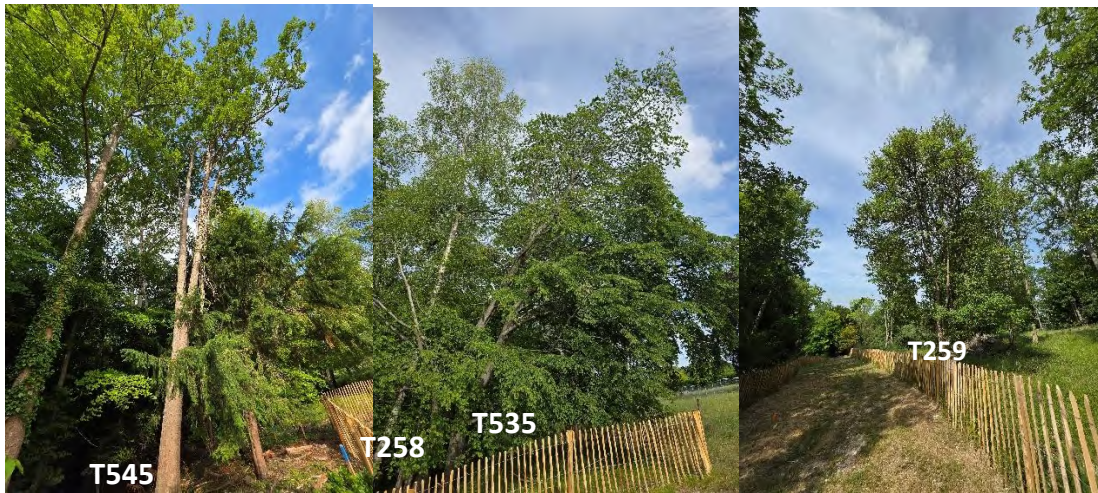
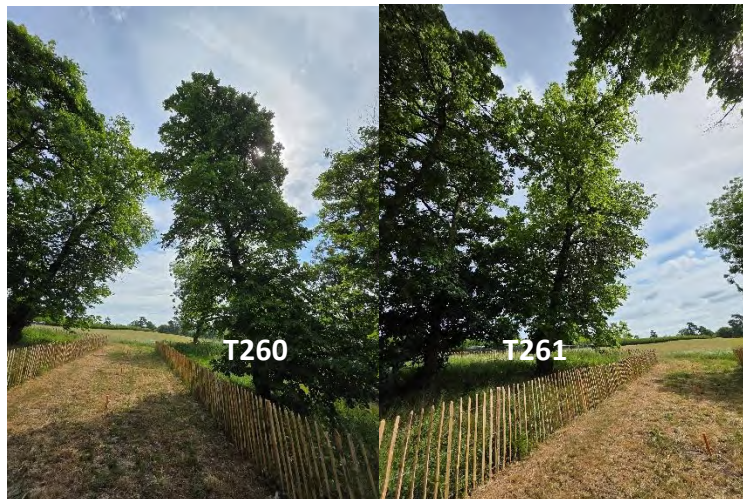
### Northern Portal

- 4.11 Due to the loss of the northern portion of G2 the risk of partial or whole tree failure of retained trees may occur. Tree T545 requires removal due to the presence of a compression union along with its newly exposed condition. T258 and T535 require end weight reductions, to reduce the lever arm affect on the main stems, which will be exacerbated by the new wind load direction.

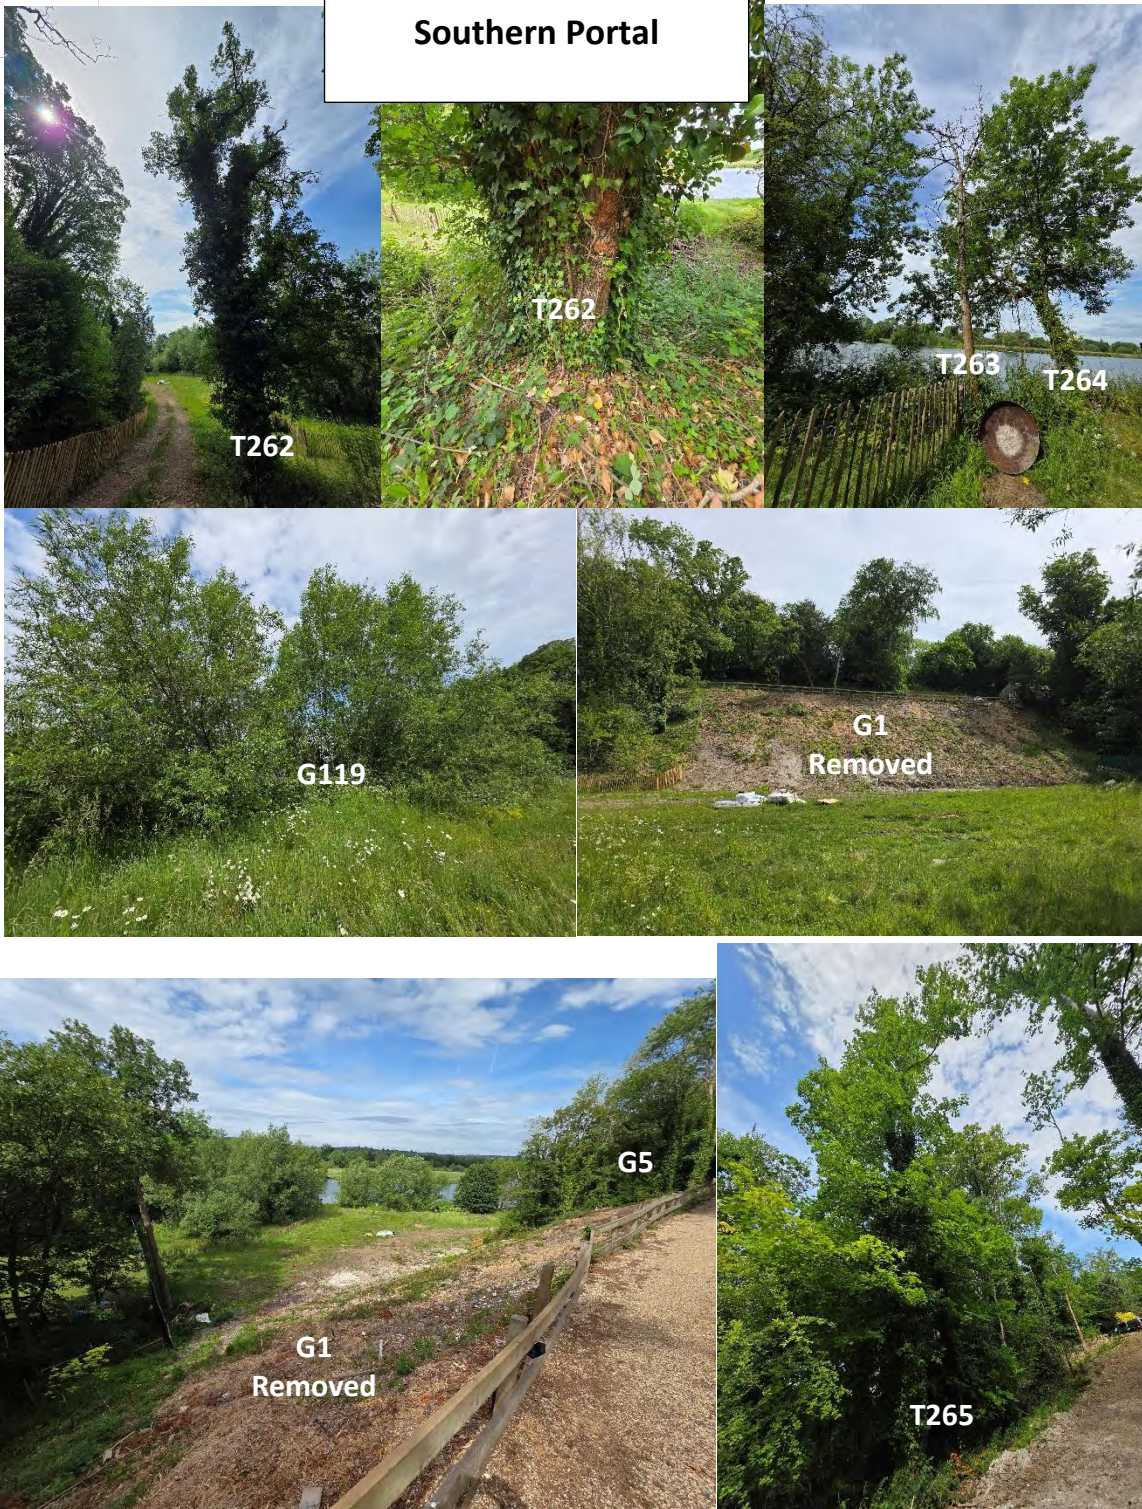
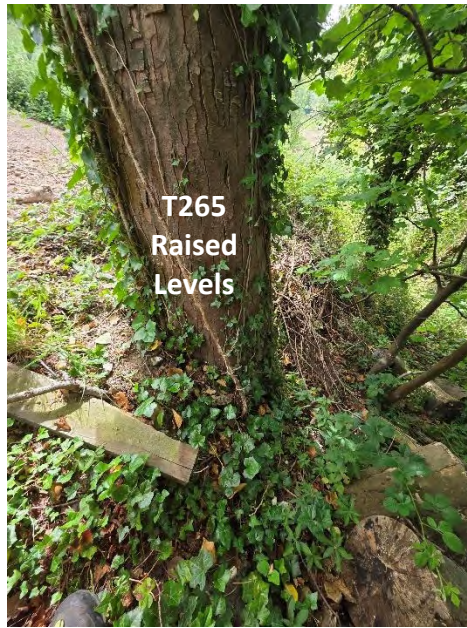
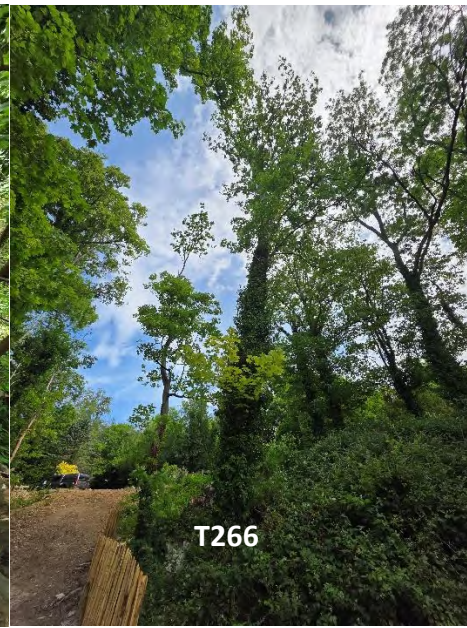
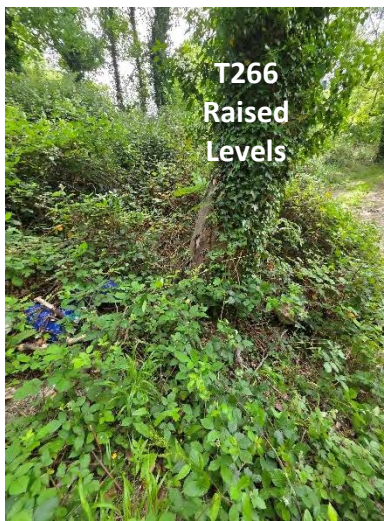
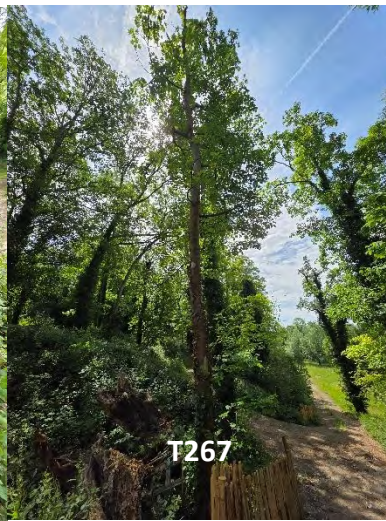
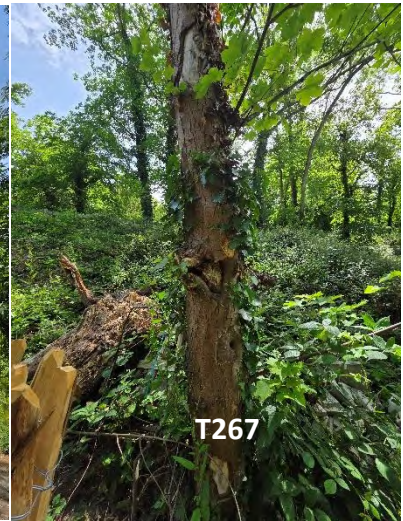
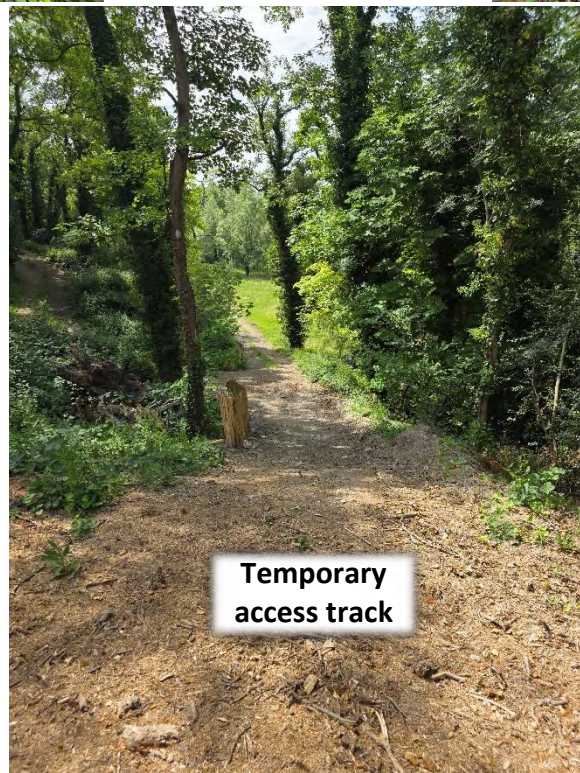
**Southern Portal**

- 4.18 Naturally occurring stem damage due to storm fallen trees has resulted in the stem damage of trees T262, T266 and T267, although T267 has evidence of historic stem damage, evident by the reaction wood around the wound.
