1App TPO 2026 1 Kerris Way Specification Plan Photos (where applicable) and Reasons (where applicable)

- Tree Work: Application for Consent for tree works to trees subject to a Tree Preservation Order.
- 
- Your Reference: TPO REF: TPO 197/ 1980 A9
- 
- From : Future Tree

- In reference to Site: Site adjacent to 1 Kerris Way, Lower Earley, RG6 5UW
- On behalf of: The Homeowner
- 
- Please find enclosed a copy of the specification for the intended tree work at the above address.

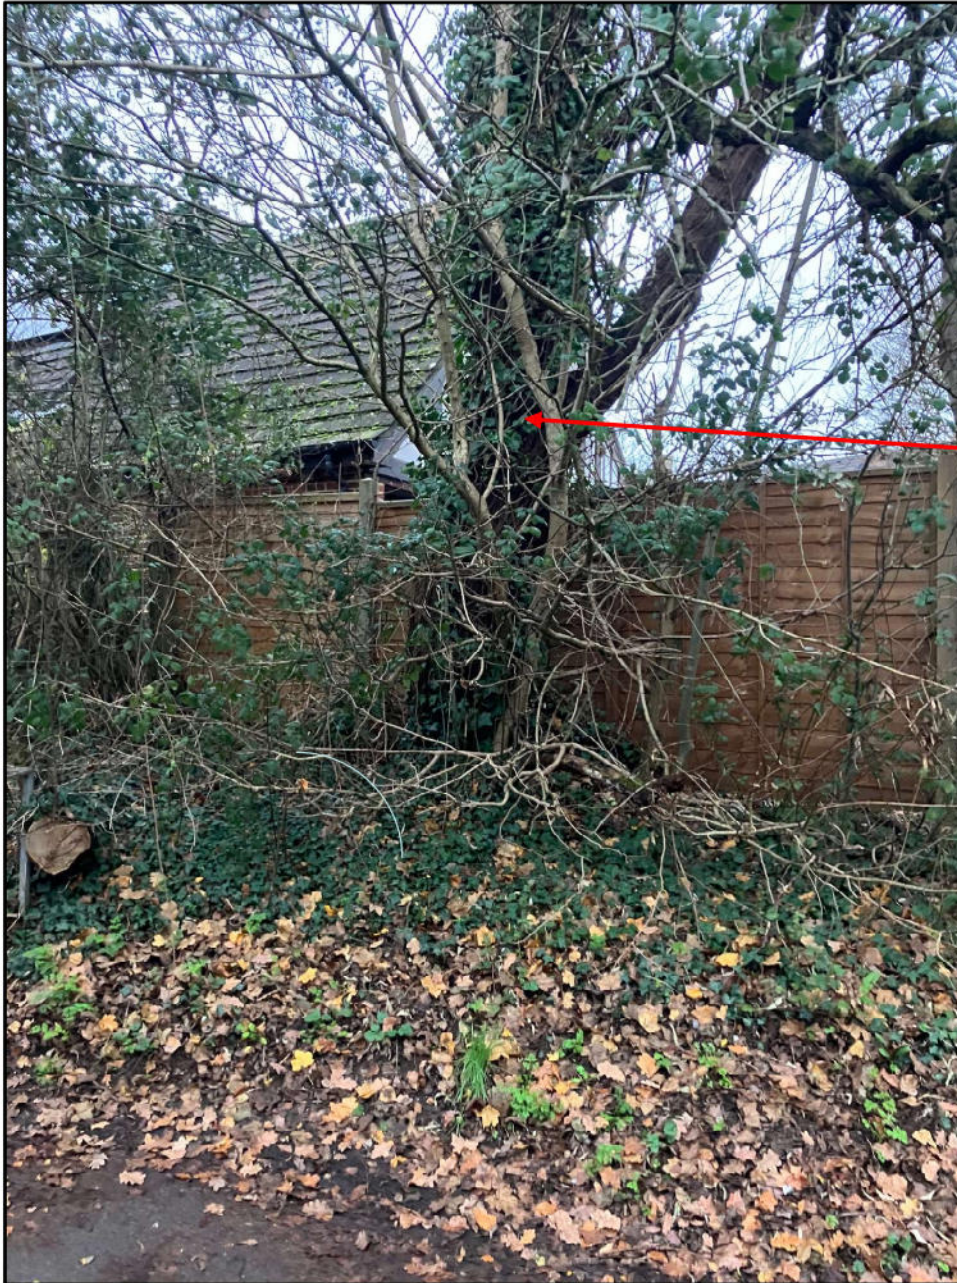
T1 Willow

- This tree has several large limbs on the West side which over sails the parking bays and garage of 1 Kerris Way to an unreasonable degree.
- The driveway is reasonably used to park the homeowners' cars and is in constant use.

- The tree consistently sheds debris across the seasons such that the use and enjoyment of the property is compromised.
- That damage may be sustained to the vehicles parked below is foreseeable.

- The root system of the tree has evidently caused subsidence to the block paving surface of the drive with significant undulations being plain to see. As yet, no evidence of subsidence to the house has been reported, although issues with tree related subsidence have occurred within Lower Early since clay soils are a feature of the area.

- It is reasonable to anticipate that if one of more of the elongated limbs were to fail it would be likely that cars may be parked underneath, and that persons may be at risk.

Grows on  
municipal land  
managed by  
Wokingham  
Borough Council

- **Proposed Action:** Remove back to close to the boundary fence line the lateral limbs on the West side of this tree. Leave an approximately 1-1.5m length portion of the limbs to where they already have secondary growth. Prune lowest limb to the north to clear the streetlight by approximately 2m.

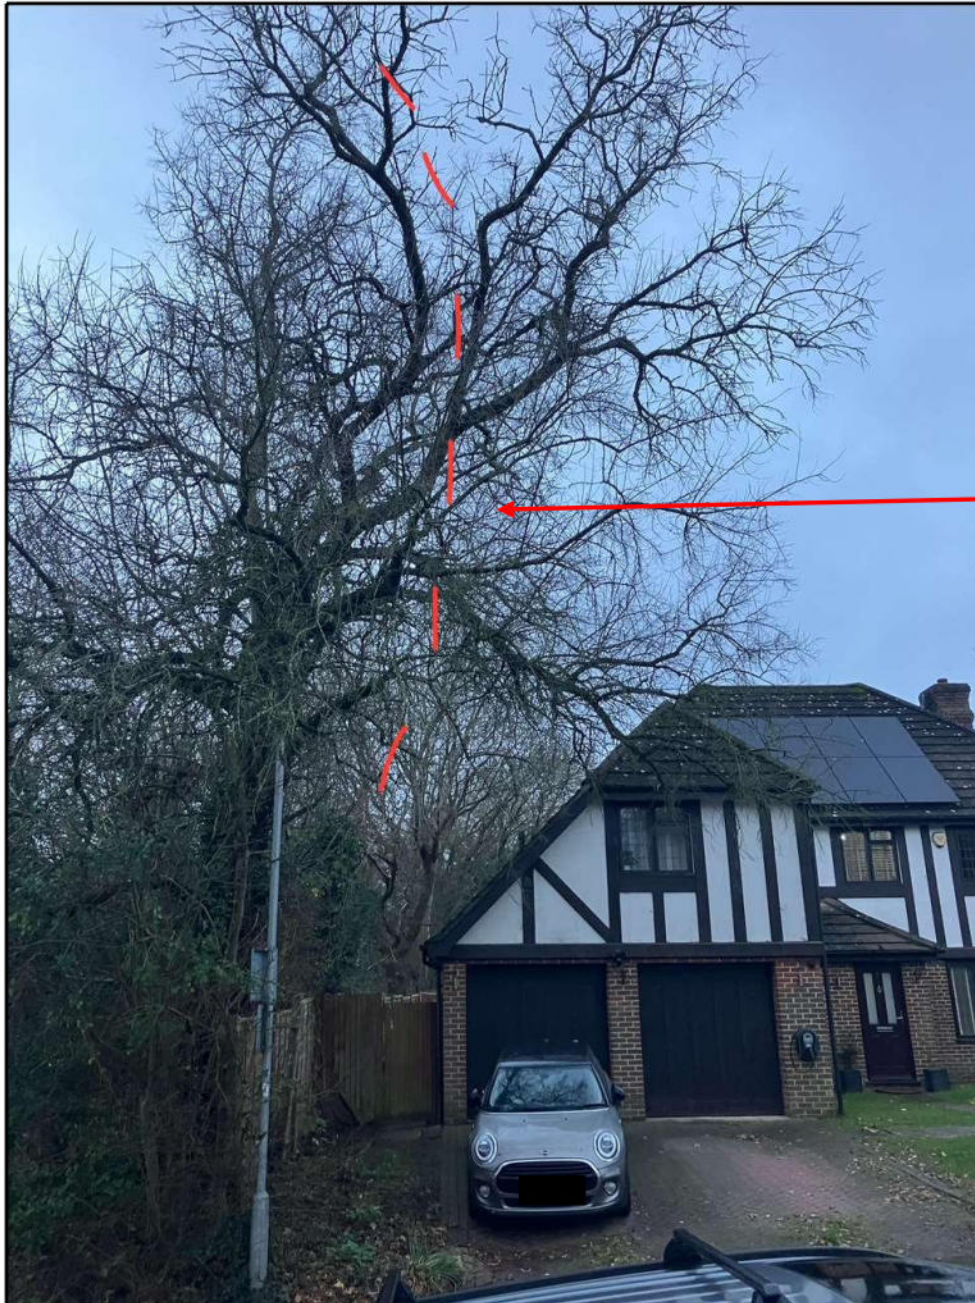
T1 Willow

Viewed from the North showing the extent of the canopy overhang above the driveway of 1 Kerris Way, and the notional pruning line.

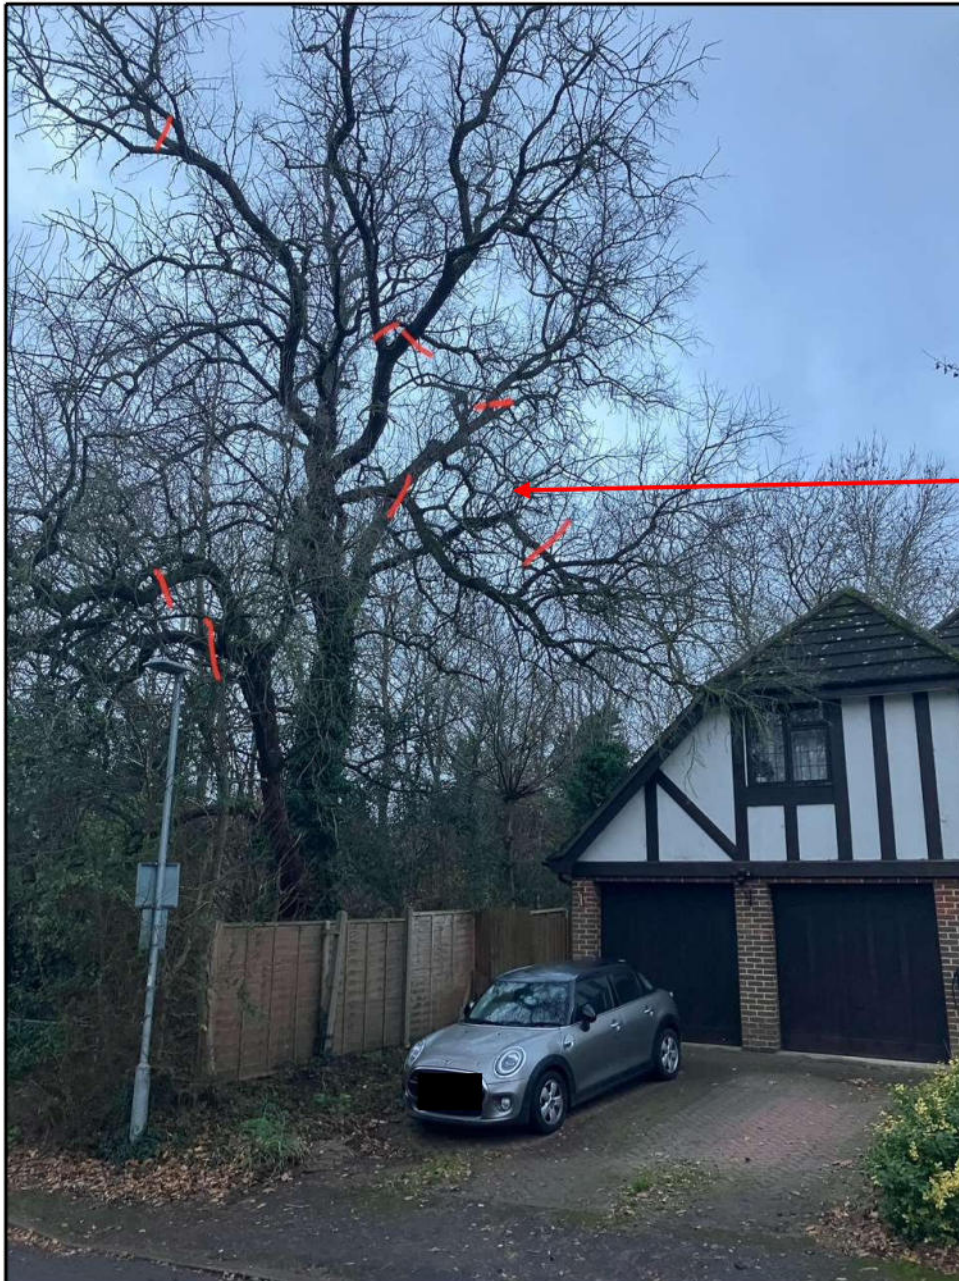
T1 Willow

Viewed from the Northwest and indicating in more detail anticipated pruning points within the canopy.  
Note: includes clearance of the streetlight.
